Assessment of a Post-Fire Debris Flow Impacting El Capitan Watershed, Santa Barbara County, California, U.S.A.

JONATHAN YONNI SCHWARTZ*

Key Terms: *Debris Flows, Post-Fire, Sherpa Fire, Wildfire, Transverse Ranges, Santa Ynez Mountains*

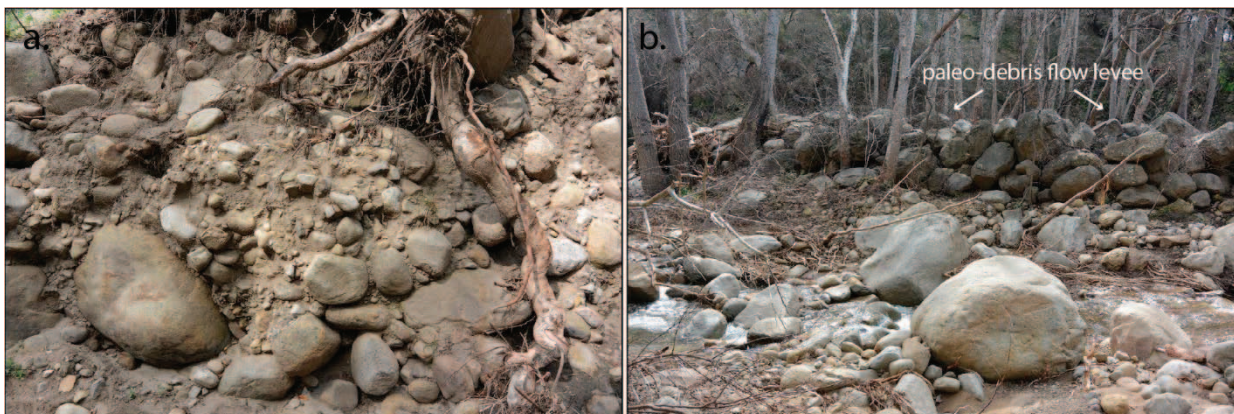
Figure 8. (a) Lateral bank erosion occurred mostly on the outer banks at channel bends, exposing unsorted, non-stratified, matrix-supported, paleo debris flow deposits. (b) Paleo debris flow levees composed of weathered sub-angular boulders were observed on the lateral margins of the active channel in El Capitan Creek.

bris flow deposits, available to be transported (Figure 8b). The parent materials of these watersheds are, for the most part, alternating sandstone and shale units, where shale units provide fine-grained colluvium for slurry production and sandstone units provide coarser colluvium and boulders (Figure 6b and c). In addition, immediately after the Sherpa Fire, ground surveys revealed widespread dry ravel further loading the channels (Schwartz, 2016). Analysis of aerial photography taken from a flight reconnaissance conducted during the BAER assessment of the Whittier Fire (9 July 2017) revealed surface erosion in the form of widespread rilling and sheetwash throughout the steep burned slopes of the Sherpa Fire, especially in the shale units, and first-order channels were scoured to bedrock (Figure 6a). Based on the steep terrain, the underlying geological units, the extensive moderate and high SBS, and the high-intensity rainstorm that triggered this event, we concluded that the steep unstable slopes and channels in the upper portions of these watersheds functioned as major sediment sources for the 20 January 2017 El Capitan flooding and debris flow event.

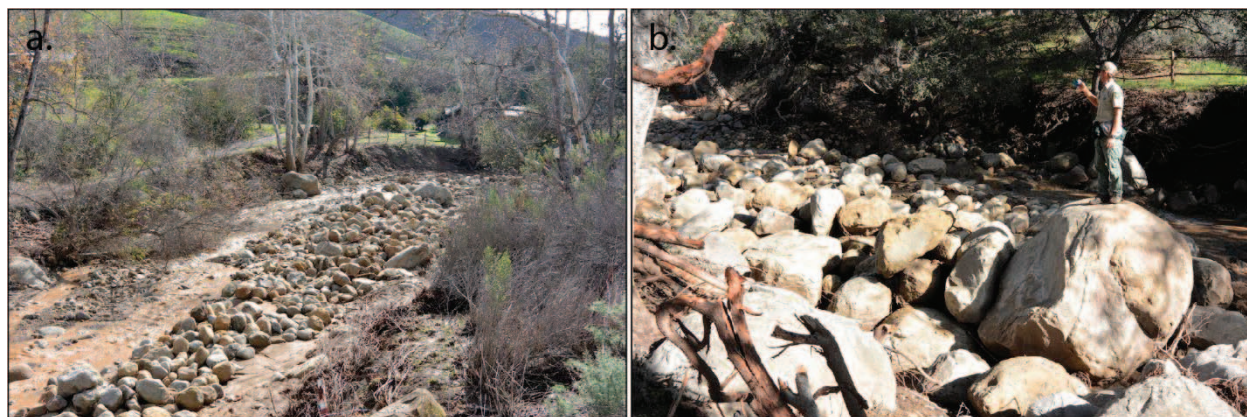
Field observations along the stretch of El Capitan Creek between the State Park boundary (upper end of the El Capitan Canyon Resort) and the Mid-Canyon Bridge (Figure 7) revealed that some segments of the stream experienced channel incision and scour depths ranging from 1.2 to 1.5 m. Other segments of the creek, mostly below the Mid-Canyon Bridge, accrued boulders and finer sediment deposition up to 4 m in depth. Lateral bank erosion occurred mostly on the outer banks at channel bends, exposing unsorted, non-stratified, matrix-supported alluvial channel and older debris flow deposits (Figure 8a). Since the field observation for this study began 24 January 2017 after the third consecutive rainstorm in a 4-day period (Figure 5), it is difficult to determine the exact time the scour and deposition took place along these segments of the stream channel. Along segments of the creek that experienced deposition, elongated boulder fields ranging in size from ~60 m to 140 m long, 10 m to 20 m wide were documented in the channel and were comprised of sub-angular to sub-rounded sandstone boulders ranging from 0.3 m to more than 2.5 m in diameter (Figure 9).

Figure 9. (a) Large elongated boulder fields that were deposited in the active channel. Boulder fields ranged in size from ~60 m to 140 m long and ~10 m to 20 m wide, and contained (b) sub-angular to sub-rounded sandstone boulders ranging in size from 0.3 m to more than 2.5 m in diameter.

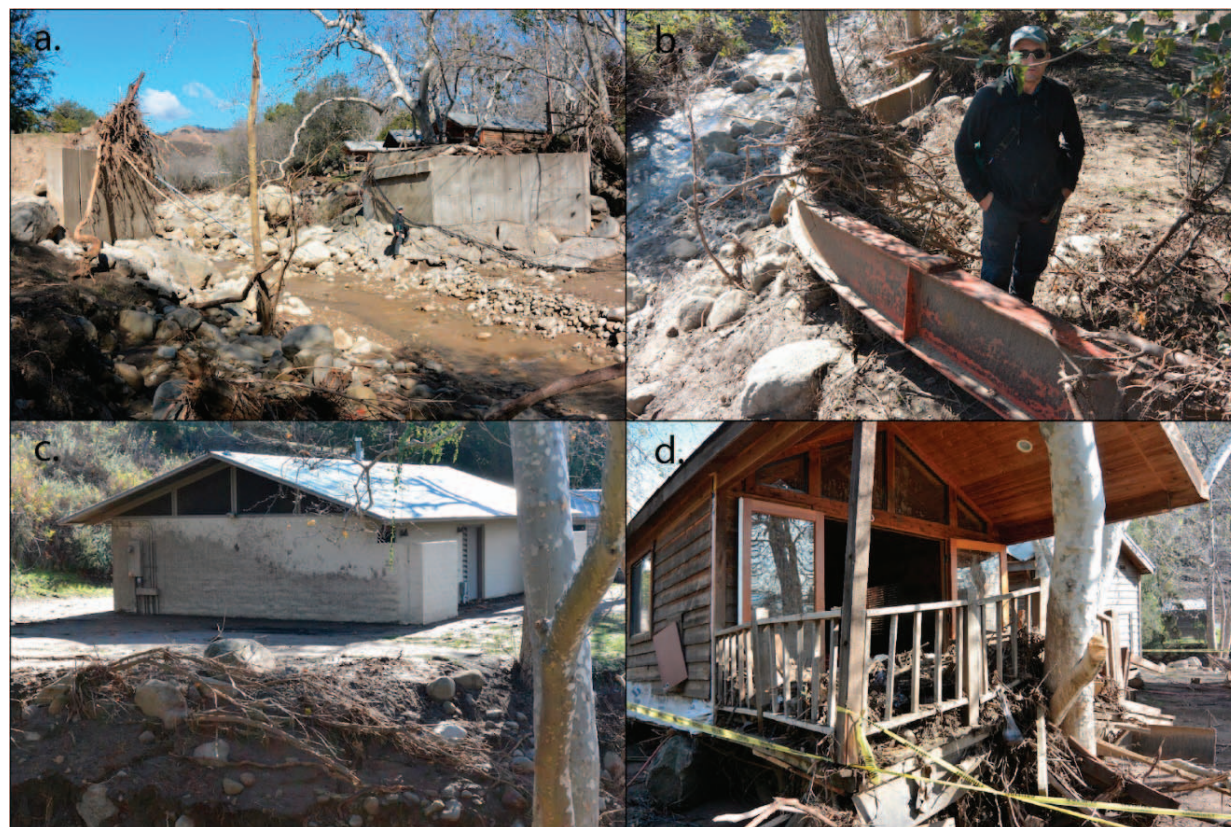
9:20 a.m. PST, about 13 minutes after the period of highest 15-minute rainfall intensity. Field evidence and eyewitness reports suggest the debris flow surge front included coarse woody debris that plugged foot and vehicle bridges, culverts, and the Hwy 101 underpass, similar to the 9 January 2018 Montecito debris flows that followed the 2017 Thomas Fire. This coarse woody debris included burned tree limbs and other vegetation transported down the creek from the upper portions of the watershed as well as riparian vegetation that survived the fire but was stripped and transported downstream by the powerful flooding and debris flow. The first bridge to be impacted by the debris flow was the Mid-Canyon Bridge, a large wood deck bridge, approximately 5 m wide and 15 m long. This bridge was supported on both sides of the creek by concrete abutments (Figure 10a). Attached to the top of these abutments and supporting a wooden deck were three metal I-beams 45.72 cm high, 19.05 cm wide, 0.95 cm thick, and 15 m long. The debris flow surge front demolished the bridge, knocking it off its abutments. The metal I-

beams were carried downstream and twisted around large standing trees (Figure 10b).

mud patinas to heights of up to 2.5 m above the bank-full discharge (Figure 10c). Similarly, along the channel bed, large oak and sycamore trees surviving the flow path were marked by mud patinas and scarring on their upstream side to heights of 2.5 m above bank-

levels of damage (Figure 10d). Nine cabins were forced off their foundations and swept downstream and as many as 21 vehicles were carried away and crushed, some reaching the ocean.

Figure 10. (a) Damage to the Mid-Canyon Bridge, supported on both sides of the creek by concrete abutments. (b) Twisted metal I-beams that supported the Mid-Canyon Bridge prior to the debris flow event. (c) Structure on the flood plain marked on its up-stream side by mud patinas to a height of up to 2.5 m. (d) Damaged cabins at the El Capitan Canyon Resort.

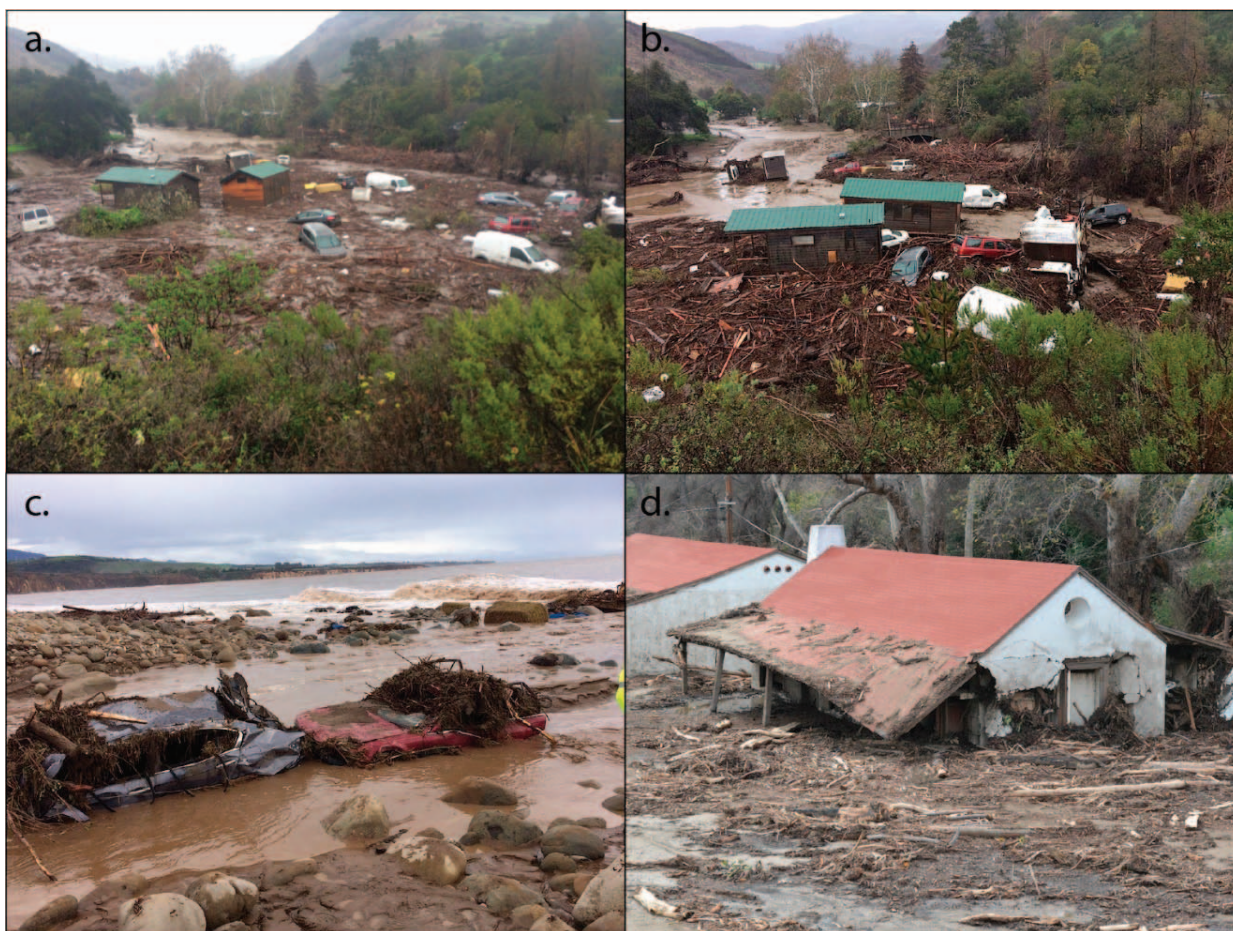
Figure 11. (a) Large soil-surfaced parking lot near the entrance of the El Capitan Canyon Resort turned into a debris catchment basin as debris flows and flooding impacted the El Capitan watershed and plugged the Hwy 101 underpass. (b) Once the Hwy 101 underpass was clear of debris, the high level of water in the soil-surfaced parking lot area subsided and much of the debris (including cars and cabins) was deposited in the parking lot. (c) In total, four cars, one truck, and one tractor were transported out to the ocean at the mouth of El Capitan Creek. (d) In the Canada Del Corral watershed, woody debris clogged the Hwy 101 underpass, which created a backup that caused mud and boulders to flow overbank onto the floodplain, resulting in damaged historic adobe structures located north of Hwy 101.

Resort Entrée Bridge. As these bridges were completely plugged, the flood was diverted out of the channel and into a large soil-surfaced parking lot (approximately 100 m by 60 m) located below and to the west of the El Capitan Canyon Resort Entrée Bridge and adjacent to Hwy 101 (Figure 7). As debris and flows avulsed the channel, flooding the parking lot area, flows continued toward the Hwy 101 underpass. At this stage, in addition to large amounts of woody debris, mud, rocks and boulders, the debris included cars and cabins that were swept away by the flows. As a result of debris plugging the Hwy 101 concrete underpass (3.6 m wide \times 4.6 m high), the large soil-surfaced parking lot turned into a debris catchment basin (Figure 11a). Based on the size of the parking lot and depth of debris estimated from photo documentation of the parking lot during the peak of the event, it is estimated

that the volume of debris retained in this “temporary debris basin” ranged from 12,000 m³ to 16,000 m³ between 9:20 and 9:45 a.m. PST.

From eyewitness reports and security camera videos at the Exxon-Mobile oil and gas facility located at the confluence of Cañada Del Corral and Las Flores Canyon, it appears that at the same time El Capitan Creek was impacted by flooding and debris flows, Cañada Del Corral and Las Flores Canyon were experiencing similar events. Video footage demonstrates that the event impacting these drainages was primarily sediment-laden flooding with large amounts of woody debris and smaller quantities of large boulders as compared to the event in El Capitan Creek. The surge front of this sediment-laden flooding reached the oil and gas facility at 9:20 a.m. PST and continued for approximately 25–30 minutes. By 9:50 a.m. PST the high flows in both drainages subsided. As in El Capitan Creek, once the woody debris flowing down Cañada Del Corral reached the Hwy 101 underpass, it clogged the underpass and inundated the floodplain, damaging historic adobe structures located north of Hwy 101 (Figure 11d).
