# IMAGE Failure Review Board Final Report

## *Executive Summary*

September 19, 2006

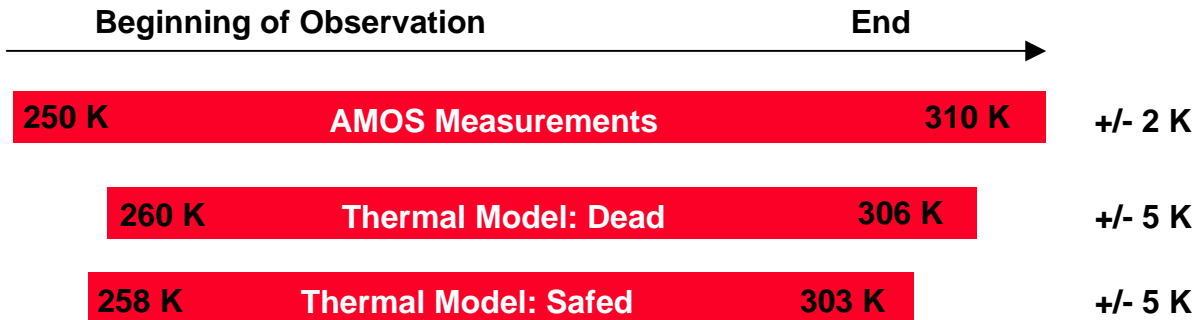
Figure 4-1: Summary of AMOS and thermal model temperature comparisons.

Figure 4-1, which shows the comparison of beginning and end of observation temperatures for the AMOS measurements vs. the two modeling cases discussed above. As can be readily seen, although the thermal models have good agreement with the AMOS measurements, the temperature difference between the model cases is smaller than the error in each. This is due largely to the fact that a large percentage of all 10 sides of the IMAGE spacecraft are covered with solar arrays that dominate the average temperature observed and predicted<sup>9</sup>. Additionally, the solar array temperature is largely invariant over the relatively small range of loading conditions between nominal operations, safemode, and a ‘dead’ state where no power is drawn from the array.<sup>10</sup> Thus, the comparison of temperature measurements and predictions is inconclusive in determining the safed vs. dead state of IMAGE.

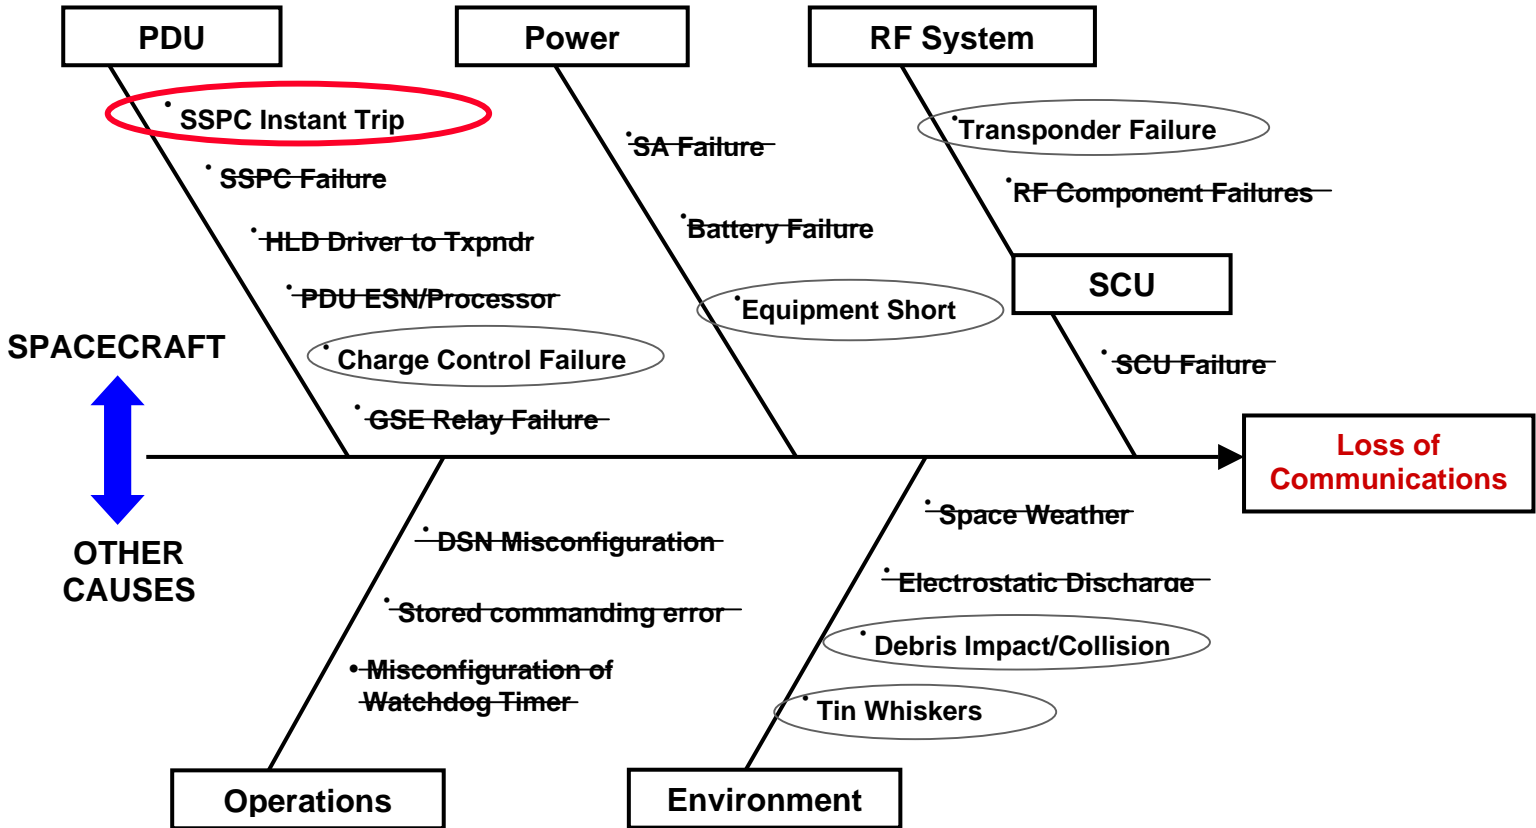
Figure 4-2: Fishbone fault analysis summary.

The result of the fault analysis was that the most likely root cause of the loss of communication event was a loss of communication capability due to the Transponder SSPC inadvertently opening (an instant trip event). This would put the Transponder into an unpowered state unable

to provide any communications capability to the spacecraft. However, several other possible causes, although considered unlikely, cannot be completely ruled out. They are; 1) Charge control system failure, 2) Massive short in the PDU or Transponder, 3) Transponder Transmitter failure, 4) Micrometeoroid or orbital debris (MM/OD) impact, and 4) Tin whisker growth resulting in massive short circuit.

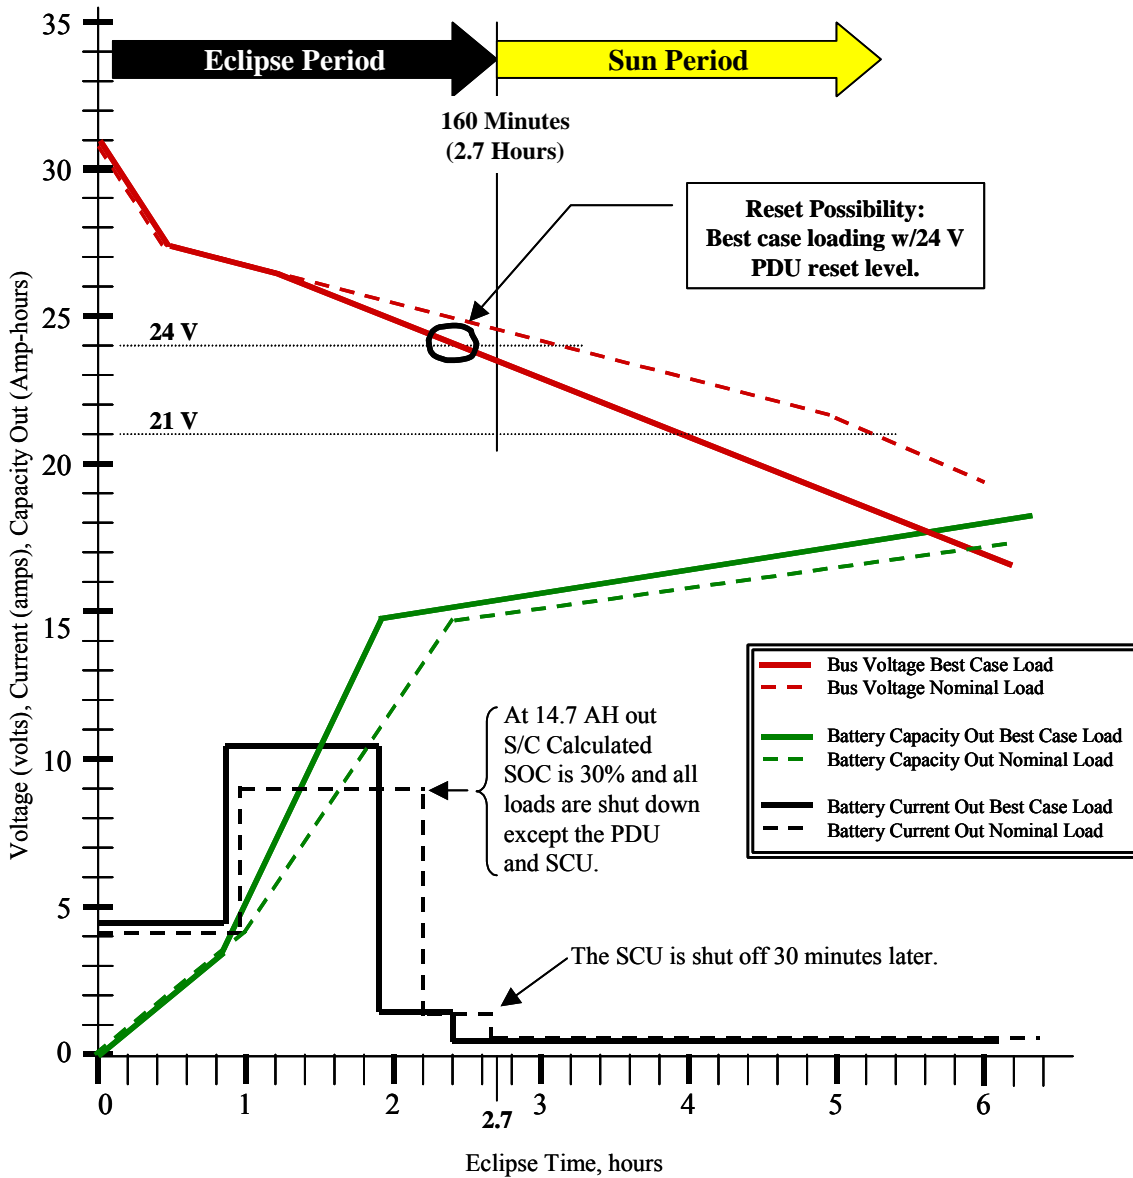
Figure 5-1: Eclipse Discharge Summary for Nominal and Best Case Load Estimates.<sup>19</sup>

An attempt was made to model the battery discharge curve (time-voltage curve during draw down) for the anticipated loading conditions described above. The methodology consisted of starting from an ideal discharge curve taken from pre-launch battery test data, then extrapolating that to account for battery aging, different actual vs. Flight Software assumed (i.e. nameplate) initial battery capacity, anticipated October 2007 eclipse load profile, etc. Two discharge curves were generated, the first assuming a best estimate current profile as described above. The second was generated assuming best case/maximum current draw that was calculated by taking the nominal values and favorably adding the error uncertainties.

That degradation rate was initially also calculated from the test data by comparing the capacity measurement from the lowest cycle to the largest cycle test curves and then computing an average capacity loss rate by converting the cycle values to equivalent years (using the average number of eclipses per year as cycles per year). The approximate capacity loss rate was estimated at 1.62 Ahr/year using this method. The capacity loss value was then applied to the original capacity of the flight battery at launch, yielding 14.25 Ahr. Next, the capacity estimate was increased to account for an estimated lower average load current during the eclipse than the test data was taken at (6.3 A vs 11 A)<sup>18</sup>. This raised the estimate to a value of 16.4 Ahr.

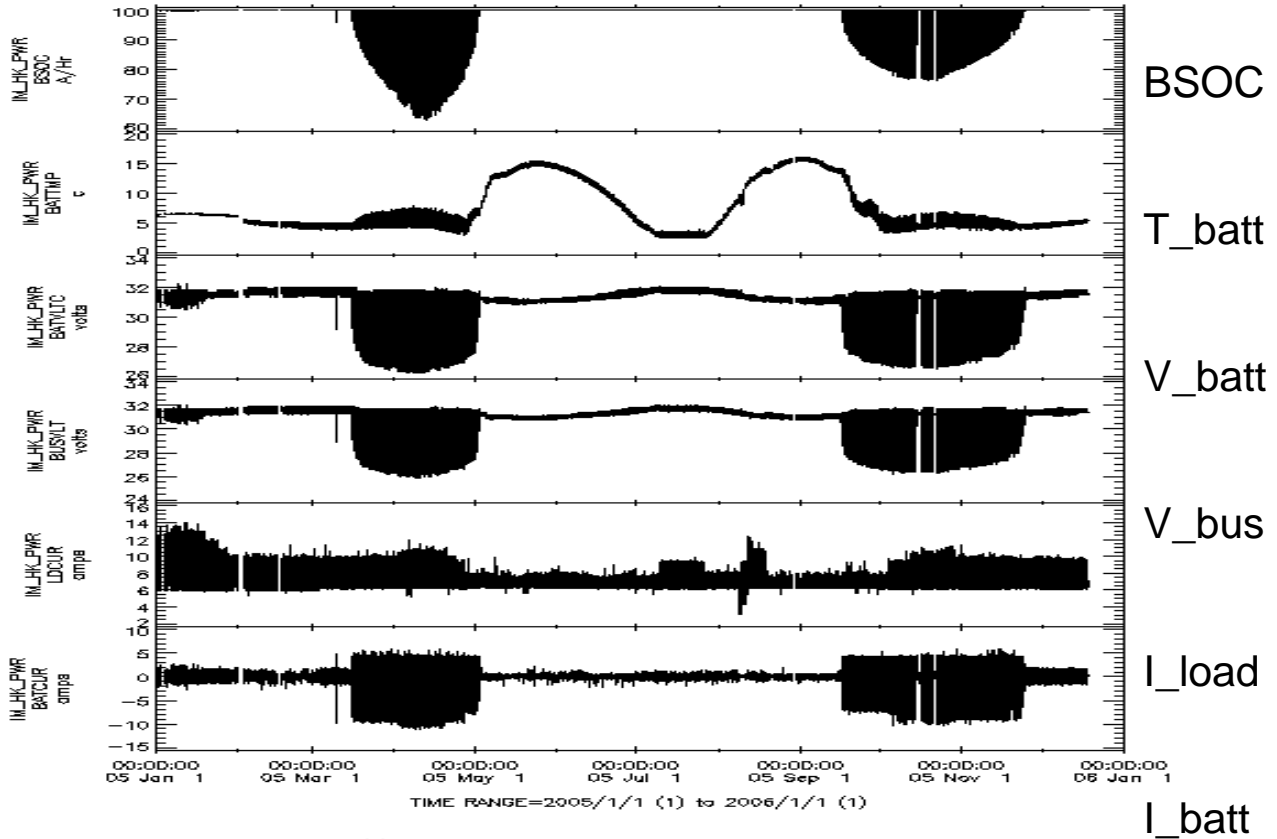
Figure A-1. Battery/bus temperature and voltage trends under typical loading.

**Conclusion:** IMAGE has no history of battery anomalies (see Figure A-1 for typical trending data). All available telemetry showed healthy batteries and no indication of cell shorting or other battery degradation. The probability of multiple battery cells shorting over a short period (~8.5 hours<sup>23</sup>) is highly improbable. Battery shorting is not a likely cause for the failed communication capability.

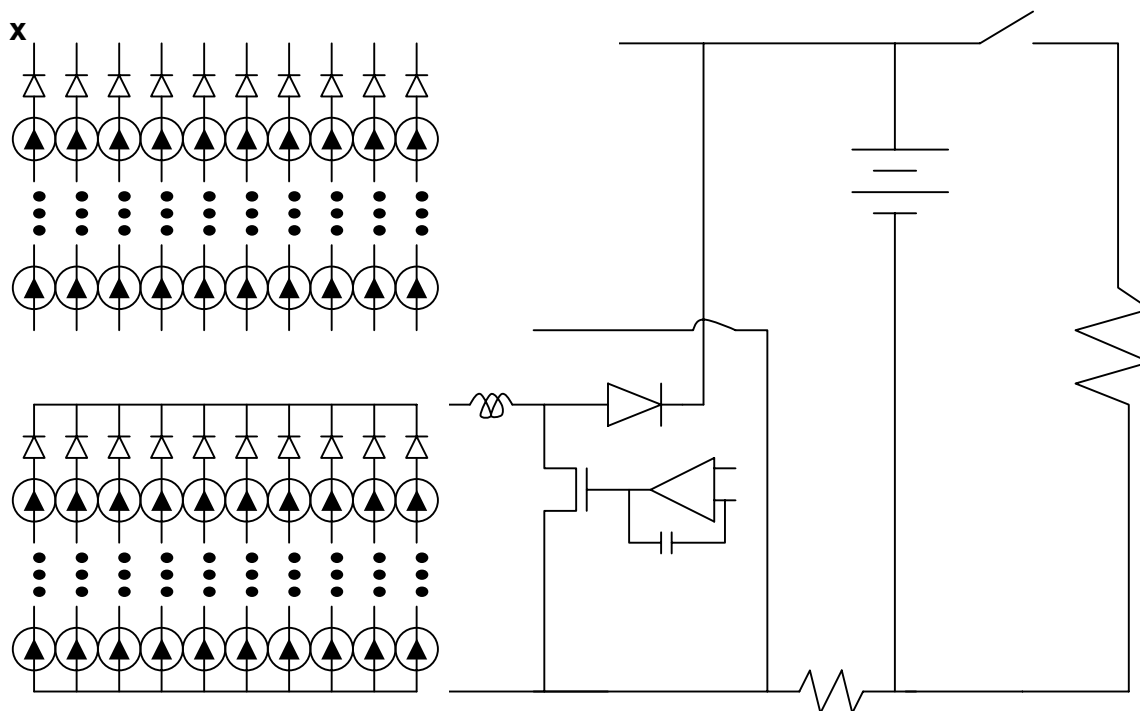
Figure A-2. High-level solar array schematic.

The array configuration uses blocking diodes and bypasses, which mean that, in the event of a short or open in a cell, a single cell failure will not take out an entire string (see Figure A-2).

**Conclusion:** IMAGE has no flight history of solar array anomalies. All available telemetry showed a healthy array with the degradation less than expected in its extended mission. The configuration of the array makes it highly unlikely that a failure involving a short or open between the array panels and the PDU input or a failure involving a significant number of individual cells is the cause of IMAGE's inability to communicate.

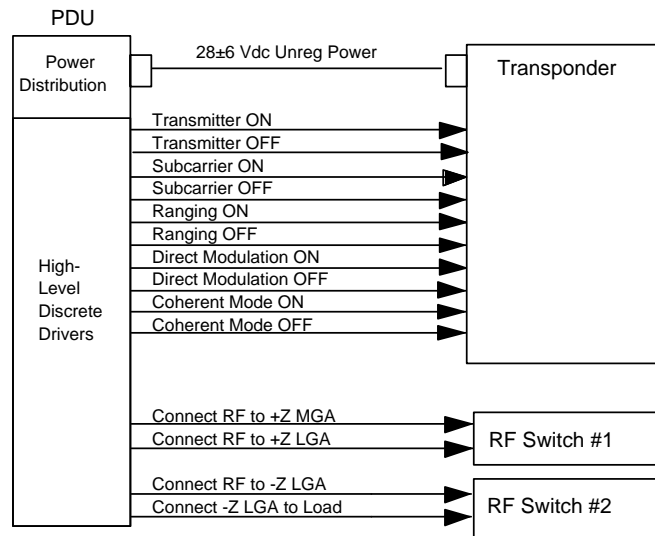
Figure A-3. High Level Discret control of Transponder.

**Analysis:** The Transmitter ON/OFF state is controlled by an internal Transmitter latching relay that is controlled by High Level Discret (HLD) pulses. A separate HLD circuit exist for the ON and OFF command function (see Figure A-3).

The most likely failure mode of the Transmitter HLD concerns three transistors controlling the Transmitter ON/OFF state, any of which if shorted allows the controlling relay coil to be continuously energized.

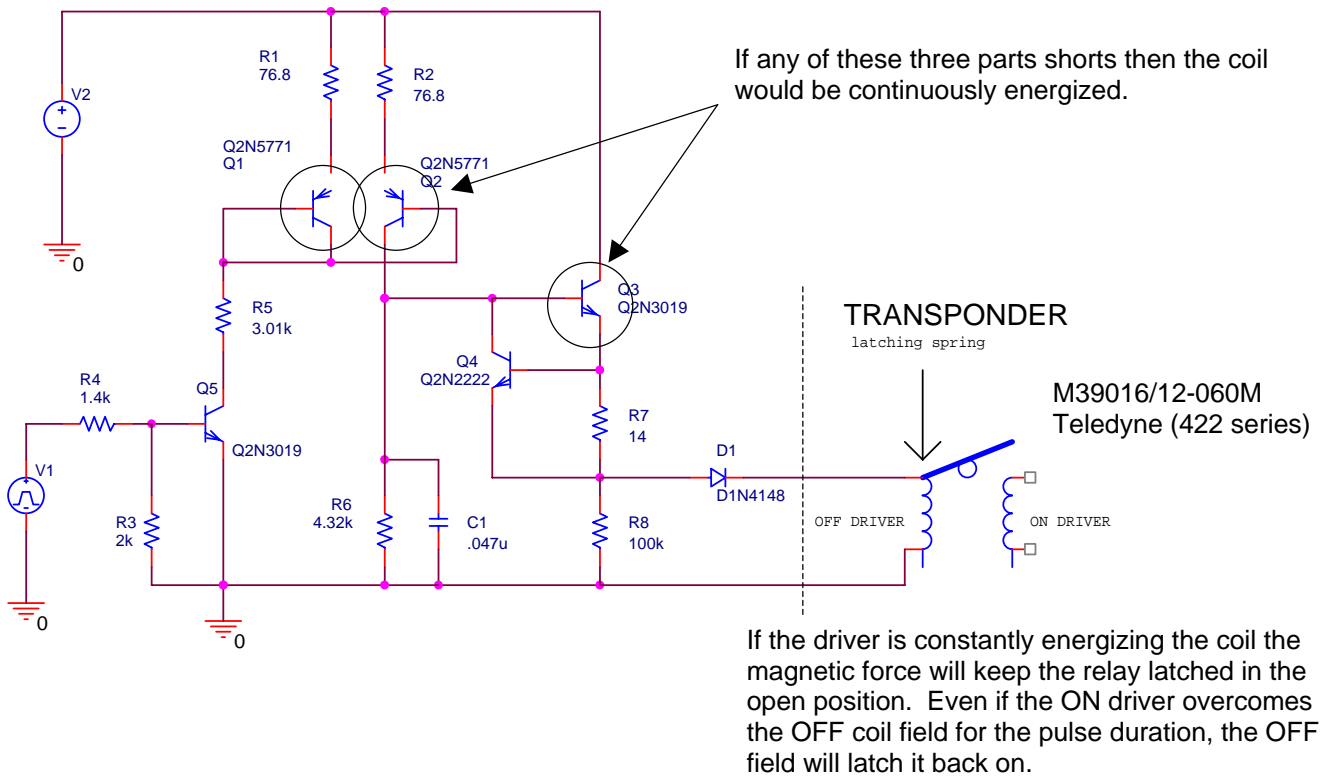
Figure A-4. Transponder HLD circuit description.

If the driver is constantly energizing the coil the magnetic force will keep the relay latched in the open (transmitter off) position. Even if the ON driver command subsequently overcomes the OFF coil field for the pulse duration, circuit analysis indicates that the OFF field will latch it back on. See Figure A-4 for HLD circuit description.

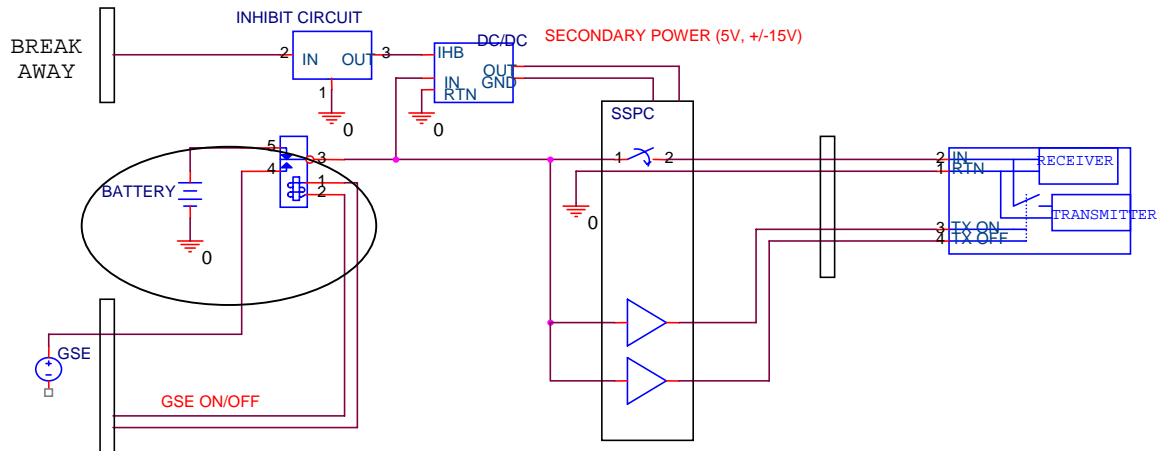
Figure A-5. GSE circuit configuration.

**Analysis:** The spacecraft has a relay that was used in I&T to control the application of either the spacecraft’s battery or GSE supplied power to the spacecraft bus. The relay is controlled through the GSE interface. There is no on-board circuit capability to change the GSE relay state (see Figure A-5).

If the relay were to fail in orbit by switching to the GSE source position, battery power to the bus is interrupted. However, the power system design is such that in a full sunlit orbit the bus is clamped to 35V and no interruption of power would occur until eclipse. The original loss of communications event occurred with the IMAGE spacecraft in a full-sunlight orbit. If the relay were in the GSE position since launch IMAGE would have experienced power loss in previous eclipse seasons – which has not been observed.

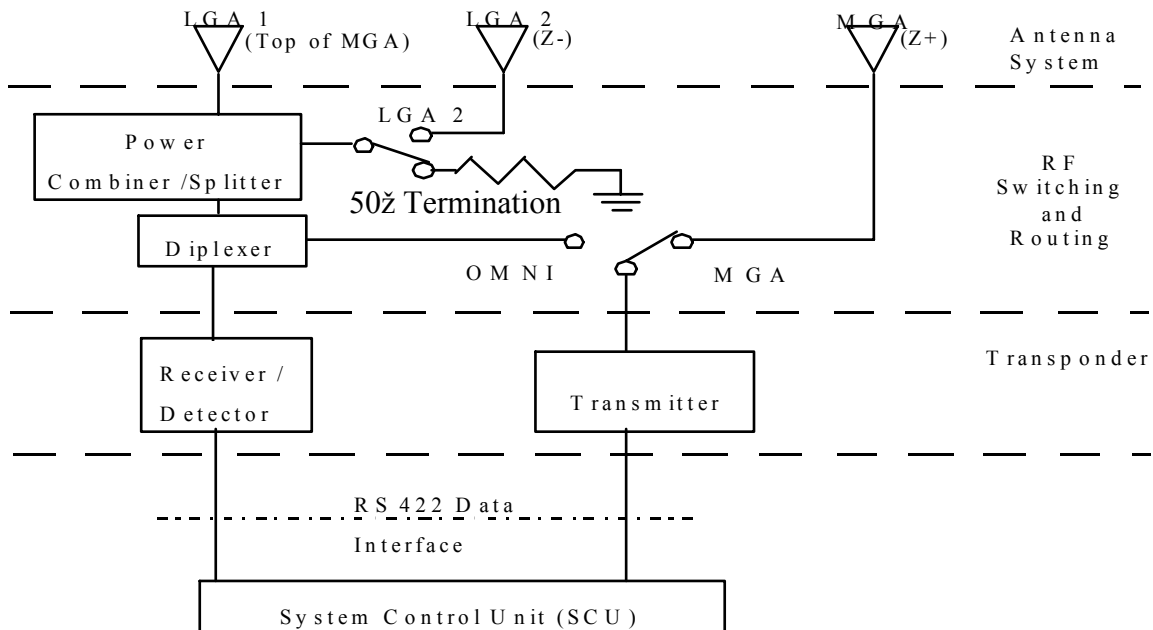
Figure A-6. RF system functional block diagram.

**Analysis:** Passive components of the RF system consist of a power splitter, diplexer, antennas, two latching mechanical relays, and coaxial cable (see Figure A-6). Active components are the Transponder itself.

Operational experience with similar passive components shows that failures are extremely rare and are typically not catastrophic when operated under a steady state condition. IMAGE RF system operation, from shortly after launch, was a continuous broadcast of 44 Kbps telemetry from the Medium Gain Antenna (MGA) antenna. Commands were received from the coaxially aligned +Z omni antenna. The mechanical RF relays were left in the configuration to allow broadcast mode. Broadcast mode was only interrupted three times due to SCU reboots that command the RF relays into a dual omni mode. Thus, the total number of cycles to the mechanical relays was well below the MTBF value, which is typically in the thousand of cycles
