**Tornado Damage in Tuscaloosa, Alabama,  
December 16, 2000**

A report prepared by  
**Larry J. Tanner, P.E.**

Submitted to NIST  
**May 22, 2001**

Wind Science and Engineering Research Center  
Texas Tech University  
Lubbock, Texas

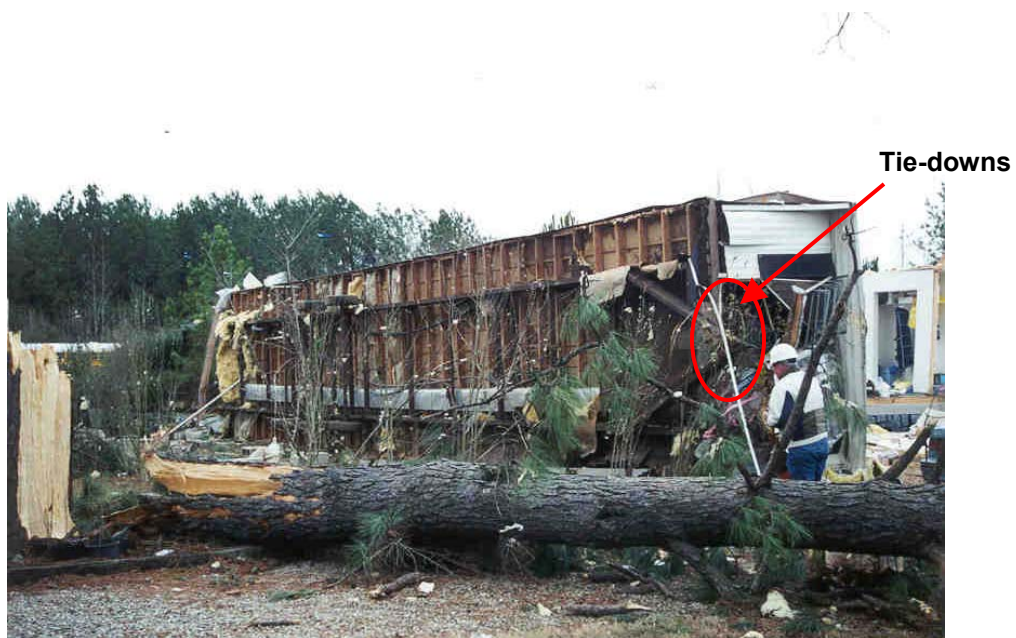
**Figure 2. Englewood Meadows Mobile Home**

The mobile home in Figure 2 represents the classic definition of the F1 description – “trailer houses pushed or overturned” (Fujita, 1971). The trailer had tie-downs and was underpinned. Photographs of the adjacent homes, Figure 3, present damage consistent with the F1 description, “roof surfaces peeled off and windows broken” (Fujita, 1971). However, the assigned wind speeds for an F1 tornado by Fujita would approach the reserve strength of the site built homes and presumably can devastate the mobile home. The assumption drawn was that either the homes were constructed better than the standard or that the wind speed better fit the category of F0 winds.

The age and general condition of the mobile homes affected by the Tuscaloosa Tornado is unknown. It is known that the state of Alabama and the Standard Building Code (SBCCI), to which the City of Tuscaloosa subscribes, specifically requires mobile home tie-downs and anchoring systems. Figure 2 shows an overturned mobile home with broken ties and Figure 13 shows further evidence of tie-downs broken by the removal of a mobile home.

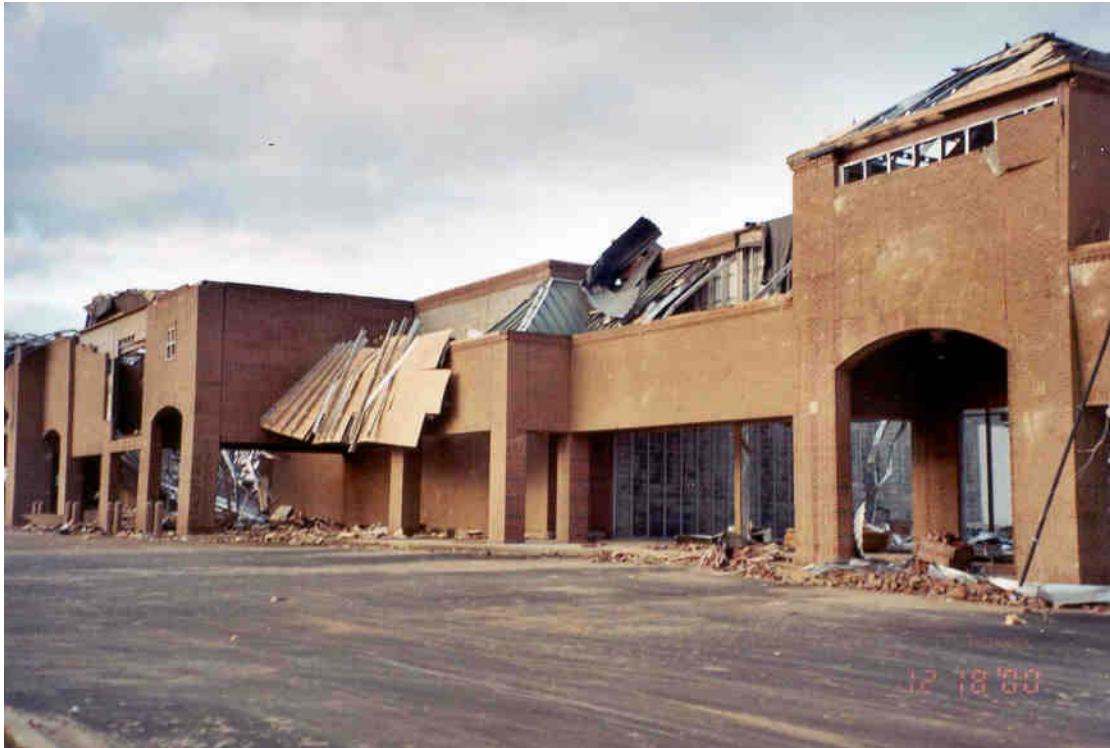
**Figure 4. Englewood Village Market Place, leeward wall**

From Englewood Meadows the tornado proceeded in a northeasterly direction crossing open ground until it struck the nearly complete and not yet occupied Englewood Village Market Place which contained the Winn Dixie Supermarket. The shopping village was constructed of built-up roofing on metal decking attached to steel bar joists bearing on joist-girders, columns and unreinforced masonry (URM) walls. The joist and girder spans were long, and the URM walls were tall (see Figures 4 and 5).

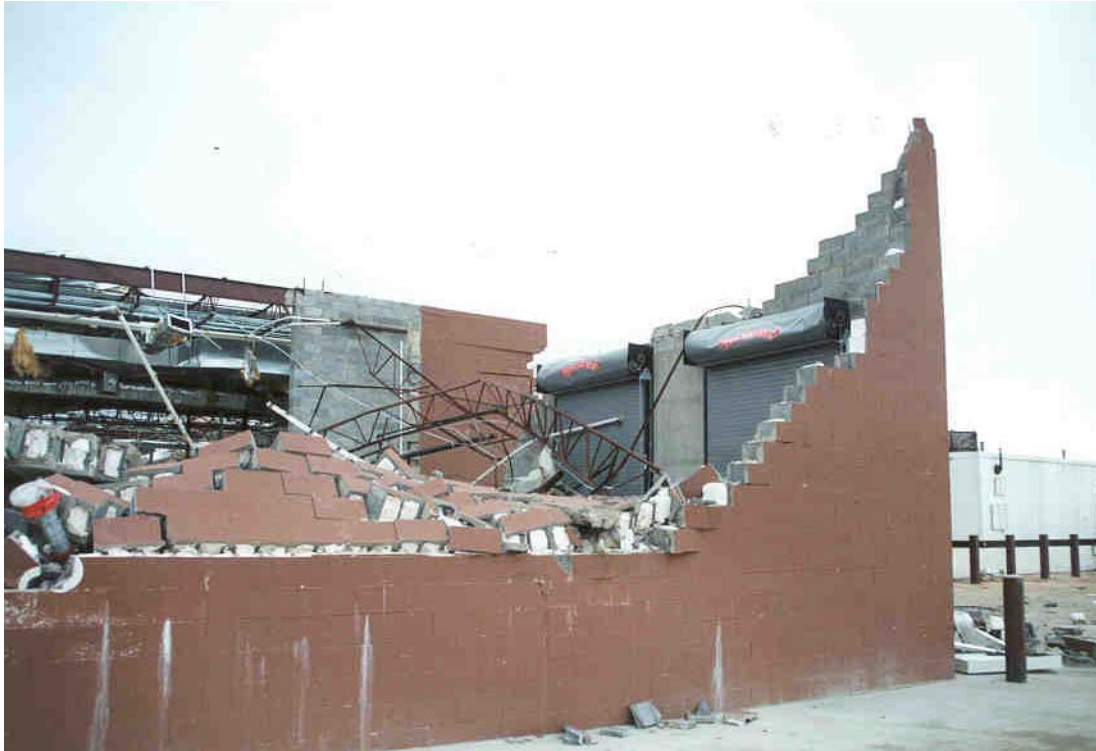
**Figure 6. Englewood Village Market Place, internal pressurization**

The shopping center building was under construction and was nearly complete; however, the window wall systems had not been installed. Therefore, for wind analysis purposes, the building would be considered as a partially enclosed structure. The wind forces acting upon the structure would have included both external and internal pressures. The combination of these forces tore the decking from the joists, thereby snarling the light steel structural elements and pulling down the URM walls. Further evidence of the internal pressurization is shown in Figure 6. The rolling doors, which would have experienced windward external forces, remained in place due to the negating internal pressures, while the roof deck experienced the combination of internal and external

pressures and was subsequently removed. Per ASCE-7, the internal pressure coefficient for a partially enclosed building would have increased the total roof uplift pressures by about 67%, thereby producing failure at a lower than expected wind load. Therefore, failure of the URM building, as predicted by the scale for an F3 storm, would have occurred at a much a lower wind speed, similar to an F1 or F2 storm.

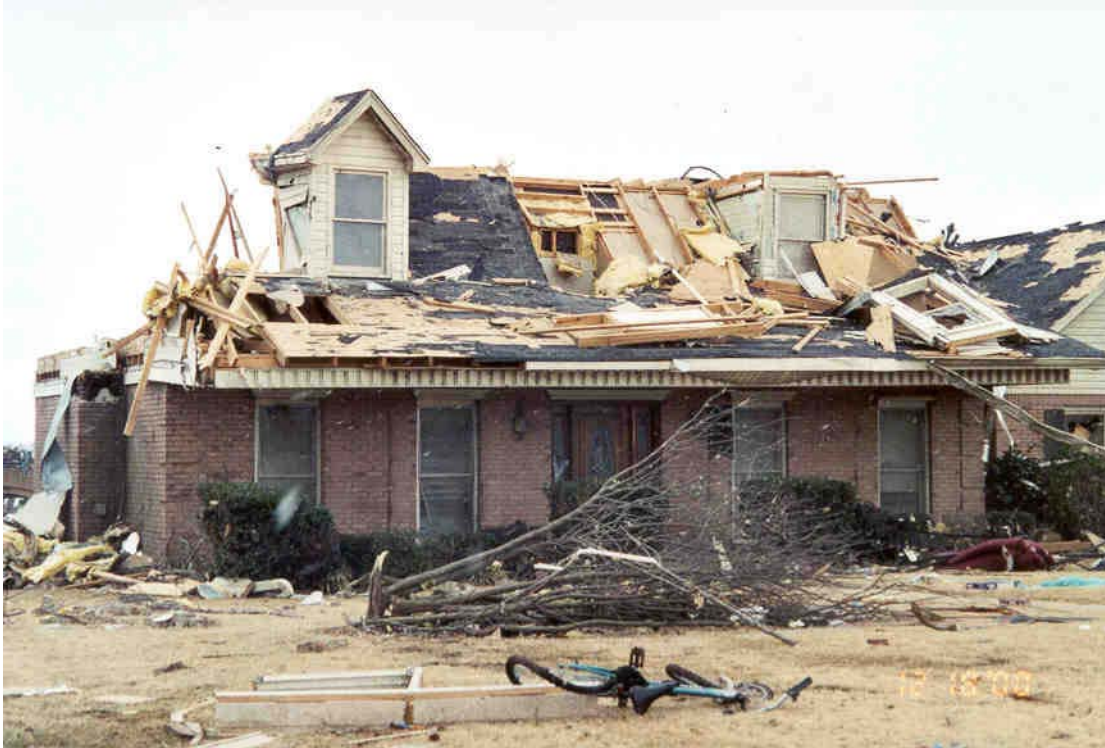
**Figure 7. Hinton Place Residence, near vortex**

From Englewood Village Market Place, the storm crossed SR 69 and struck the residential subdivisions of Hinton Place and Hillcrest Meadows, respectively. As reported by the NWS, the storm was narrow, about 750 yards wide (686 m) and the translational speed across the ground was near 60 mph (29 m/s). The homes in these subdivisions are believed to be less than 20 years old and would have been constructed under code authority. The Hinton Place home in Figure 7 was near the center of the vortex and sustained substantial structural damage to the roof and second floor wall.

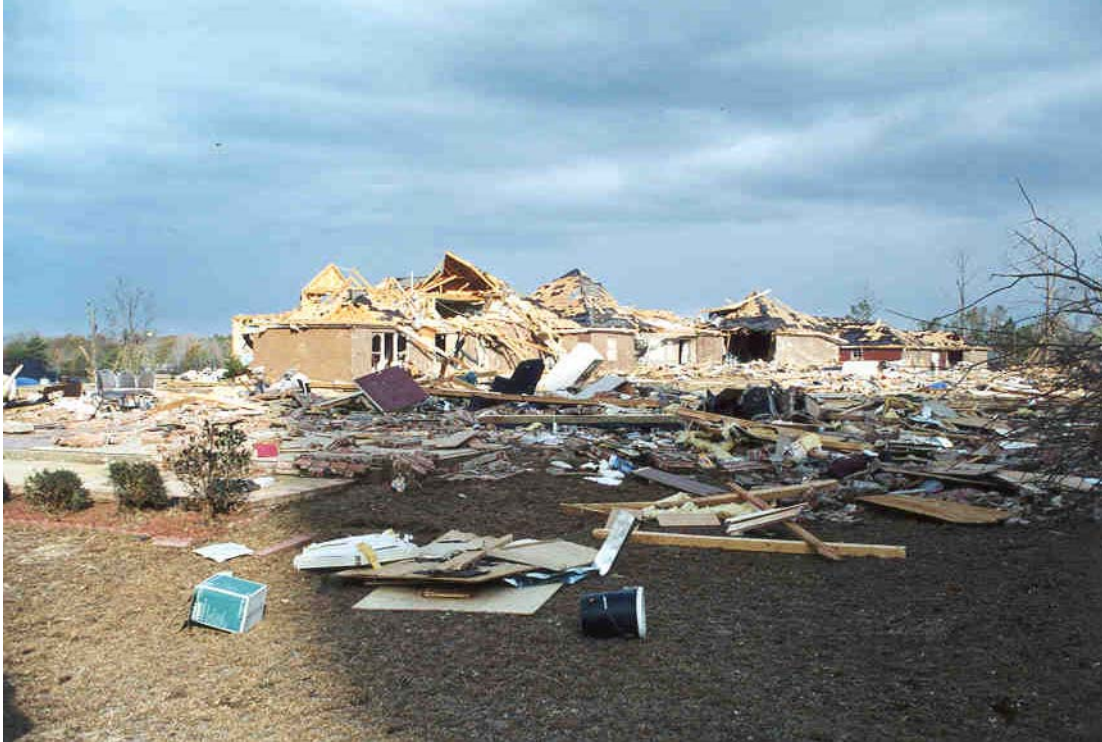
**Figure 8. Hillcrest Meadows Residence, showing gradation of damage from center of tornado**

Hillcrest Meadows was adjacent to and downwind from Hinton Place. Figure 8 portrays a line of homes on the windward side of the subdivision. The home in the foreground was totally destroyed and was presumably under the vortex of the tornado. This photo also indicates the progression of damage (from most to least). Roof damage was predominate in both subdivisions, with wall and other major damage only occurring under or near the narrow vortex.

As previously mentioned, considering construction standards and the reserve strength factors, the residence in Figure 8 could have been destroyed by winds in a range for an F2 tornado. The level of damage to the adjacent homes further supports this theory and demonstrates the range of wind speeds away from the vortex.

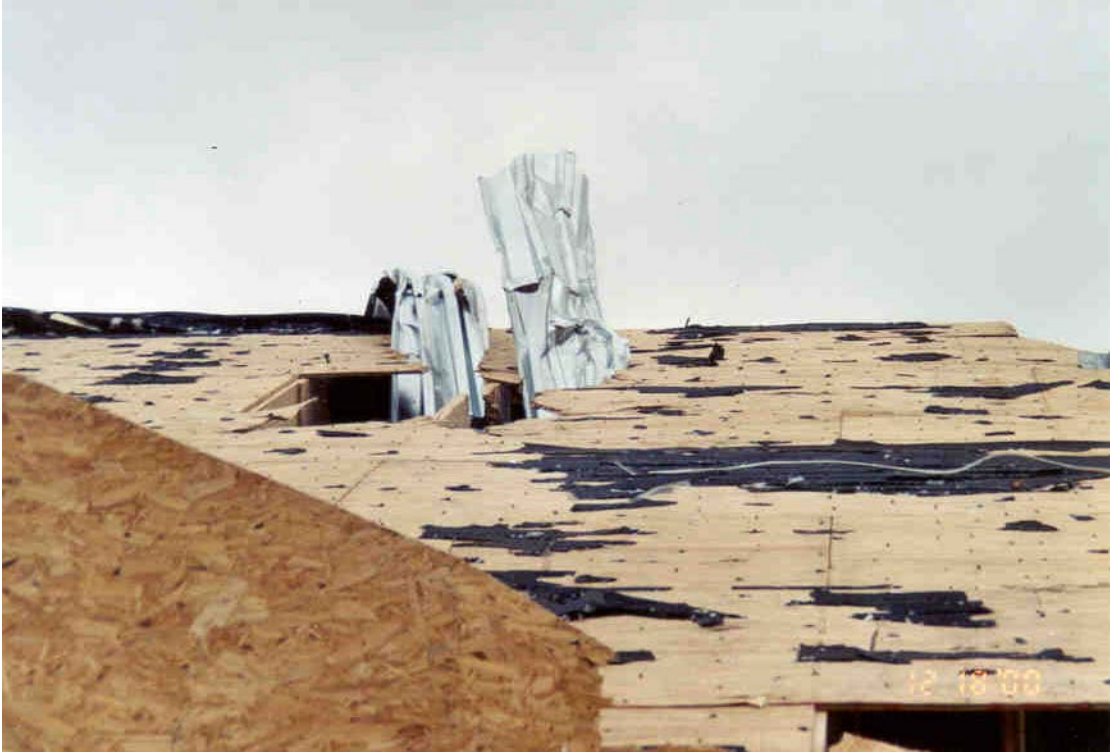
**Figure 9. Sheet Metal Missile, Hinton Place**

The generation of missiles from the storm debris is often an indicator of wind strength. According to Fujita's report, "light object missiles" begin to be generated by an F2 storm (Fujita, 1971). Investigation of the storm sites revealed only minimal missile generation. The most significant missiles was light-gage metal roof decking blown from Englewood Village that was deposited in both Hinton Place and Hillcrest Meadows subdivisions (Figure 9). Few missiles were found "prickling" structures; the few found were either fence pickets or small pieces of studs or rafters (Figure 10). Furthermore, although debris was generated by the storm at these sites, the debris was not carried downwind, as is common for a higher strength storm, i.e., F2 or greater (Figure 11).

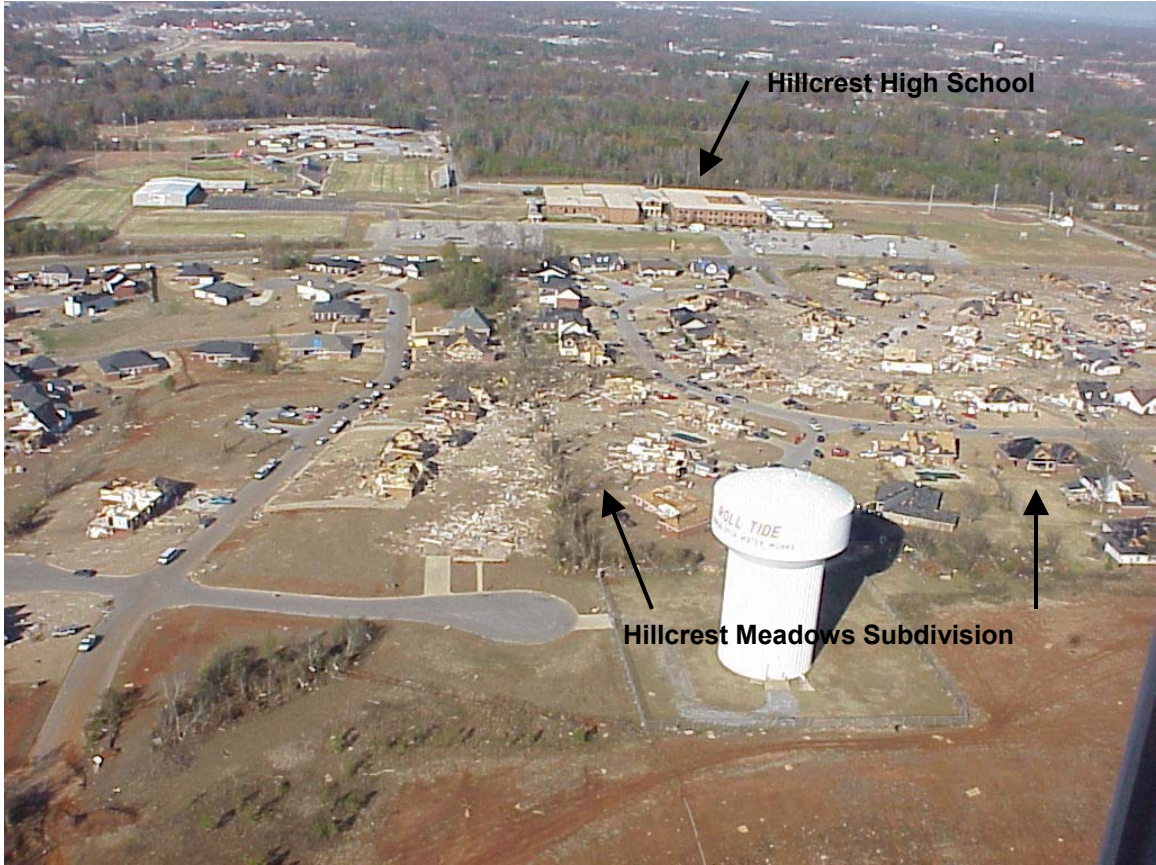
**Figure 11. Hillcrest Meadows Subdivision**

Apparently, the storm lifted between Hillcrest Meadows and Bear Creek Trailer Park, since Hillcrest High School, which was located between the two sites, received only superficial landscaping damage (Figure 11).

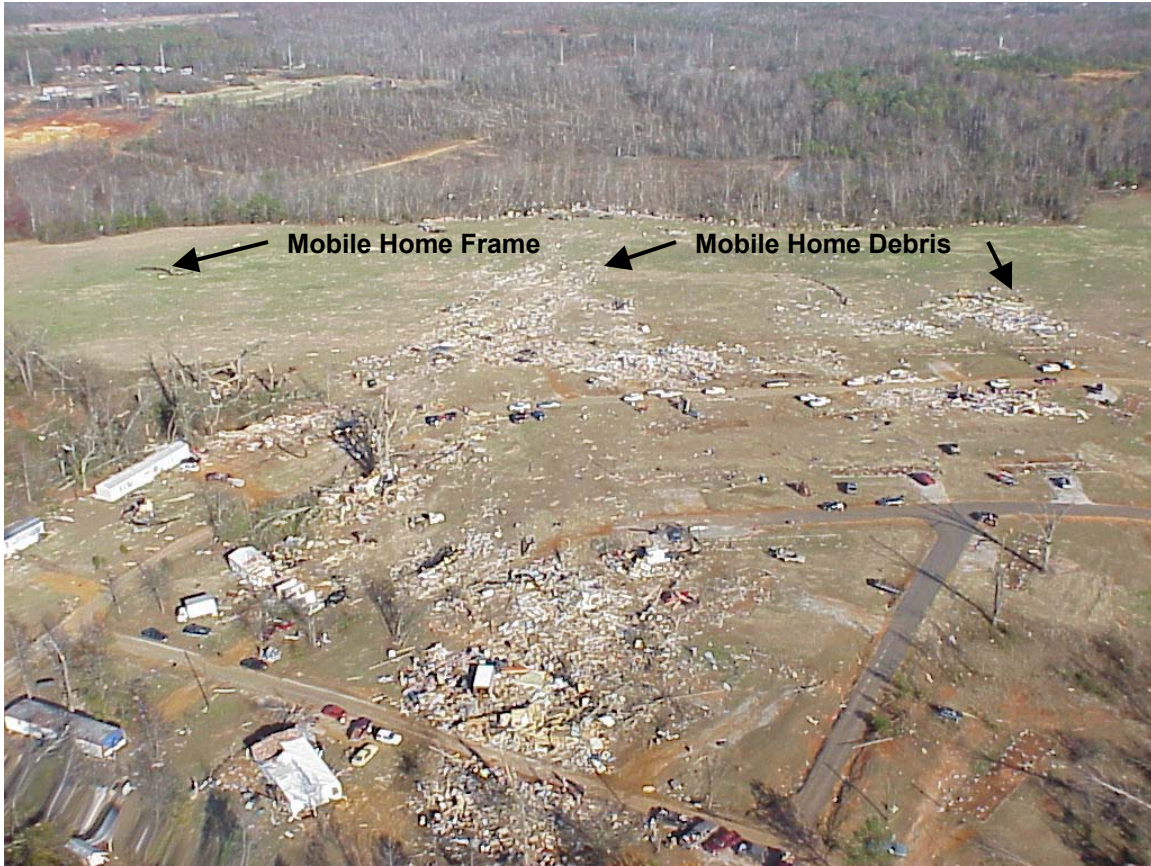
**Figure 12. Bear Creek Aerial**

Figure 12 is an aerial view of the storm path through the Bear Creek area. Close inspection of this photo reveals that large amounts of debris were generated by the destructive storm, with some debris being carried as far as the tree line. It should be noted that little, if any, of this debris was found beyond the tree line. The massive destruction of these mobile homes attests to their nearness to the vortex, their light construction, and the propensity of these lightweight materials to be transported by high wind.

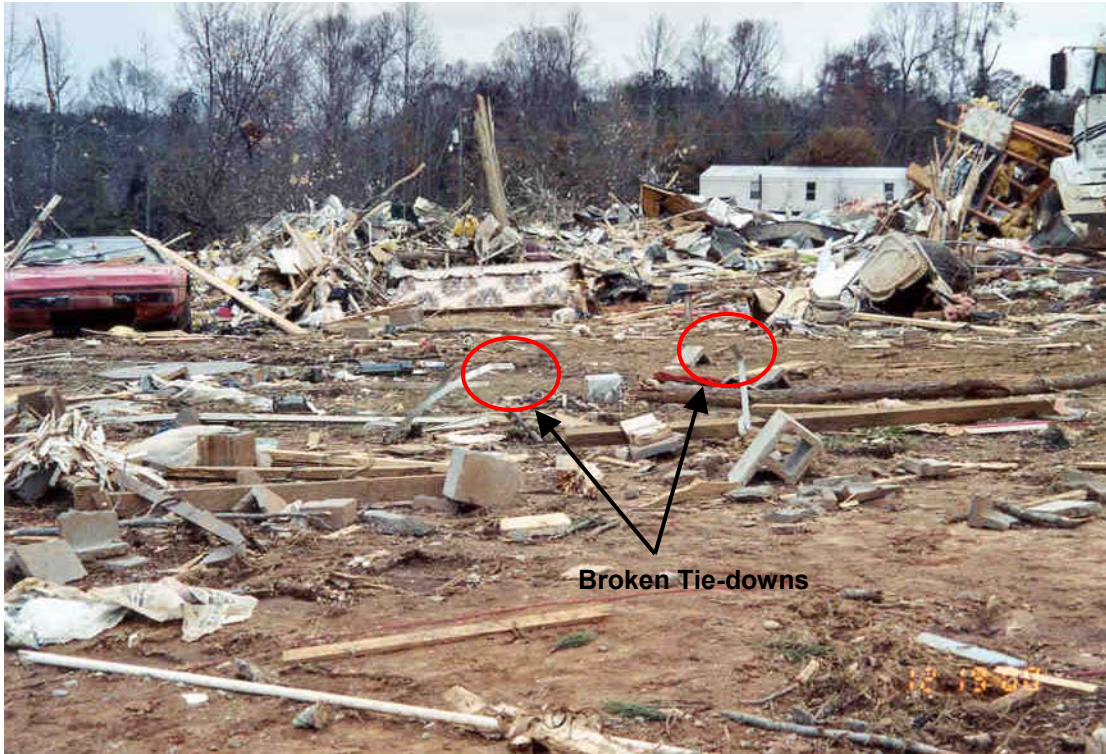
**Figure 13. Bear Creek Mobile Home Site with broken tie-downs**

Assuming the tie-downs were sufficient in number and the installation of the anchors were in accordance to building code, numerous mobile homes were still blown from their moorings, and nine deaths resulted in the Bear Creek Mobile Home Park. The strength of the mobile home construction and strength of the winds causing the destruction therefore becomes the issue. Prior to 1976, there were no wind resistance standards for the mobile home industry. Since that time, the Federal Department of Housing and Urban Development (HUD) has regulated the manufactured home industry. Included in the HUD regulations are requirements for the design of manufactured homes to resist wind effects, thereby establishing three wind speed zones for construction (Marshall, 1994). Zones II and III are located in hurricane regions and require a fastest-mile wind resistance of 100 mph (44.7 m/s) and 110 mph (49.2 m/s), respectively. Zone I includes all interior non-hurricane prone areas, which includes the County of Tuscaloosa. Zone I requires mobile homes to resist fastest-mile wind speeds of 65 mph (29.1 m/s). It is unknown how much reserve strength, related to wind speeds, is contained in manufactured housing. However, assuming the reserve strength in manufactured housing is comparable to site-built residential structures, then a 1.4 to 1.7 factor applied to the HUD standard would relate to a fastest-mile wind speed of 91 mph to 111 mph (43 m/s to 53 m/s). At these wind speeds, it would be expected that the reserve strength would be overcome and the structures totally destroyed. These factored wind speeds relate to strong F1 tornado or a weak F2 tornado.

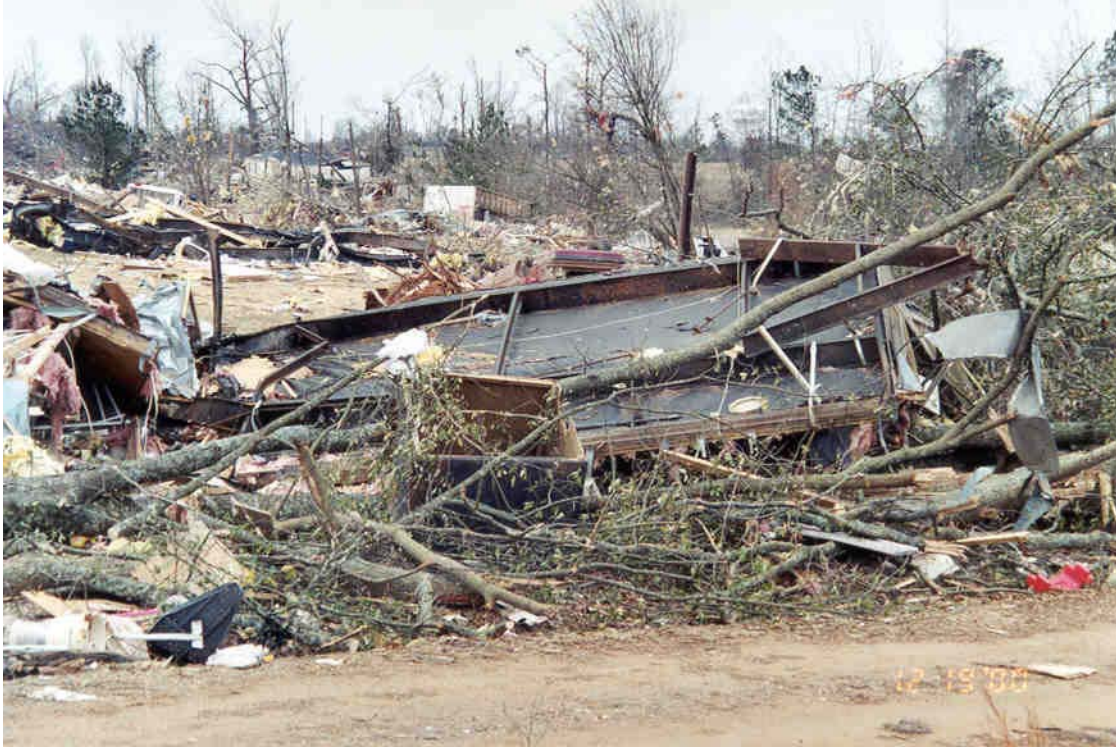
**Figure 14. Destroyed Manufactured Housing, Bear Creek**

Figure 14 shows the total destruction of several manufactured housing units. Accordingly, the Bear Creek area is classified at an intensity level equal to or less than

that of the Hinton Place and Hillcrest Meadows subdivisions; however, ten of the twelve storm-related deaths occurred in the Bear Creek Park. Given this similar intensity of wind speed, it can only be assumed that the large loss of life is attributed to the difference in construction types and quality of construction.
