Sinking of US Cargo Vessel SS *El Faro*  
Atlantic Ocean, Northeast of Acklins and Crooked Island,  
Bahamas  
October 1, 2015

NTSB/MAR-17/01  
PB2018-100342

NTSB/MAR-17/01  
PB2018-100342  
Notation 57238  
Adopted December 12, 2017

# Marine Accident Report

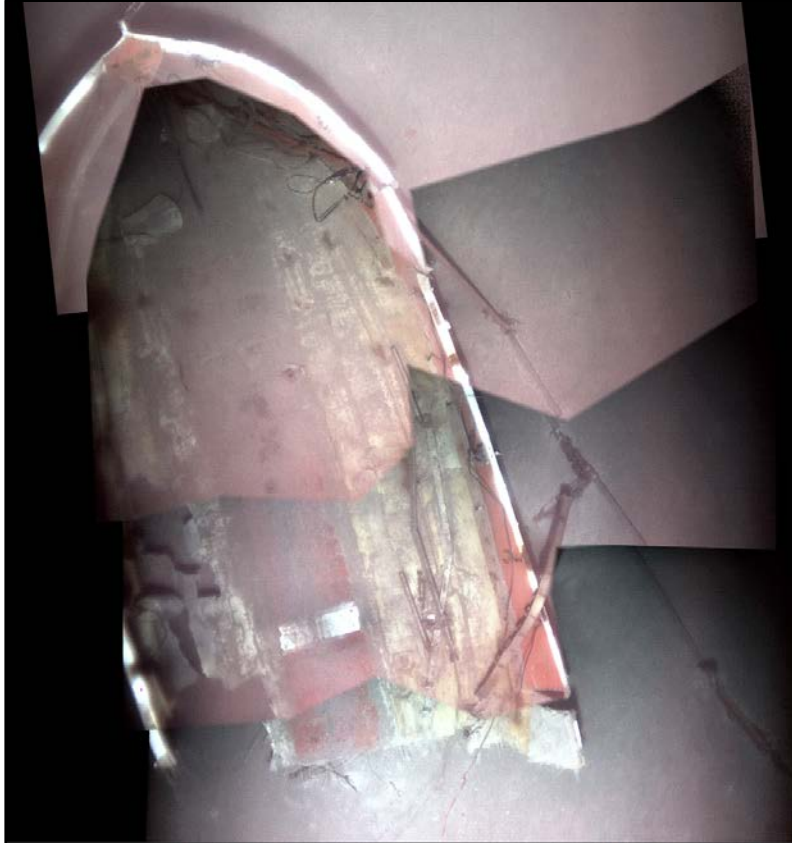
**Figure 24.** Photomosaic of *El Faro's* port lifeboat from images taken during second search mission. Bench seats and other internals are missing. Reflective tape on top of gunwales is illuminated.

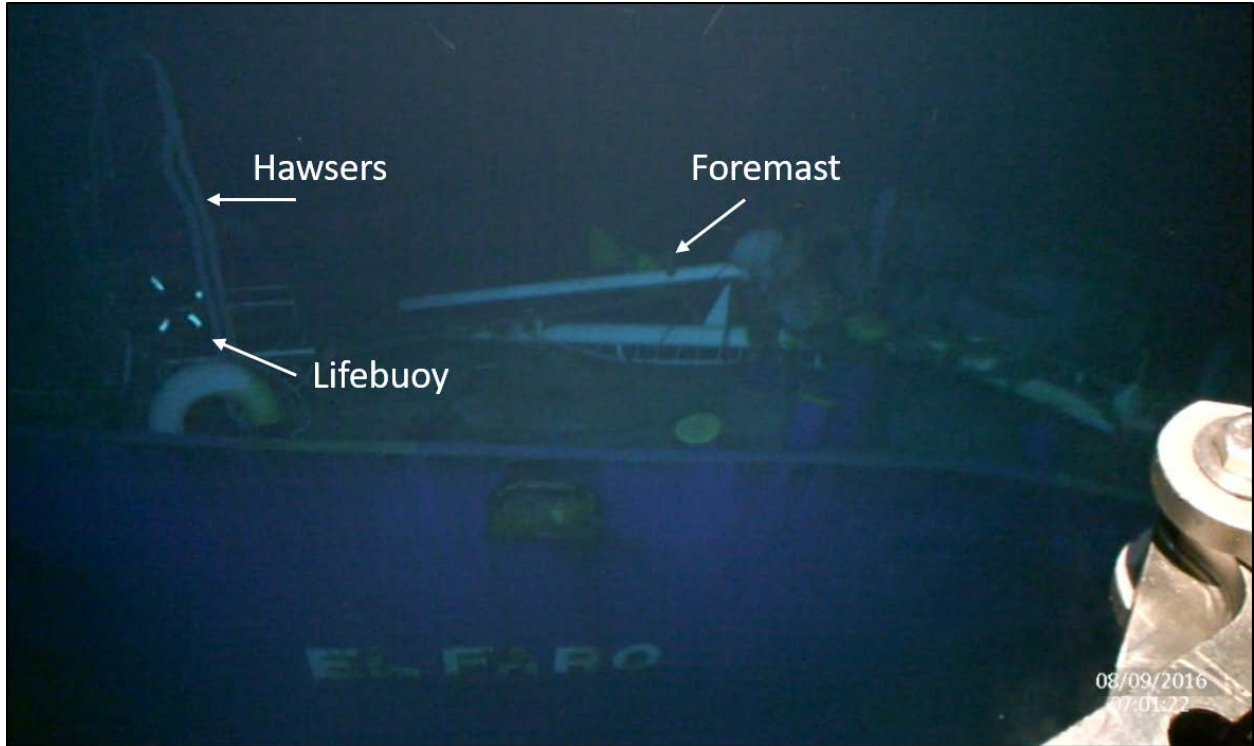
**Figure 32.** Foremast toppled on port side of bow; reflection is from lifebuoy on railing next to hawsers. (Image from mission 3)

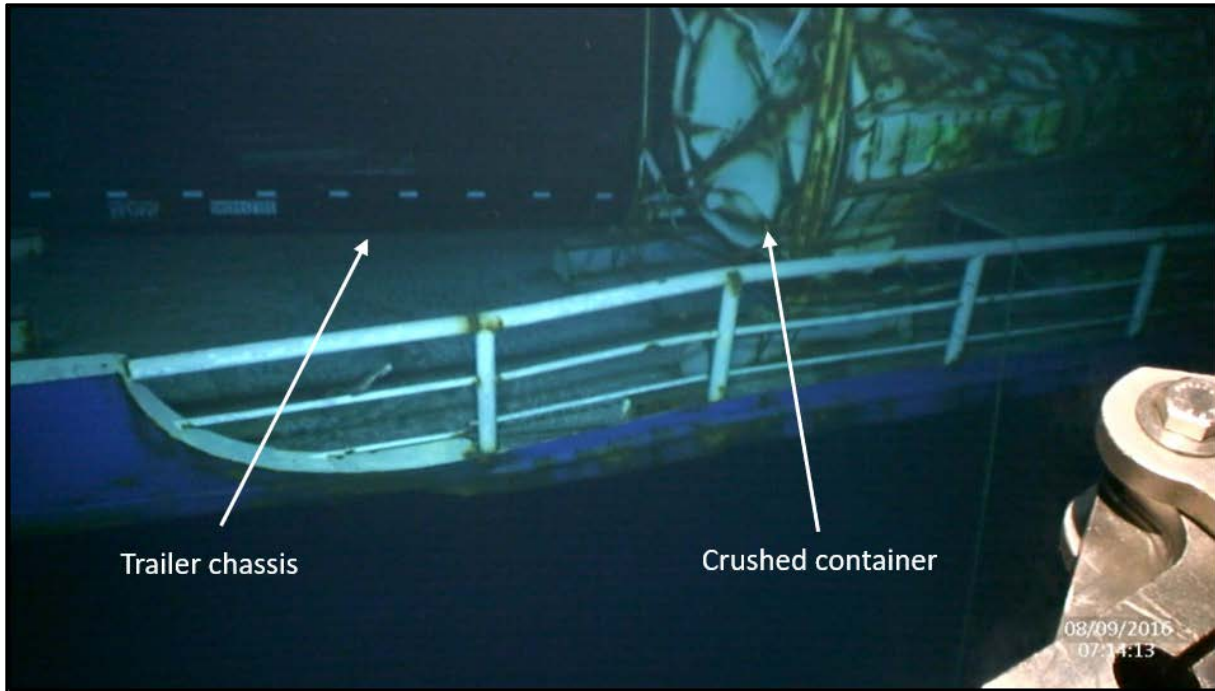
**Figure 34.** Crushed tank container in bay 2, starboard side. (Image from mission 3)

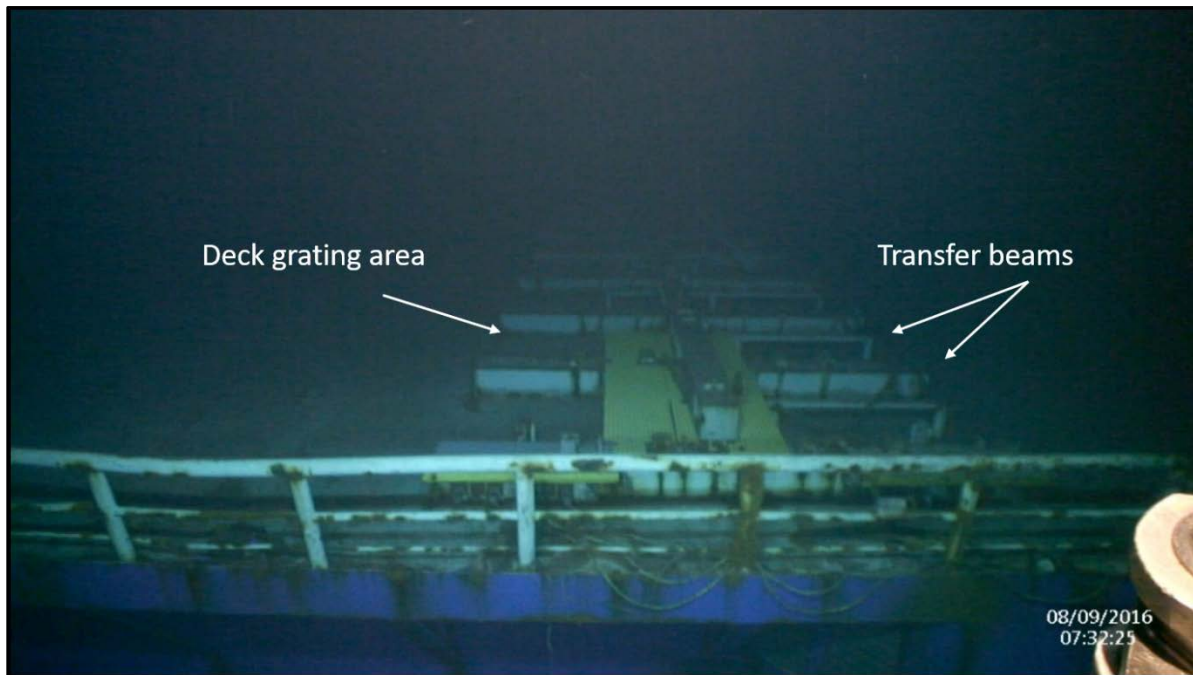
**Figure 35.** Fiberglass deck grating missing from container support beams, port side, with intact transfer beams. (Image from mission 3)
