Takata Inflator Rupture Root Cause Summary Report

Submitted by:
Orbital ATK for the Independent Testing Coalition

Submitted to:
National Highway Traffic Safety Administration

September 2016

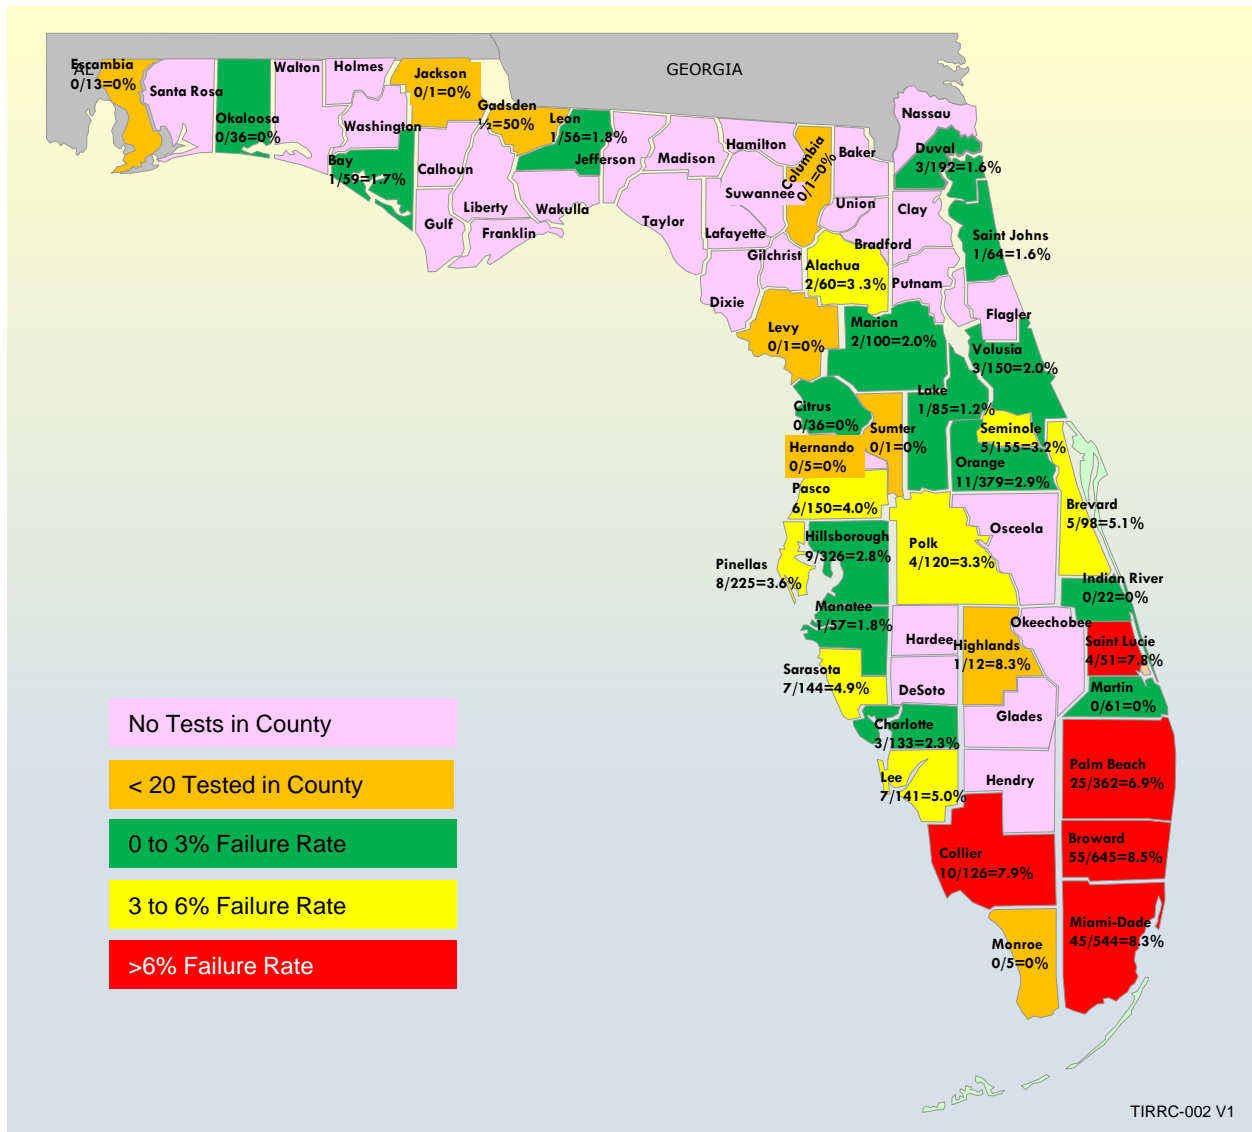
Figure 2. Failure Rates in PSPI-L for a Single Vehicle Model in Florida.

The significant difference of failure rates even within Florida is striking.

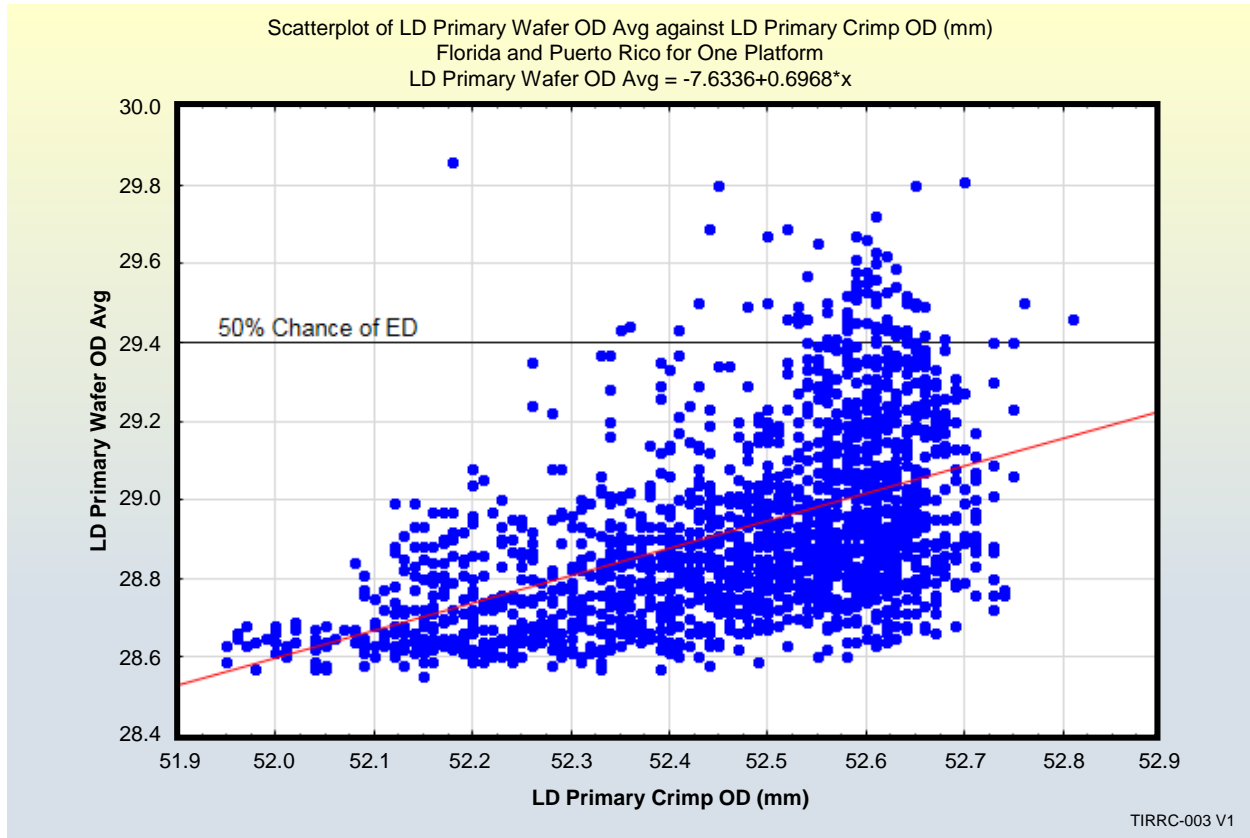
Figure 3. Wafer Outer Diameter, Crimp (case) Outer Diameter and Failure Probability for PSPI-L for a Single Vehicle Model.

The amount of data scatter seen here is typical of many of the statistical relationships but shows a trend.

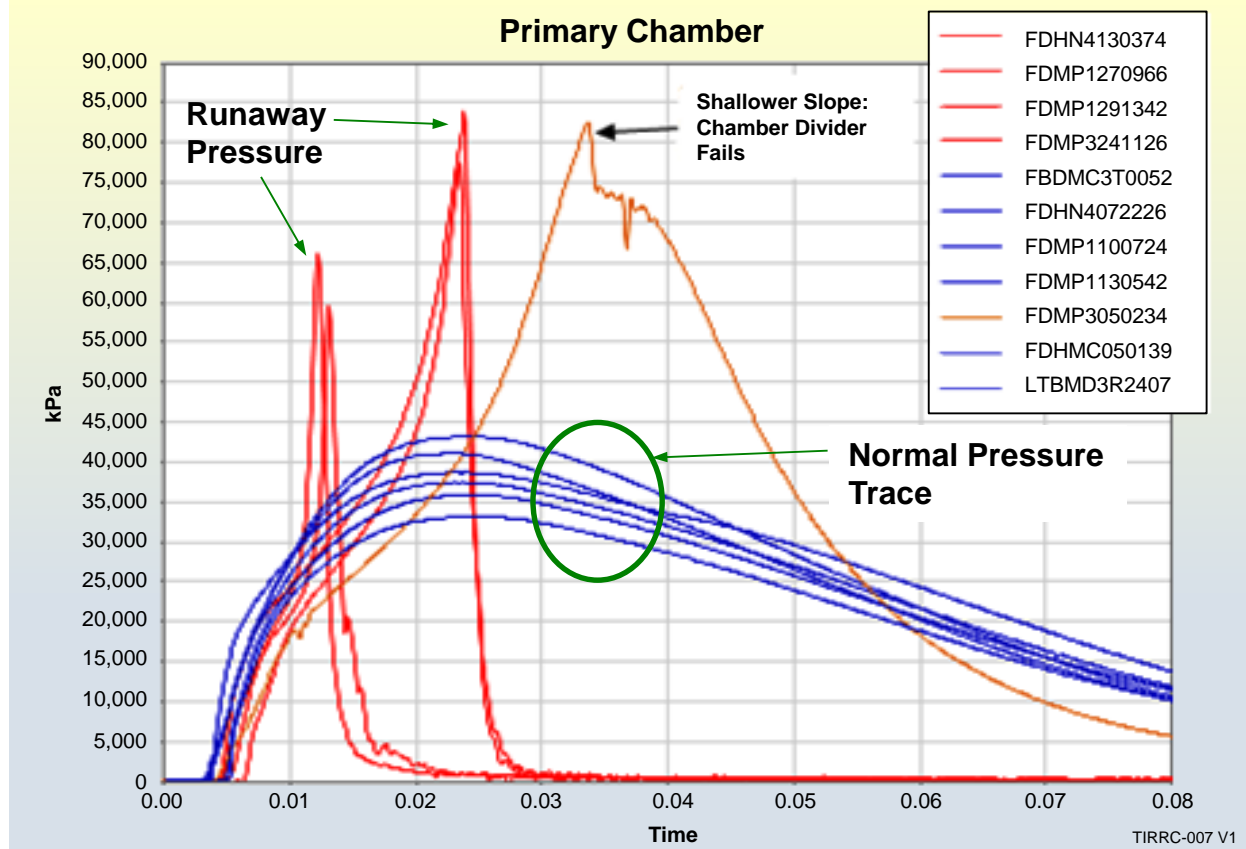
Figure 6. Typical Ballistic Traces.

Although we have no evidence of structural failure at normal pressure, there is data showing ED events are associated with runaway ballistics (Figure 6). While some of the failure traces indicate failure below design capability, a separate analysis showed this is likely due to the capability of the data acquisition system.

Shown here are typical pressure-time traces for nominal operation and runaway pressure of an ED. The rounded, “haystack” of the nominal operation is indicative of regression normal to the propellant surfaces. The unique shape of the ED trace provides information regarding what ballistic effects could lead to this shape of trace.

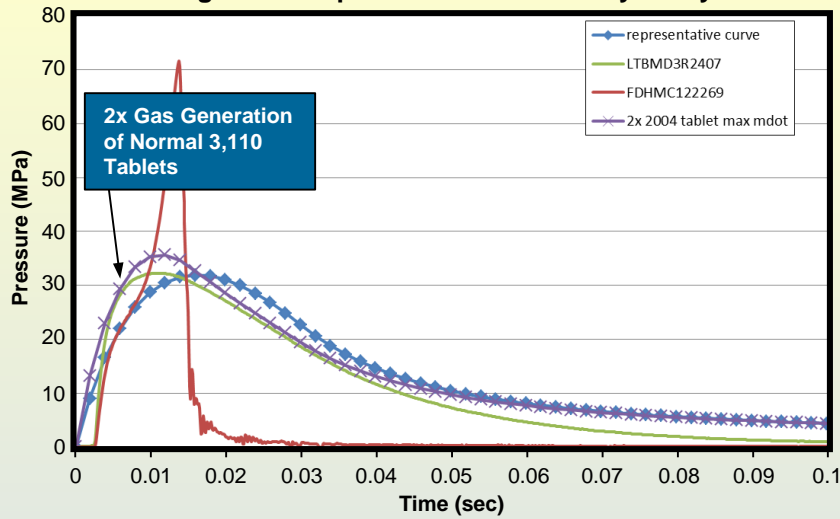
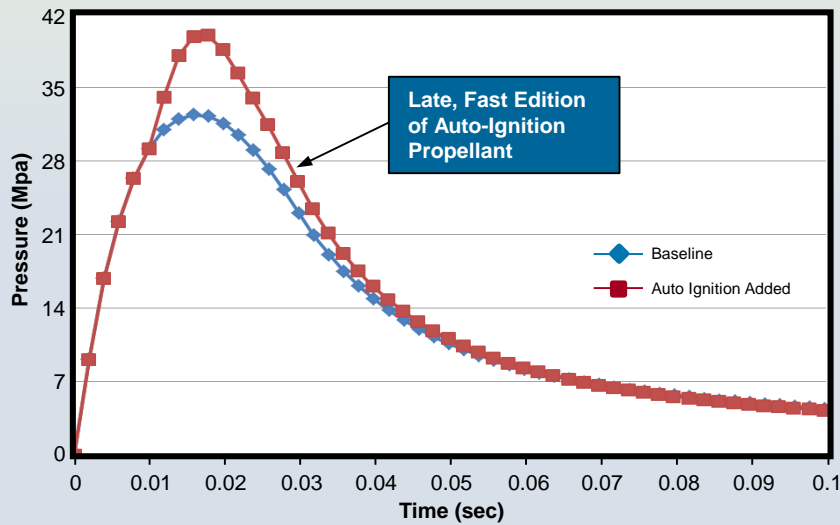
Figure 9. Potential of Ignition and Auto Ignition Propellants to Cause an ED.

These two figures show data from gas or pressure generation studies (Mdot, gas generation rate) on the potential of the igniter closure 3110 propellant (top) or the auto ignition propellant (bottom) to cause an ED. Even under extreme cases, these propellants cannot of themselves cause an ED. This focused our studies on the main 2004 propellant.

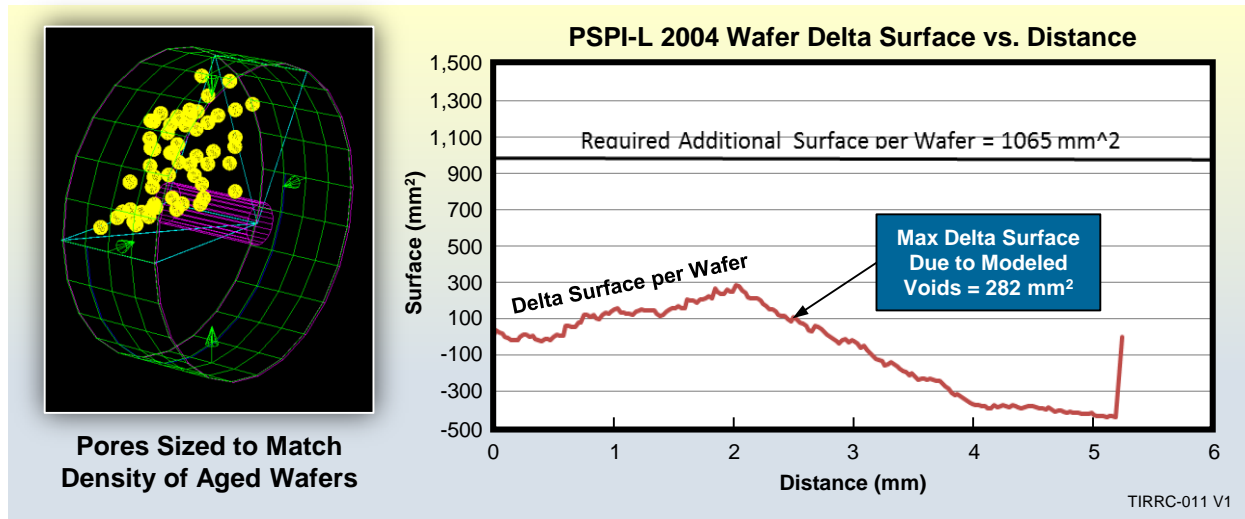
Figure 10. Closed Pore Impact on Burning Surface.

Calculations were done matching the lowest wafer density from field returns by adding closed pores to otherwise nominal wafers. With this matched density, closed pores are insufficient to explain the surface area increase needed to result in an ED event. It may contribute, however. This analysis does not apply to connected pores where there are potential gas paths as discussed below.

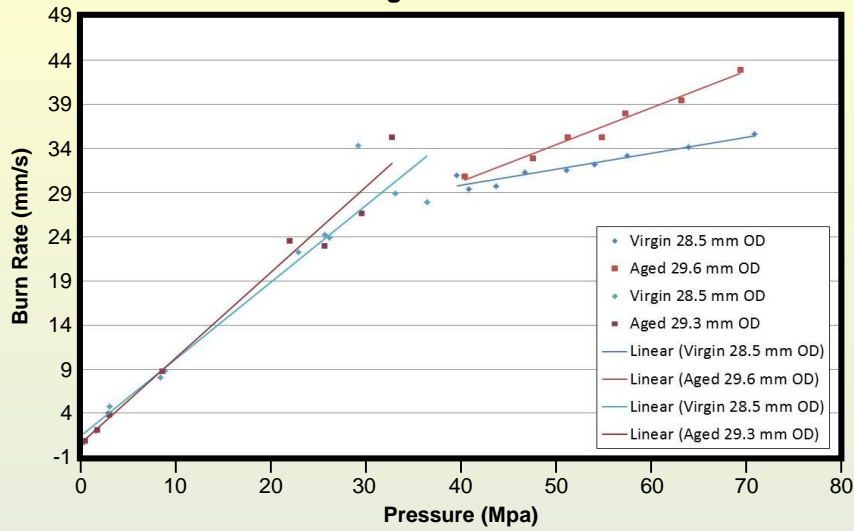
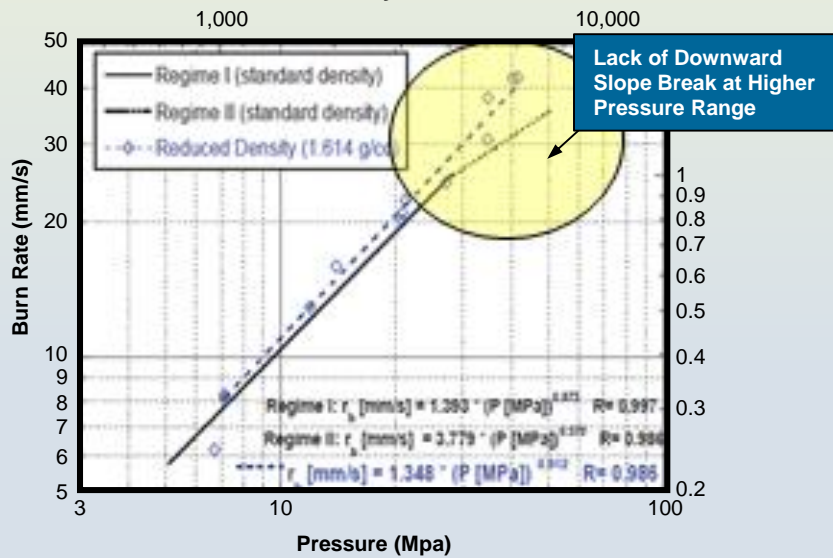
Figure 11. Change in High Pressure Regime Slope.

Orbital ATK and Penn State data² showed the potential for low-density 2004 propellant to have a slope increase at high pressure compared to the normal slope at high pressure (Figure 11). Modeling the effect of slope change shows that increasing slope from the baseline value of 0.5 to 0.8 is enough to reach ED pressure levels. This ballistic change most likely is caused by the permeable and porous burning noted below.

Data at several locations have shown similar data as depicted here from Orbital ATK (top) and Penn State (bottom). This change in apparent slope at higher pressure is consistent although graphically represented several different ways. Several phenomena can result in this apparent slope change as noted below.

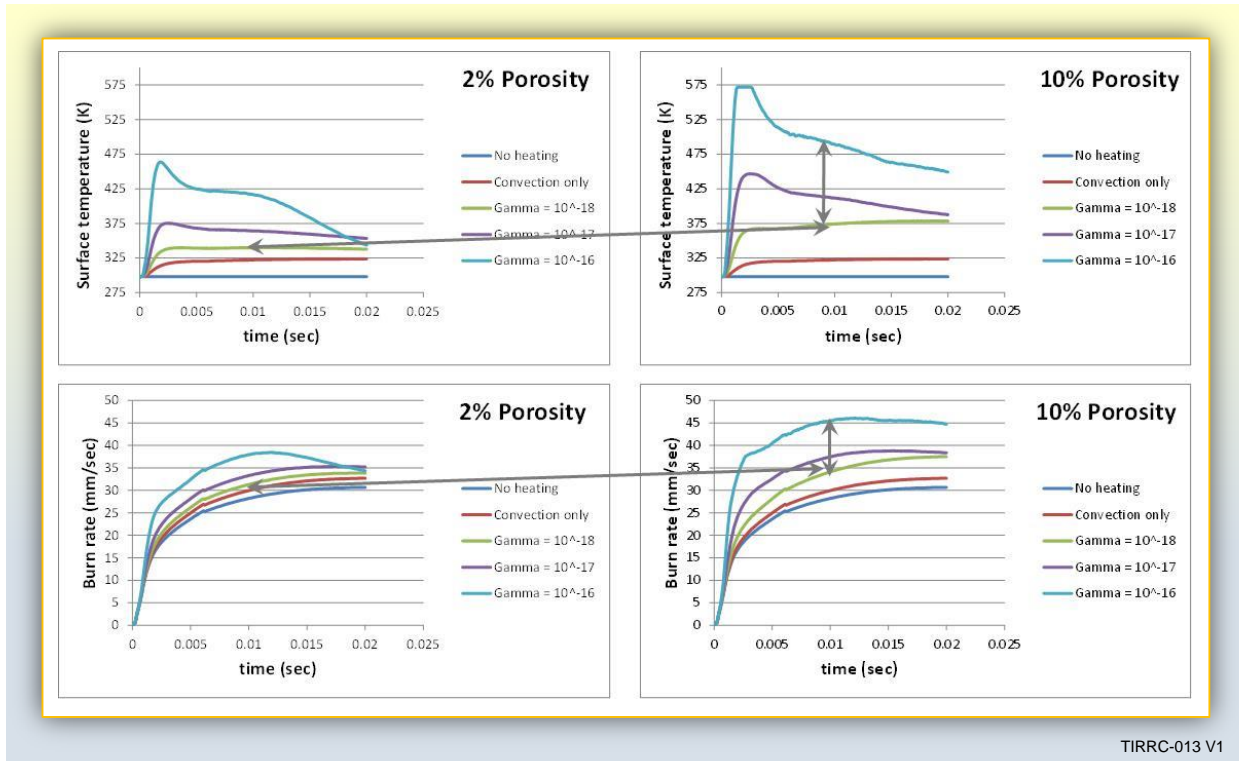
Figure 12. Impact of Porosity and Permeability.

Permeable burning is a mechanism that can increase burn rate by preheating the propellant. 2004 propellant burn rate increases with temperature until the auto-ignition temperature is reached. If the propellant is porous (volume is available for hot gas to fill) and permeable (hot gases can flow to the free volume), then hot gas has the potential to preheat the propellant to the depth the permeability extends (Figure 12). This can express itself in what appears to be “in-depth” burning as the hot gases ignite more surface area of the propellant below the normal advancing surface. In a parametric studies completed to test this phenomenon, 2% porosity is typical of virgin propellant, and 10% porosity is similar to aged propellant. For the study, three values for the permeability constant, Gamma, were chosen that span the range likely for this material and to model the potential impact from a change in permeability. This example showed the potential for a 50% burn rate increase due to changes in porosity and permeability. This theoretical underpinning may serve to explain the empirically measured “Integrated Burning Rate” data reported by Takata. Understanding the mechanism will allow validation of appropriate aging models.

These four figures graphically depict the dramatic effect on in-depth heating and burning rate with increasing porosity and permeability to hot gases. Each graph shows data for no heating and for increasing levels of permeability (gamma). This in-depth heating along gas paths is consistent with the real time radiography, pycnometry data and ED event ballistic traces.

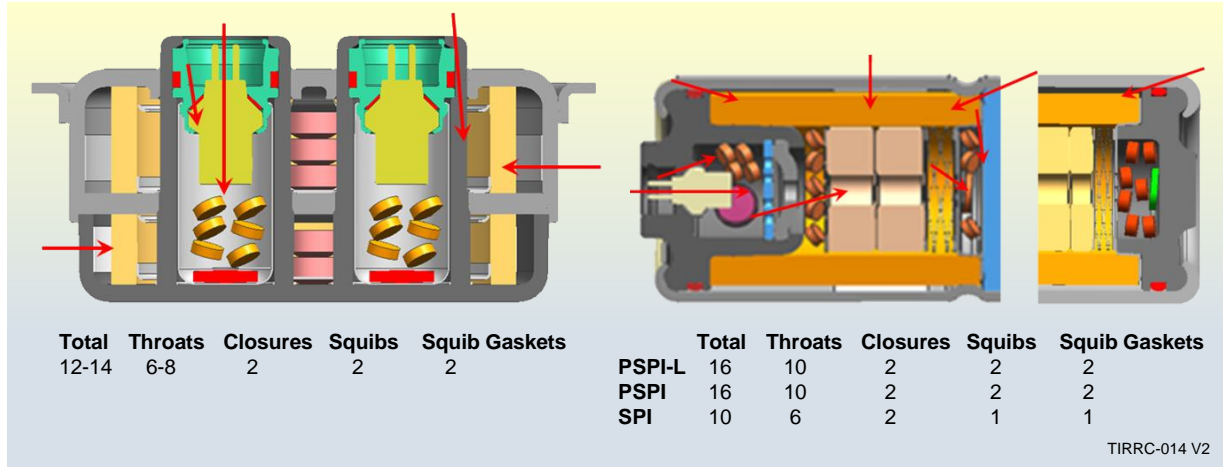
Figure 13. Potential Leak Paths in Takata Inflators.

Analysis of the seal systems showed that each driver and passenger inflator has multiple potential leak paths (Figure 13). The leak path of greatest concern is the passenger closure O-ring seal (Figure 14). Based on nominal dimensions for the closure, O-ring and case (away from the crimp zone), O-ring squeeze is excellent. Unfortunately, the closure crimp footprint overlays the O-ring sealing footprint. This design/manufacturing feature allows the possibility of no O-ring squeeze at the maximum engineering-allowed crimp outer diameter (OD) of 52.65 mm. In addition, many inflators were built with crimp ODs that exceed the allowed value. These paths result in greater moisture movement in and out of inflators than what would be calculated based on diffusion through a rubber O-ring and is consistent with reports from Takata, Fraunhofer ICT and original equipment manufacturers (OEM) of higher moisture levels in field return inflators. This moisture movement is critical to generate the observed growth in wafer diameter.

Several different seals are present in both passenger and driver inflators (marked by red arrows). While a great deal of emphasis has been placed on the passenger crimp and O-ring, every seal is a potential path for moisture to enter the inflator and must be considered in any valid moisture transport model.

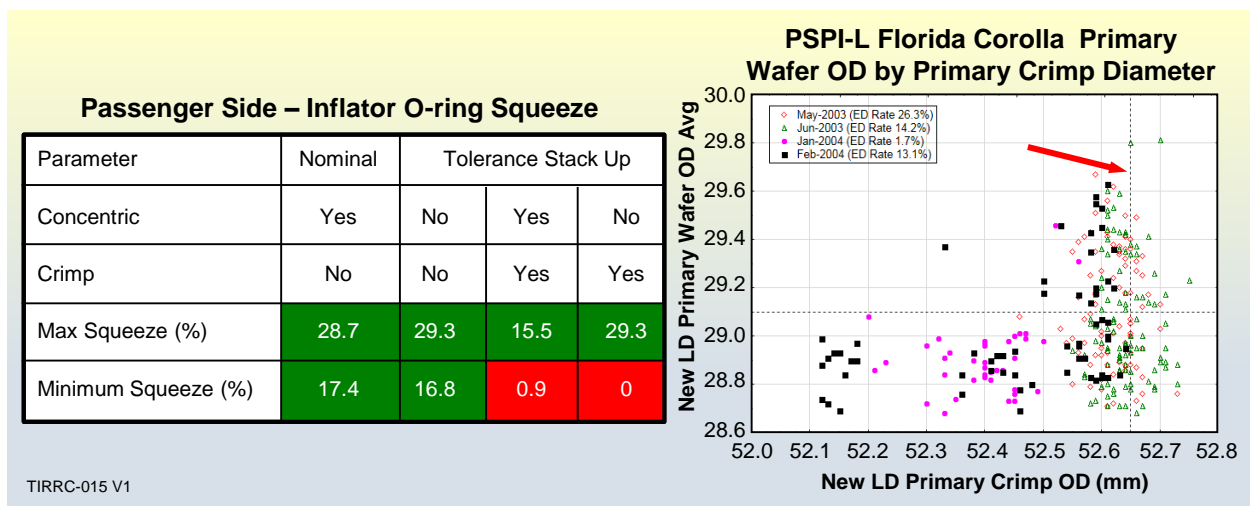
Figure 14. Passenger Inflator Primary Crimp Data.

The table on the left presents results from analysis using a proprietary tool developed by Orbital ATK to be a more accurate measure of O-ring squeeze. The tool was developed due to the criticality of O-ring seals in rocket motors. The data on the right show that manufacturing in the time frame of interest for these recalls (2003 and 2004 shown here), that a measurable percentage of all primary crimp diameters exceeded the engineering allowed maximum of 52.65 mm (marked by the red arrow).

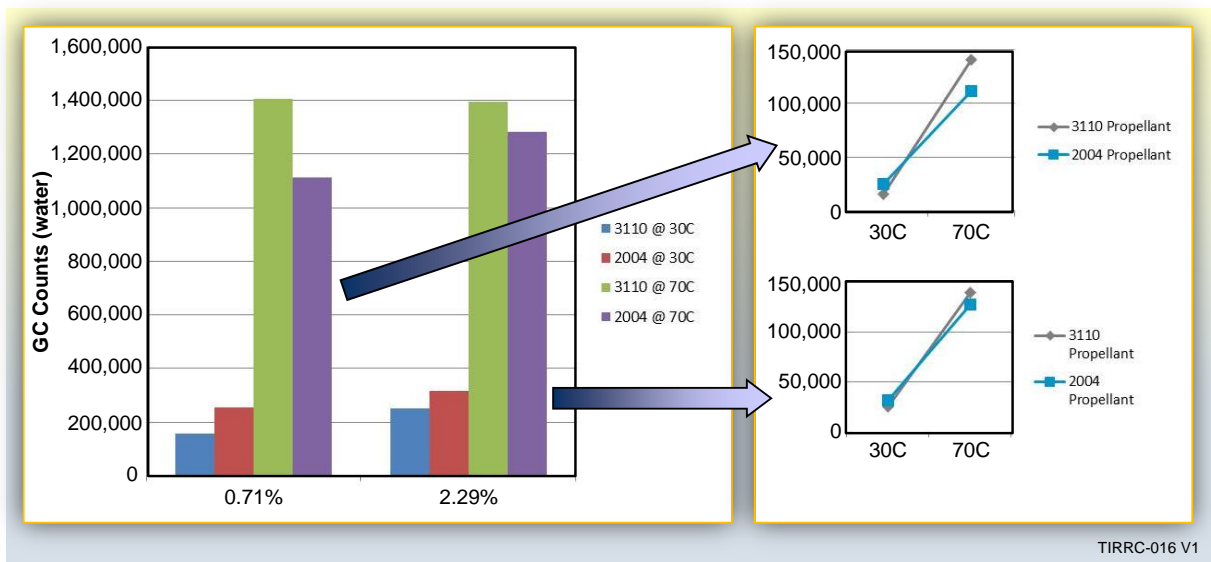
Figure 15. Headspace Moisture Above 2004 and 3110 Propellants with Moisture Added as a Function of Temperature.

In each case, the change in the amount of water that is available is dramatic when transitioning from 30°C to 70°C. This suggests transport is much more likely at the higher end of the range. The 3110 propellant shows a modest increase in propensity to give up moisture compared to 2004. This variability gives rise to the “x-graph” when suitably drawn although the effect is not as dramatic as suggested in some depictions.

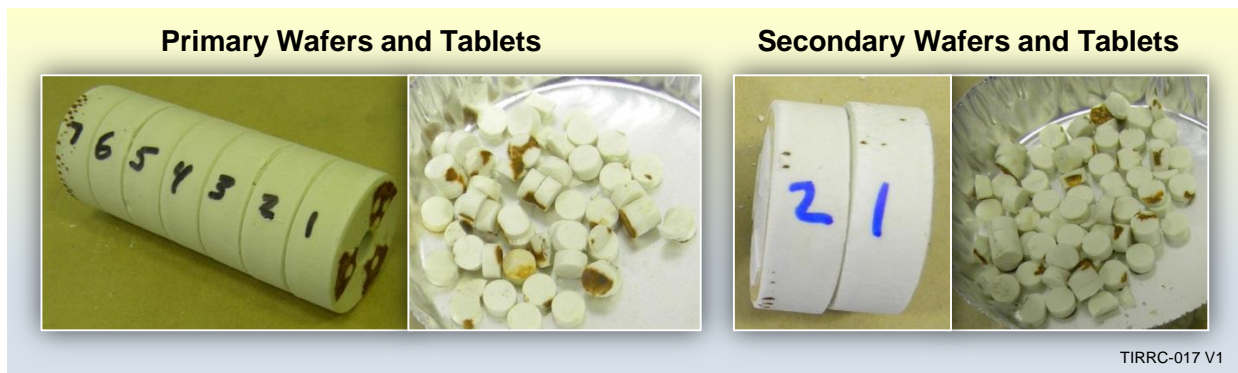
Figure 16. Examples of Fused Wafers and Tablets.

Both tablets and wafers are often fused in inflators where there has been significant diameter growth in the wafer consistent with a process similar to Ostwald ripening. The kinetics of such processes are relevant to any aging models.

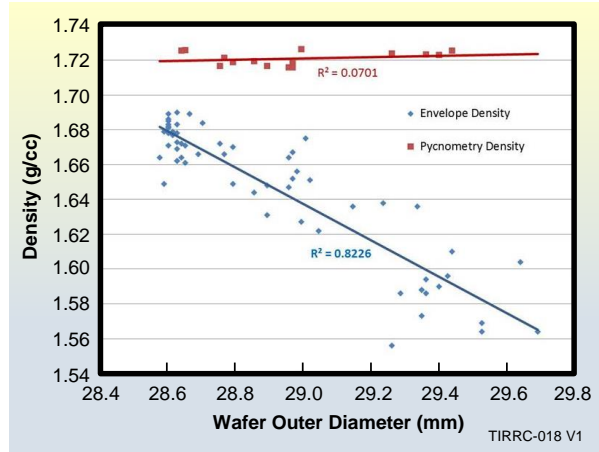
Figure 17. Density Measurements for 2004 Propellant Wafers.

Shown here are measurements of a large number of propellant wafers with increasing OD. Outer diameter has been correlated with likelihood of an overpressure event. These data show two different density measurement techniques. The envelope density method gives an overall geometrical density while the pycnometry density method allows gas penetration, yielding a result that remains constant due to accessibility to gas to the majority of low-density spaces or voids in the propellant. These data show that the low-density voids generally allow gas to pass from one to the next, suggesting connected or communicating voids.

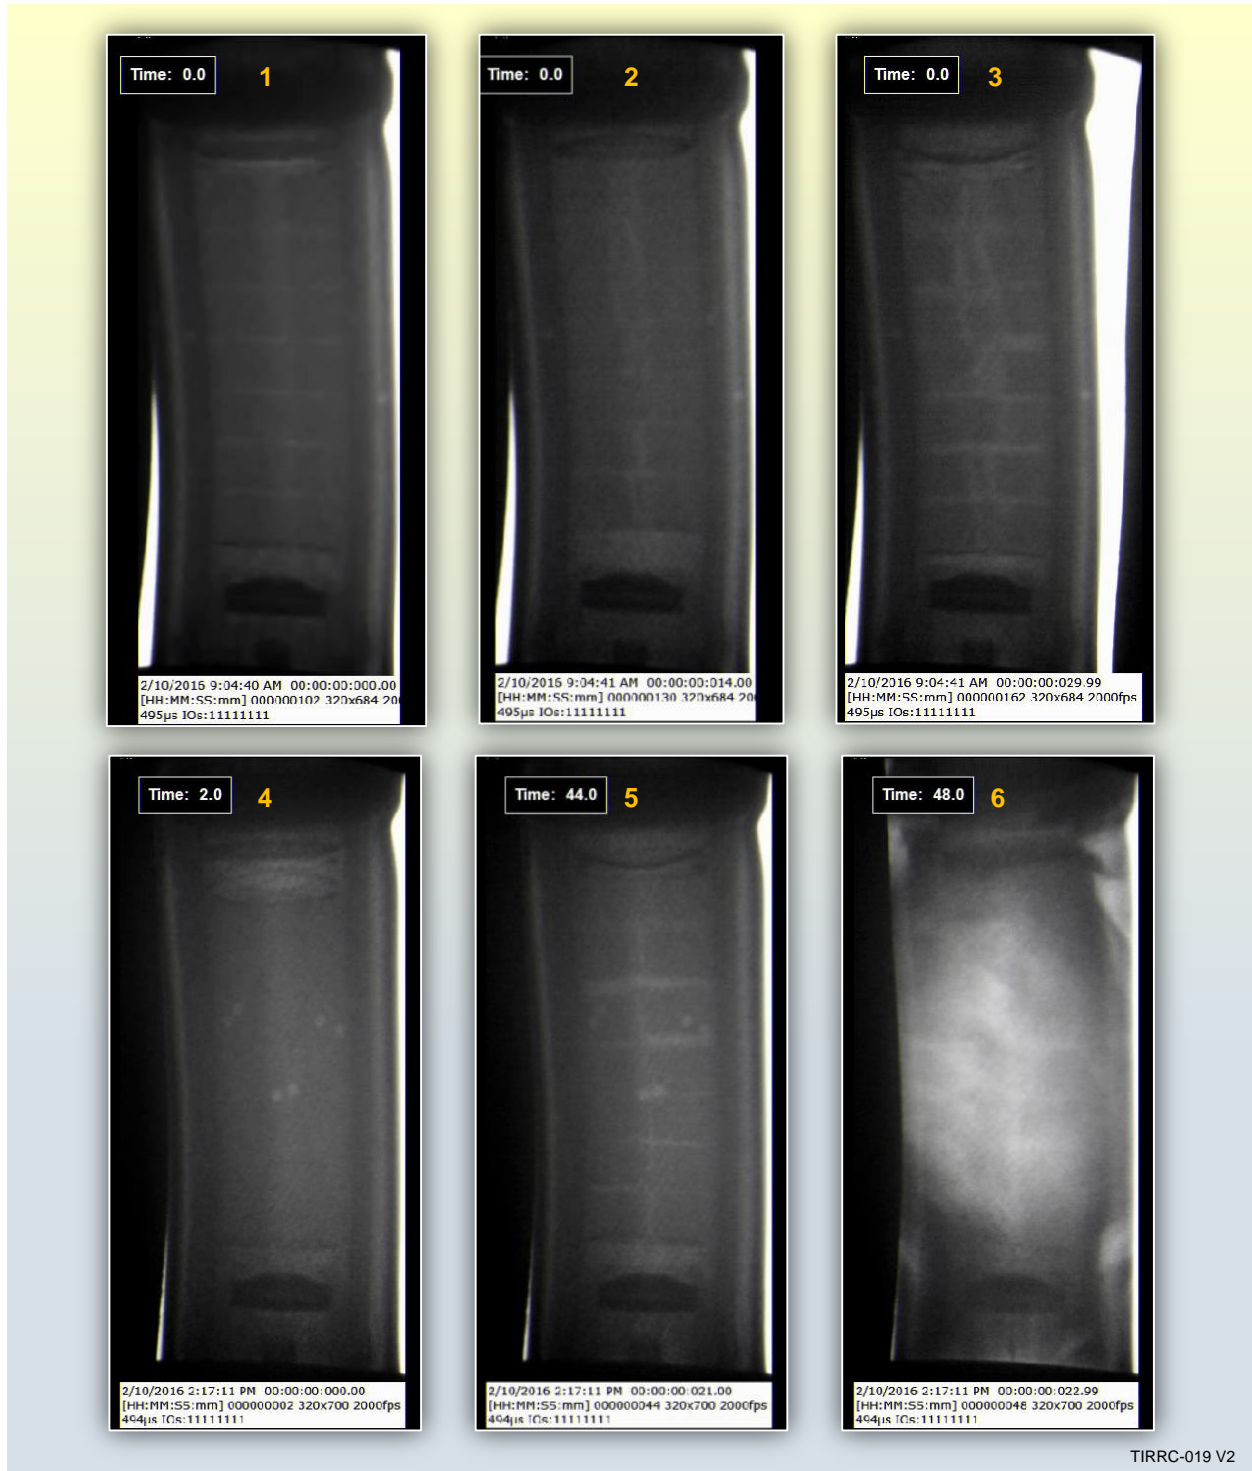
Figure 18. Real Time Radiography Still Images.

Real time radiography (RTR) provided remarkable insight into the processes involved in both a nominal burn and during over-pressure events. This technique showed the typical fracture of wafers during ignition. In a nominal deployment, the regular burning normal to all surfaces is apparent. However, in an ED, the initial state shows less distinct wafers, consistent with wafers expanding into direct contact with each other. Fracture occurs on ignition, although perhaps less pronounced than in a nominal deployment. Initial burning is followed by a transition to a much higher mass consumption, consistent with ballistic traces and penetration of combustion gases through void spaces resulting in increased surface area (Figure 18).

Shown above are individual frames from two RTR experiments with PSPI-L FD inflators showing the primary chamber. Stills 1-3 are from test #98553, which was a nominal firing. Stills 4-6 are from test #95179, which was an ED. The time sequence is from left to right. In the first pictures (1 and 4), differences can be seen with the distinct individual wafers with space between wafers in #1 and less distinct boundaries in #4 reflecting the wafer growth in #4. In pictures 2 and 5, the ignition has occurred and flame spread has begun. The typical fracturing of wafers is visible. Space between wafers from flame intrusion is now clear, which is not seen in the baseline (picture 4) for test #95179. In #3 and #6, radical differences are clear. In #3, regression of the surfaces, reducing wafer size but maintaining integrity, is observed. In #6, combustion at a much higher rate and in depth in the wafers is visible although some integrity remains as would be expected. Rupture occurred shortly thereafter attributed to excessive chamber pressure.
