BUILDING PERFORMANCE ASSESSMENT REPORT

**OKLAHOMA AND
KANSAS**

Midwest Tornadoes of May 3, 1999

**OBSERVATIONS, RECOMMENDATIONS,
AND TECHNICAL GUIDANCE**

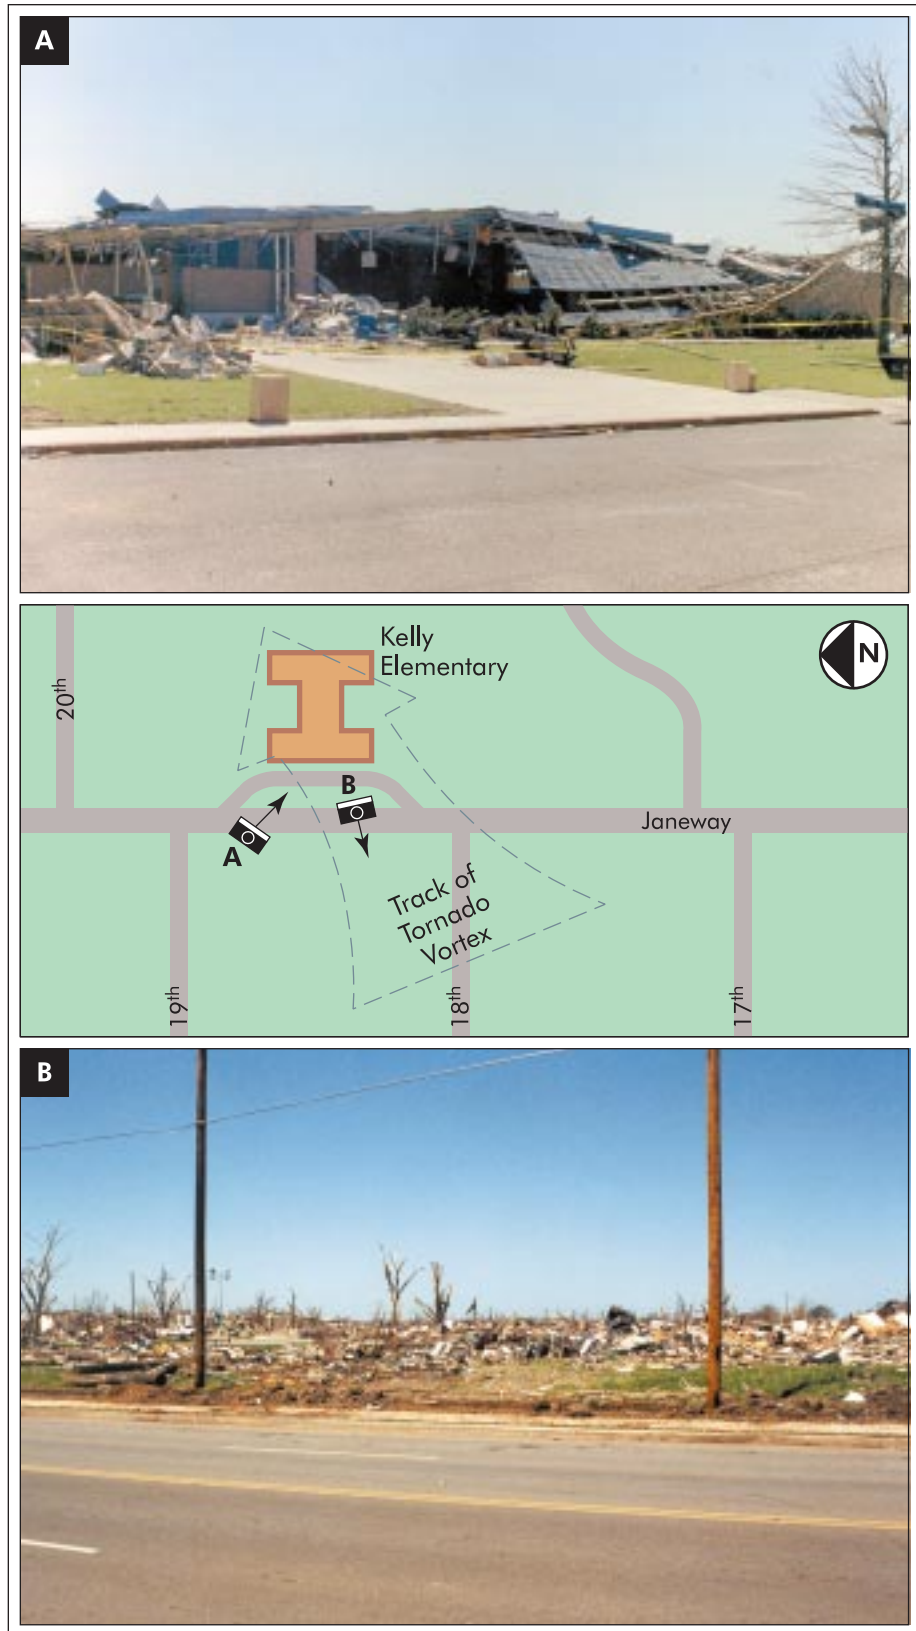
FIGURE 3-1: Differences in the performance of non-residential (engineered) buildings and residential buildings. The violent tornado that passed through Moore, Oklahoma, severely damaged the Kelly Elementary School (Figure 3-1, photo A) but left some elements standing. By contrast the neighborhood directly across the street, (Figure 3-1, photo B) was reduced to rubble. Note: The utility poles in photo B were replaced after the tornado, original poles are on the ground on the left side of the photo,

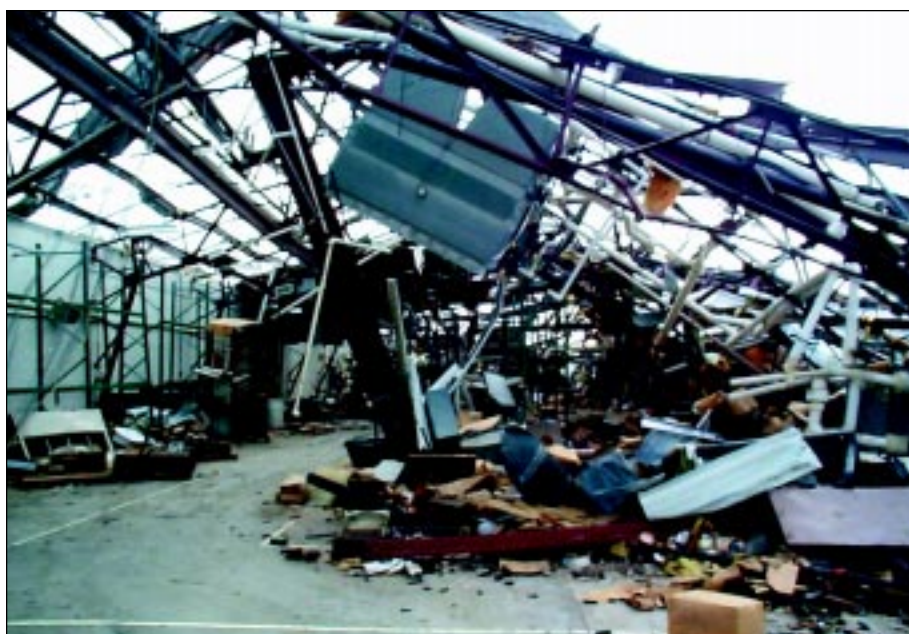
FIGURE 3-12: *The vortex of a violent tornado passed within 100 yards of this plastics manufacturing plant in the city of Haysville, Kansas. The wind forces caused the failure of its primary structural system: a pre-engineered steel frame with masonry infill walls.*

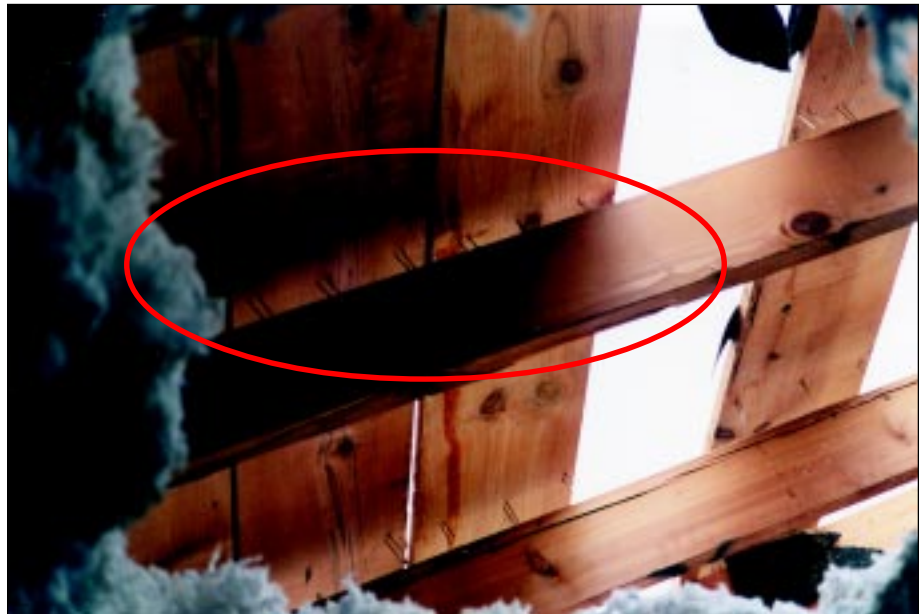
FIGURE 4-4: Although roof sheathing was lost at this Wichita, Kansas, home, code requirements of staggering joints in sheathing applications was observed. This house experienced inflow winds from a strong tornado.

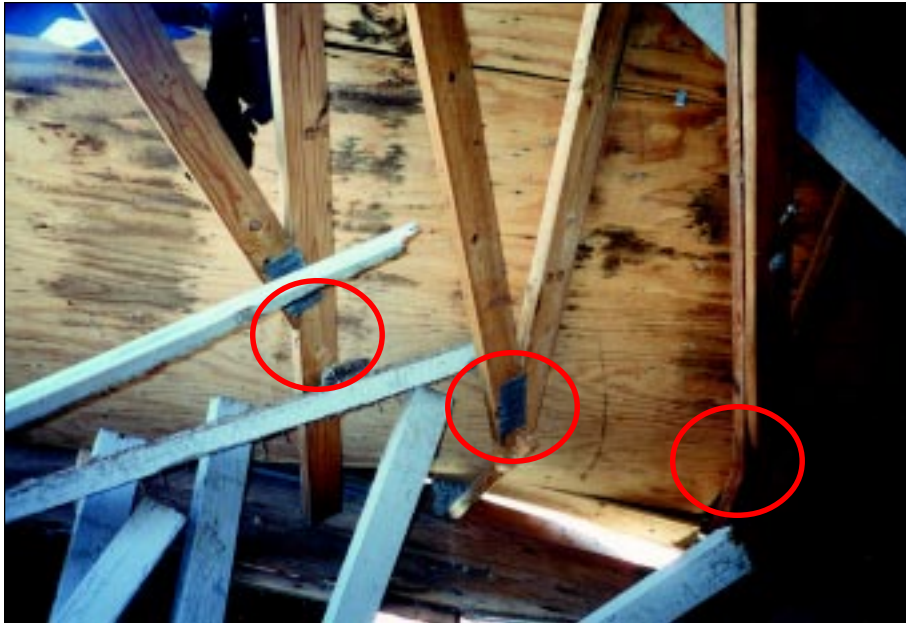
FIGURE 4-7: Roof truss failure. A single nail (circled) was used to connect each truss to the top plate. This house was in Midwest City, Oklahoma, and experienced inflow winds from a violent tornado.

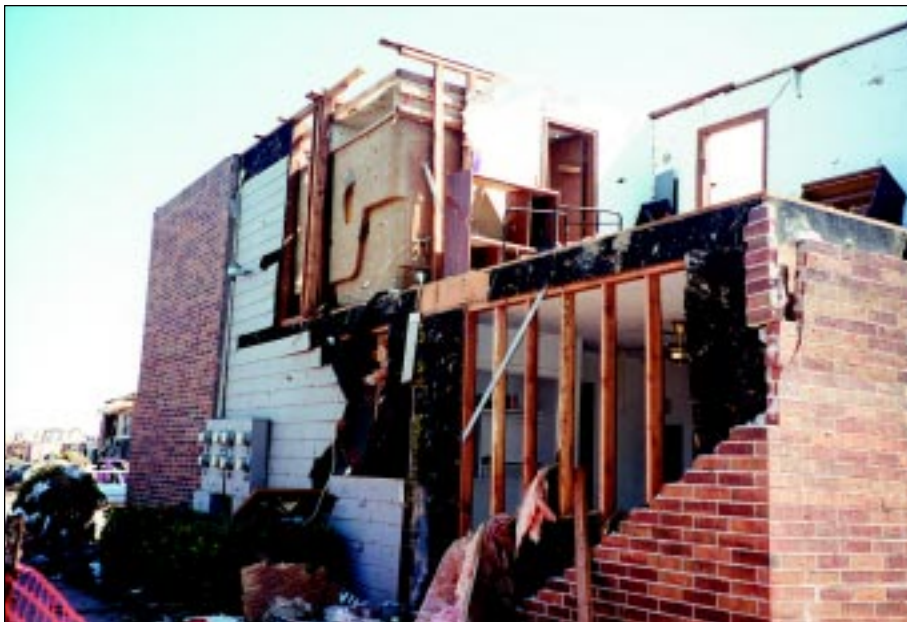
FIGURE 4-11: Stud-wall and sole-plate-to-floor failure on a second story wall. This multi-family residence in Moore, Oklahoma, was located a few hundred feet from the vortex of a violent tornado and was exposed to inflow winds.

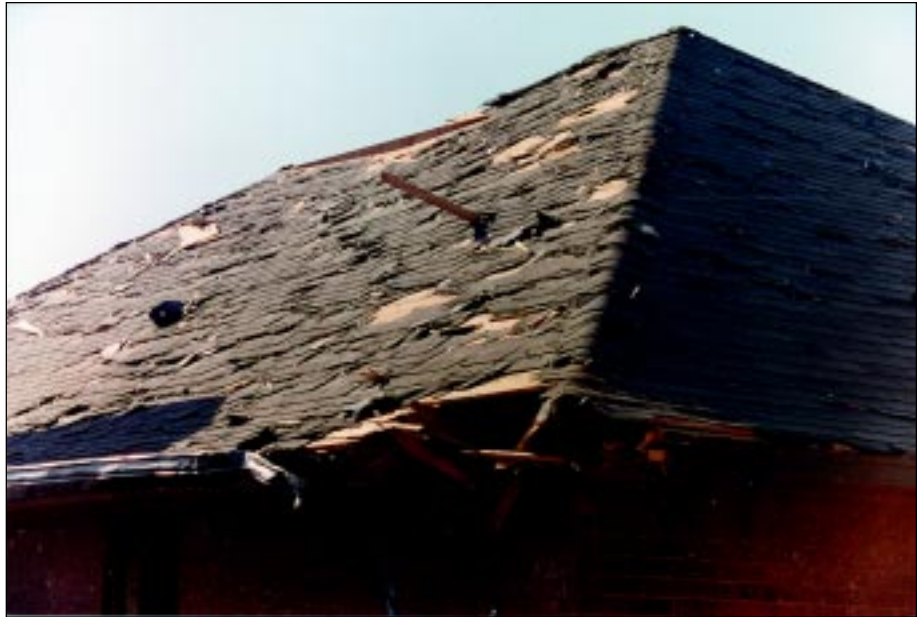
FIGURE 4-15: *Several T-lock shingles on this house were lifted and torn. This house was on the periphery of a weak tornado in Wichita, Kansas.*

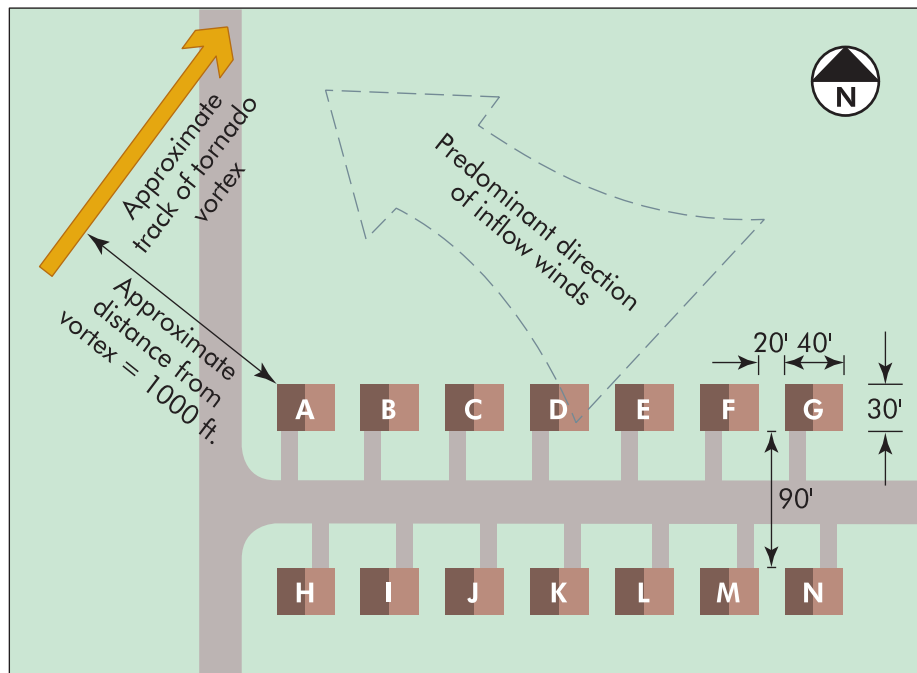
Homes located at H and A are shown in Figure 4-22. The damage states of the two homes are significantly different even though they are located directly across the street, approximately 95 feet apart, from one another and may have experienced relatively similar wind conditions based on the approximate track location (Figure 4-21). The home located at H had seven broken windows, primarily at the back of the home as a result of debris generated from a failed wooden fence. It also had one breached glass entry door, and lost approximately 60% of its roof covering. The home located at A lost its entire roof structure and several exterior walls. This was likely due to the failure of the garage door from inward wind forces. For the remaining houses, similar “across-the-street” damage gradients were observed between the homes, A through G and H through N, with the exceptions of the home at location F, which did not lose its entire roof structure, and the home at location G, which did not lose any roof structure, but did sustain severe roof framing damage due to uplift.

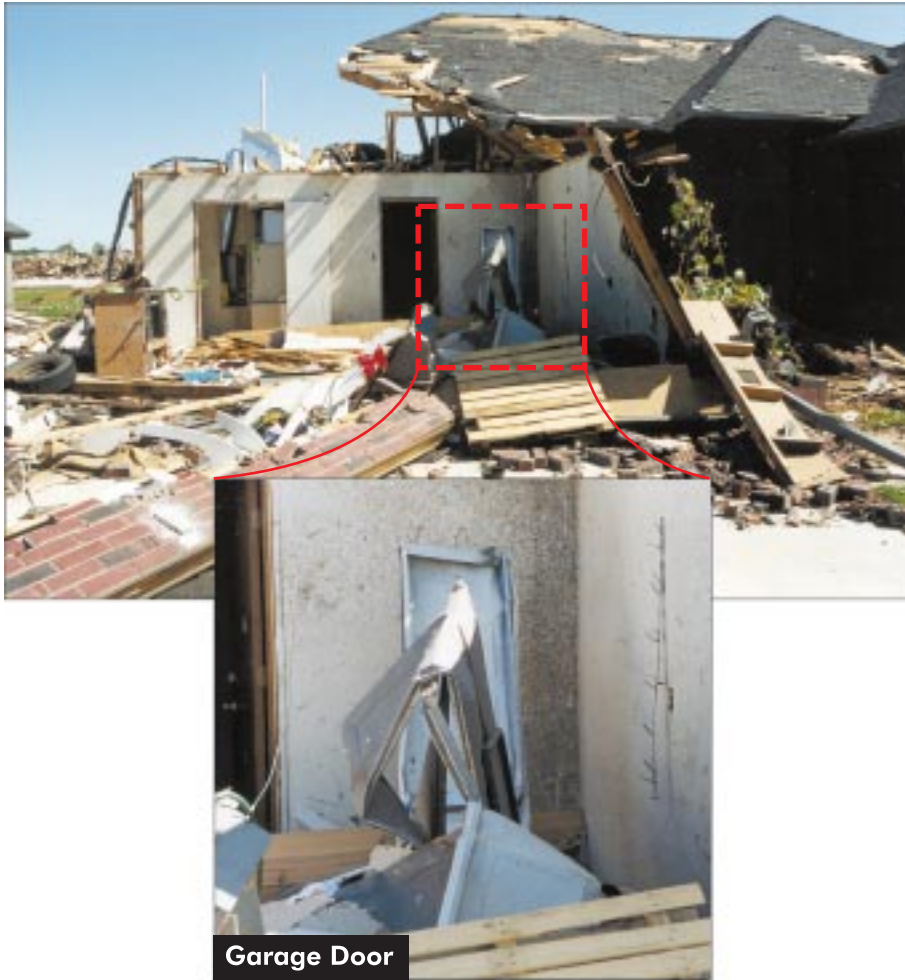
For several of the homes, H through N, it was observed that the garage doors had sustained permanent deformation due to negative (outward) pressure loads. This observation supports the assumption that the garage doors for homes A through G located across the street failed in positive pressure, as shown in Figure 4-22 for the home located at A. This door failed under a positive load. Full scale pressure tests on garage doors performed in laboratories have demonstrated that a typical garage door is significantly stronger in negative (outward) loading than in positive (inward) loading, which may explain why no garage doors completely failed on the homes, H through N (assuming comparable winds).

FIGURE 4-23: Garage door failure possibly resulting in the localized partial roof failure on the left side of this home located in Moore, Oklahoma.

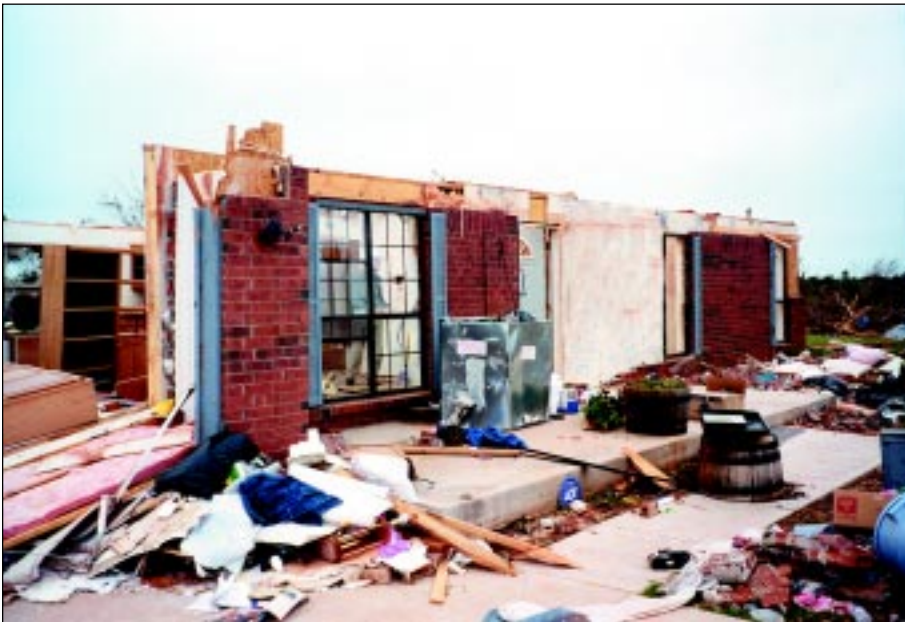
FIGURE 4-33: Brick veneer failure at the house shown in Figure 4-32.

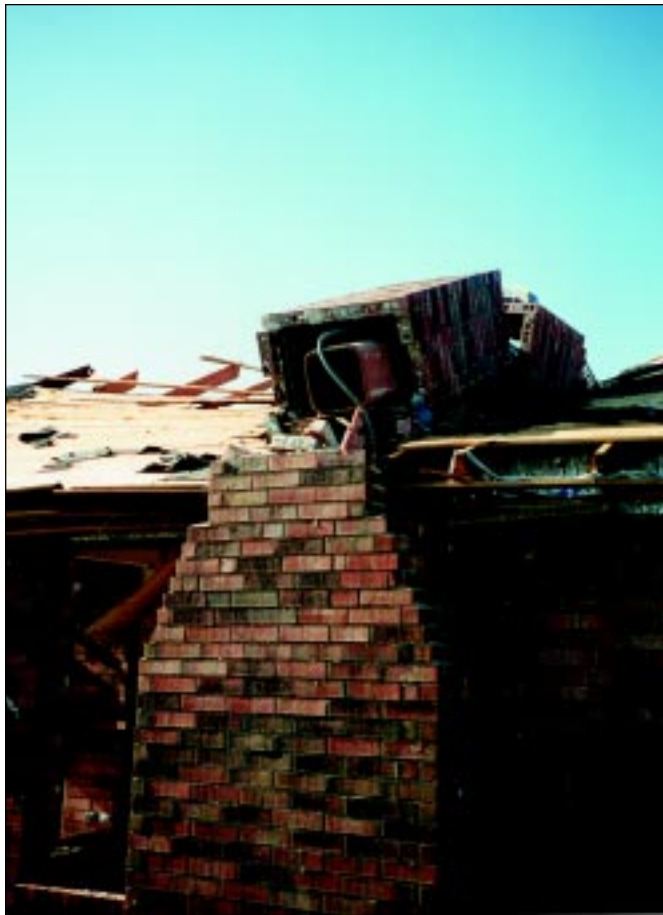
FIGURE 4-41: Close-up view of brick chimney failure in Figure 4-40.

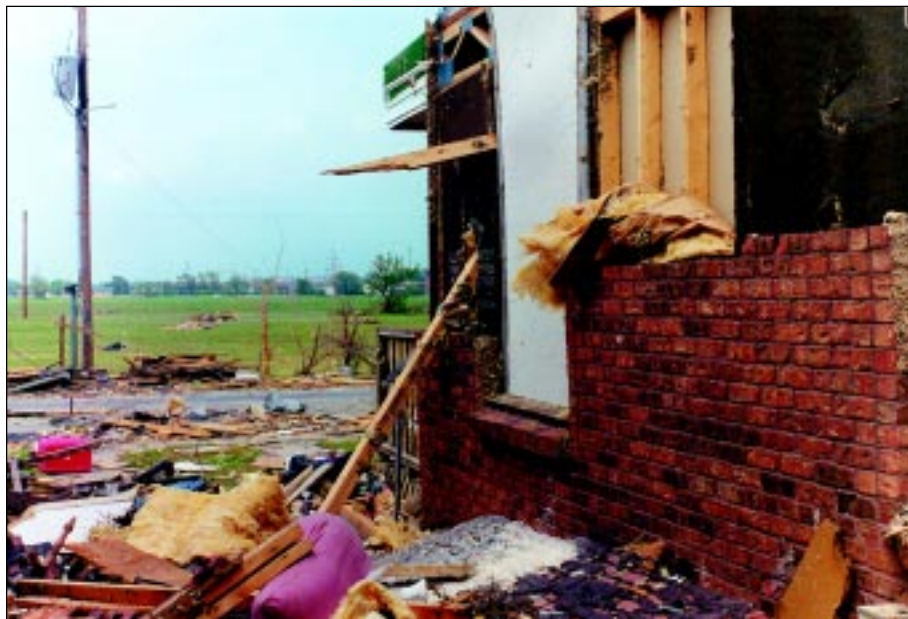
FIGURE 4-45: Failure of brick veneer at a multi-family housing unit in Wichita, Kansas. This building experienced inflow winds from a strong tornado.

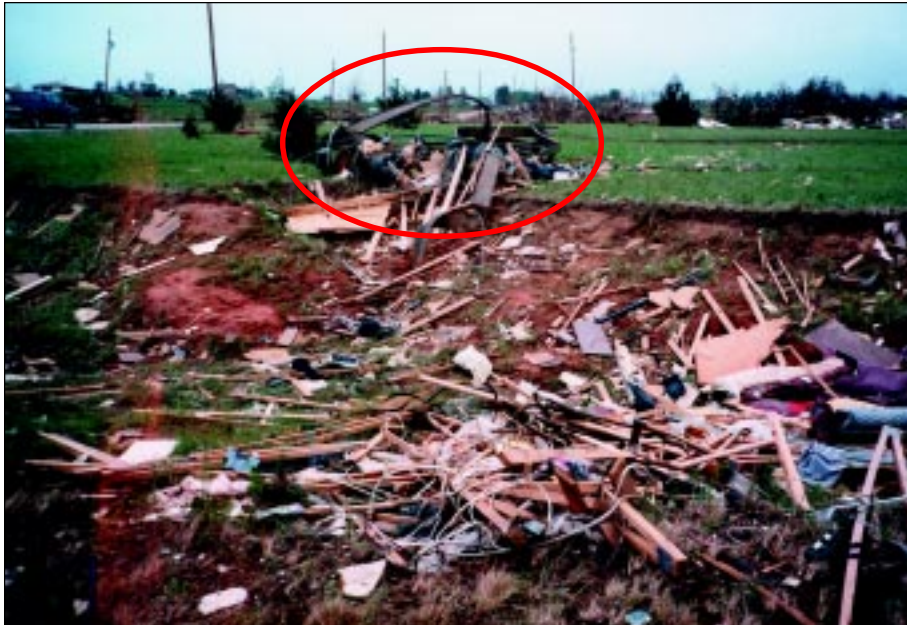
FIGURE 4-47: This 14-ft x 60-ft manufactured home chassis in the background of this photo moved about 200 yards from its original anchoring site in Figure 4-49, Bridge Creek, Oklahoma.

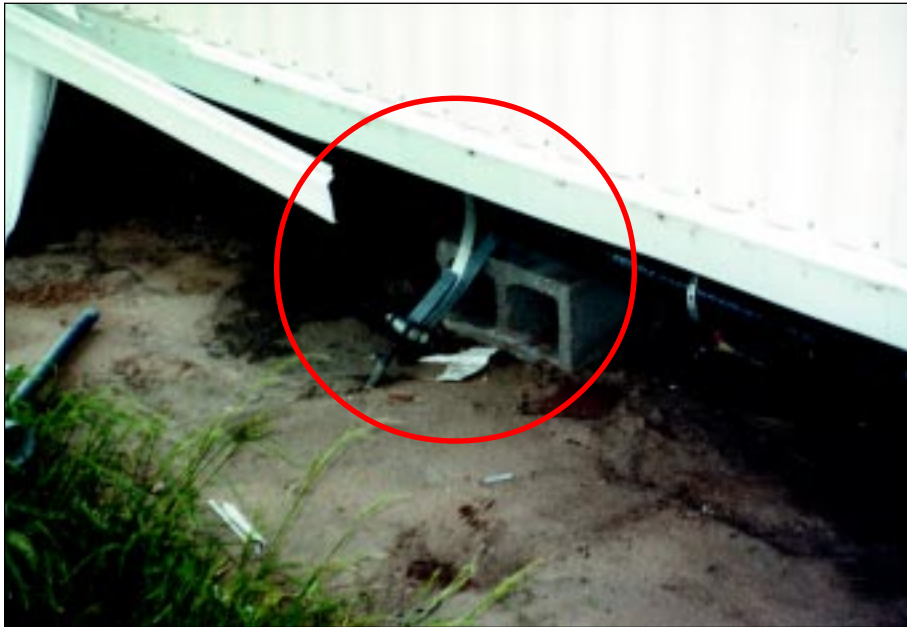
FIGURE 4-51: Anchor of manufactured home bent and pulled up from soil. This home in Wichita, Kansas, was located within the inflow area of a strong tornado.

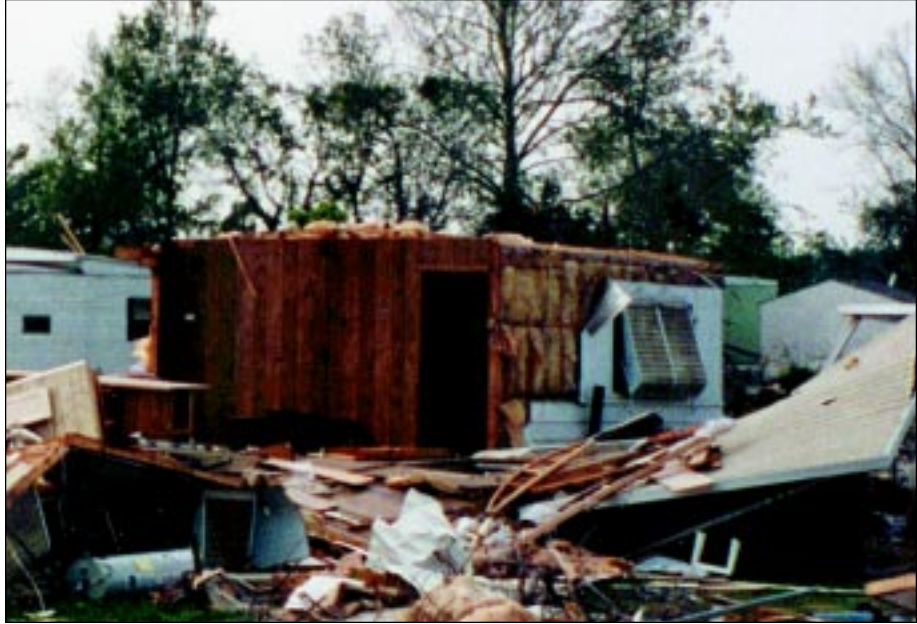
FIGURE 4-54: *Damage to a manufactured home located on the periphery of a strong tornado, Wichita, Kansas.*

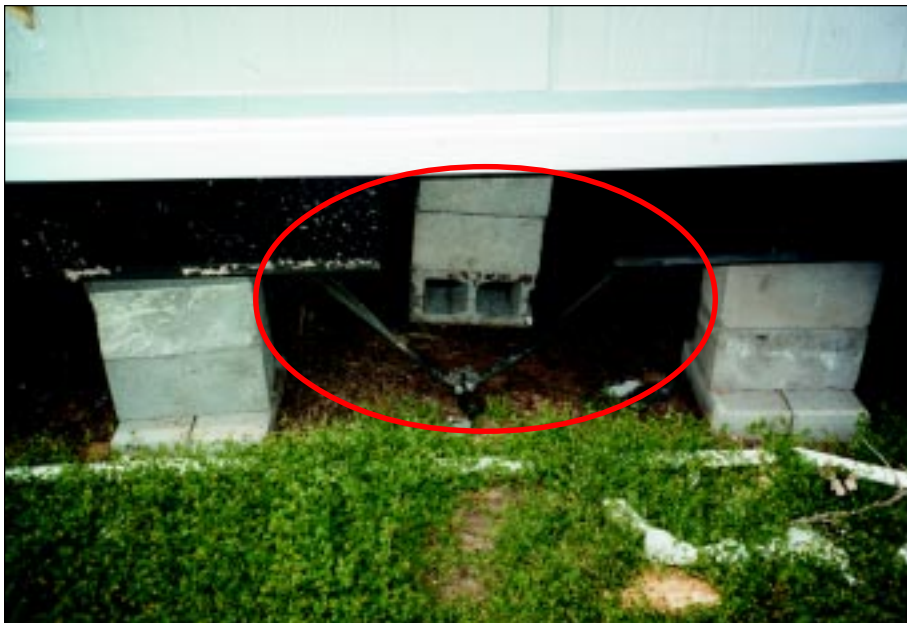
FIGURE 4-59: View of anchor strap and attachment indicating some lateral shifting of a manufactured home located along the periphery of a violent tornado, Wichita, Kansas.

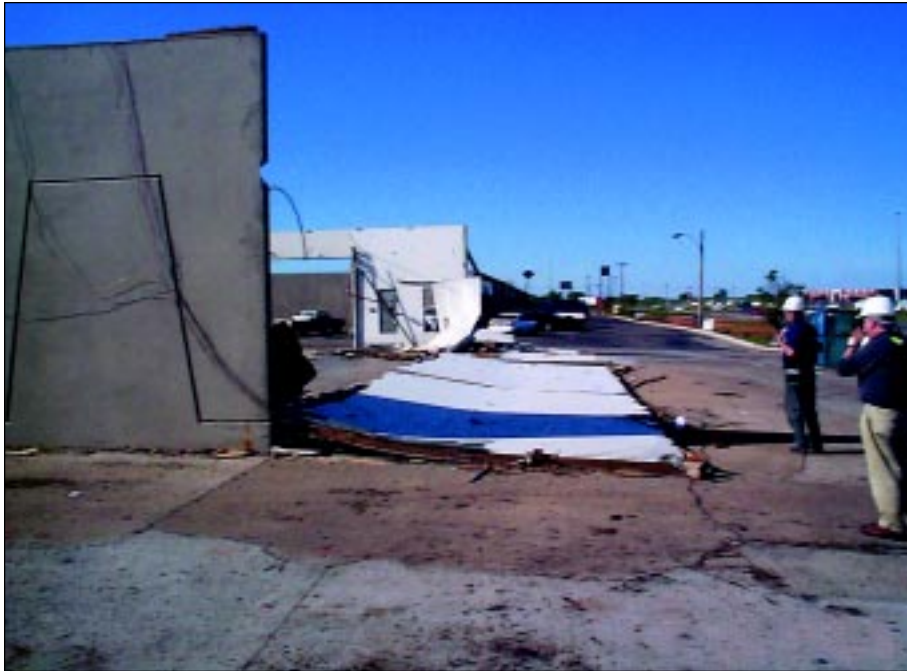
FIGURE 5-2: Tilt-up precast concrete walls at a storage building located outside Del City, Oklahoma. After the roof joists separated from the walls, this end wall became unable to withstand suction forces and failed.

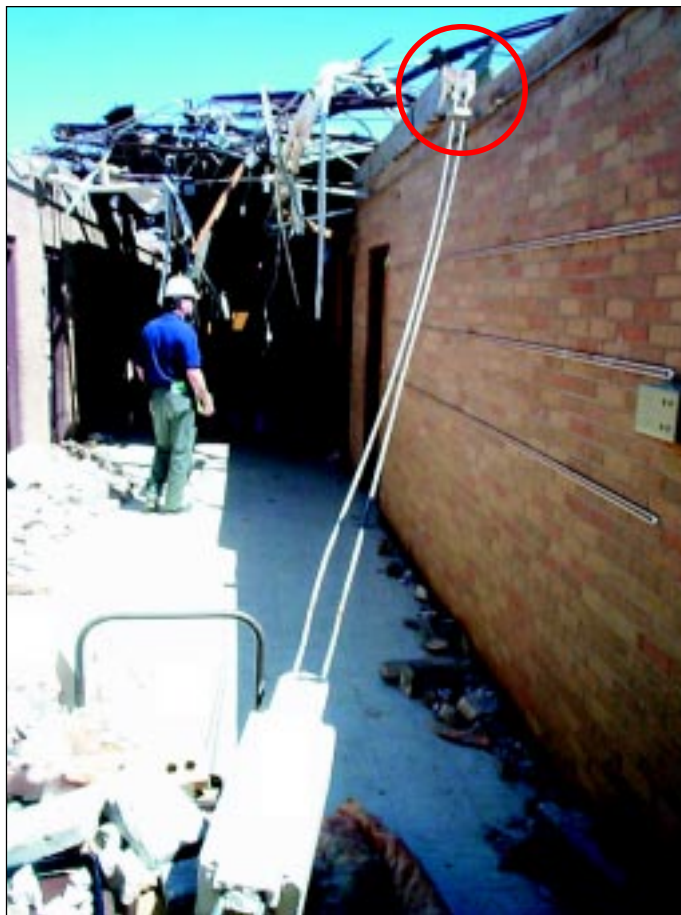
FIGURE 5-3: Kelly Elementary School, in Moore, Oklahoma, hit by vortex of violent tornado. Damage to school displaying separation between the bond beam and supporting wall and separation between bond beam and roof bar joists.

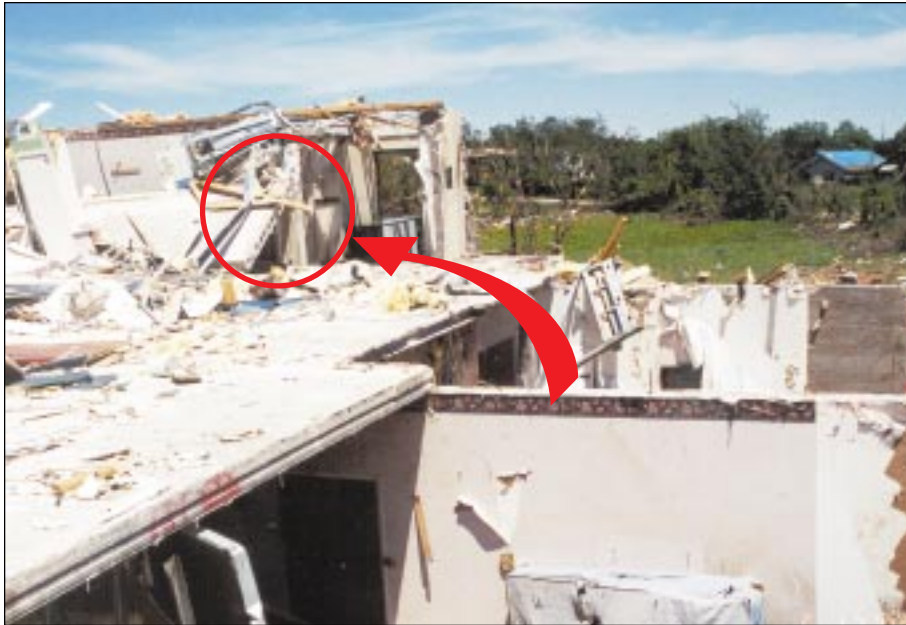
FIGURE 5-21: Hollow-core plank formed on second floor of a Midwest City, Oklahoma, hotel that was struck by the vortex of a strong tornado.

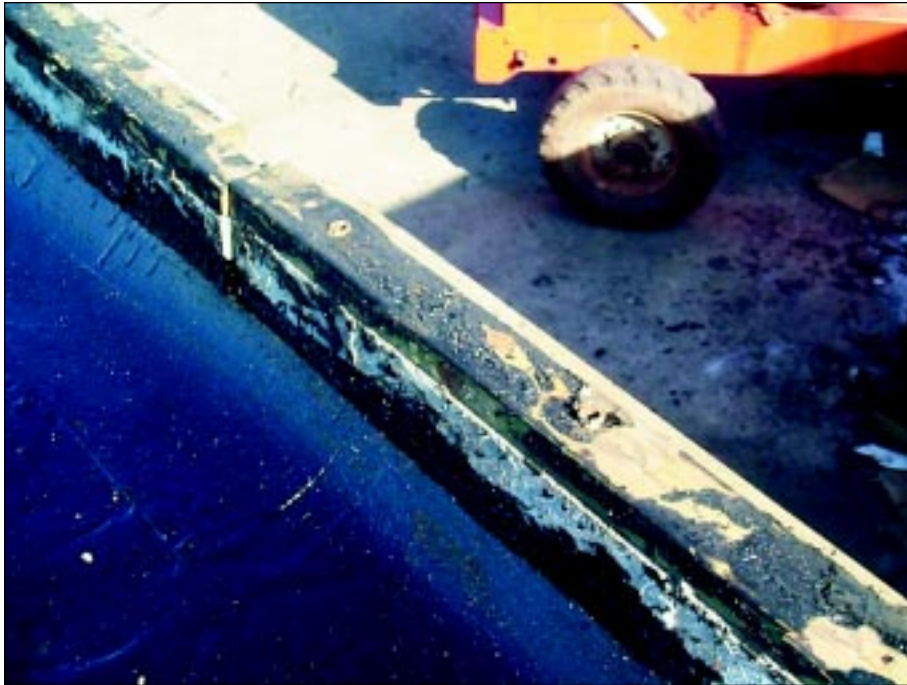
Investigations revealed poor connections between wood nailers (used for flashing attachment) and the structure at roof perimeters. In one case, roofing nails were used to attach perlite insulation. This type of attachment offered very little uplift resistance.

FIGURE 5-27: *Nailer at the roof of the hospital in Stroud, Oklahoma. The roof surface in this photo was replaced prior to this photo, but the same nailer was used again during repairs.*

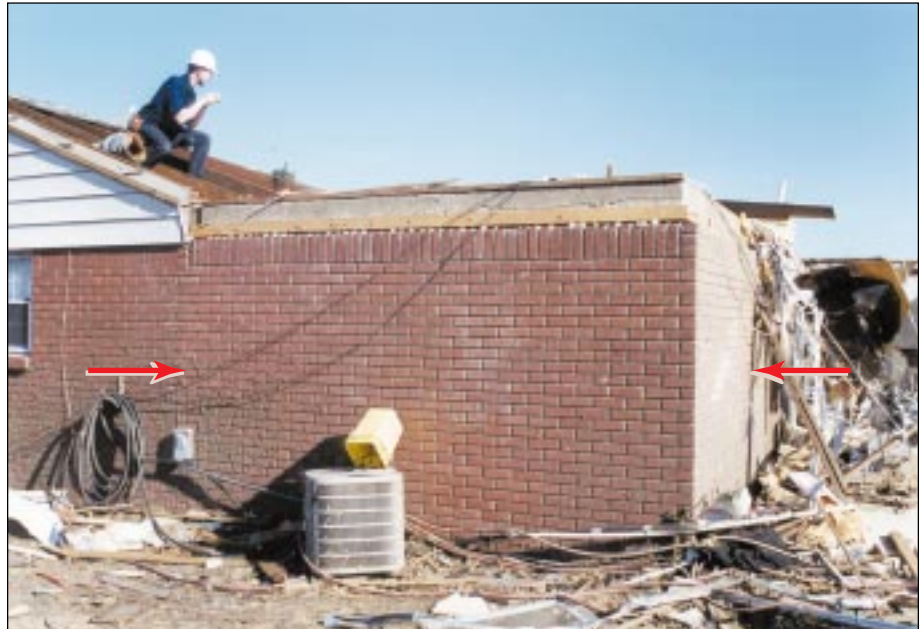
FIGURE 6-2: *Damage to houses near the home in Figure 6-1. This photo is taken from the roof of the concrete shelter.*

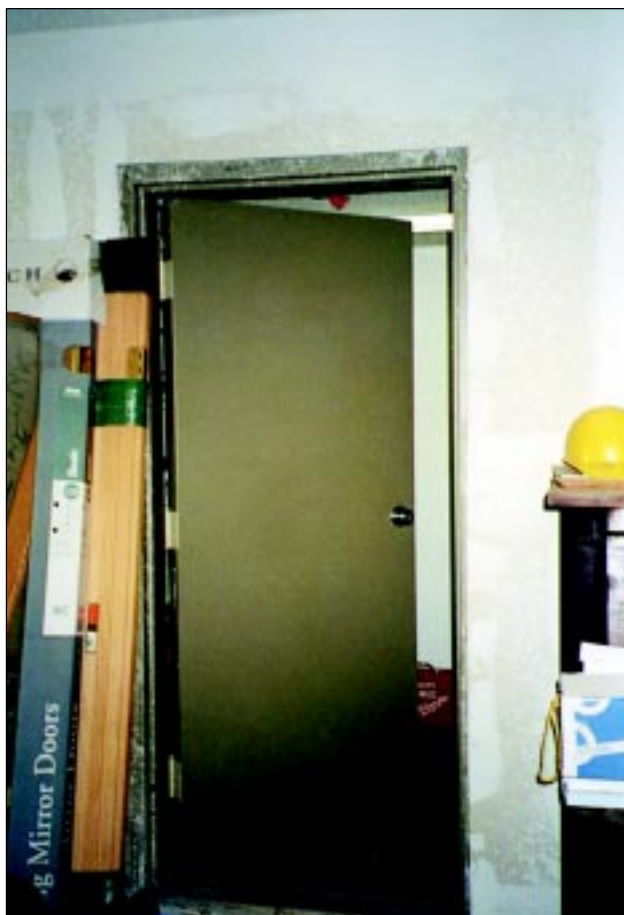
FIGURE 6-3: Entrance to the ICF shelter in Bridge Creek, Oklahoma. This residence and shelter were on the periphery of the inflow winds of a strong tornado, and damage was limited to light missile impacts.

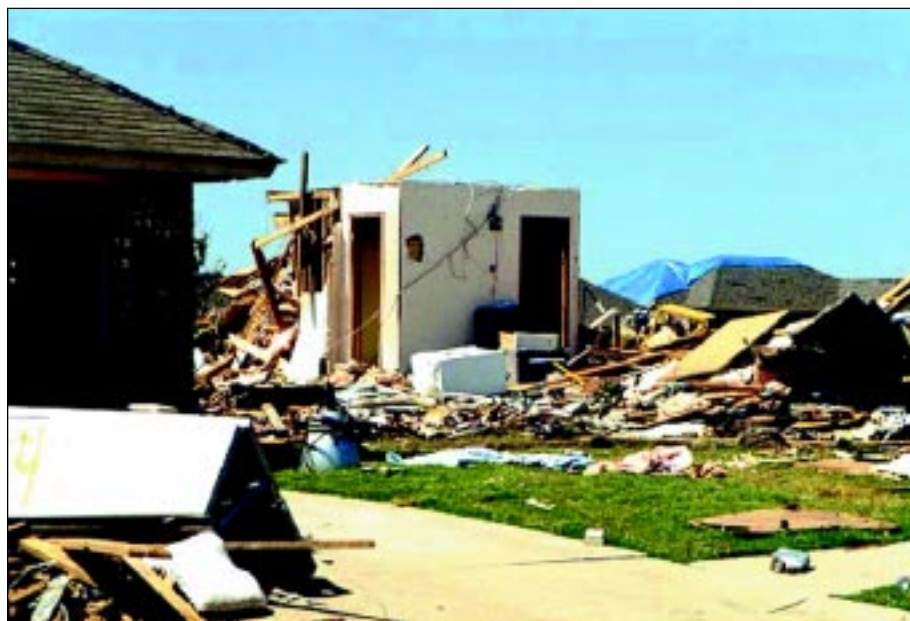
FIGURE 6-28: *The core remnant of this house consisted of a central room and closets.*

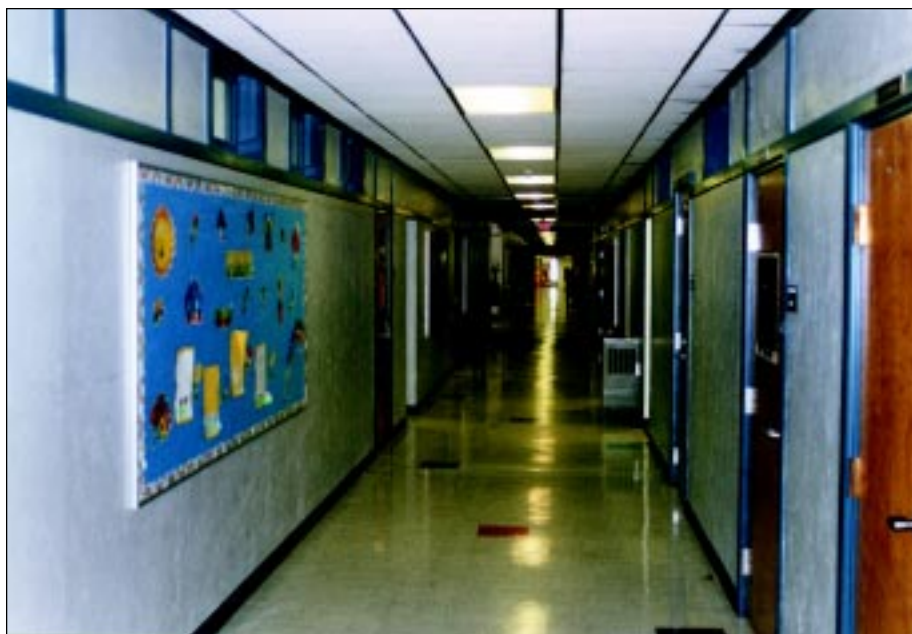
FIGURE 6-36: *Sooner Rose Elementary School, Midwest City, Oklahoma. According to the tornado plan for this school, this hallway is designated as a place of refuge.*
