Cocoa Beach Tornado

February 12, 2008

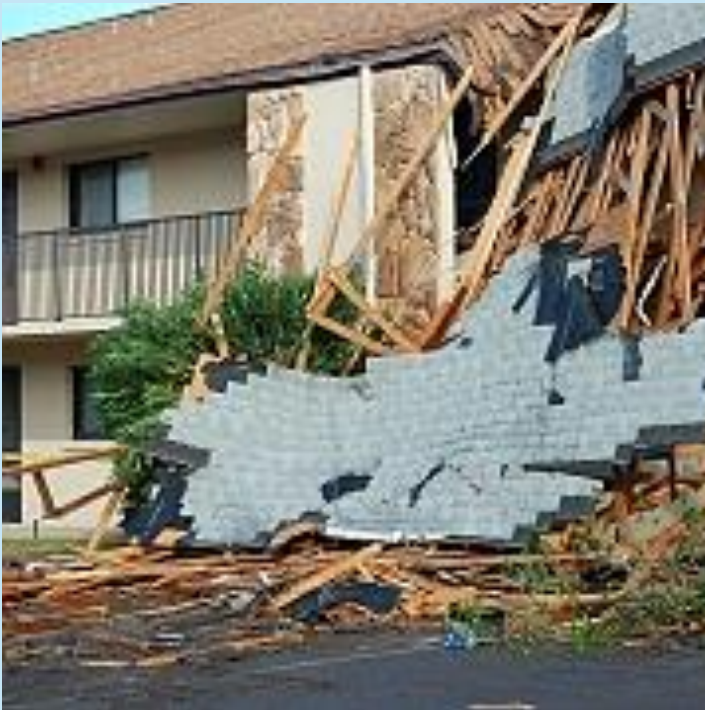
Part of the roof from Diplomat Condo where it landed
on nearby Windrush Condo

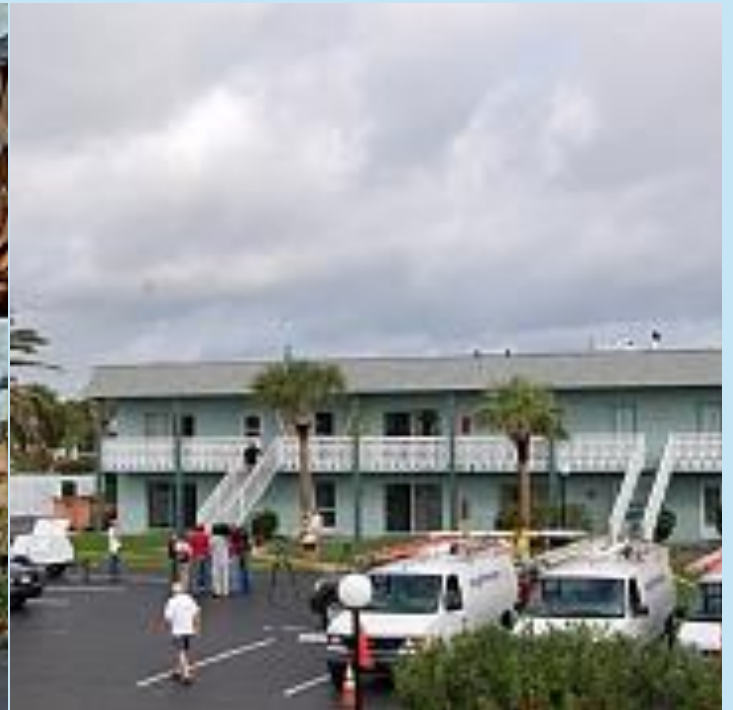
Unroofed Diplomat Condo building.

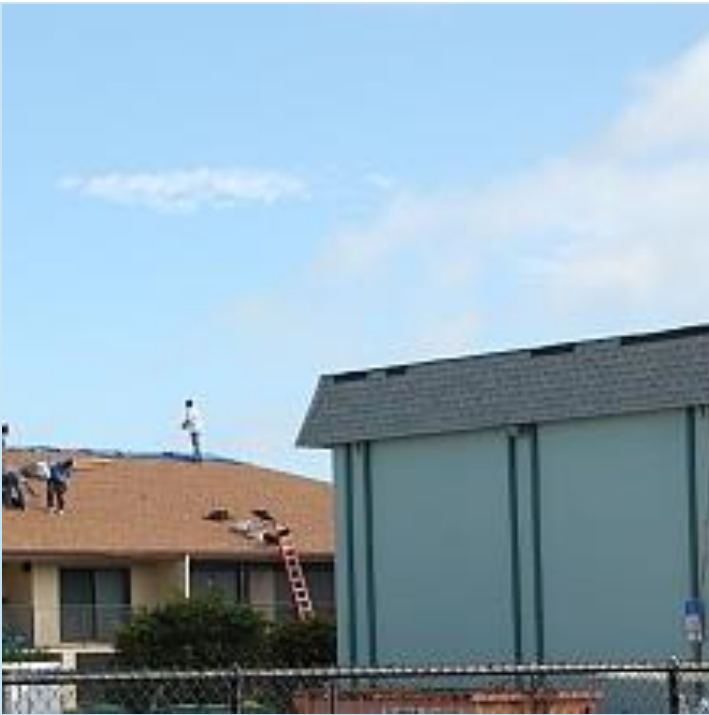
Illustrating the proximity of Diplomat Condo to Windrush Condo. The roof from building in foreground hit the building behind it.

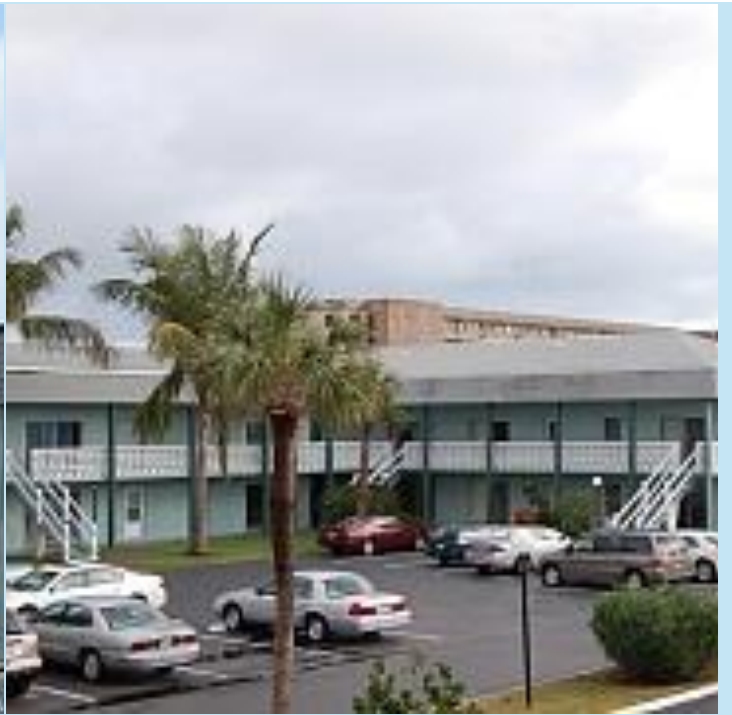
This illustrates how the roof structure of the Diplomat Condo appeared like prior to the tornado. This is a another building in the Diplomat Condo complex.
