The Indialantic Tornado - 2/17/98

Overview of Indialantic Tornado - the tornado first touched down around 7:07 AM on February 17th, 1998 in the 500 block of South River Oaks Drive on the barrier island near Indialantic. The tornado knocked down some fencing in the backyard and tore the porch roof off of one house and damaged portions of the main roof. A car in the driveway was spun around and damaged by flying debris ([photo 2](#)). The neighboring house was damaged by flying debris from the first house, including a roof beam that completely penetrated the wall of the house ([photo 1](#)). The tornado was rated F1 (73-112 mph at this point FUJITA DAMAGE SCALE). The tornado immediately lifted to near treetop level and continued to do minor (F0 damage - winds less than 73mph) further along South River Oaks Drive and North River Oaks Drive. Trees were topped off and one concrete light pole was broken off ([Photo 3](#)) near the top indicating winds speeds were much higher than F0 just 20 or 30 feet off the ground. The tornado then lifted for about 1/4 mile and touched down again just north of the Hoover Junior High School on Riviera Blvd and produced damage consistent with an F1 torn

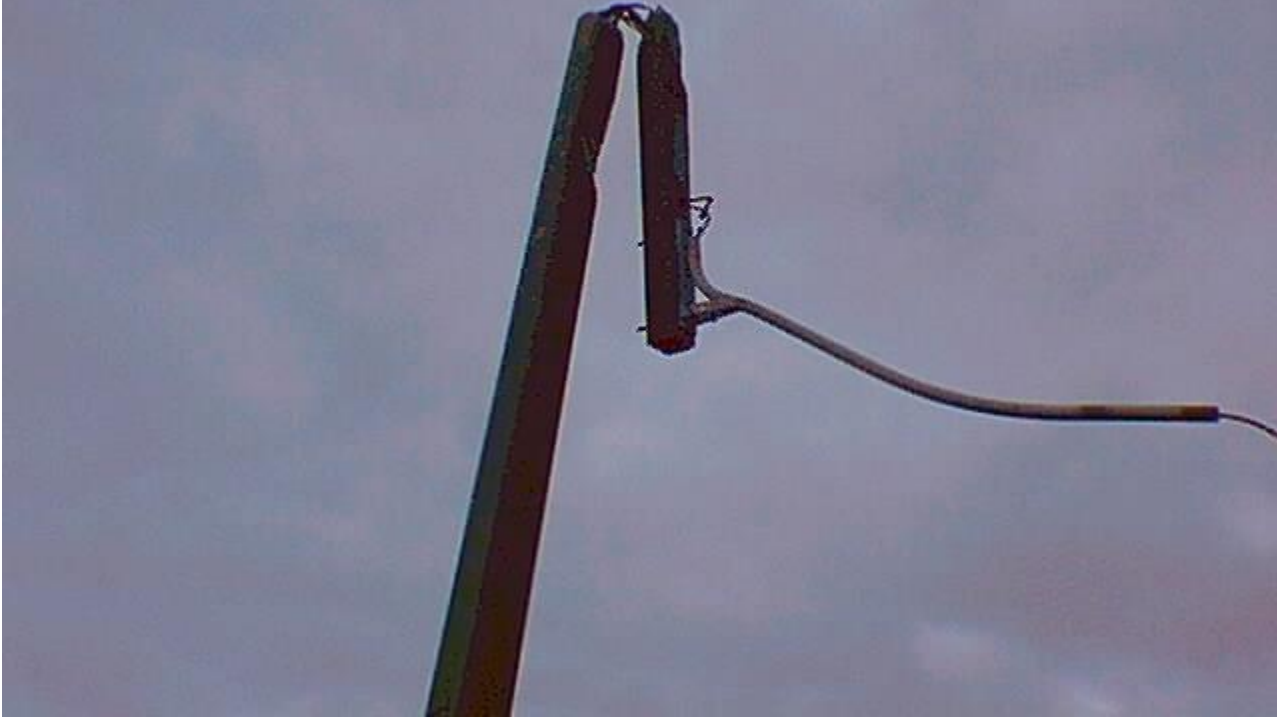
Damage photo at location 3.

A cement power-pole snapped and hanging by its embedded reinforcing bar.

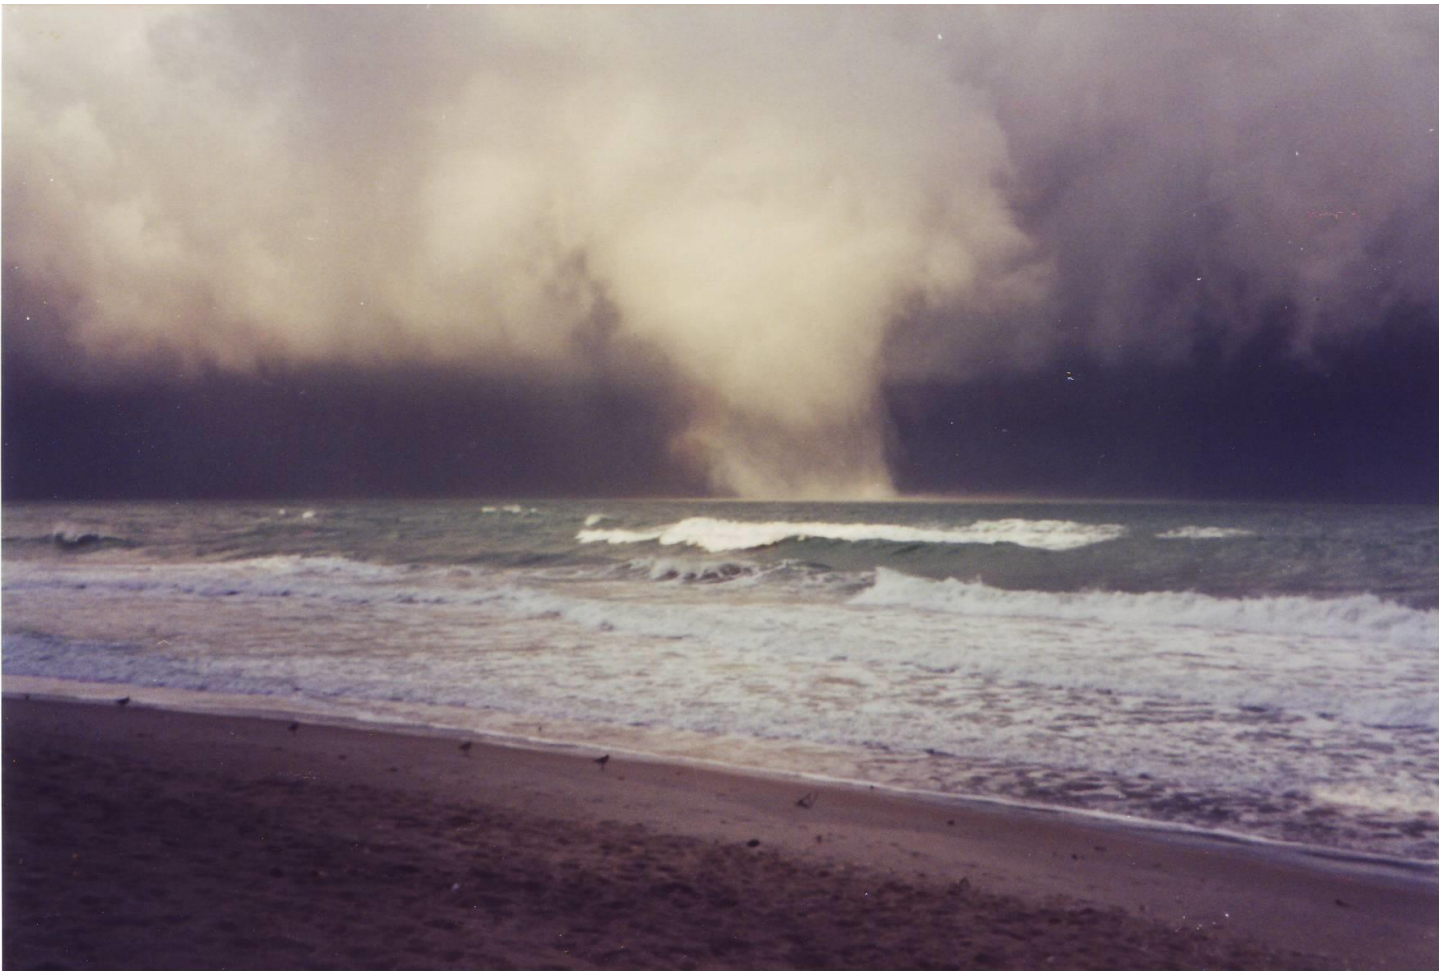
Photo 5. Tornado that moved offshore on 2/22/98 near the same path of the 2/17/98 tornado!

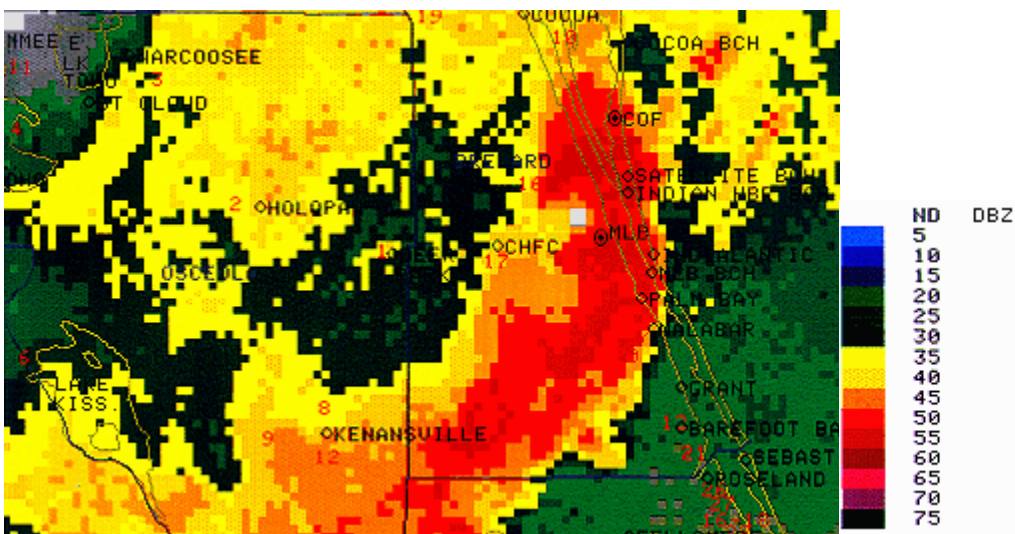
Composite Reflectivity 7:09 AM EST 2/17/98

This radar reflectivity image from the NWS Melbourne WSR-88D shows an intense "Bow Echo" approaching Indian Land and the barrier islands. Typically, this type of feature is associated with damaging straight line winds, however short-lived tornadoes can spin up rapidly along the leading edge of the bow echo.

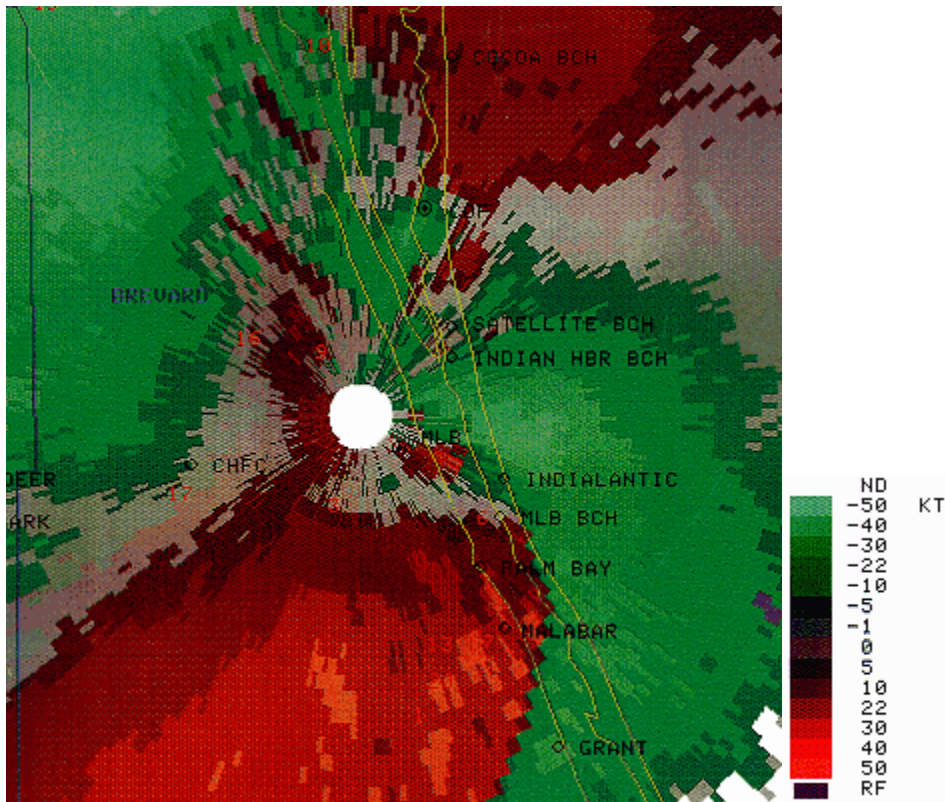
Velocity 7:09 AM EST 2/17/98

This Doppler velocity image from the NWS Melbourne WSR-88D shows the small circulation associated with the Indialantic tornado between the Melbourne radar site (the white circle in the middle of the image) and the town of Indialantic. The circulation is located near the letters "MLB" on the image. Green indicates air moving toward the radar site and red indicates winds moving away from the radar and reveals the classic counterclockwise circulation around the great majority of tornadoes.
