# Okeechobee Storm

August 1, 2003

ON FRIDAY EVENING...A NATIONAL WEATHER SERVICE DAMAGE SURVEY TEAM INVESTIGATED WIND DAMAGE WHICH OCCURRED APPROXIMATELY BETWEEN 2:30 AND 2:40 PM IN AND NEAR THE TAYLOR CREEK ESTATES ON THE SOUTH SIDE OF THE CITY OF OKEECHOBEE.

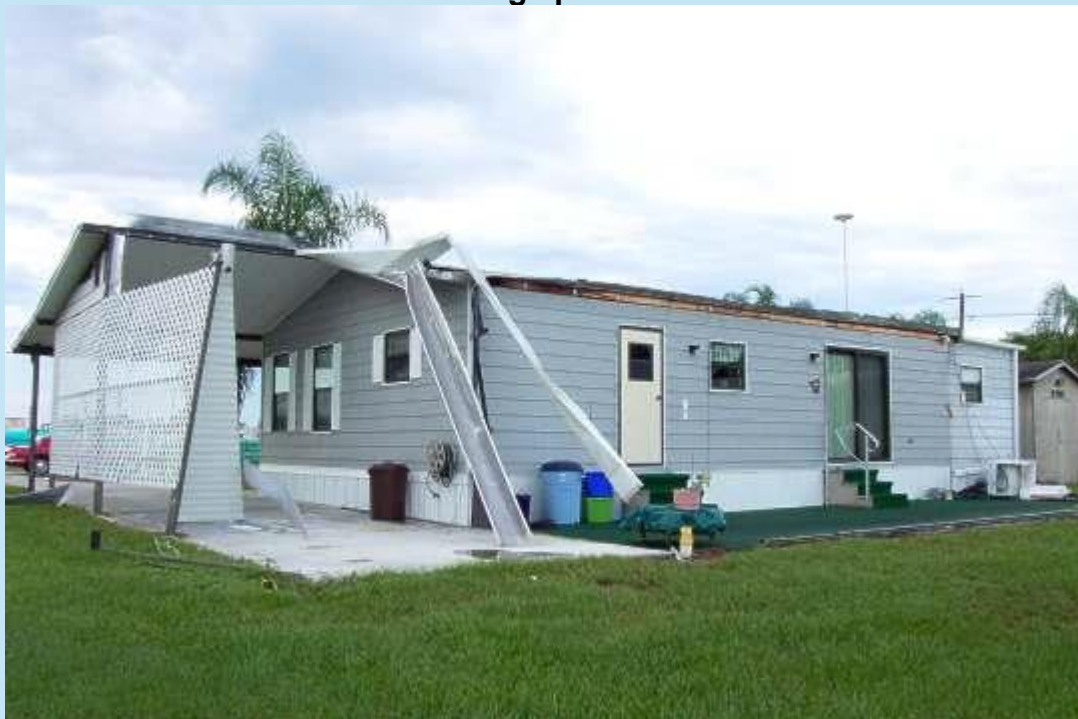
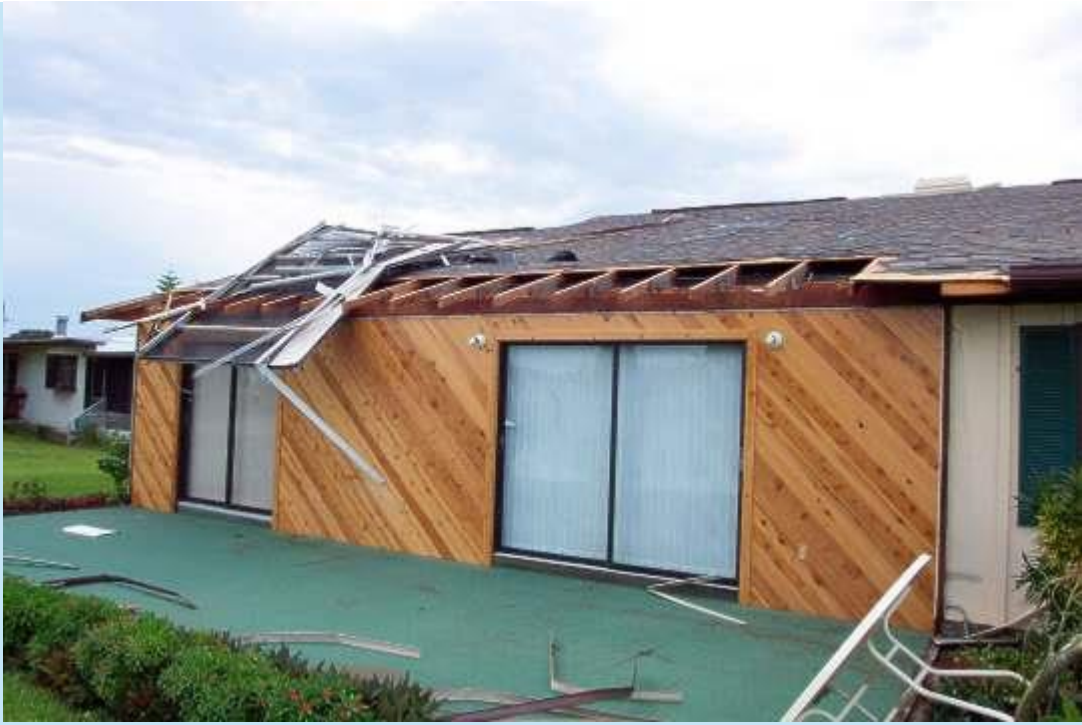
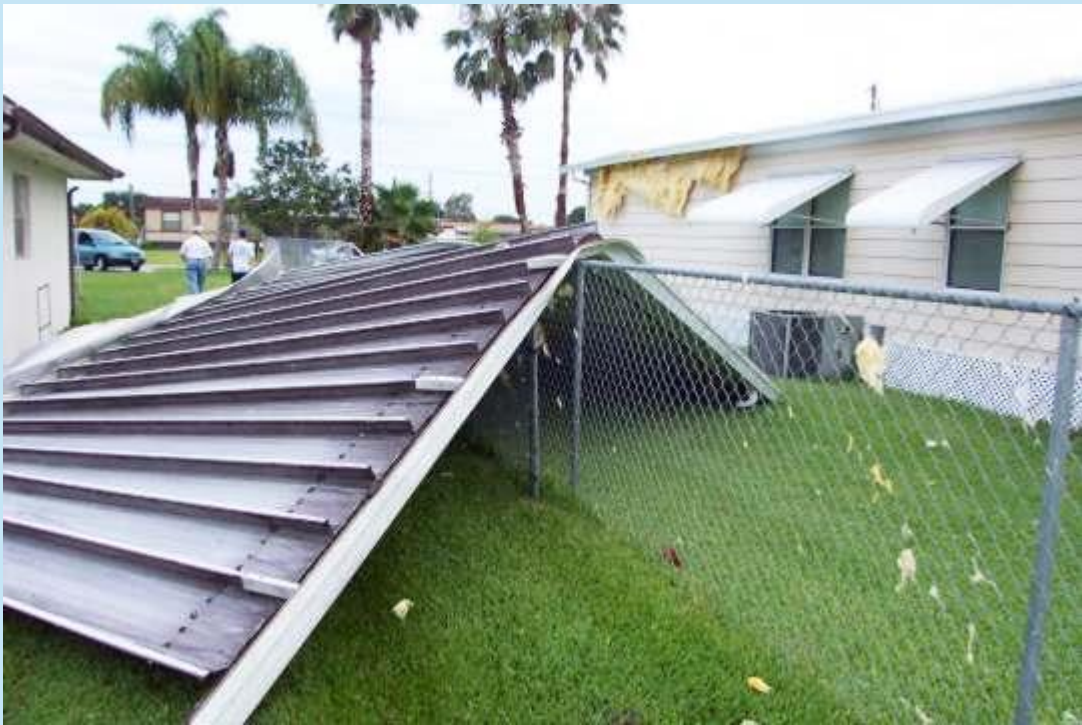
**Damage photos:**

THE DAMAGE TRAIL WAS PICKED UP AT THE CORNER OF SOUTHEAST 18TH TERRACE AND SOUTHEAST 30TH STREET...WHERE AN EAST-FACING CARPORT AND ADJACENT PORCH WAS TORN FROM A RESIDENCE AND BLOWN WESTWARD ACROSS SOUTHEAST 18TH STREET INTO A CONSTRUCTION SITE...WITH SOME ALUMINUM DEBRIS BEING WRAPPED AROUND ELECTRICAL POLES AND WIRES.

TO THE EAST-NORTHEAST OF THIS DAMAGE ON SOUTHEAST 29TH STREET A CARPORT AND TRAMPOLINE WERE DAMAGED, BLOWN TOWARD THE EAST. TREES AND MARSH GRASS WERE OBSERVED TO BE BLOWN DOWN TOWARD THE NORTHEAST. ON THE SOUTH SIDE OF SOUTHEAST 27TH STREET A PORCH AND A SECTION OF ROOF AND SHEATHING WAS PICKED UP AND CARRIED OVER TO THE NORTH SIDE OF THE HOUSE, WITH A PIECE OF THE ROOF SHEATHING CARRIED OVER THE TOP OF A HOUSE ACROSS THE STREET; A DISTANCE OF ABOUT 30 YARDS. SOME OF THE ALUMINUM PORCH WAS BLOWN TO THE NORTHEAST. ON THE SOUTH SIDE THE HOUSE IMMEDIATELY TO THE EAST AN OUTBUILDING SECURED WITH TIE DOWNS SLID ABOUT ONE FOOT OFF IT'S BLOCKS.

FINALLY, ANOTHER HOUSE ON THE NORTH SIDE OF SOUTHEAST 24TH BLVD HAD A LARGE SECTION OF IT'S CORRUGATED ALUMINUM ROOF WAS PEELED OFF AND DEPOSITED IN AN ADJACENT YARD, WITH ALUMINUM DEBRIS AND FIBERGLASS INSULATION SCATTERED TOWARD THE NORTHEAST.
