# National Weather Service Melbourne, Florida

## NWS Melbourne Damage Survey EF-1 Tornado | July 25, 2014 Edgewater, FL

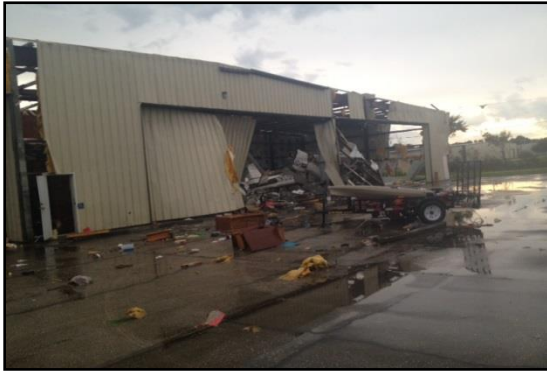
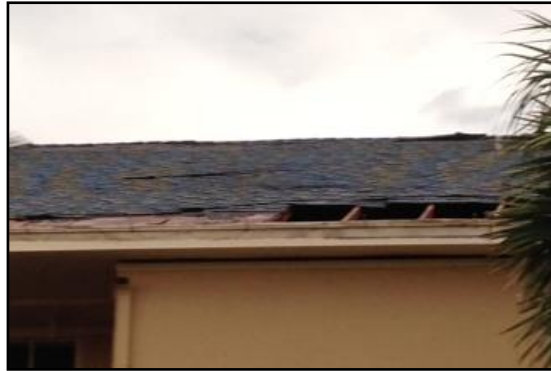
SURVEY SUMMARY: TORNADO TOUCHED DOWN AT THE MASSEY RANCH AIRPARK IN EDGEWATER WHERE THREE SMALL AIRCRAFT WERE FLIPPED AND THREE HANGARS SUSTAINED MAJOR DAMAGE. TORNADO CONTINUED NORTHEAST AND UPROOTED NUMEROUS TREES AND CAUSED MINOR ROOF DAMAGE TO SEVERAL HOMES IN AN ADJACENT NEIGHBORHOOD. FARTHER DOWNSTREAM, SPORADIC TREE DAMAGE AND MINOR STRUCTURAL DAMAGE OCCURRED. TORNADO LIFTED NEAR THE HALIFAX RIVER, APPROXIMATELY 1.5 MILES FROM WHERE IT TOUCHED DOWN.

### Damage photos below courtesy Central Florida News 13:

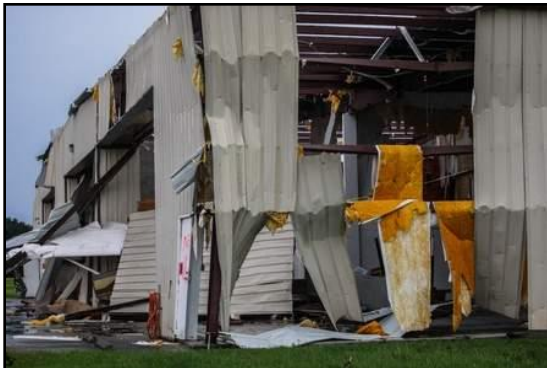
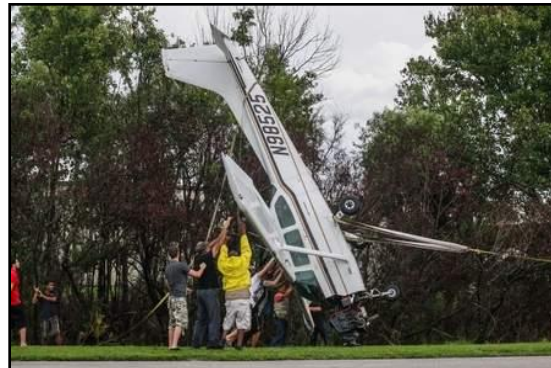
### Damage photos below courtesy Daytona Beach News Journal:

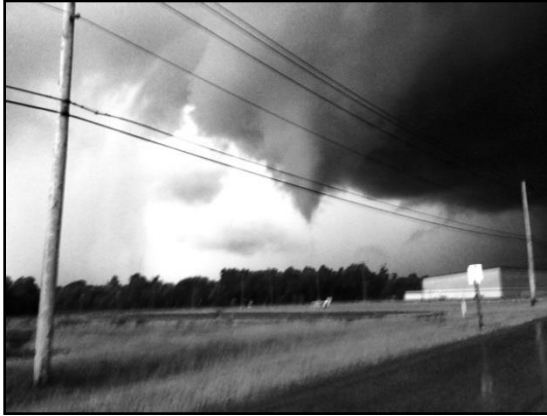
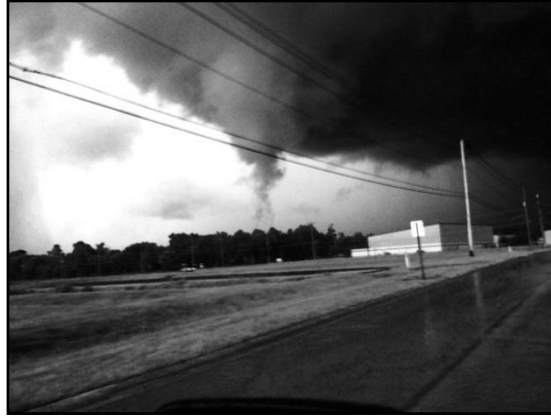
Photos below courtesy of Donald Smith:
