# EF-0 Hamlin Grove Tornado

## Public Information Statement

...Damage Survey for 09/01/16 Tornado Event...

.Hamlin Grove Tornado...

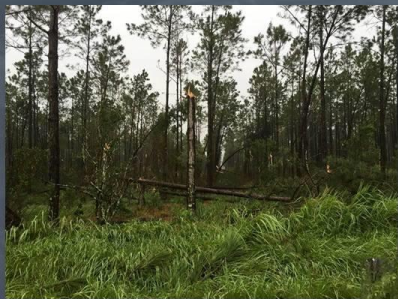
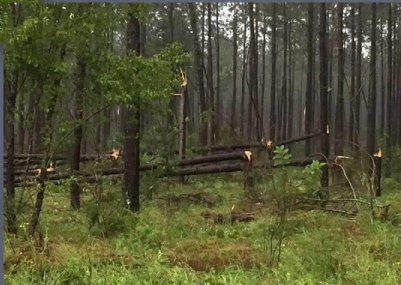
Damage reports included snapped trees, fences, a pool screen enclosure & damage from flying debris near Winter Garden.
