# **North DeLand EF-2 Tornado August 18, 2020**

## **Orange City EF-0 Tornado**

### **Event Summary**

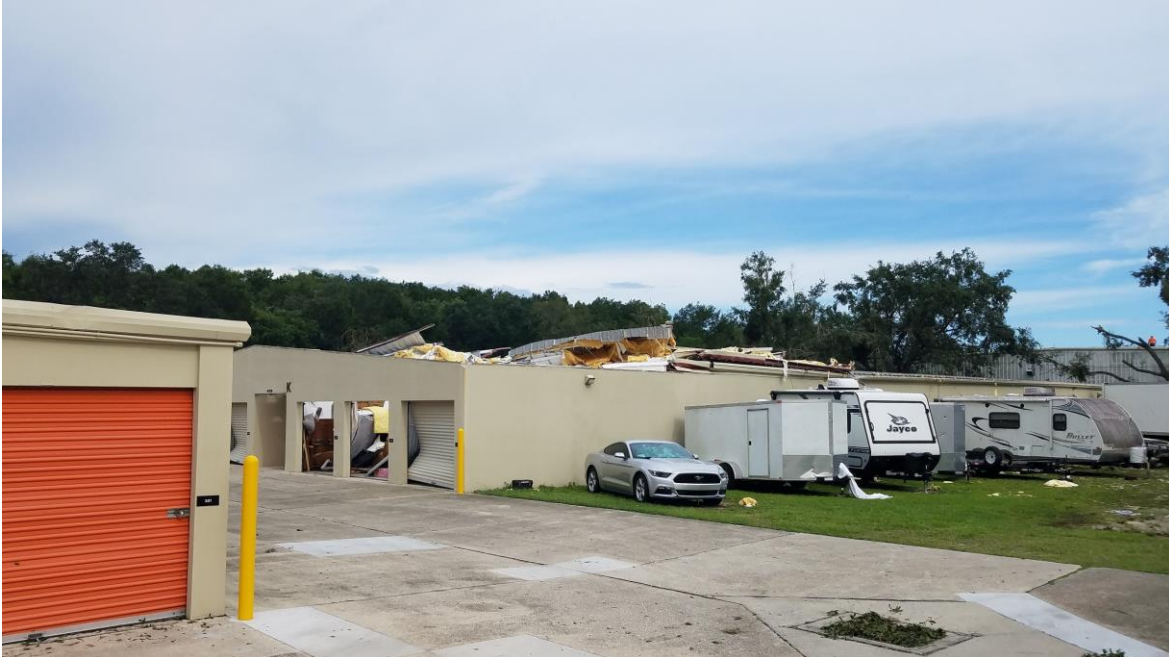
*EF-1 damage occurred at a storage facility near W Plymouth Ave & Spring Gardner Ave*

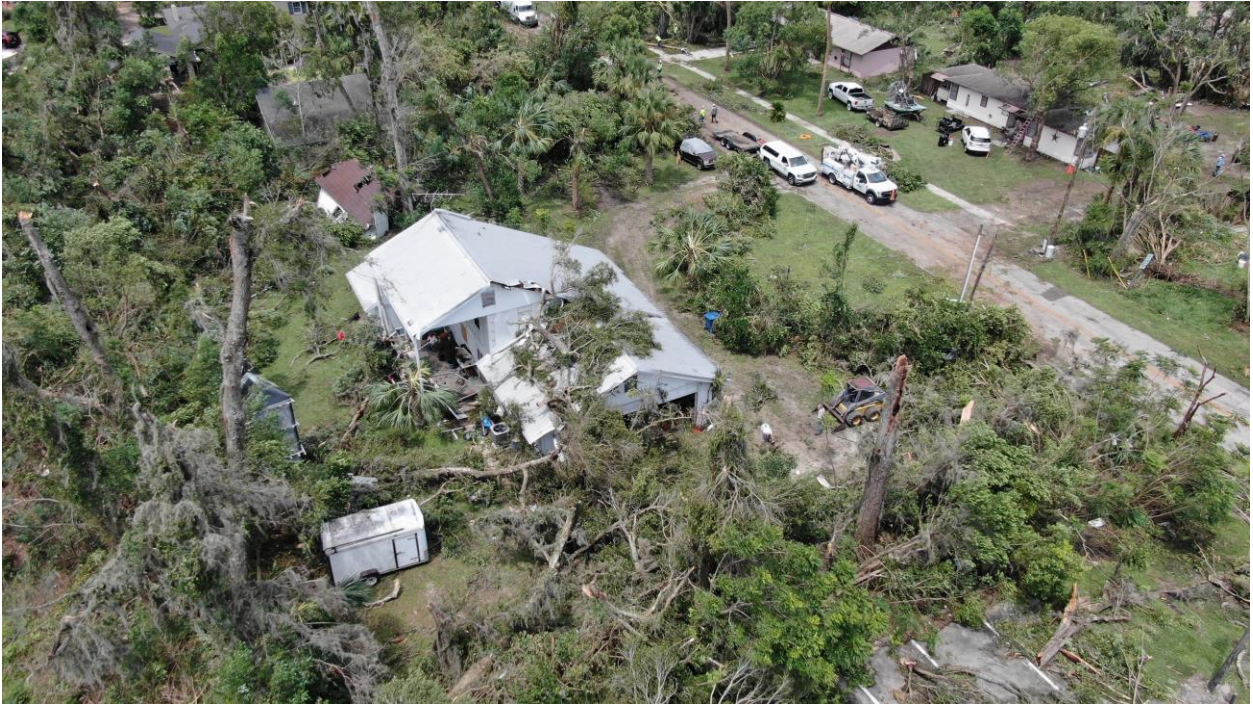
*Aerial image of tree and home damage near W Washington Ave.  
(source: Volusia County Emergency Management)*

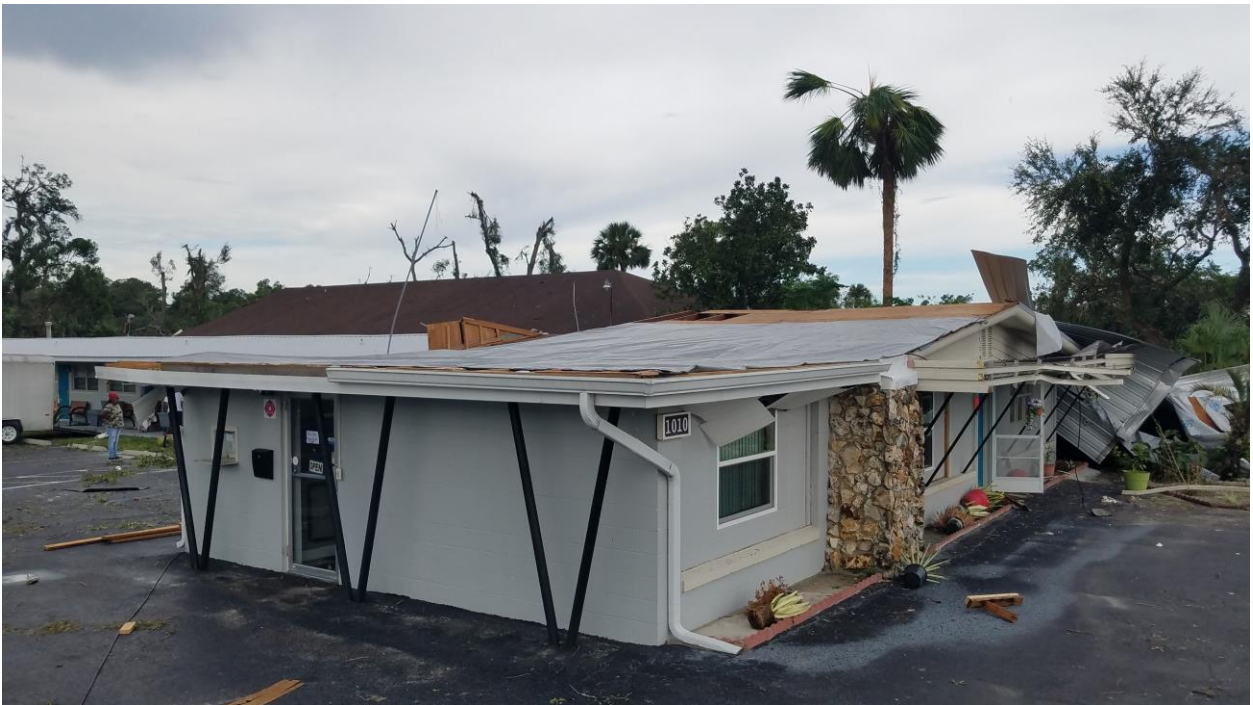
*Damage to a building along North Woodland Blvd.*

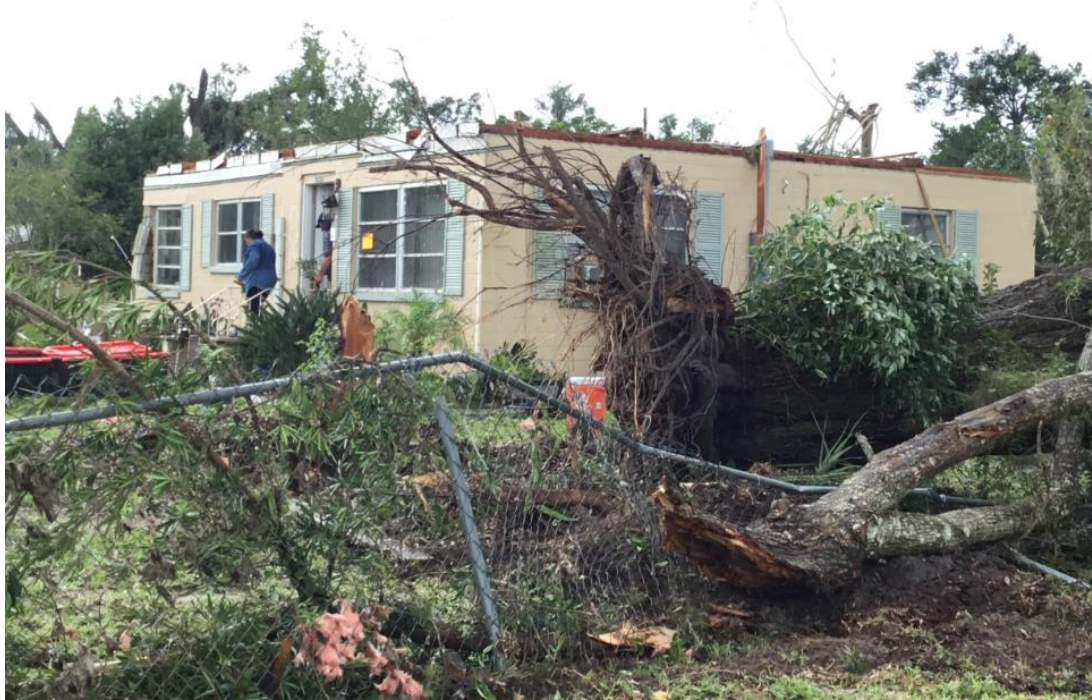
*EF-2 tornado damage to homes along E Washington Ave.*
