December 16, 2007 Land O' Lakes Tornado Damage Survey

Anthony Reynes, Daniel Noah - NWS Tampa Bay

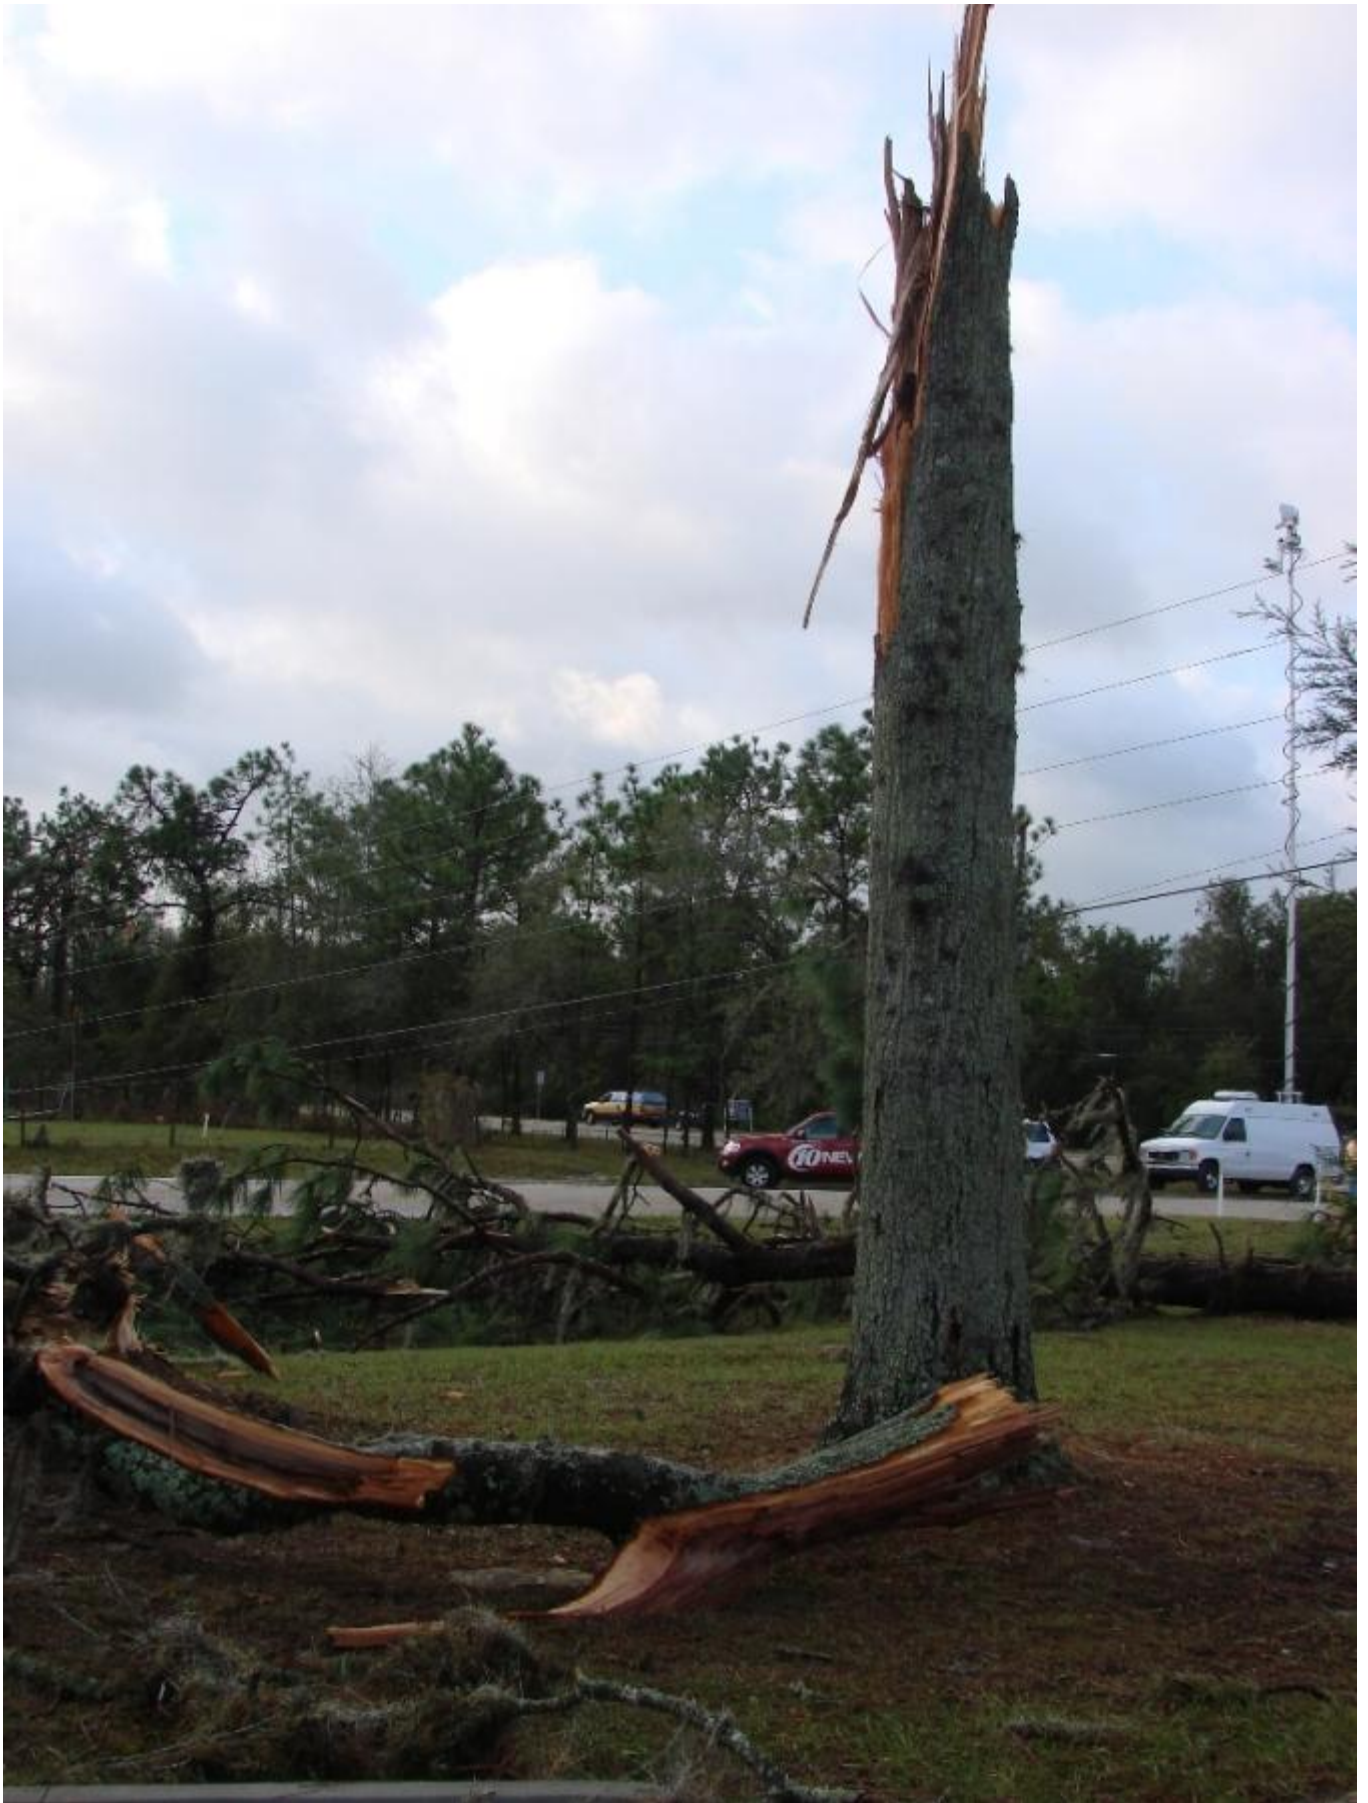
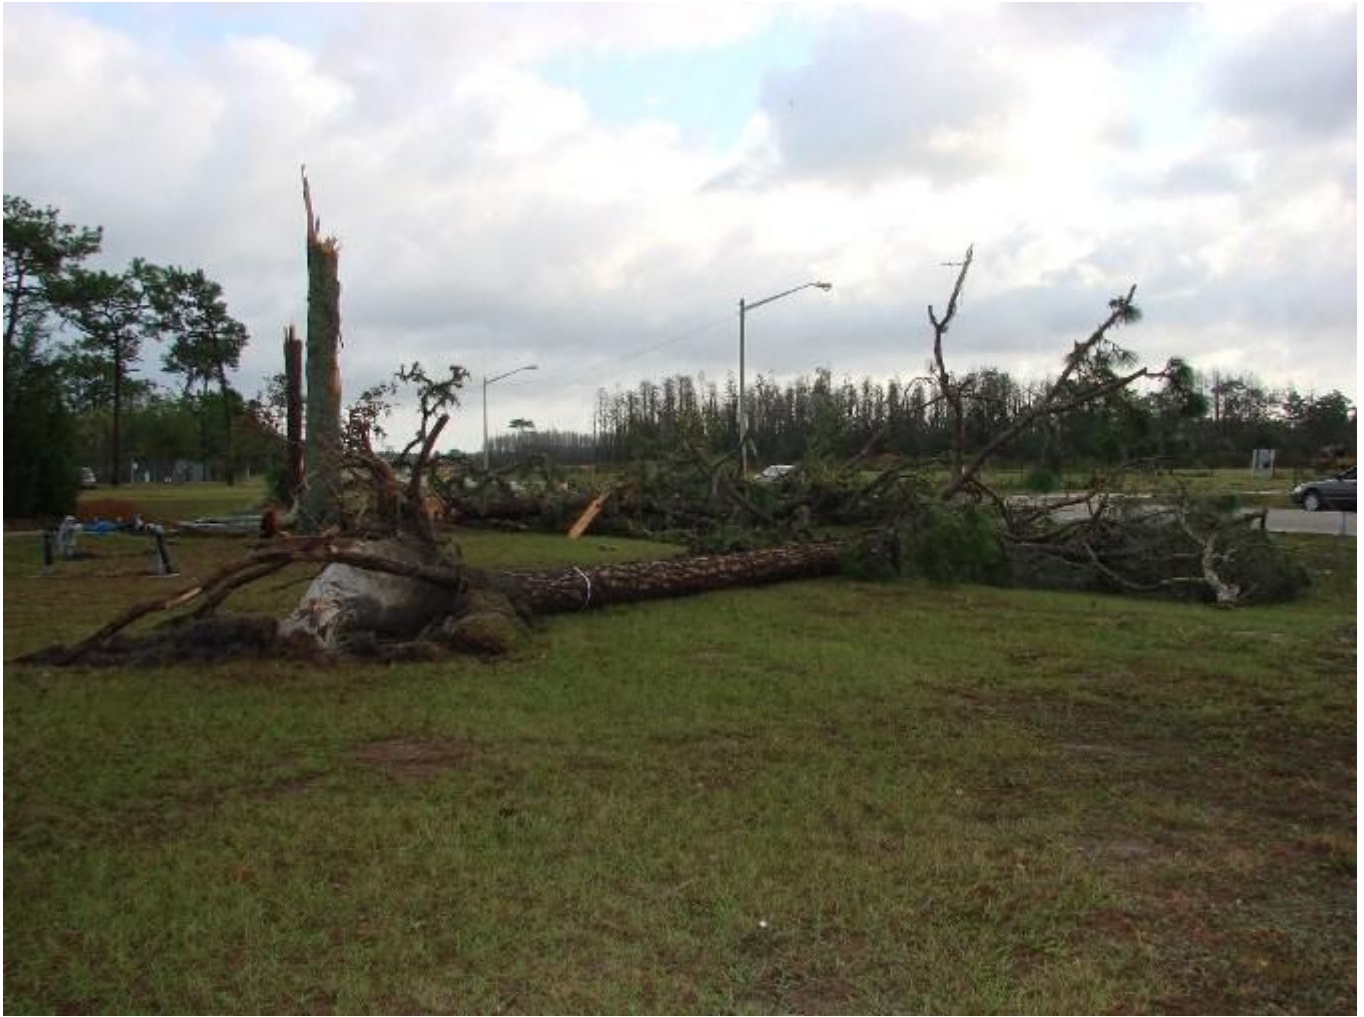
The path of damage (Figures 3 through 7) began with two large trees in front of the Fire House. An adjacent football field was also damaged by the winds. Half a mile down the road, the tornado struck gardening facilities and a pig farm. A hydroponic garden structure was destroyed, along with a large storage shed. A large field of scattered debris was found.

Figure 3. Site A damage (beginning of Central Blvd Rd and Fire House Station).

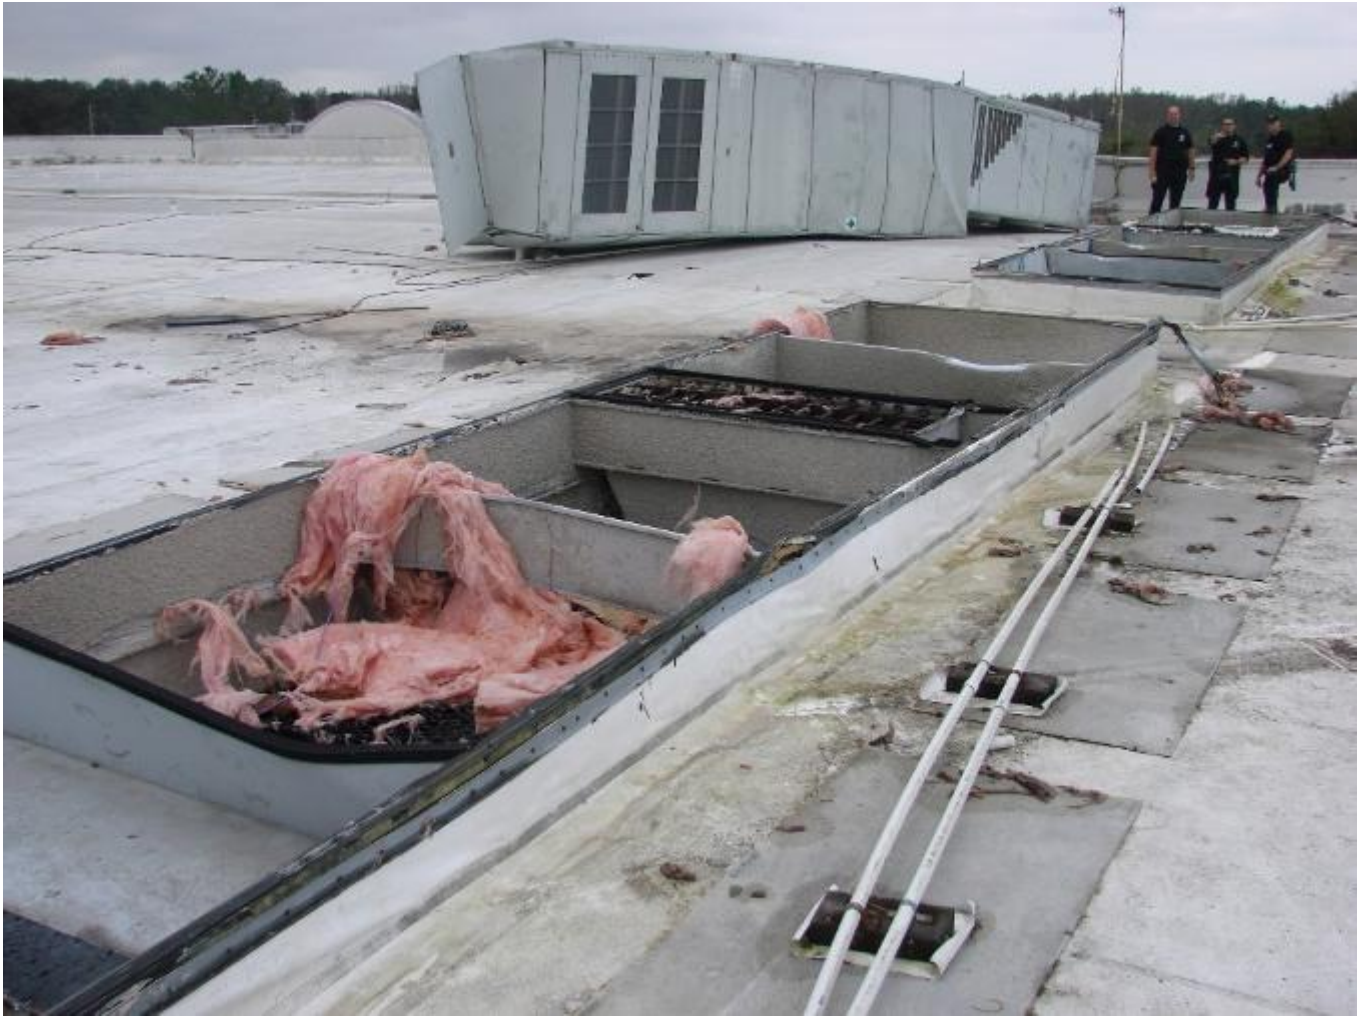
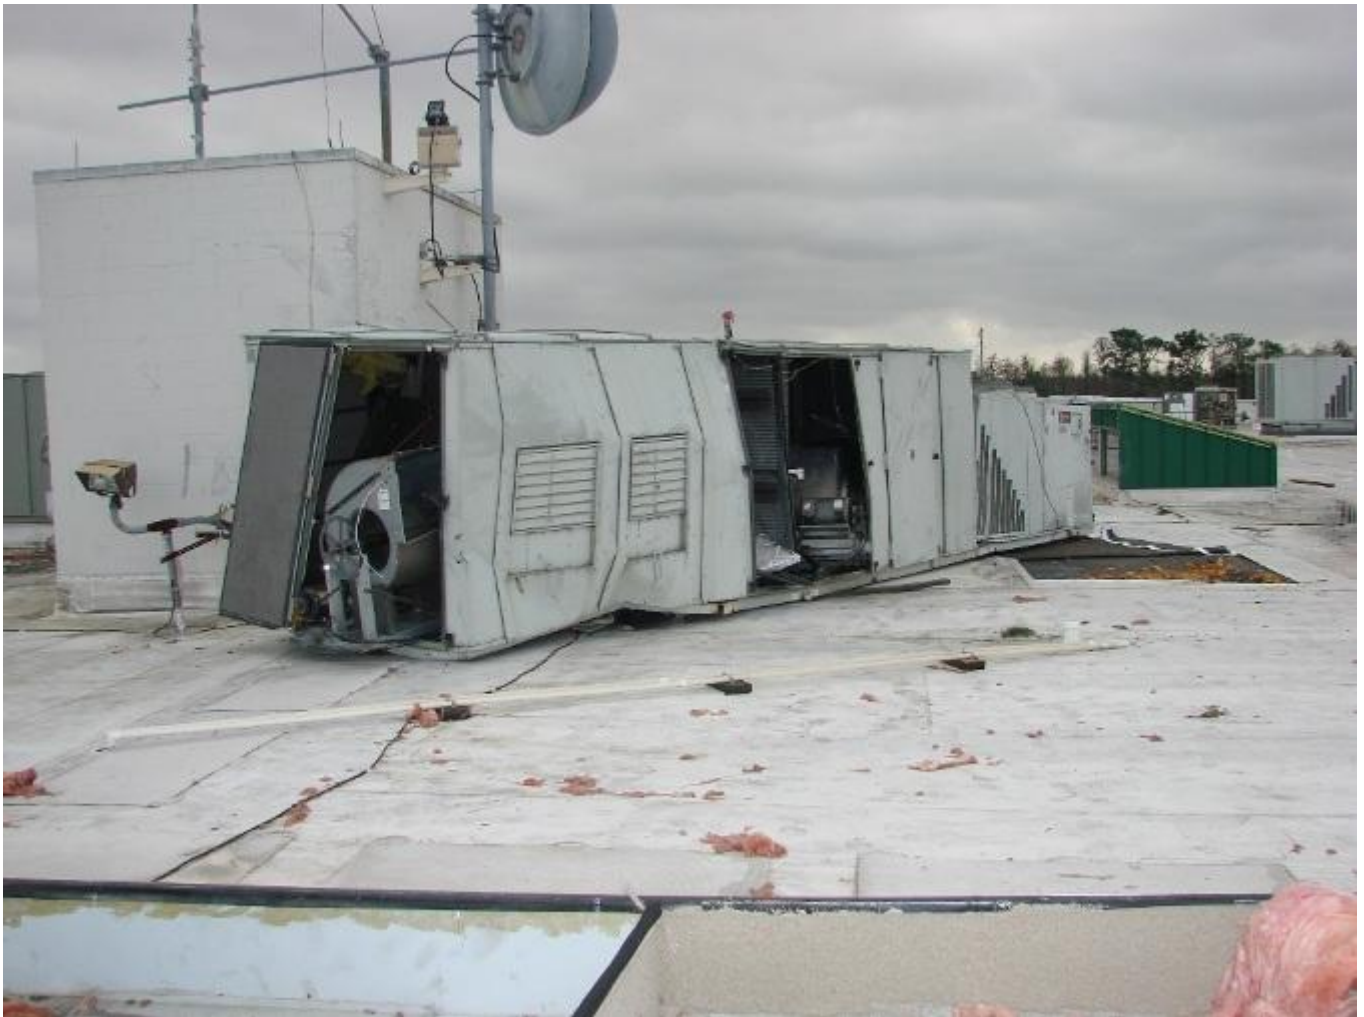
At the Jailhouse main building, there was damage to the front parking lot facility. This damage included downed traffic signs and uprooted trees. There was also a service pickup truck observed to be overturned and leaning against a power pole (Figure 6). Also at the main building, the most significant damage was found on the roof where several industrial air conditioning units were moved from their foundations. Each unit weighs approximately 7000 lbs and rested on an iron base. Three units were partially or completely destroyed (Figure 5). The most heavily impacted area was a temporary facility in back of the main building. It was completely destroyed (Figure 6). Another large vehicle was turned sideways (not shown). At the end of the estimated path of the tornado, on State Road 52, a line of power poles was damaged. Many broke in half or were twisted until reaching the ground (Figure 7). The preliminary conclusion is that this was a solid EF-1 with winds of 100 mph.

Figure 5. Site C damage (Jailhouse air conditioning roof units).

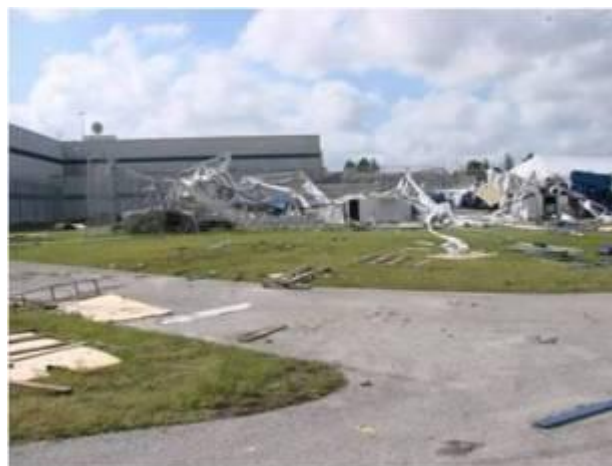
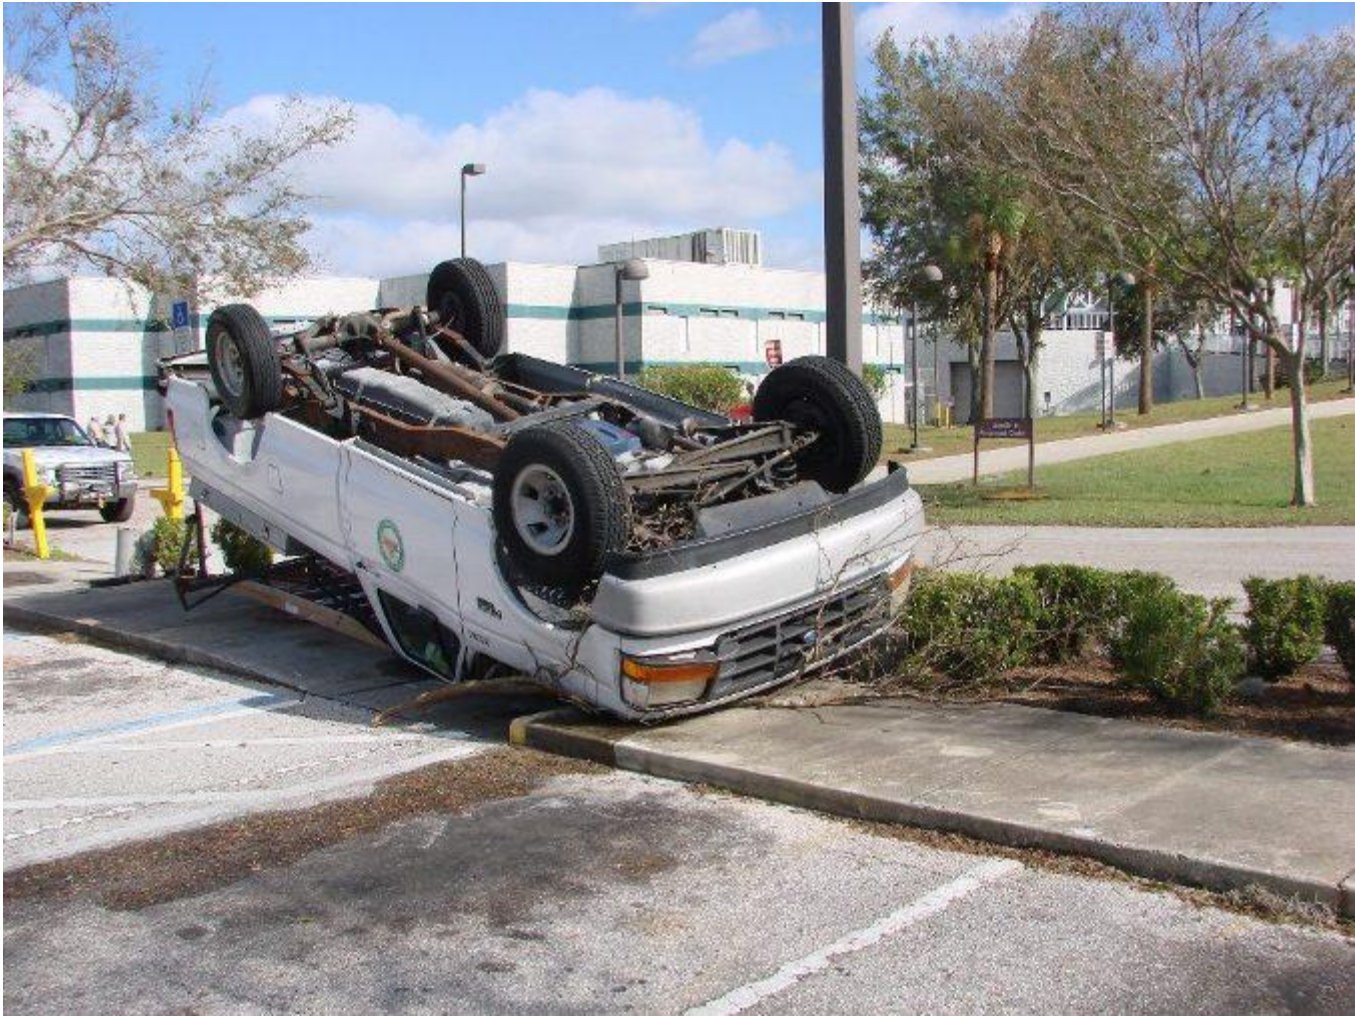
Figure 6. Site C damage (Jailhouse parking lot and rear field).
