Jan. 27, 2012 EF-1 Port Charlotte Tornado

DETAILS
• Tornado Rating: EF-1 (around 95 MPH)
• Begin: 5:35 AM, 26.998° latitude, -82.028° longitude
• End: 5:45 AM, 26.999° latitude, -82.024° longitude
• Path Length Over Land: 0.75 miles, interrupted path
• Path Width: 20 yard

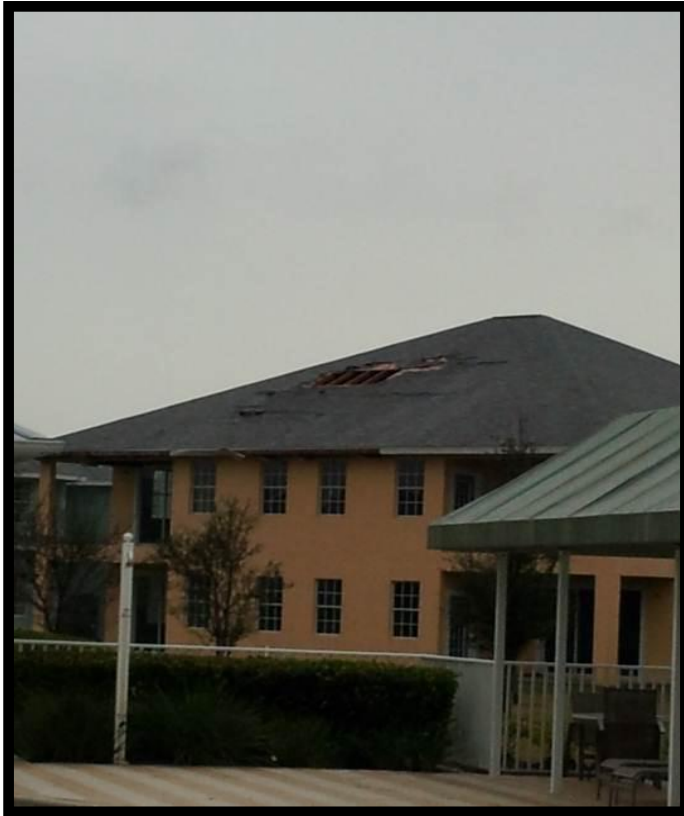
Tornado Damage at Point 1. Courtesy of Charlotte Co. EM

Point 1 shows tornado damage to an apartment building near Royal Tern Circle.

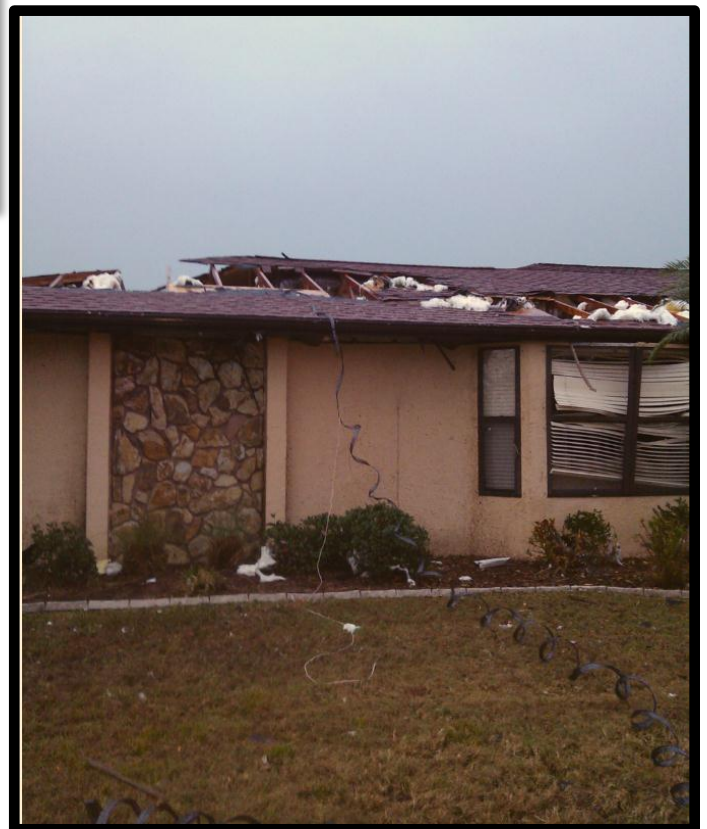
Tornado Damage at Point 2. Courtesy of Charlotte Co. EM

Point 2 shows significant damage to a house on Nuremberg Blvd. The tornado lifted after damaging the apartment complex and briefly touched back down near this house.
