5.3 Damage Survey of the Tuscaloosa-Birmingham Tornado on 27 April 2011

Timothy P. Marshall, P.E.¹, Jim Stefkovich², John DeBlock³, James G. Ladue⁴, Chris Karstens⁵

¹Haag Engineering Co.

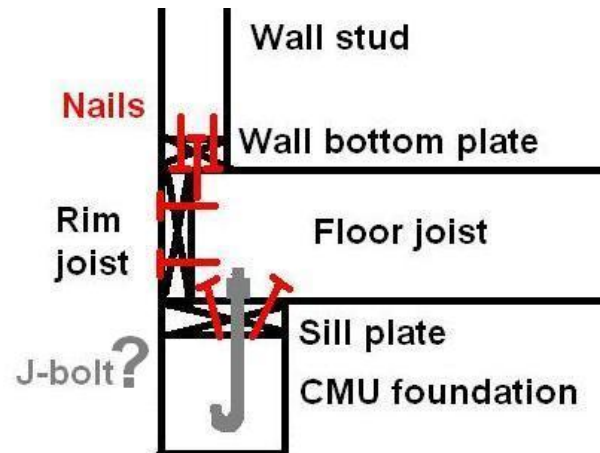
The definition of a well-built house can vary among individual damage surveyors. We defined a well-built house as one that had a continuous load path of straps and anchors from the roof to the ground, without weak connections in the horizontal or vertical planes. Unfortunately, we did not find a single house that was well-built. Almost all homes in the tornado path had CMU foundations. The concrete masonry consisted of hollow cells stacked in a common bond pattern. Wood sill plates rested on top of the foundations but rarely were attached to the masonry (Fig. 2). In a few instances, anchor bolts connected the sill plates to grouted top cells in the foundations. Regardless, such connections had little lateral strength and the bolts

either broke out of the cells or the top block broke out of the foundation.

Figure 2. Typical cross section of the base of a house supported on a CMU foundation. Nails are indicated in red. J-bolts were rarely used to attach the sill plates to the foundations.

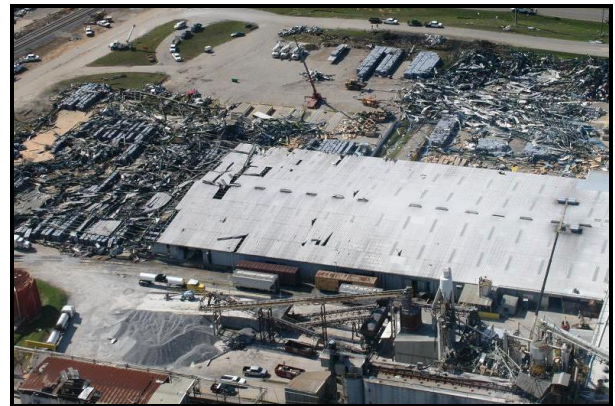
Figure 5. Collapse of metal buildings at the Tamko Roofing Plant.

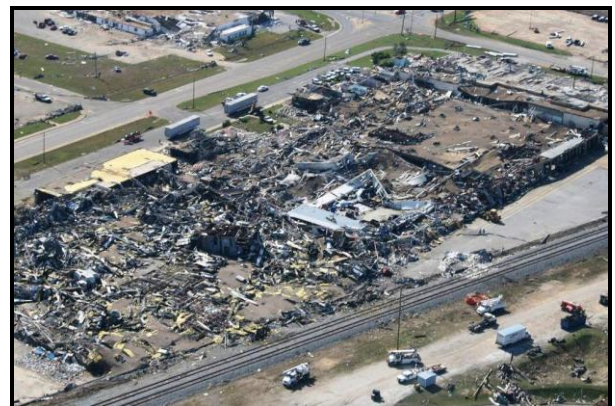
This tornado touched down approximately 38 km southwest of Tuscaloosa, or about 7 km northwest of the Union community in Greene County. It traveled through rural areas damaging a few homes and other buildings before moving into southwest Tuscaloosa County and the city of Tuscaloosa. The tornado entered the Industrial District on the southwest edge of town and cut a diagonal path extending northeast across the city. Several metal buildings collapsed (DI 21, DOD 8) in and around the Tamko Roofing Plant (Fig. 5). We estimated failure wind speeds to be 69 m s^{-1} (155 mph) or EF-3. Across the street from the Tamko Plant was the Curry Building (Fig. 6). This was a steel-framed warehouse type building with a flat

roof that collapsed (DI 23, DOD 7). Failure wind speeds were estimated to be 71 m s^{-1} (158 mph) or EF-3. According to FEMA (2012), the emergency operations center (EOC) was located at the south end of the building and lost all functionality during the tornado.

Figure 6. Collapse of the steel-framed Curry Building.

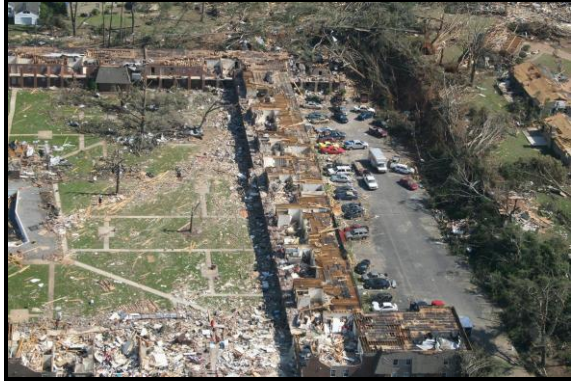
Figure 7. Removal of the roof and second story walls at the Charleston Square Apartments.

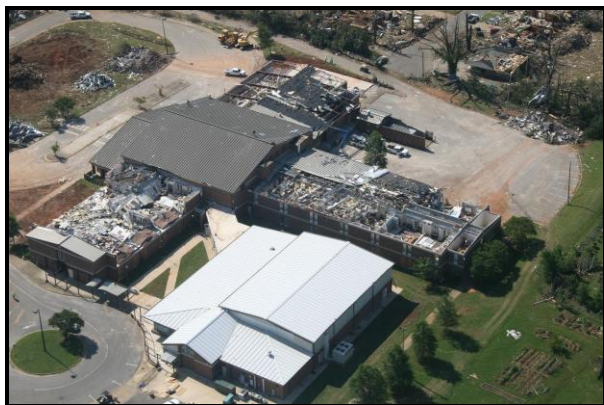
After passing through another residential area, the tornado struck the University Place Elementary School off 18th Street. The two-story school was T-shaped in plan and constructed with CMU perimeter walls. Open web steel joists supported the roofs over the classrooms. The joists were attached to masonry bond beams along the tops of the walls. Several joists were lifted and portions of the south and west masonry walls fell inward (DI 16, DOD 10). Such uniform failure along the bases of the walls suggested that the walls were not attached securely to the concrete floor. We estimated a failure wind speed of 71 m s^{-1} (158 mph) or EF-3 (Fig. 8). A gymnasium at the south end of the school had a large span roof supported by steel trusses. The south end wall collapsed and most of the steel roof decking blew away (DOD 7). Collapse of the tall masonry wall indicated a failure wind speed of about 51 m s^{-1} (114 mph). Outside the building, we noticed that light standards remained upright in the parking lot with a few that were slightly bent (DI 26, DOD 2). Wind speeds estimated to fail such light poles would be around 46 m s^{-1} or 102 mph.

Figure 8. Aerial view of the University Place Elementary school looking southeast. Roofs over the classrooms and gymnasium were removed including many of the steel joists.

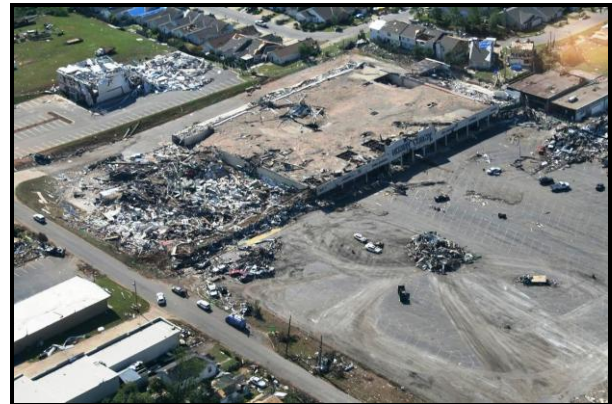
The tornado traveled through another residential area causing EF-4 damage to several houses then crossed Forest Lake before passing through a busy intersection at 15th Street and McFarland Blvd. The tornado literally “threaded the needle” between the University of Alabama and University Mall but hit the Wood Square Shopping Center along McFarland Ave. The shopping center consisted of unreinforced CMU perimeter walls and steel interior beams and pipe columns that supported relatively flat built-up roofs. Large portions of the north and west ends of the shopping center collapsed (DI 10, DOD 9). Estimated failure wind speeds were about 76 m s^{-1} (171 mph) or EF-4 (Fig. 9). Several light standards in the parking lot were broken (DI 26, DOD 3). Estimated wind speeds to fail such light poles would be about 53 m s^{-1} (118 mph) or EF-2.

Figure 9. Northwest elevation view of the Wood Square Shopping Center. Large portions of the building collapsed.

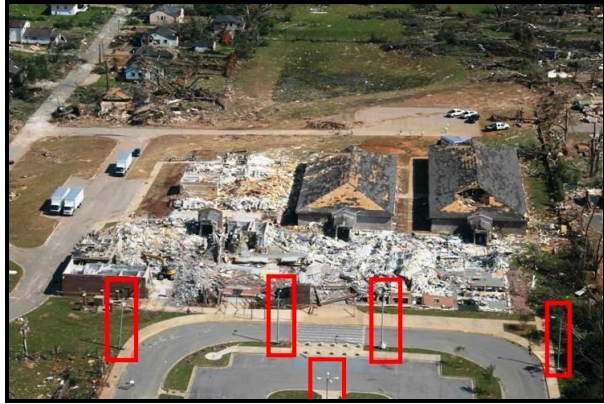
The core of the tornado passed just to the north, subjecting the school to strong south and west winds. Both south and west buildings collapsed (DI 15, DOD 10). South and north walls fell to the north while east and west walls fell to the east. Walls pivoted about their bases (Figs. 10 and 11). According to FEMA (2012), rebar was placed every 1.3 m along the foundation perimeter and extended into grouted cells in the masonry with two-inch overlaps with the wall rebar. Such lapped splices simply pulled apart as the walls toppled. Such wall construction provided little in the way of lateral wind resistance. Due to such poor construction, we reduced our failure wind speeds to the lower bound of 68 m s^{-1} (152 mph) or EF-3. We

believe actual wind speeds may have been even lower as light poles remained upright in the parking lot. Both tall steel poles (street lights) and shorter poles (lantern type lights) remained. Only a few poles were bent (DI 26, DOD 2) indicating expected failure wind speeds could have been as low as 46 m s^{-1} (102 mph) or EF-1.

Figure 10. Aerial view of the Alberta Elementary School looking north. Two of the four buildings collapsed. Note the light standards (red boxes) in the parking lot remained upright.

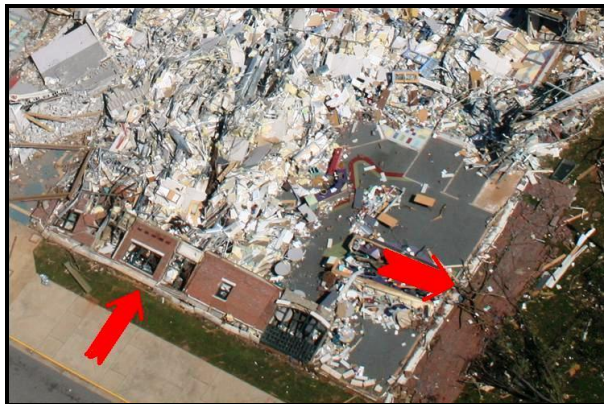
The tornado then struck a number of businesses along University Boulevard before striking the Alberta Elementary School. The school consisted of four (each), one-story buildings that had both perimeter and interior CMU walls and wood-framed roofs. Portions of the perimeter walls were constructed with brick veneer over steel studs.

Figure 11. Southeast corner of the Alberta Elementary School. Stacked masonry walls were anchored poorly to the foundation and fell over in the directions indicated (red arrows).

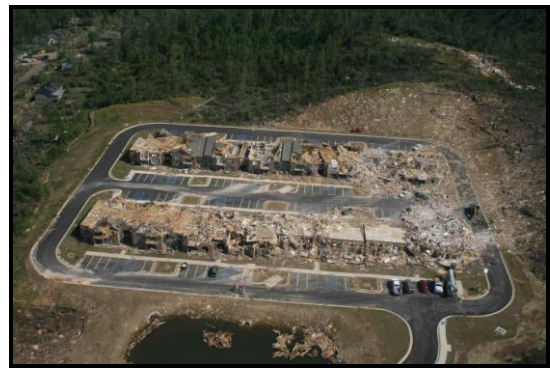
After causing EF-4 damage to residences, the tornado struck the Chastain Manor Apartments located in northeast Tuscaloosa along 34th Avenue East. There were two, wood-framed apartment buildings oriented east-west and constructed on the side of a hill that faced south. These buildings were “split-level”, with one-story on the north elevations and two-story on the south elevations. The gable type roofs were constructed with manufactured wood trusses that were attached to the tops of the walls with metal “hurricane” straps. However, the bases of the walls were fastened to the concrete slabs with cut nails instead of anchor bolts. The tornado removed the one story framing down to

the slab along the east end of the south building (DI 5, DOD 5 to 6). Given the poor connection between the wall framing and foundation, we estimated failure wind speeds to be lower than 76 m s^{-1} (170 mph) or EF-4 (Figs. 12 through 14).

Figure 12. Aerial view of the Chastain Manor Apartments looking north. A portion of the concrete floor slab was exposed on the east end of the south building.

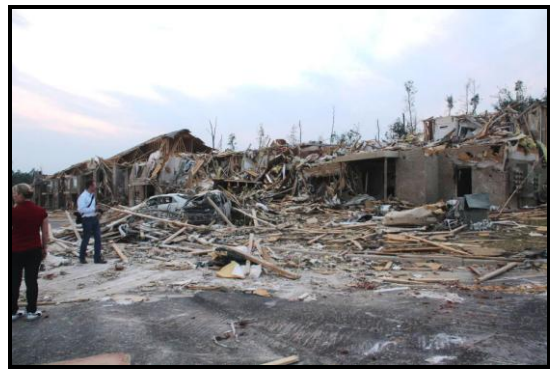
Figure 13. Ground level view looking northwest at the Chastain Manor Apartments. The tornado removed the top story.

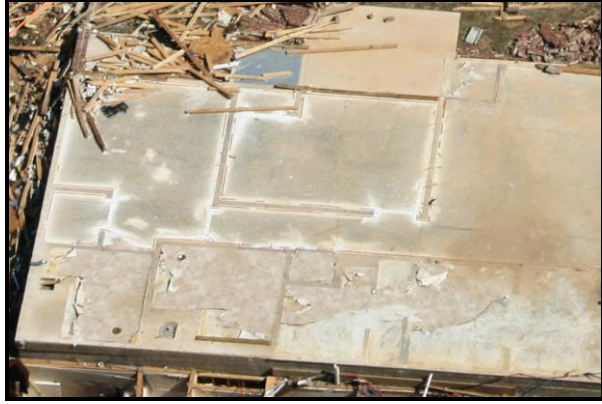
Figure 14. Closer view of the slab foundation at Chastain Manor Apartments. Wall plates were secured to the slab with cut nails instead of anchor bolts. Such connections had little pull out resistance from lateral or upward forces.

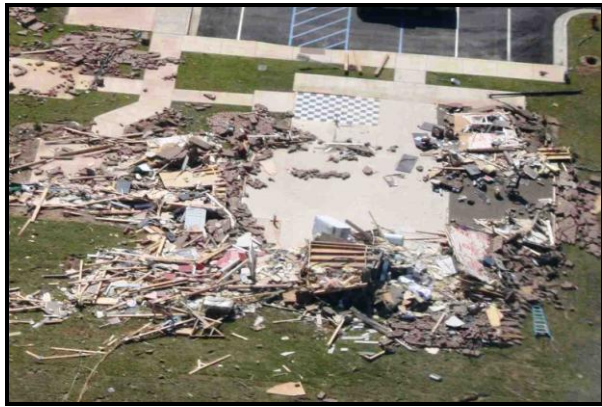
There was a one-story, wood-framed office building on site that was completely leveled by the tornado (Fig. 15). Close examination of this building revealed the wood-frame walls had been bolted to the concrete slab foundation. However, wall failure occurred when the straight-nailed connections between the wall studs and bottom plates pulled apart (Fig. 16). Walls fell outward except for the front (southeast) wall that blew away. Given the weak stud-plate connection, the survey team decided failure likely occurred at or below the EF-4 level. There was a third wood-framed apartment building southwest of the office building. This one-story, wood-framed building was constructed on level grade and sustained less severe damage than the two other buildings constructed on the hillside. Interestingly, a steel manhole cover lifted off a storm drain and was found in a nearby ravine.

Figure 15. The office building at Chastain Manor Apartments was leveled. The walls fell outward, leaving the slab foundation exposed.

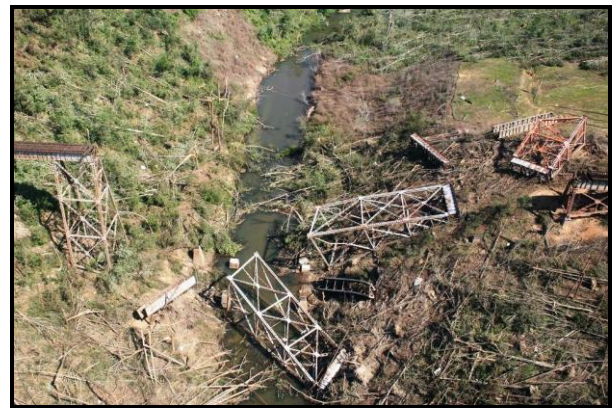
The tornado continued into rural areas northeast of Tuscaloosa but remained intense, causing EF-4 damage to residences. Several mobile homes were destroyed by strong winds on either side of Crescent Ridge Road. Boats were tossed more than 100m from a boat storage facility. The tornado toppled a railroad bridge that spanned Hurricane Creek near the town of Holt. Five, tapered, steel towers supported the bridge. Three towers fell over with the smallest tower being flipped (Fig 17). The bases of the towers were bolted to concrete pier caps. Failure of the towers occurred when the bolted connections failed. In a few instances, the pier caps had broken. The tornado continued through hilly and forested terrain, toppling and uprooting thousands of trees. Refer to Karstens et al. (2012) for a detailed study of tree damage from this tornado. The tornado also destroyed a marina on the south shore of the Black Warrior River. Aerial photography of downed trees indicated the tornado was widest here (approximately 1600 m), yet DIs other than trees were not available.

Figure 17. Toppled steel towers that had supported a railroad bridge over Hurricane Creek, northeast of Tuscaloosa.

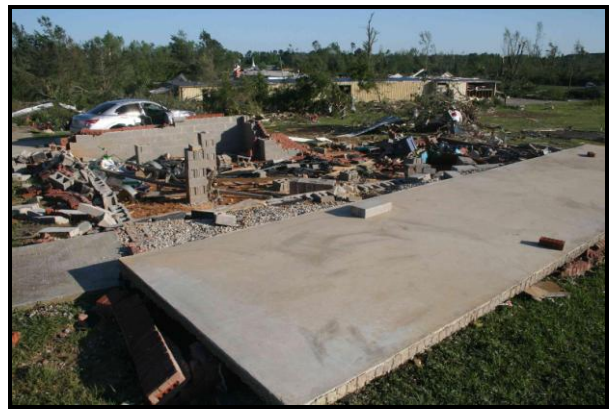
The tornado entered western Jefferson County about 9 km west of North Johns and traveled through Concord, Pleasant Grove, McDonald Chapel, Pratt City, and Fultondale, all northern suburbs of Birmingham (Fig. 18). More than 200 homes had all walls knocked down or were removed from their CMU foundations (DI 2, DOD 9). In many cases, front porch slabs remained in place, and cars remained in their driveways or garages (Figs. 19 and 20). Thus, we estimated failure wind speeds to have been at or below 76 m s^{-1} (170 mph) or EF-4.

Figure 19. An unanchored home on a CMU foundation. The front porch slab (foreground) and vehicle (background) remained although the unanchored slab did shift.

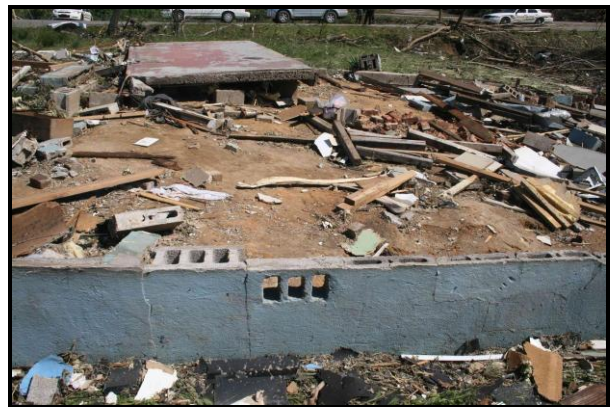
Figure 20. Unanchored home that slid off its CMU foundation. Note front porch slab remained.

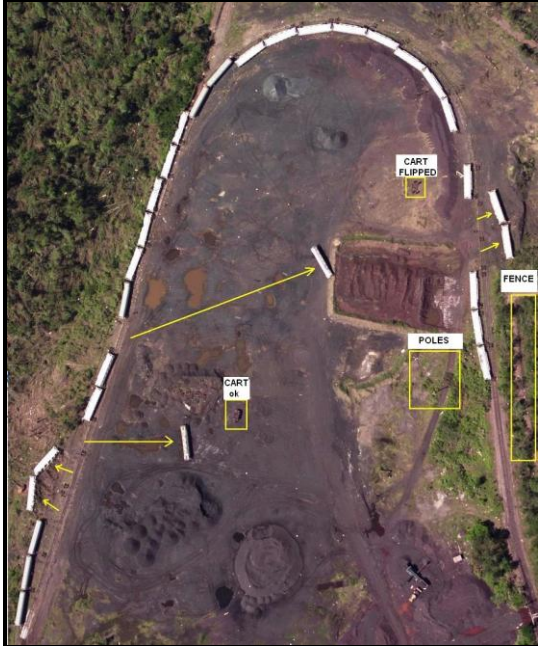
Interestingly, the tornado crossed a coal loading facility just east of Pleasant Grove. Several empty railroad cars overturned and one car traveled (leaving the steel wheels behind) approximately 120 m (Fig.

21). According to McCaul et al. (2012) each rail car weighed 36 tons. Calculations will have to be done to estimate the wind speed necessary to overturn and transport the coal cars. Note, this DI is not listed in the EF-scale, presently. However, a nearby power pole, fence, and cart were not damaged.

Figure 21. Empty railcars that were blown off the tracks at this coal loading facility.

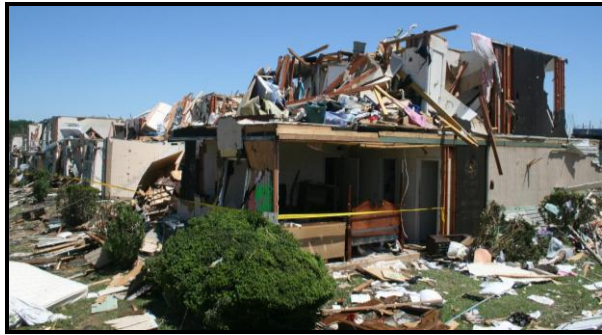
After passing through another residential area and causing up to EF-4 damage, the tornado struck the Southbrook Apartments on Cherry Avenue in Pratt City. This apartment complex comprised of five, two-story, wood-framed buildings oriented north-south. The tornado removed most of the gable roofs and portions of the second stories (DI 5, DOD 5). We estimated failure wind speeds to be 71 m s^{-1} (158 mph) or EF-3. Several cars in the parking lot were pushed sideways and crashed into each other (Fig. 22).

Figure 22. Tornado damage to the Southbrook Apartments in Pratt City. The roof and most second story walls were blown away.

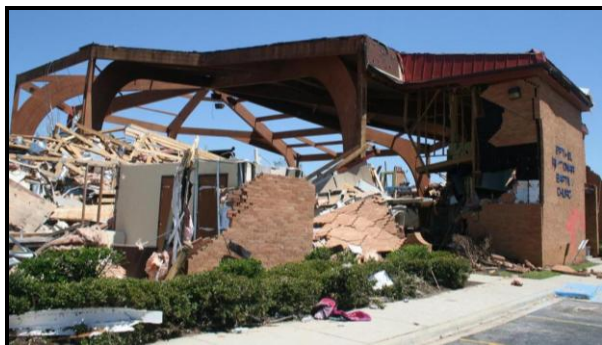
Nearby, the tornado struck the Bethel Baptist Church. The main building consisted of a large, tall, star-shaped sanctuary that was supported with glulam (glue laminated) beams, columns and purlins. Steel bolts and brackets connected intersecting purlins and beams. The roof deck consisted of tongue-and-grooved boards straight-nailed to the tops of the beams and purlins; walls were framed conventionally. Exterior walls were brick masonry veneer. The tornado removed most of the roof decking, wall framing, and brick masonry, leaving the glulam frame intact. Unfortunately, there is no DI in the current EF-scale criteria for churches. Therefore, we used the DI for Junior High Schools as this DI contained a provision for the collapse of tall masonry walls such as a gymnasium or auditorium (DI 16, DOD 7). An adjacent metal building exhibited buckling of purlins and loss of most of the roof panels (DI 21, DOD 5). Light poles remained in the parking lot; a few were bent (DI 26, DOD 2). Given these three observations, we estimated the expected failure wind speed for the area was around 51 m s^{-1} (115 mph) or EF-2 (Fig. 23).

Figure 23. Tornado damage to the Bethel Baptist Church in Pratt City. The roof decking and wall framing were blown away leaving the primary glulam framing.

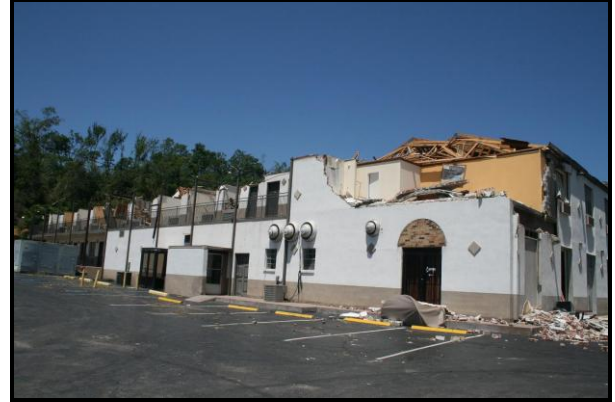
The tornado then paralleled Interstate 65 before it entered Fultondale. Hundreds of trees were toppled and several light poles were bent along the interstate. The tornado struck the Super 8 Motel located at the intersection of U. S. Highway 31 and Interstate 65. The motel was constructed with CMU walls. Wood top plates were attached to grouted cells in the top courses of the masonry using steel J-bolts with nuts and washers. The gable roof was comprised of manufactured wood trusses that were toe-nailed to the wall top plates. The tornado removed a large portion of the roof and toppled several second story walls (DI 7, DOD 5). We estimated failure wind speeds to be 59 m s^{-1} (133 mph) or EF-2 (Fig. 24). The tornado began to weaken as it paralleled U. S. Highway 31 and lifted just west of AL Hwy 79, about 6 km north of Tarrant.

Figure 24. Tornado damage to the Super 8 Motel in Fultondale. A large portion of the roof blew away and several second story masonry walls toppled.
