Timothy P. Marshall*
Haag Engineering Co.
Dallas, TX

1. Introduction

A large, destructive tornado moved across Butler and Black Hawk Counties in northeast Iowa traveling through the south end of Parkersburg on 25 May 2008 (Fig. 1). The tornado damaged or destroyed more than three hundred residences in addition to two bank buildings, a high school, and many other buildings. Seven people died.

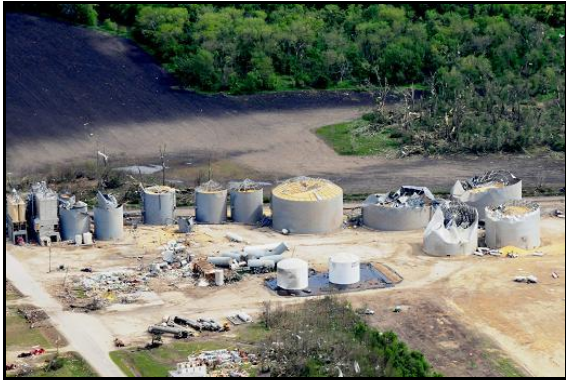
The tornado entered the southwest corner of Parkersburg around 2156 UTC traveling eastward along Highway 57/14 destroying residences, businesses, two banks, and the high school along a 2 km path. The intensity of the tornado damage increased toward the east end of town as more and more debris was ingested into the tornado. A wind row of debris was noted in open corn fields east of town. The tornado then struck large grain silos filled with corn just east of Parkersburg before traveling through river bottoms uprooting and breaking hundreds of trees (Fig. 7).

Figure 7. Damage to grain silos filled with corn just east of Parkersburg.

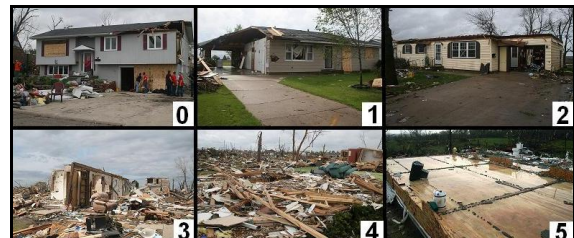
EF-scale numbers were assigned to 370 houses based on increasing severity of the damage (Figs. 10 and 11). Degree of damage (DOD) descriptions were followed in accordance with those developed by the Wind Science and Engineering Center (2006). Homes were rated EF-0 if they had some damage to their roof coverings and/or lost some of their vinyl or metal siding (DOD=2). A rating of EF-1 was assigned to those homes that lost most of their roof covering and/or had minor structural damage to the roof such as displaced gable ends or loss of some roof decking (DOD=4). Homes were rated EF-2 if they had lost most of their roof structure but the walls remained standing (DOD=6). A rating of EF-3 was given to homes that lost most of their walls (DOD=8). An EF-4 rating was given to those homes that had all walls down and a pile of debris remaining on their foundations (DOD=9). EF-5 ratings were given to homes that were swept clean above their anchored floor platforms (DOD=10). These homes were found in the eastern portion of the damage path. The damage path did widen as the tornado exited town.

Figure 10. EF-scale ratings to wood-framed houses within the Parkersburg tornado damage path.

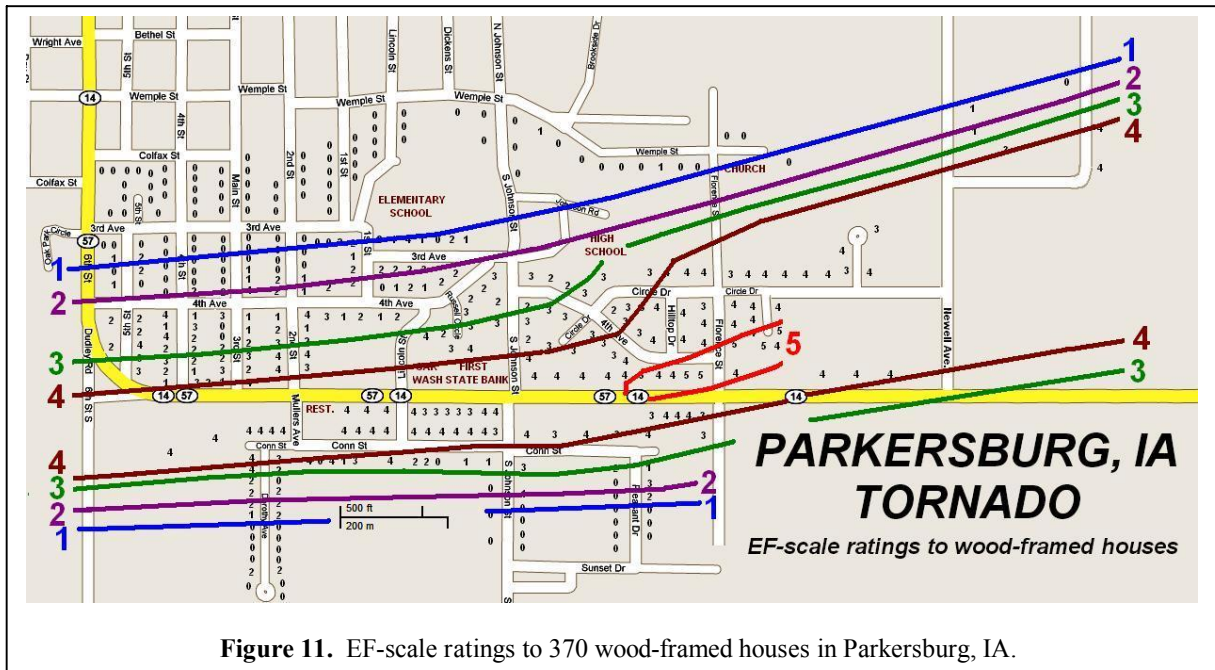
Figure 11. EF-scale ratings to 370 wood-framed houses in Parkersburg, IA.

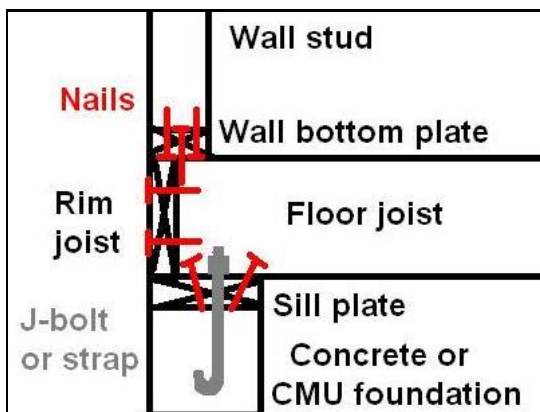
Homes were typically built on top of concrete masonry unit (CMU) or poured concrete foundations (Fig. 12). A few old homes had rock foundations. Wood sill plates were usually secured to the foundation with J-bolts or straps. Wood floor joists were usually toe-nailed into the wood sills a plywood subfloor was nailed to the joists. Wood wall studs were straight-nailed to wood bottom plates; the plates were straight-nailed into the plywood subfloor. Failure of the home typically occurred where the wall studs and plates were straight-nailed into the floor leaving the floor platform intact. In some instances, the anchor bolts

Figure 12. Typical foundation-wall cross section of Parkersburg home. Nails are indicated in red.

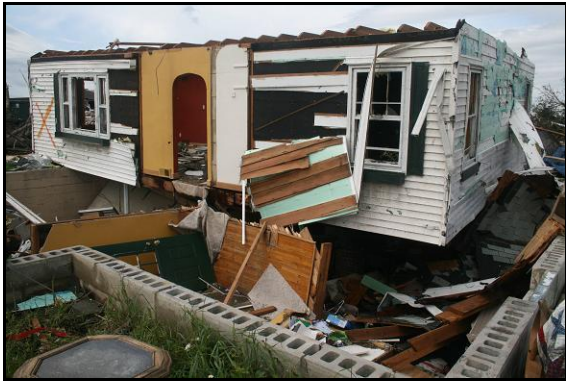
were pulled out of the CMU or the anchored CMU was dragged along with the floor. Such failures are common and have been described by Marshall et al. (2003). We found 33 homes that slid off their foundations. These homes were rated EF-2 or assigned an EF number of the adjacent home that did not slide off its foundation (Fig. 13).

Figure 13. Unanchored home that slid off its CMU foundation was rated EF-2 due to loss of its roof.

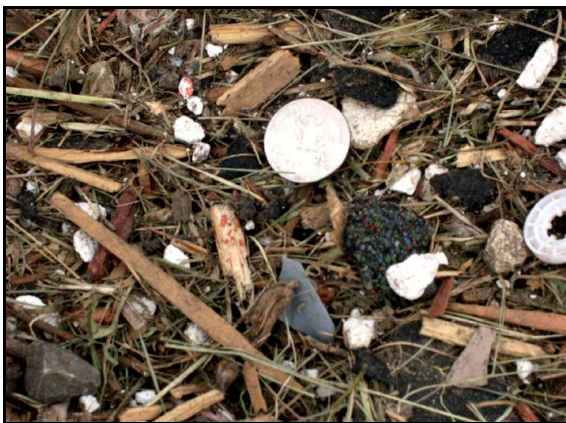
Figure 14. Bits of roof shingles, wood, corn stubble, and gravel along the center line of the tornado damage path in Parkersburg. A quarter coin was added for size. Image from NWSFO/DSM.

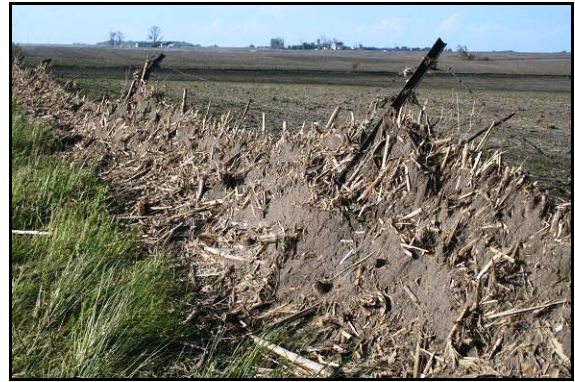
Figure 15. Mud and corn stubble plastered barbed wire fence.

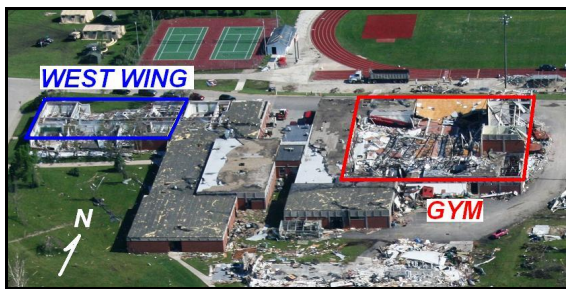
Two sections of the high school collapsed to the south. The north masonry wall on the west wing toppled inward at its base and the south masonry wall to fell outward (Fig. 17). A hinge line formed at the base of the both walls. In addition, the walls failed at window joints. Windows openings extended almost the full height of the walls and this interrupted the continuity of the walls. In addition, winds from the north broadsided the north wall loading the wall in its weakest direction.

Figure 16. Aerial view of the Parkersburg Community High School looking north. The west wing and gymnasium (outlined) collapsed.

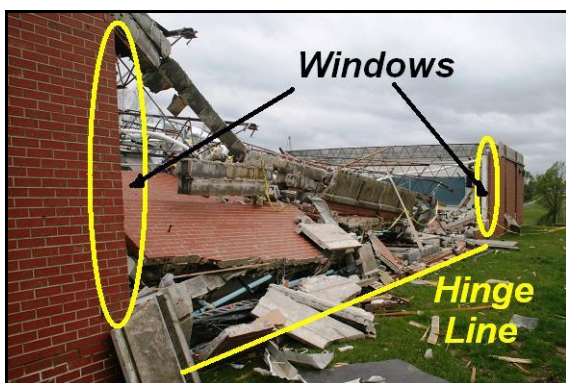
Figure 17. Collapsed north wall on the west wing of the high school. The wall collapsed about a hinge line at the base of the wall. Tall window openings (circled) created weak vertical joints in the wall.

Specific study of the damage to the Parkersburg High School revealed weak points in the construction of the unreinforced masonry walls. In particular, hinge lines formed at the bases of walls causing them to topple just above ground level. Elongated (floor-to-ceiling) windows in the walls also created weak vertical joints in the walls making it easier for wall sections to topple inward or outward when broadsided by the wind.

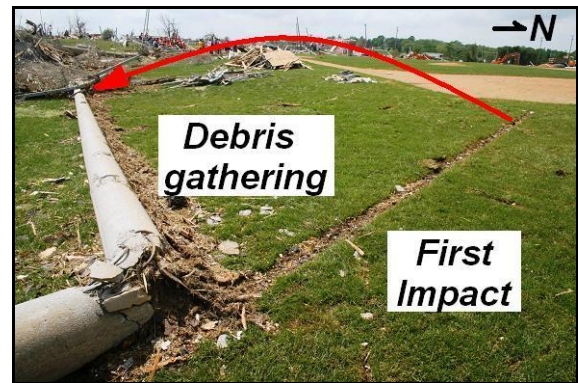
Six, hollow spun, steel reinforced concrete light poles toppled to the west and northwest in a baseball field located just east of the high school. Each pole was about 30 m tall and was broken at its base. All six poles left impact marks in the ground. However, the wind was strong enough to push the top half of one pole along the ground to the south. Fine debris accumulated up to 3 cm deep upwind of this pole (Fig. 18). This example illustrated that strong inflow winds occurred very close to the ground.

Figure 18. Concrete light pole had impacted the ground, then the top portion was pushed to the south. Debris gathered on the upwind side of the pole. This indicated that strong inflow winds occurred very close to the ground.

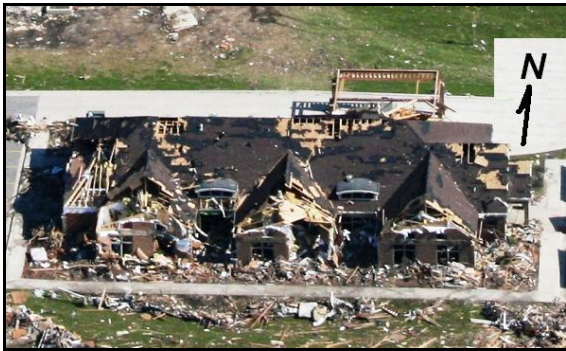
Figure 19. Aerial view of the First State Bank building looking north. The bank was near the center of the tornado path and survived relatively intact.

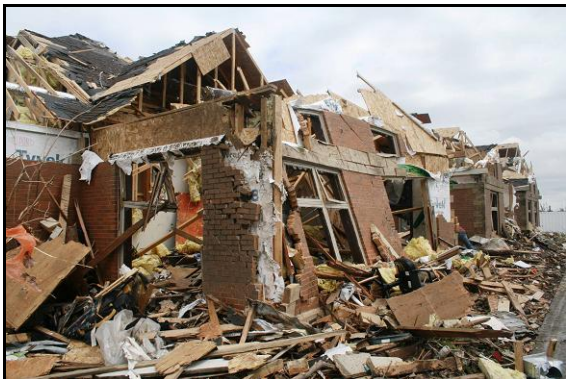
The bank building sustained considerable damage from the tornado but exterior walls remained. However, some of the south and west walls were pushed inward pivoting about their bases (Fig. 20). There was greater than 20 percent damage to the roof covering and some of the roof decking had been removed. The degree of damage to the bank was given an EF-2 rating. By comparison, homes north and south of the bank building were assigned EF-3 and EF-4 ratings.

Figure 20. A south facing wood-framed wall on the bank building had been pushed inward, pivoting about its base.
