***May 12, 2008 Sichuan, China  
Earthquake Reconnaissance***

Zhenming Wang  
Kentucky Geological Survey  
228 MMRB

KGS Brown Bag Seminar  
July 10, 2008

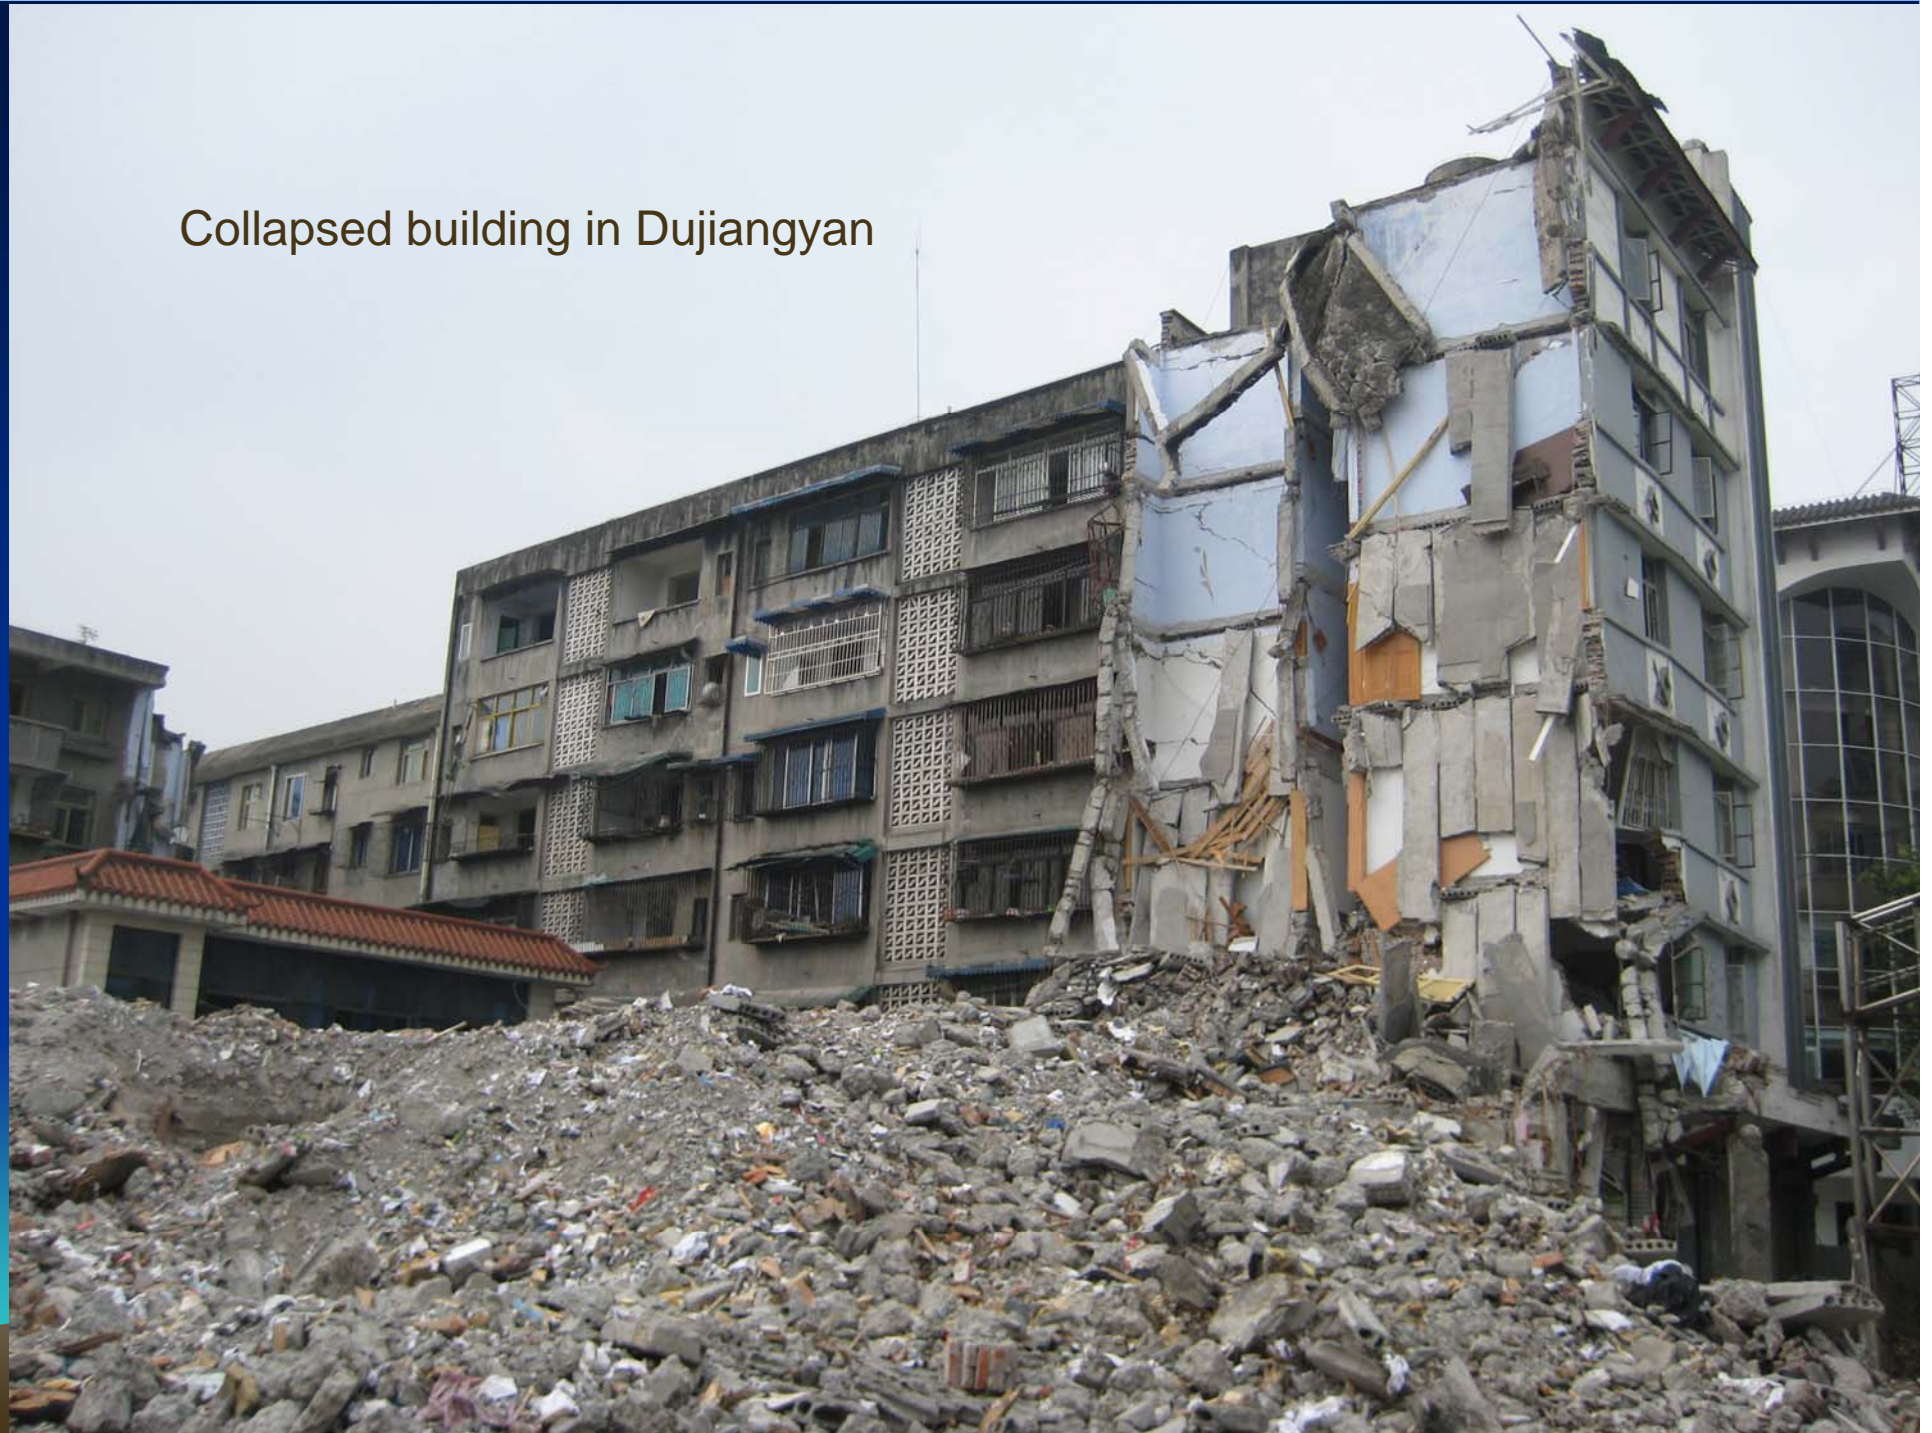
Collapsed building in Dujiangyan

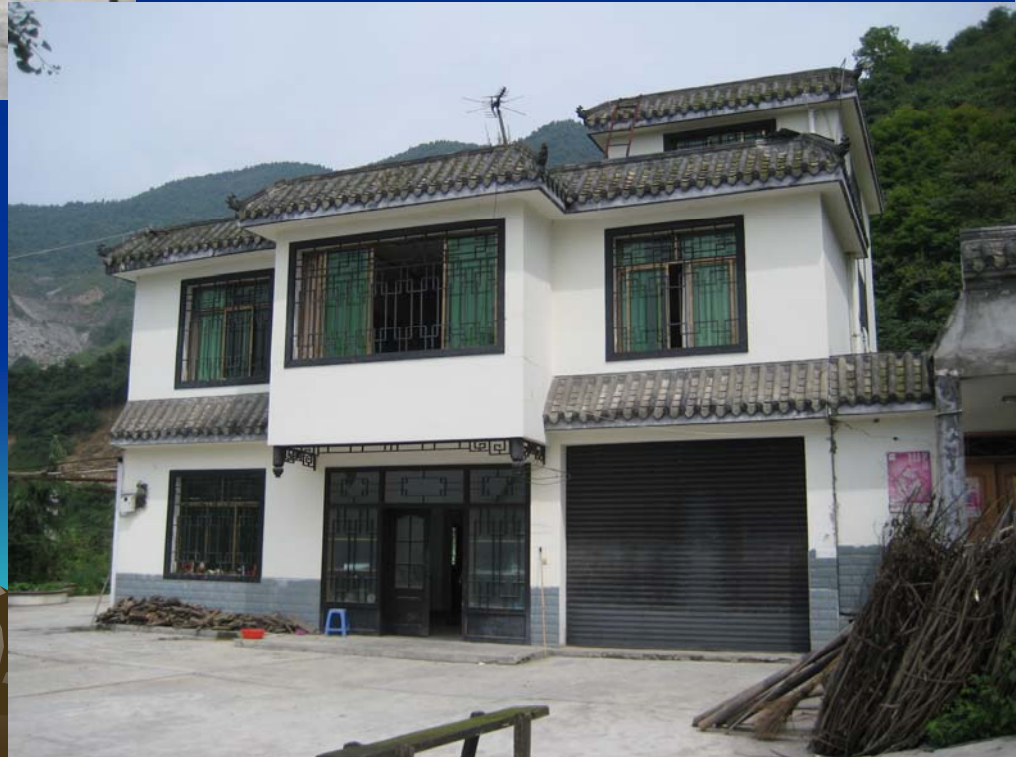
Damaged house

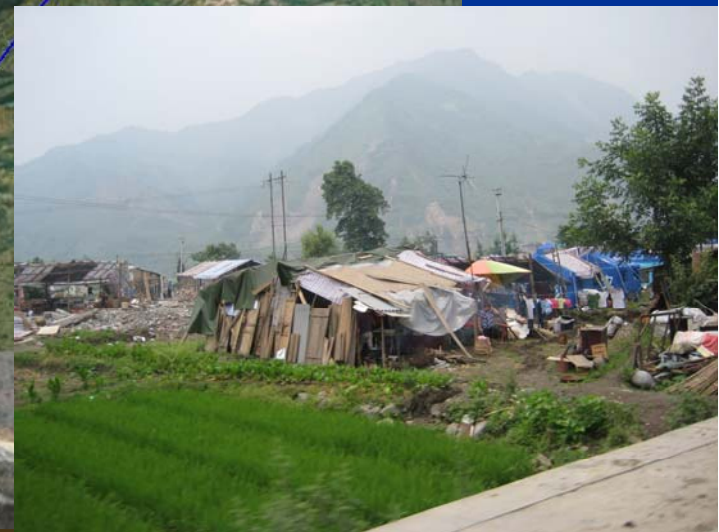
Collapsed and severe damaged houses in this area

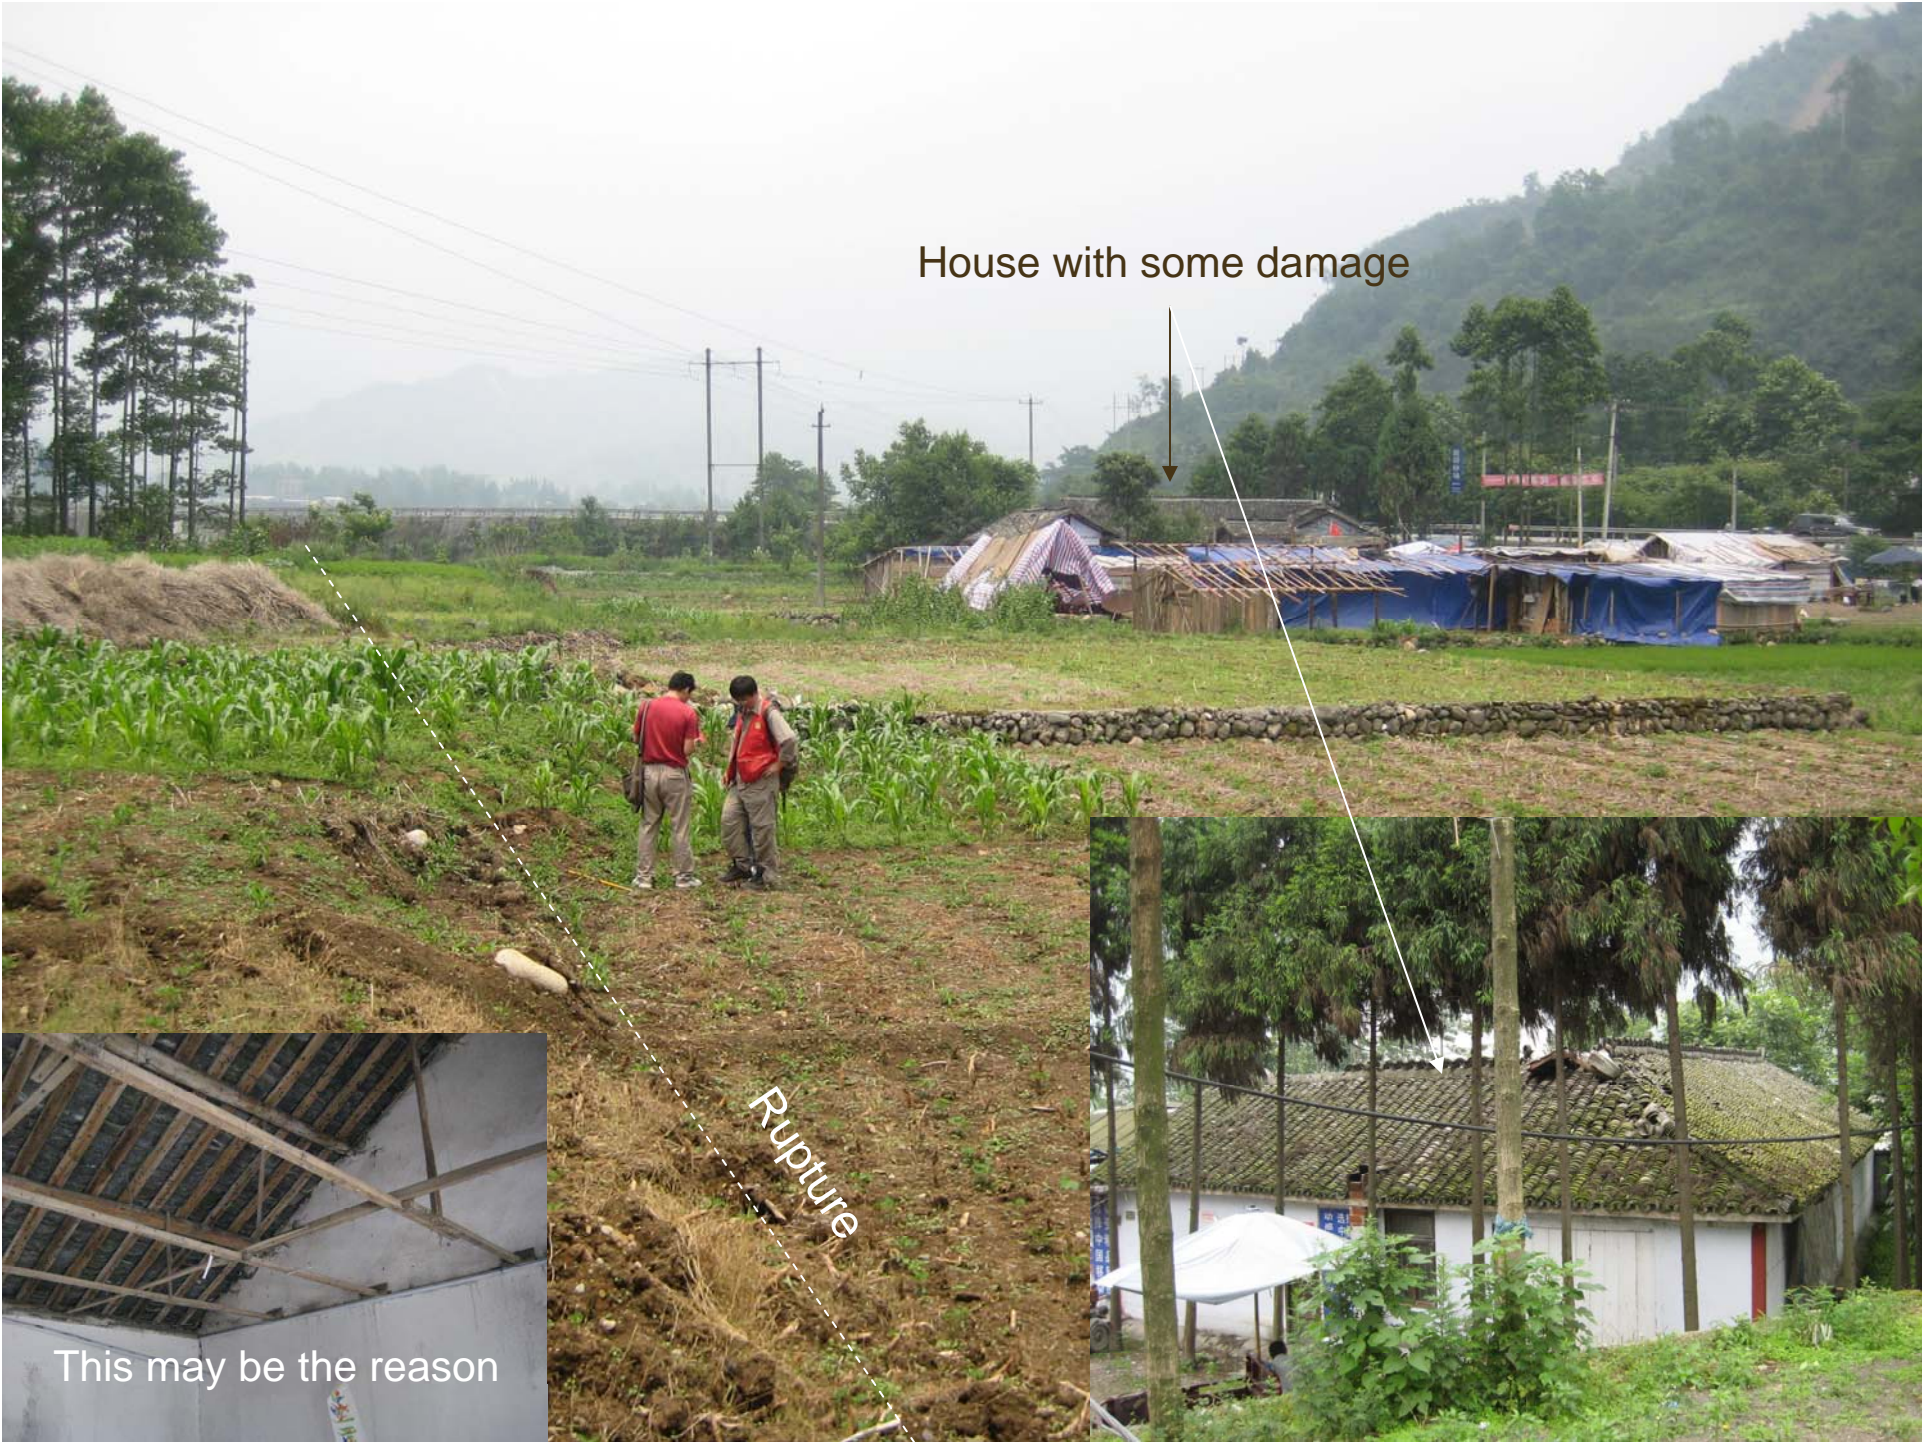
House with some damage

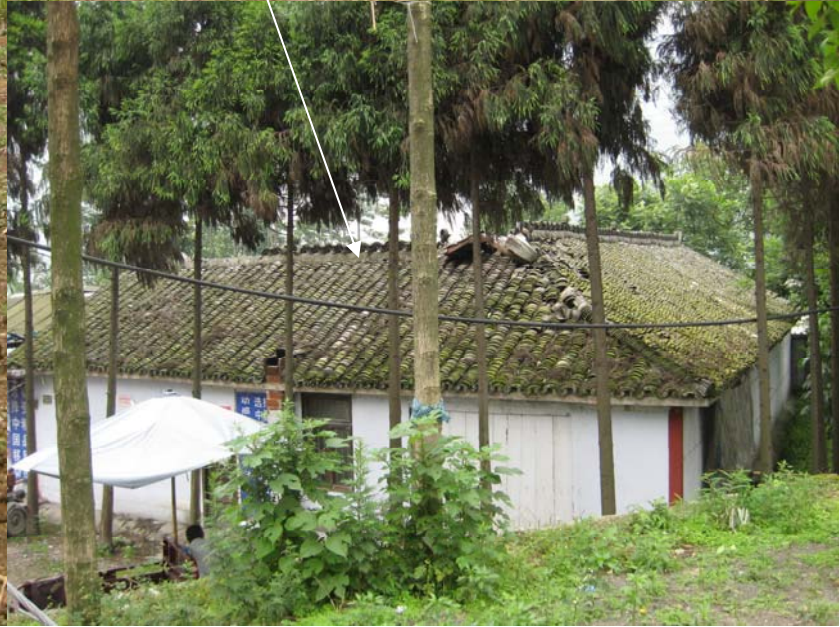
This may be the reason

Rupture

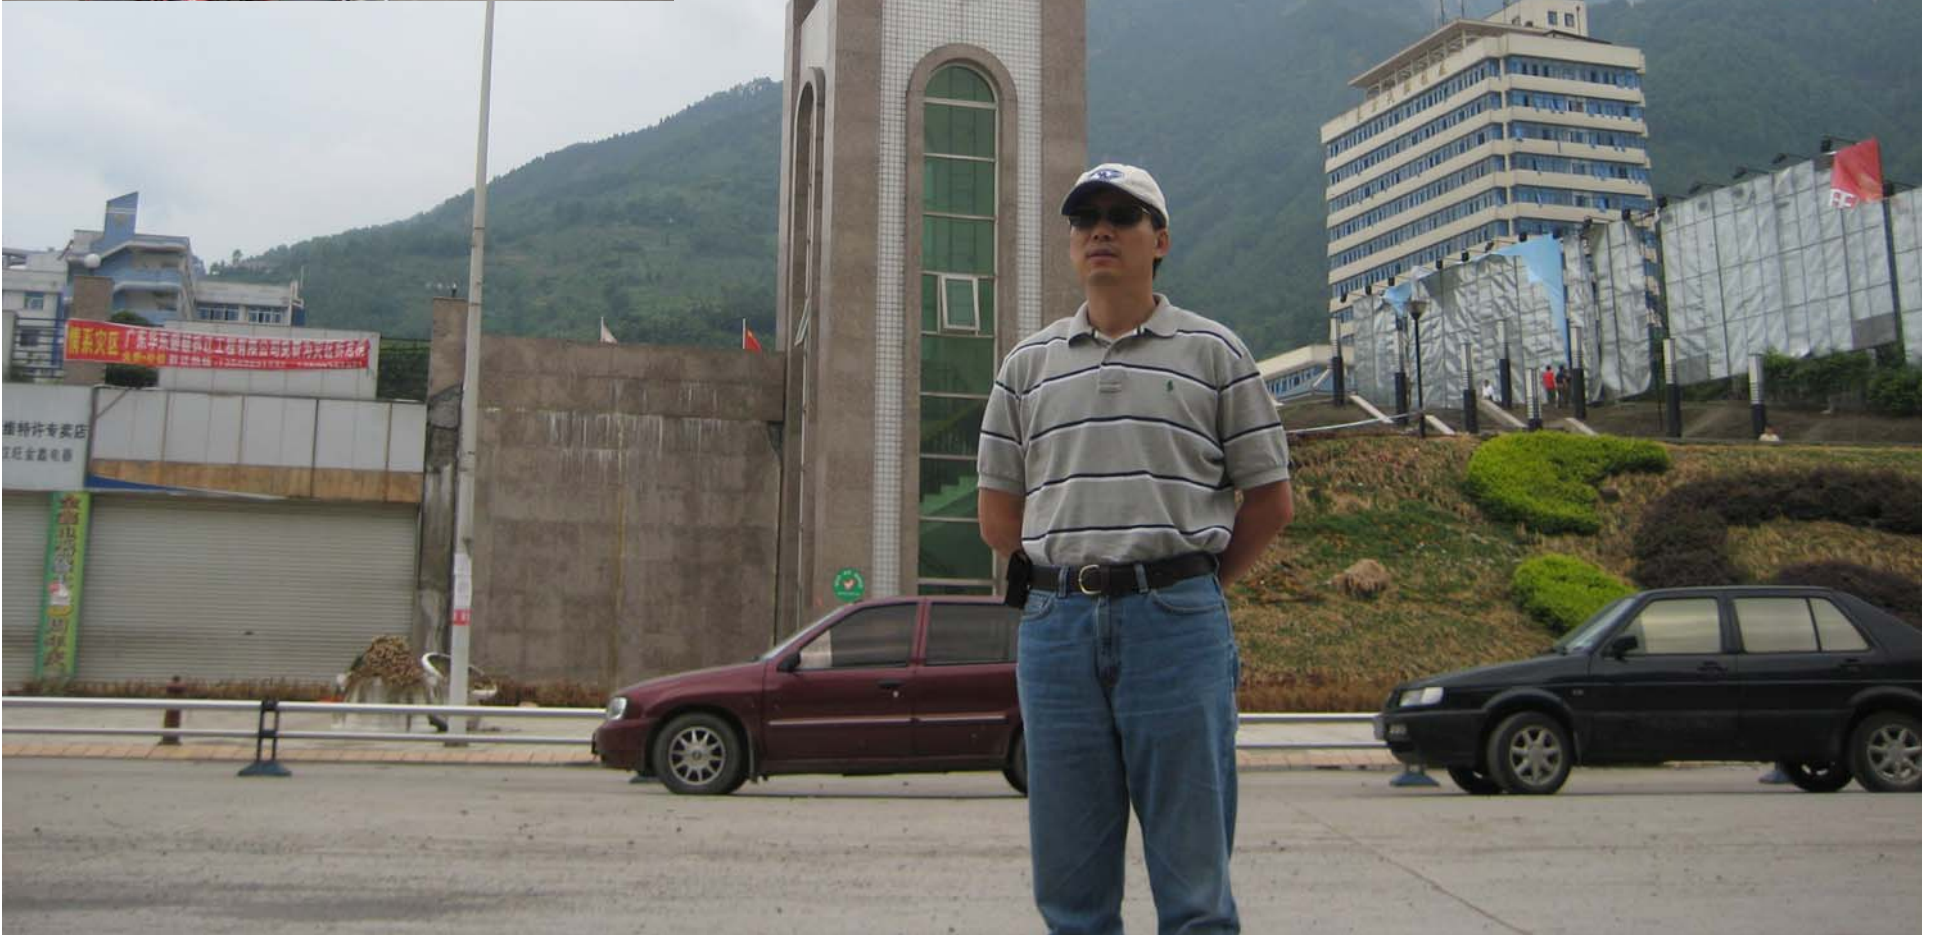
Clock stopped at 2:28pm on May 12, 2008

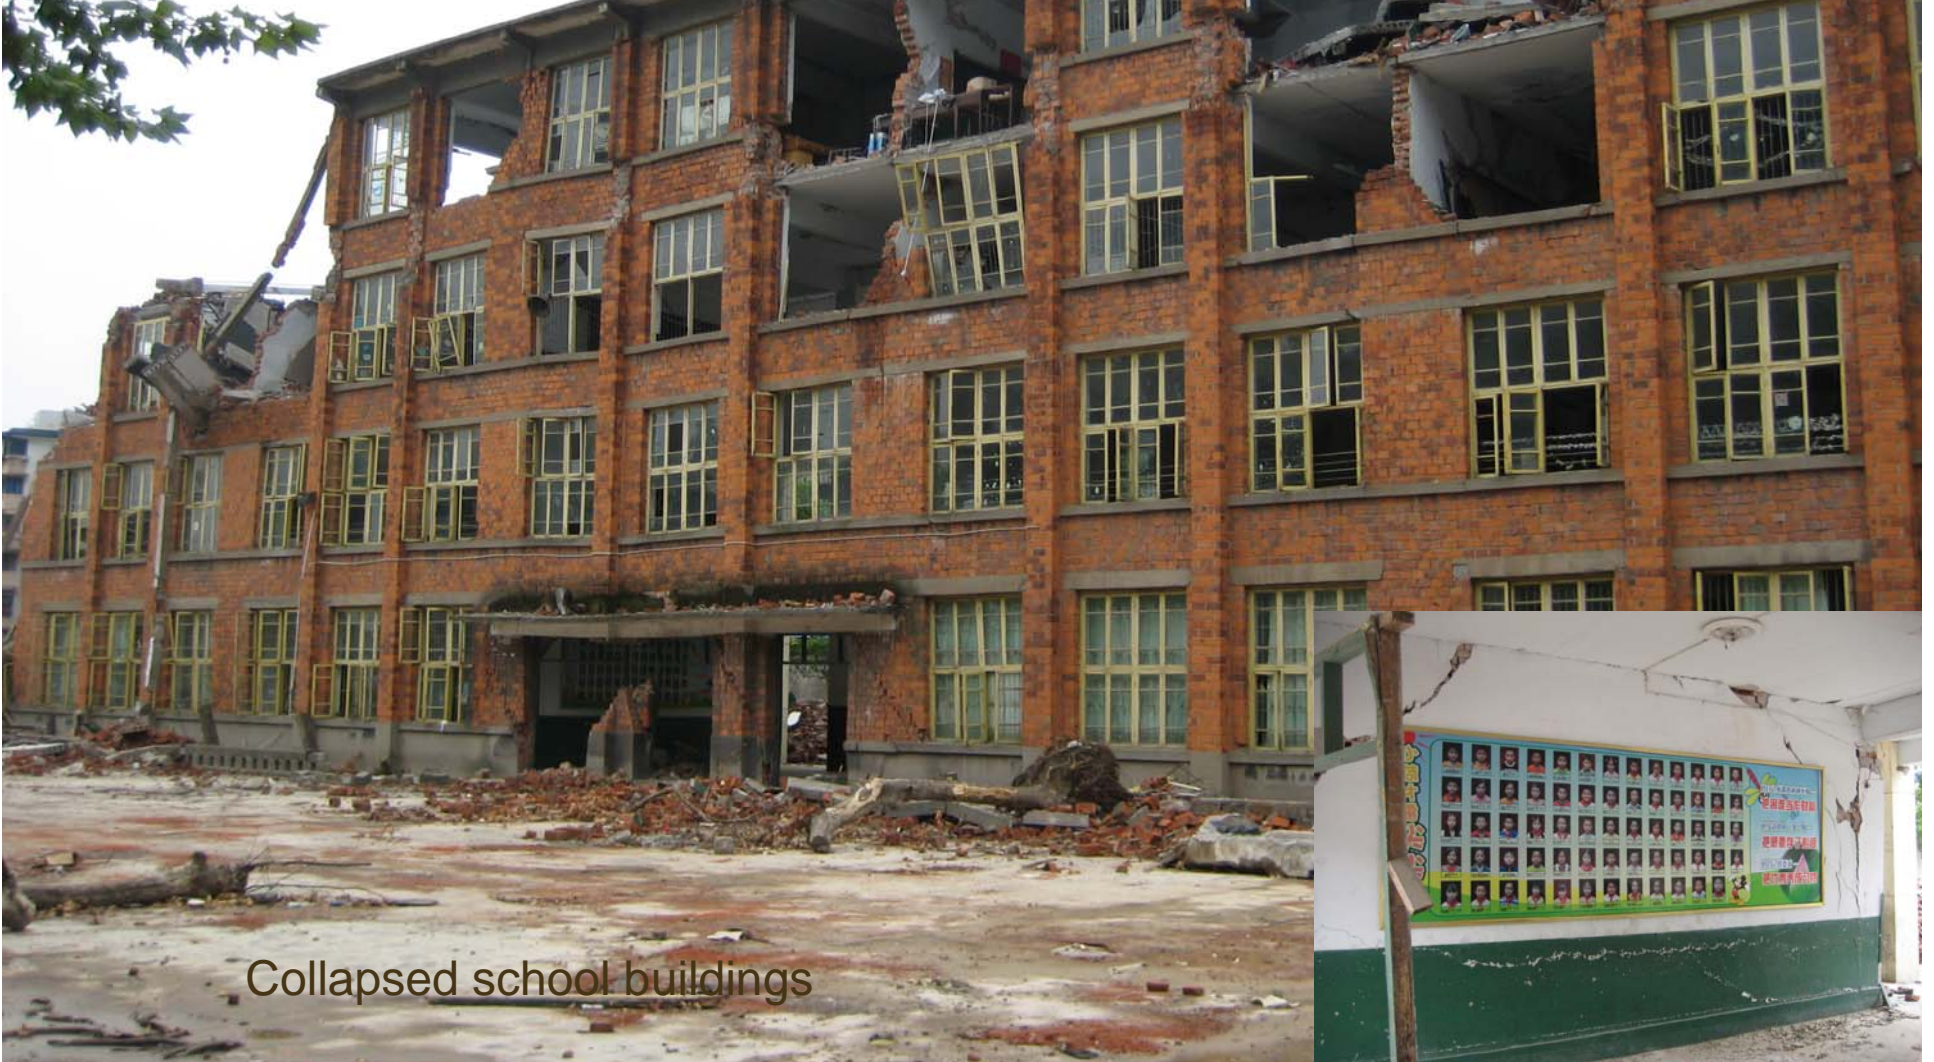
Collapsed school buildings

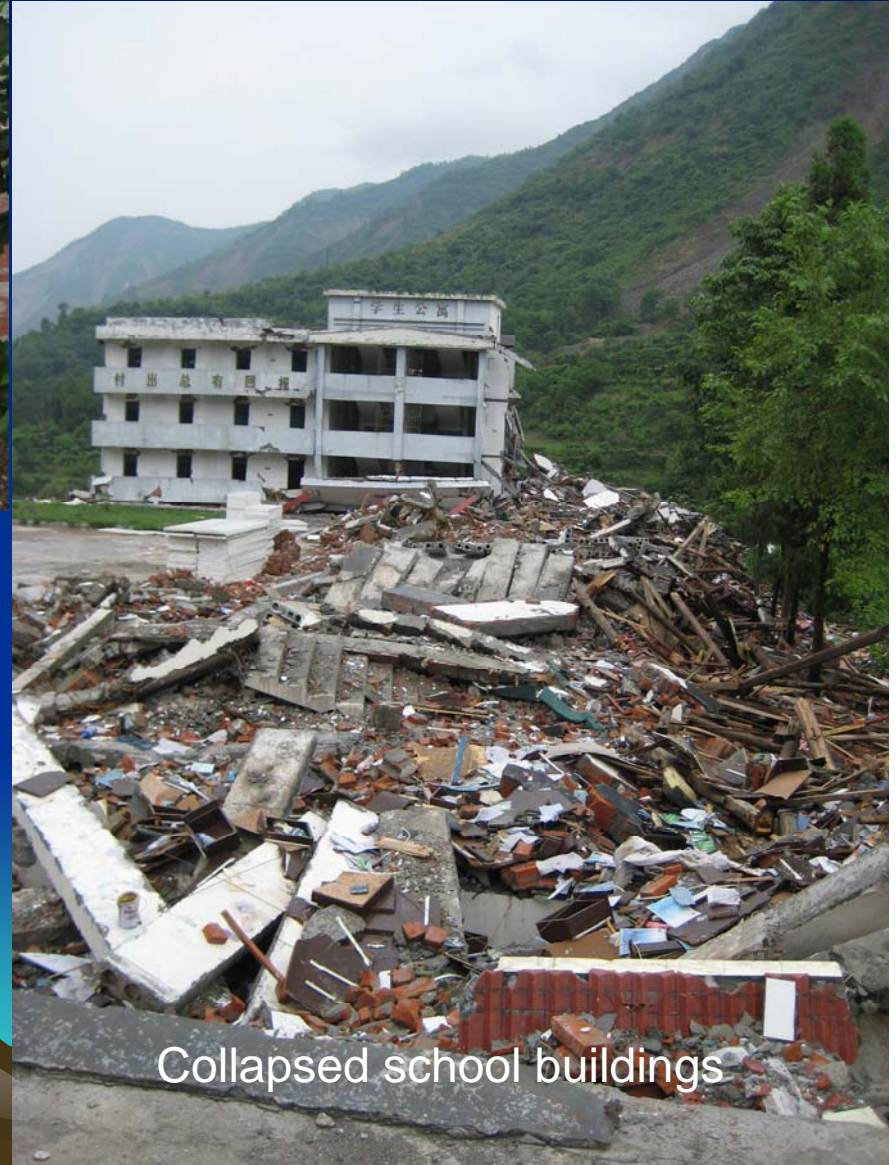
100+ students were killed

Collapsed school buildings

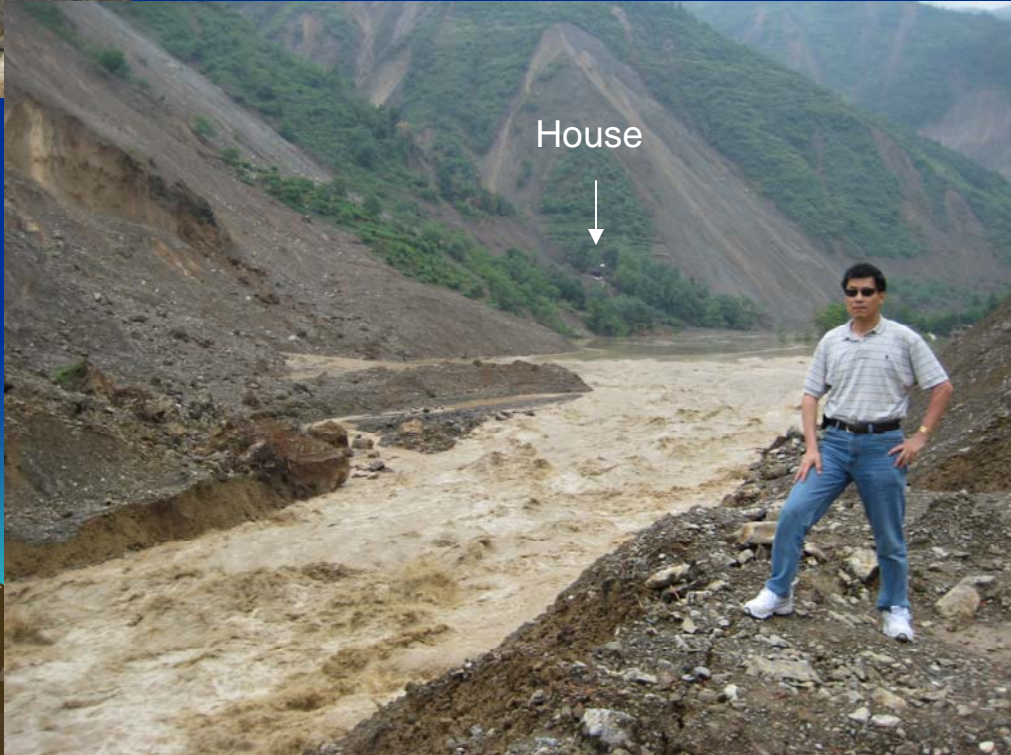
Buried house

Large landslide

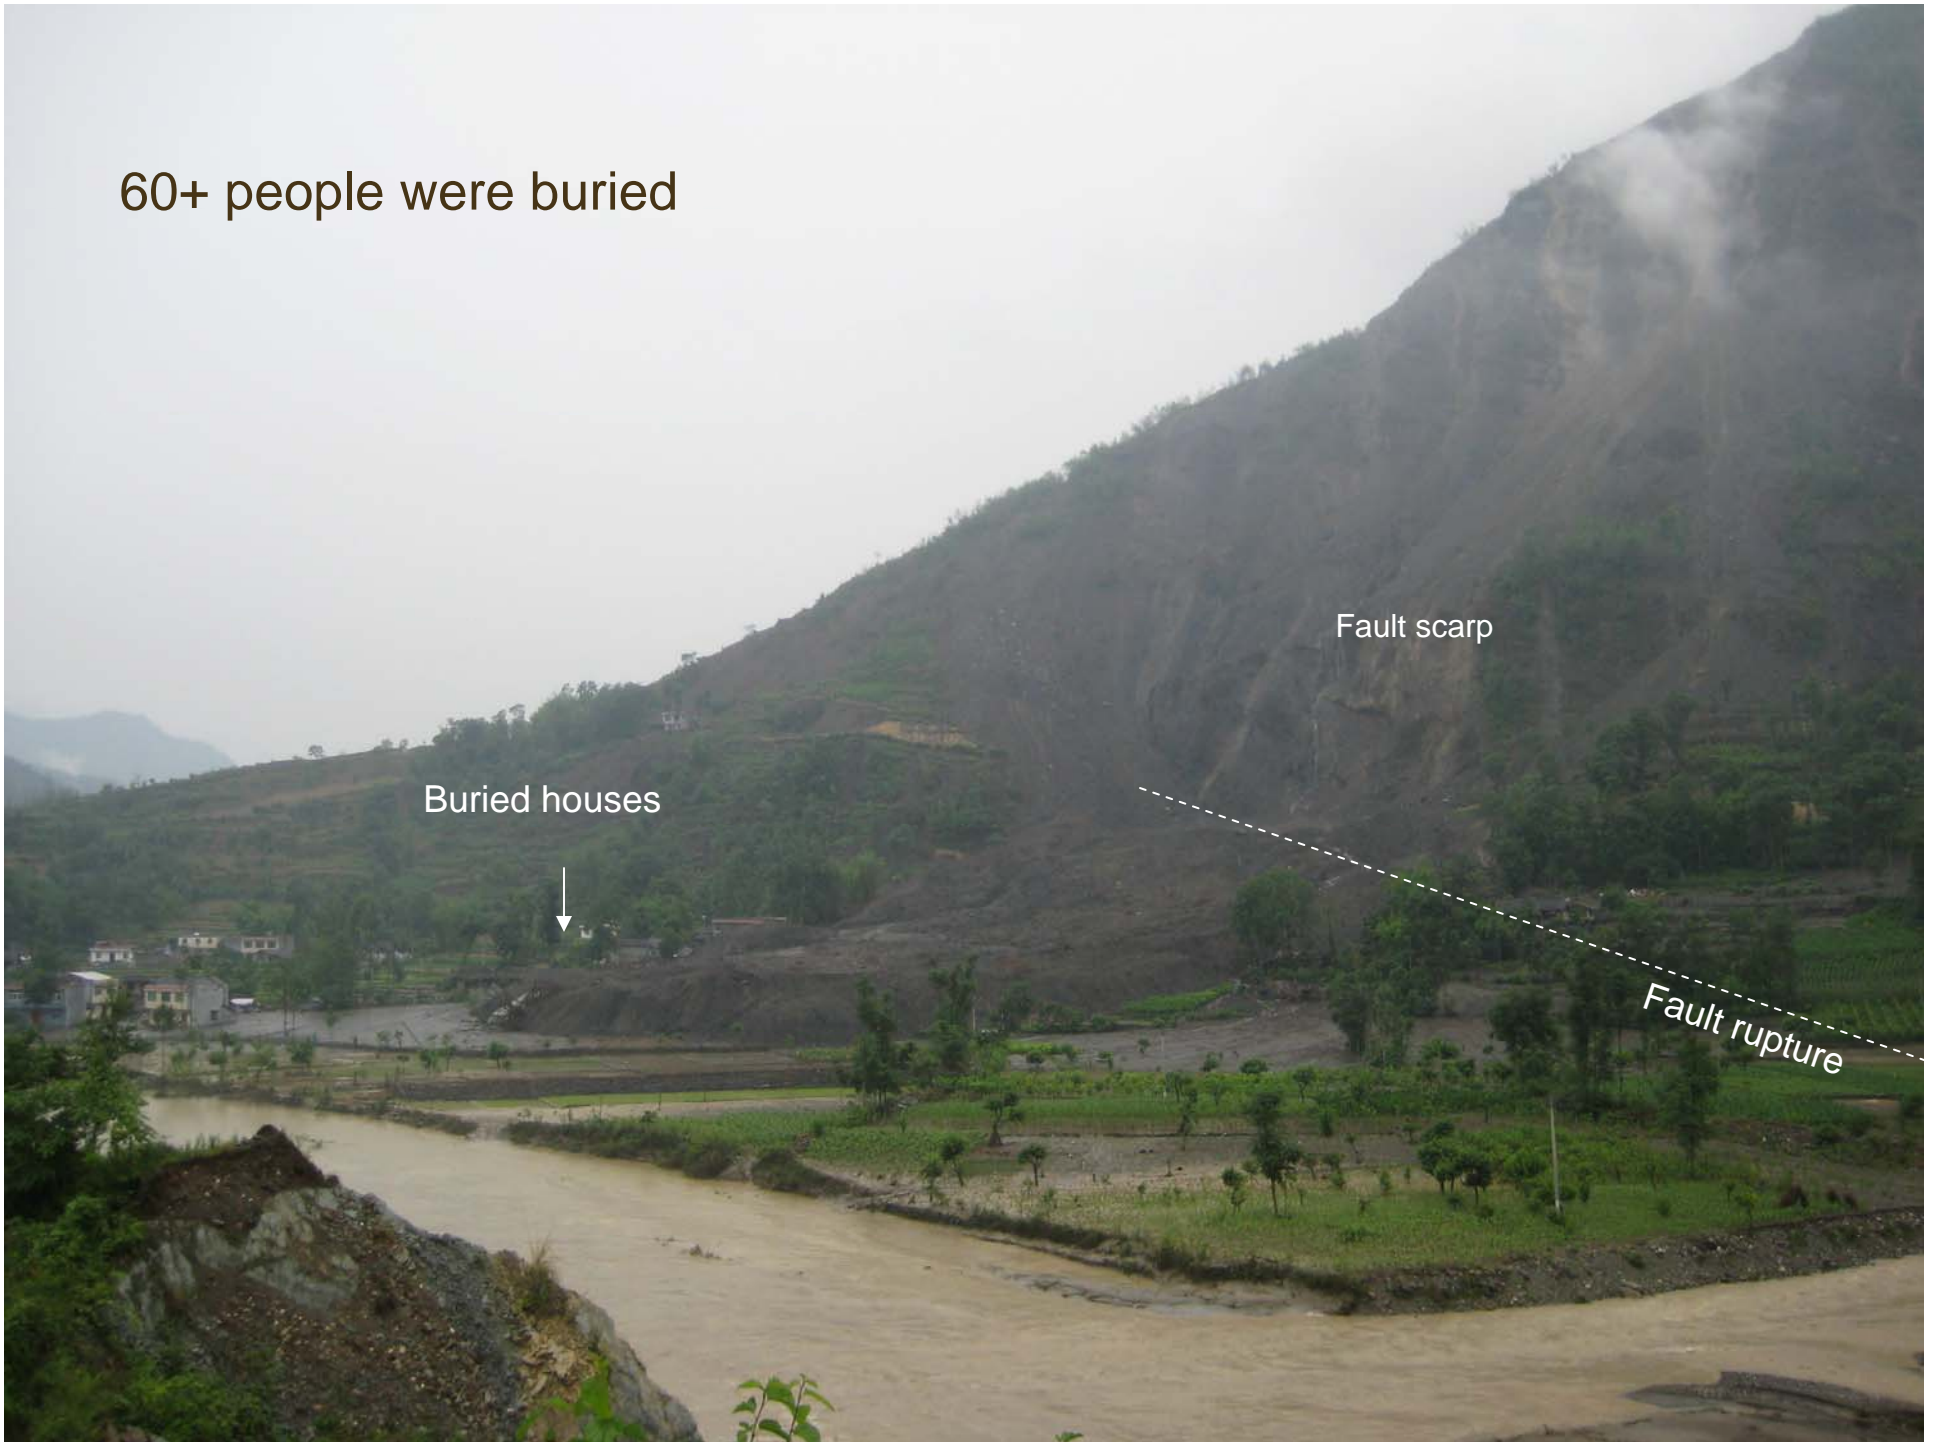
60+ people were buried

Buried houses

Fault scarp

Fault rupture
