71-260-2024

November 1, 2024

Welder Fell 32 Feet from Storage Tank Roof

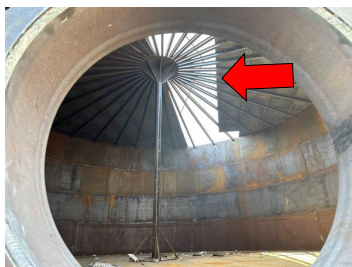
Hole in roof where welder fell.

While sitting on the rafter, he used a pry bar to bend and move the sheet into place for welding. As he pried, he fell backward through the hole between the rafter and leading edge. After landing on the ground, he was badly hurt but still conscious and breathing. Emergency responders arrived and had a critical care helicopter airlift him to the hospital. He died the next day.

- Use a crane instead of workers to move sheathing near roof leading edges.
- Develop FPWP and PFAS policies in their accident prevention program (APP). Policies should require pre-planning the use, training, and inspection of site-specific fall protection.
- Have supervisors review fall protection requirements with workers at pre-job crew meetings, routinely check that they are following them, and implement corrective action when needed.
- Demonstrate fall prevention leadership by prioritizing fall prevention at pre-job crew meetings, monthly safety meetings, annual stand-downs, and in company newsletters and social media.
