# **The Tornadoes of Oklahoma City of May 3, 1999**

a report prepared by

Wind Science and Engineering Research Center  
Texas Tech University  
Lubbock, Texas

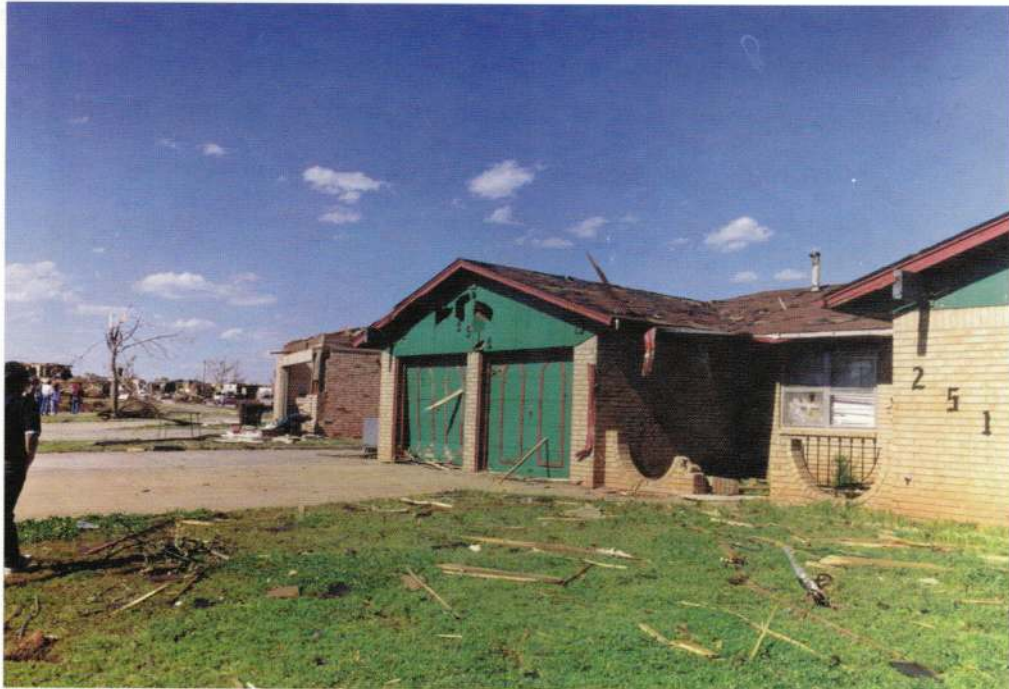
**FIGURE 4. GARAGE DOOR DAMAGE**

Orientation of a building, relative to the direction of the approaching winds, can affect the extent of damage a building experiences. One of the most vulnerable areas of single-family residences (relative to orientation) is the attached garage. Garage doors are notorious for blowing inward during extreme wind events, allowing the wind to enter the building and increase internal pressures. The resulting uplift on the roof compromises the roof and eventually other parts of the building. Therefore, homes with garage doors oriented in the direction of the approaching winds typically fare worse than homes without the garage door oriented into the wind (Minor et. al 1983; FEMA 1992; FEMA 1999). Figure 4 shows two homes with two-car garages. Notice that the home with two single garage doors (foreground) has an intact roof structure, whereas the home (background) with one double garage door is missing its garage door and roof structure. Both garages were oriented towards the approaching winds (wind direction is established from the debris penetrating the single garage doors on the house in the foreground). The double garage door was breached due to its larger area and flexibility, which ultimately led to the loss of the roof structure.

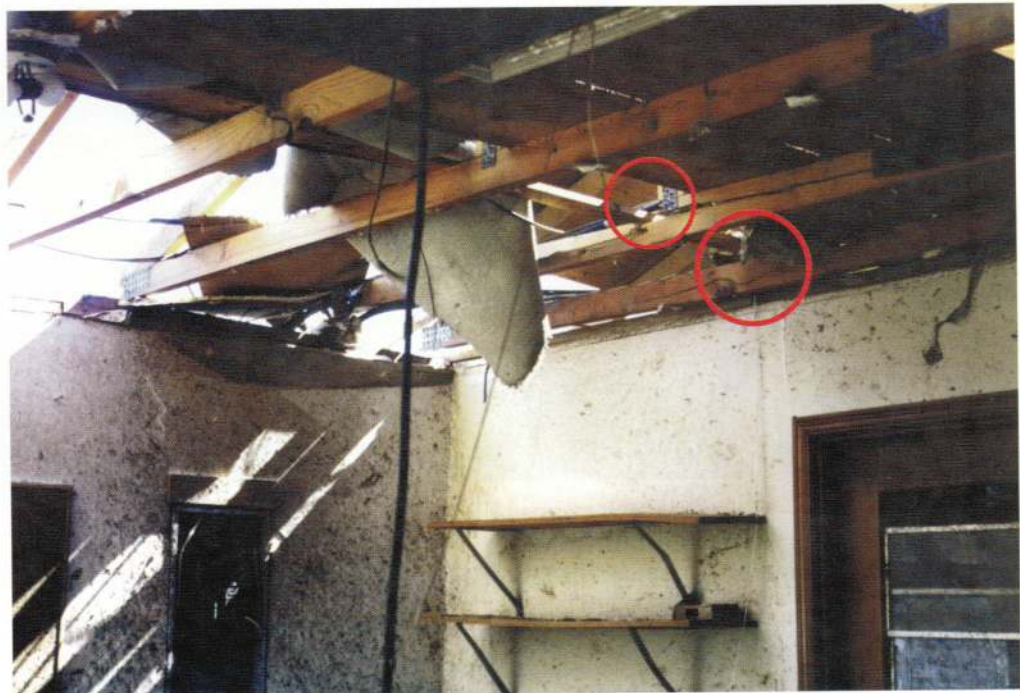
**FIGURE 5. FAILURE AT KNOTS IN WOOD MEMBERS**

The extensive use of wood in residential construction also makes material quality integral to the structural integrity. Wood structural members tend to fail at locations where there are knots, wane, or other imperfections (Figure 5).

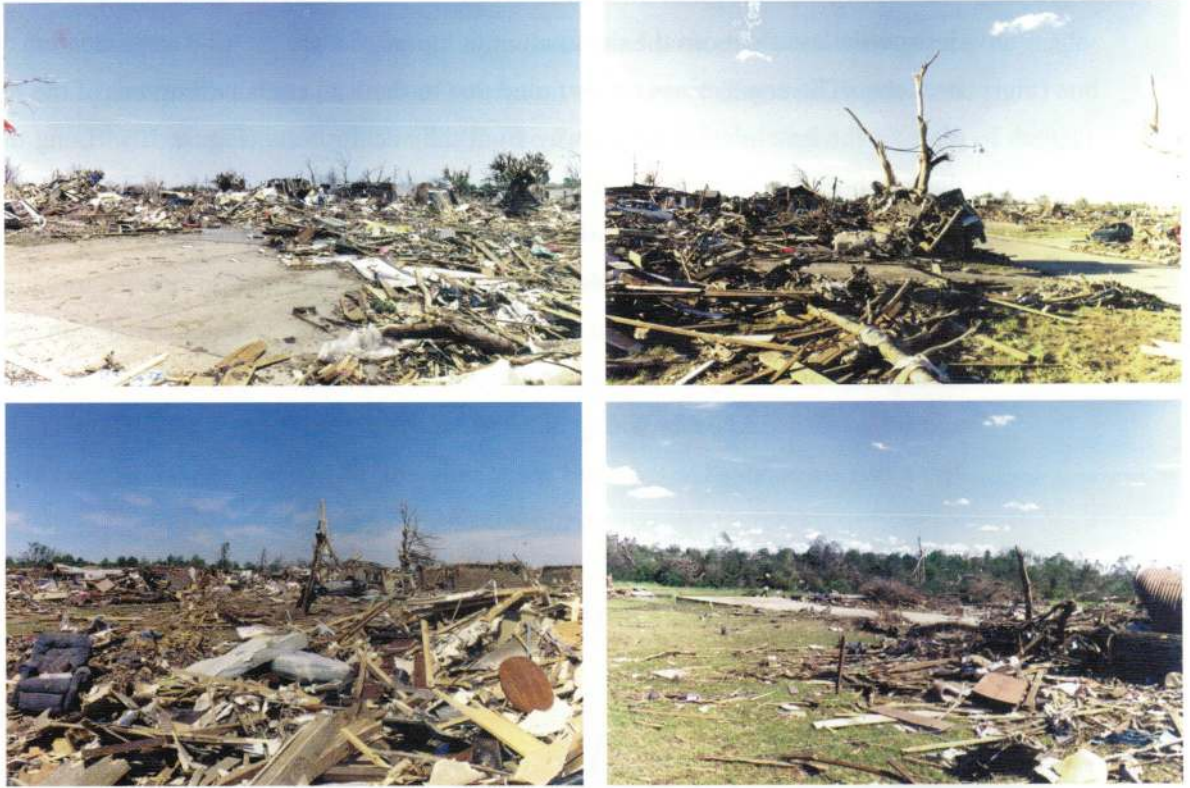
**FIGURE 9. DESTROYED (F4-F5 DAMAGE LEVEL)**

Structures wiped from the slab, leaving no roof or exterior or interior walls are classified as destroyed (Figure 9, all). Damage classified as destroyed is considered

unsurvivable. Although essentially all of the homes in the storm path had the better performing slab-on-grade foundations and all slabs were intact, in both severe and destroyed classifications the dominating failure mode was the wall to foundation connections. The connections either failed due to the wall studs pulling out of the base-plate or the base-plate ripping away from the anchor bolts (Figure 10). Long durations of high winds are believed to be a significant factor in resulting in severe damage and complete destruction of residences, and was also considered the culprit for the devastating damage and loss of life experienced in the Jarrell, Texas, tornado on May 27, 1997 (Phan and Simiu, 1998). Residential structures classified with severe damages or as destroyed are considered a total loss. These types of residential damage are estimated to occur with gust wind speeds in the range of 54 to 72 m/s (120 to 160 mph), as opposed to the wind speed range of 74-143 m/s (164-320 mph) associated with F3-F5 Fujita damage scale.

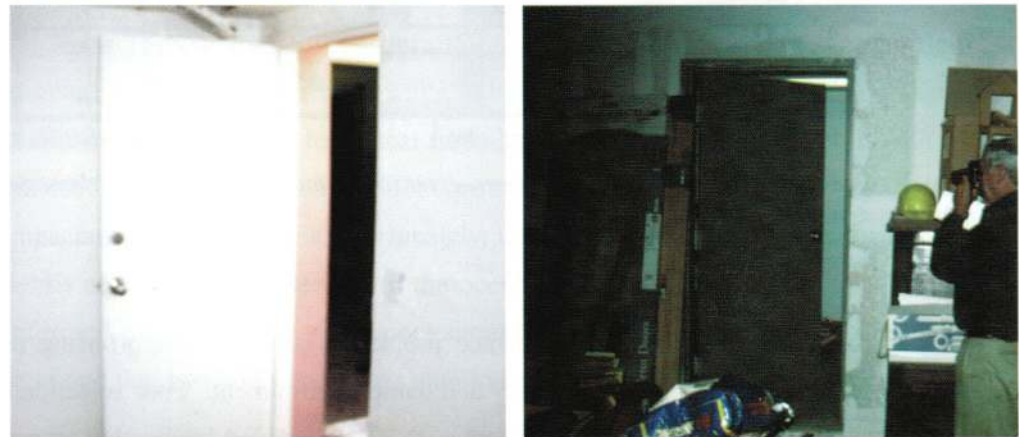
**FIGURE 17. SHELTER DOORS**

*Bartlett Shelter, Del City, OK (left); Lewis Shelter, Bridge Creek, OK (right).*

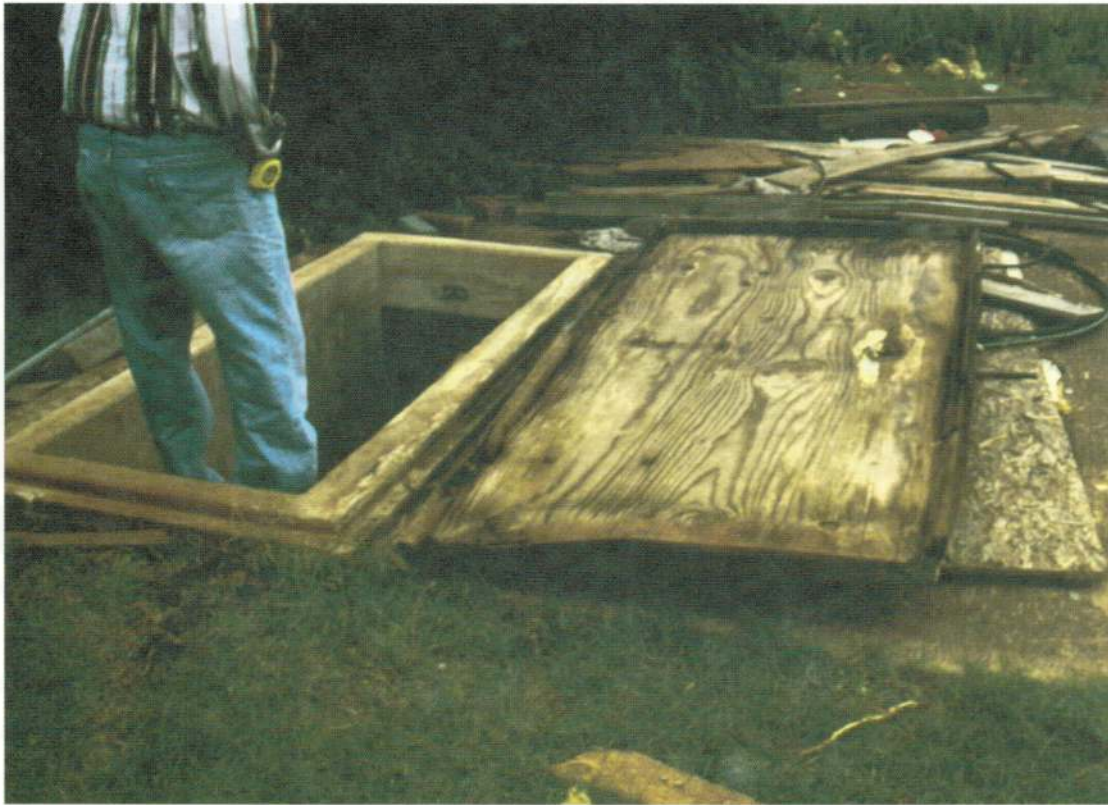
**FIGURE 18. BRIDGE CREEK CELLAR DOOR**

cellars suffered from maintenance problems, such as waterproofing of walls and roofs, which resulted in a musty and damp environment. Poor selection of materials and maintenance of painted items such as hinges and latches led to rusting, which

resulted in failures or poor performance. Cellar doors normally consisted of a single sheet of plywood covered with thin gage sheet metal, which exhibited deterioration of the zinc galvanization resulting in rust (Figure 18). The plywood backing was often found to be highly deteriorated from moisture (Figure 19). The older cellars were vented with substantial heavy steel pipe vents that performed well in the storm event (Figure 20).

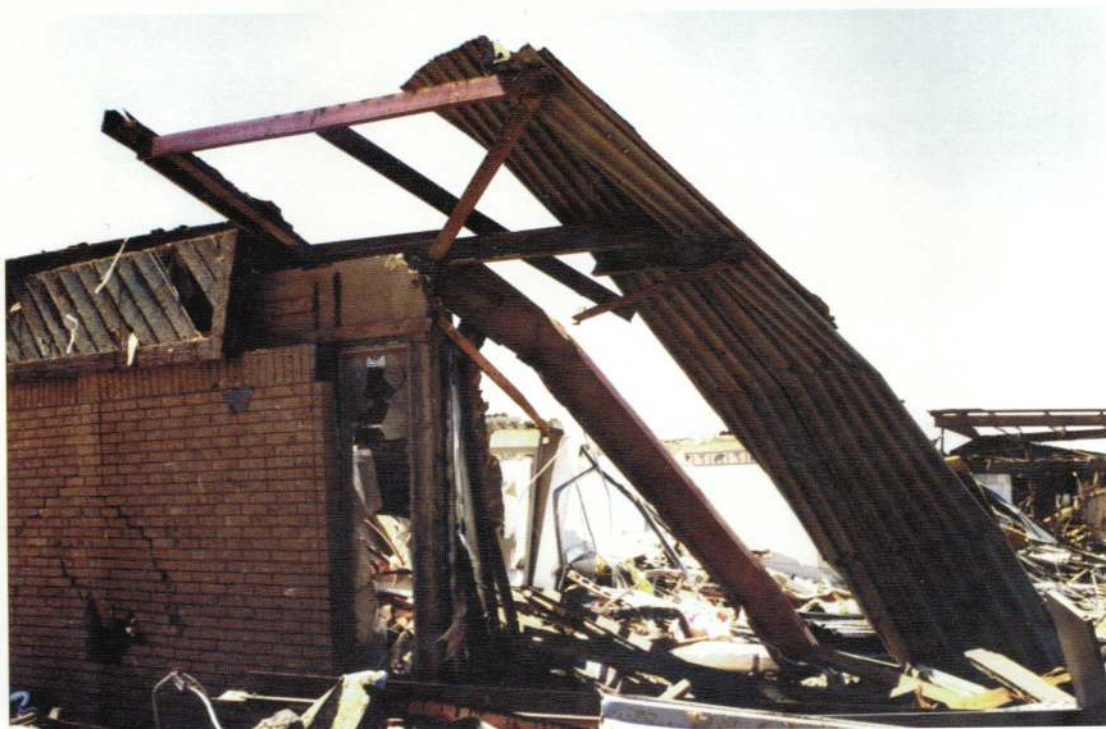
**FIGURE 25. OFFICE BUILDING, MOORE, OK**

The third steel structure was a single story office building (Figure 25), which was located adjacent to the bank shown in Figure 24. The structure was constructed of metal decking over bar joists bearing on lightweight beams and pipe columns. This structure would have experienced the same wind forces as the bank. However, the lighter steel structure was incapable of withstanding both the internal and external forces. Failure occurred at virtually all structural connections.

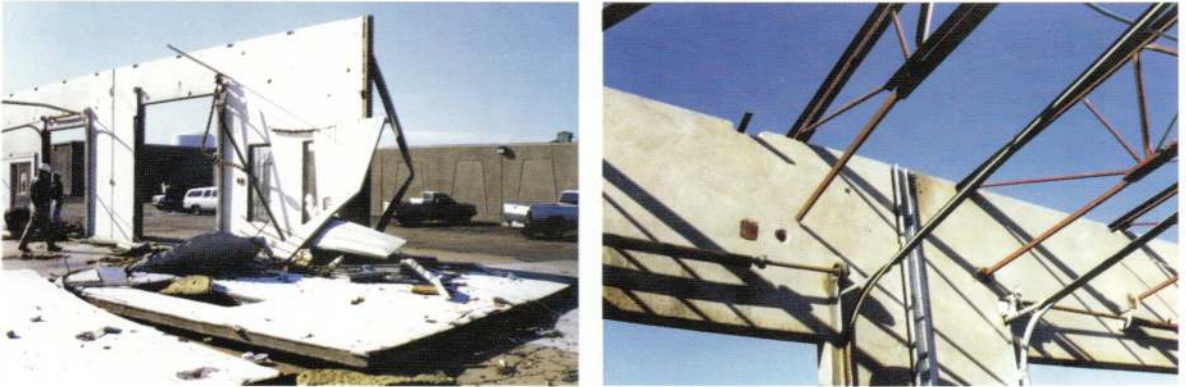
**FIGURE 28. TILT-UP CONCRETE WAREHOUSE, MOORE, OK**

The warehouse constructed of tilt-up concrete experienced numerous overhead door failures, thereby allowing internal pressures coupled with the external pressures to remove the roof decking and set up a chain of failure events. The roof decking was tack welded to the top of the end walls in order to provide lateral bracing of the walls. Lateral support of the load-bearing walls was provided by the bar joists bearing top chords and the extended bottom chords, that were welded to plates embedded in the wall panels (Figure 28, left). The chain of failure after the decking removal included loss of the end wall panels and the subsequent weakening and failures of the welds of the bar joist top and bottom chord connections (Figure 28, right).

*Lateral support failure of load bearing walls (left); failure of bottom bar joist chord connections (right).*

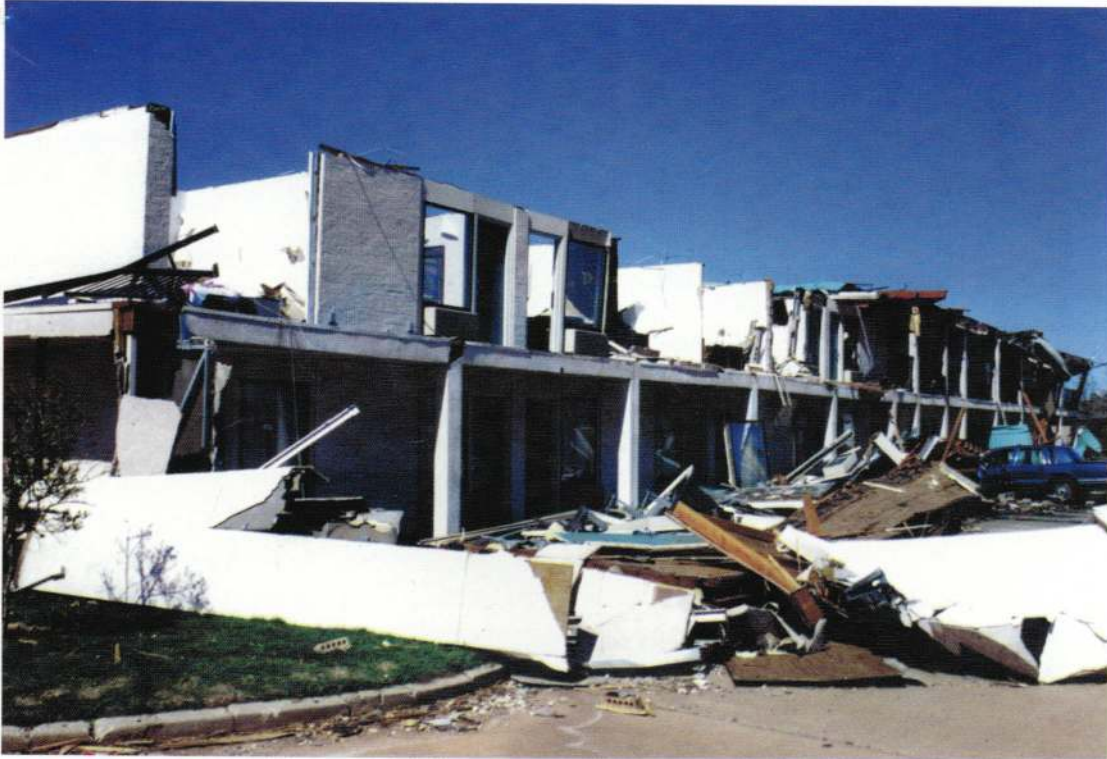
**FIGURE 29. BEST WESTERN MOTEL, MID-WEST CITY, OK**

The Best Western Motel was constructed with pre-cast hollow core concrete floor slabs supported on masonry walls. The architectural design consisted of back-to-back rooms stacked two stories with wide exterior corridors and roof overhangs ringing the building exterior. The wind forces acted on the top and bottom surfaces of the overhangs, and windborne debris compromised the large guest room windows. Many of the structural systems failed, including removal of some of the wood roof structure (Figure 29).
