# PARKERSBURG - NEW HARTFORD, IOWA EF-5 TORNADO

May 25, 2008

43 Mile Damage Track

National Weather Service - Des Moines, Iowa

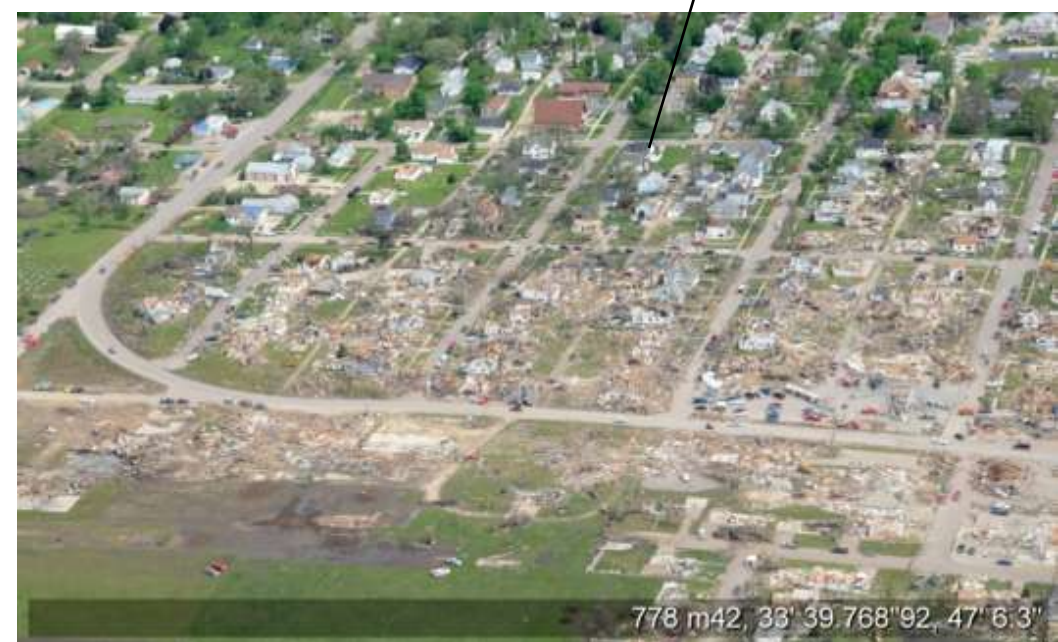
The most severe destruction in Parkersburg occurred south of the tornado core, which tracked directly over the First State Bank (left photo). Several fatalities occurred in the neighborhood of the center photo, as floors were swept away exposing basements. Mature trees were reduced to debarked stubs. The high school (right photo, Getty Images) received EF2-3 damage.

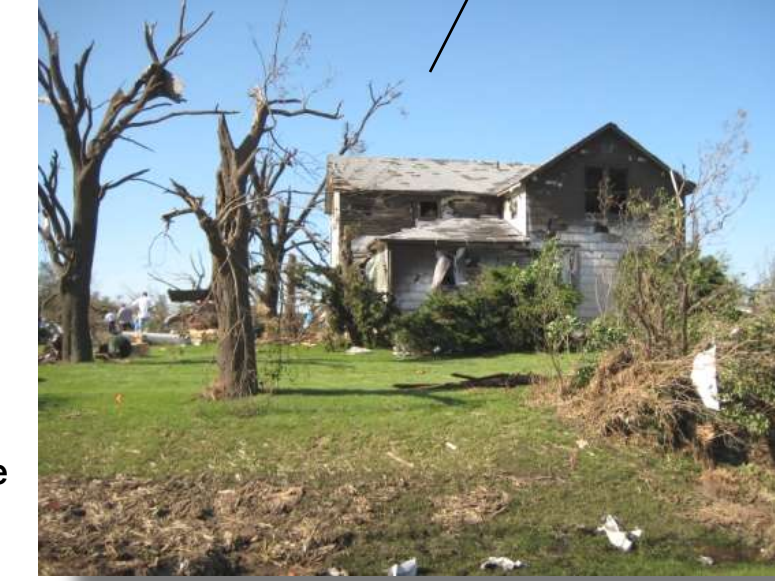
Damage on Adams Rd between Dunkerton and Fairbank was high-end EF2. The house at the farm on the left had several walls down. Photo from John McLaughlin, IowaHelicopter.com

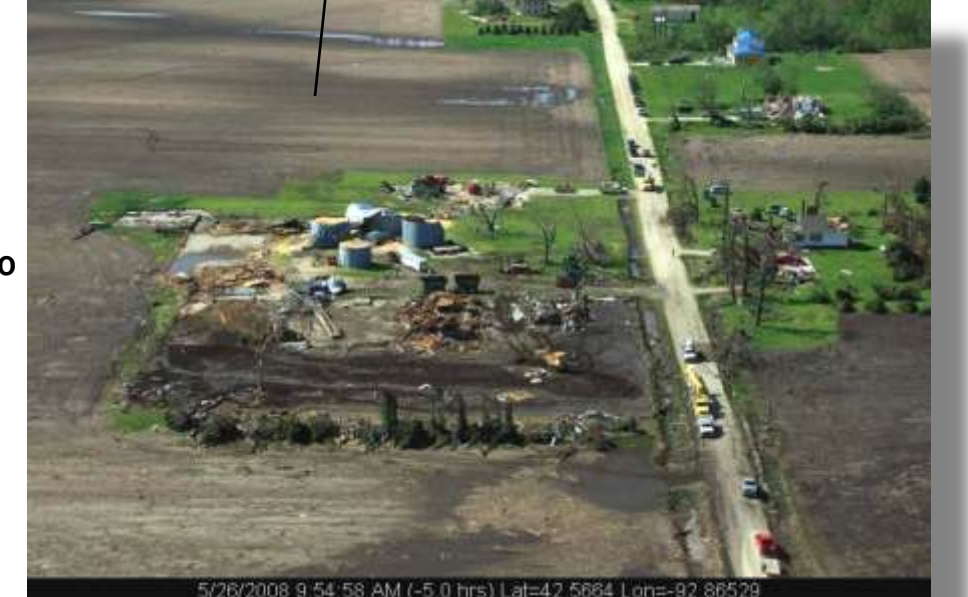
Aerial photos from the Civil Air Patrol and IowaHelicopter.com show the path of the destruction through south and east Parkersburg. Damage was EF4-5 at the core of the track.

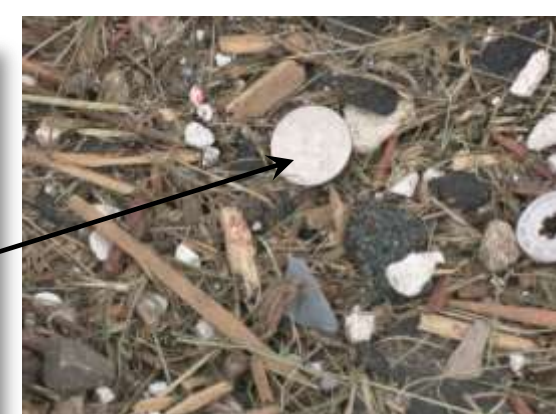
Size and distribution of debris played a big role in determining the EF-5 rating. A quarter was placed here for reference. NWS survey photo.

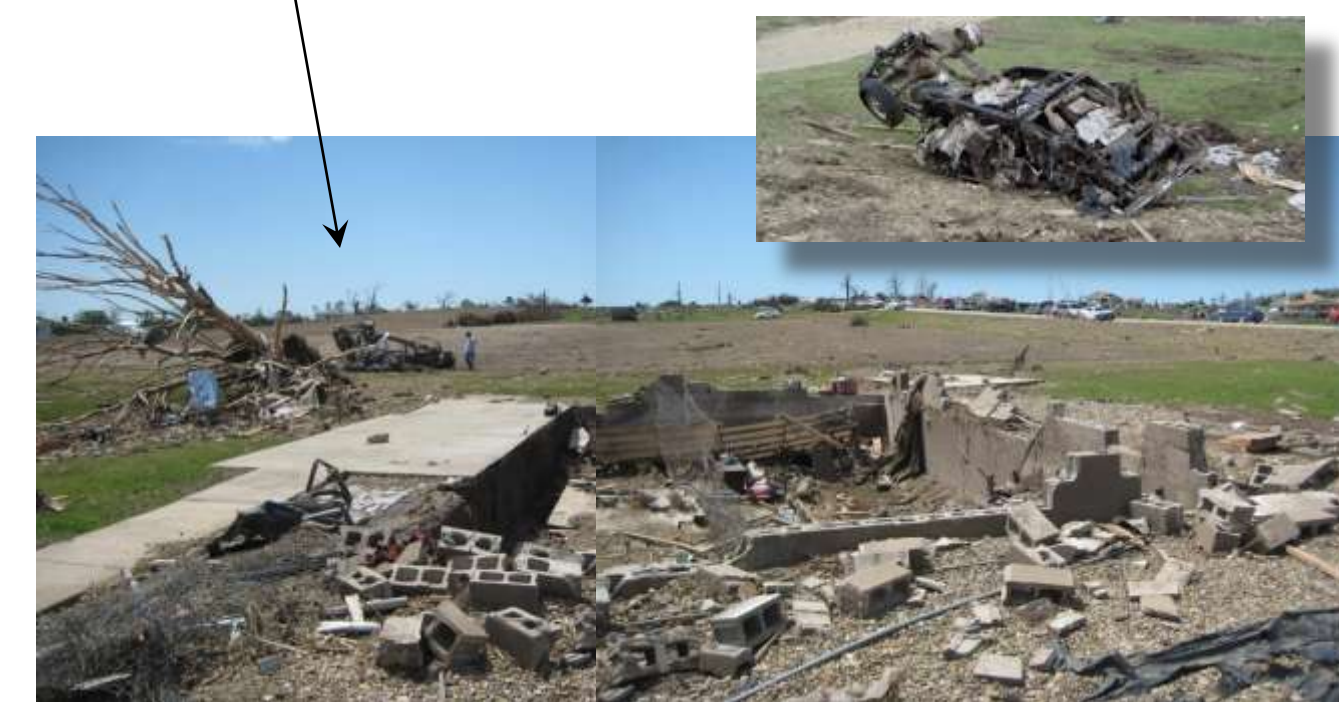
North of New Hartford, a woman was killed as her home was swept away. Only vehicle frames and tree trunks remained. Even the basement was cleared. The tornado was rated EF-5 at this location. The New Hartford cemetery is in the background. NWS survey photos.

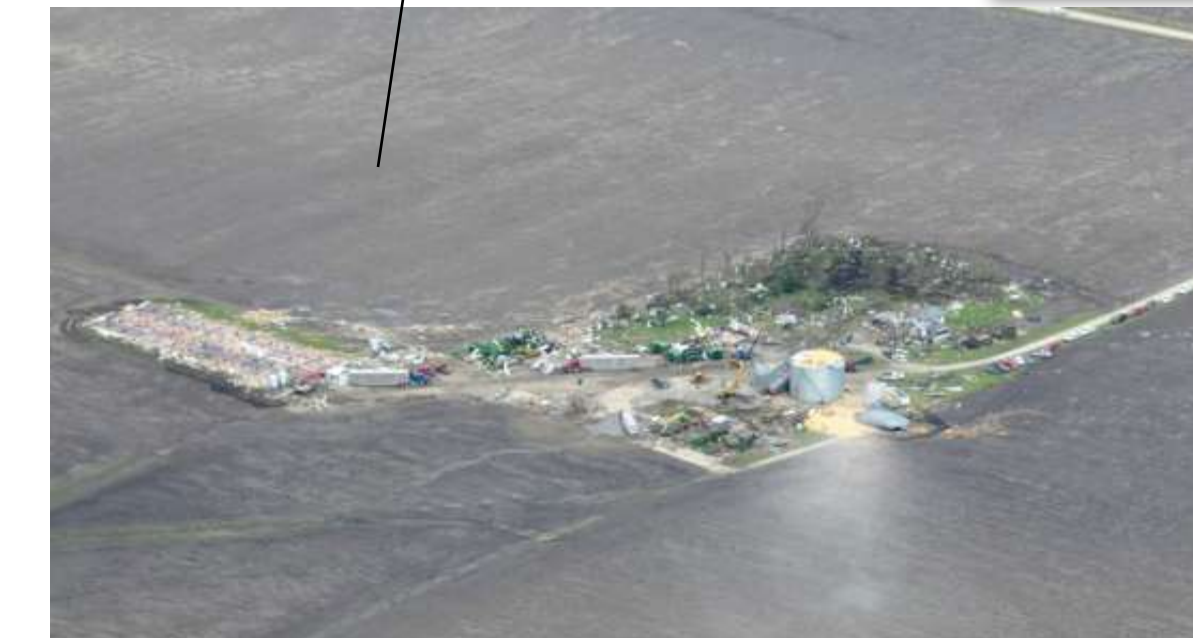
Damage on Lester Rd northwest of Dunkerton approached EF3 at several farm sites. Many hog confinement buildings were flattened. Here, hogs can still be seen in the building with some being loaded onto trucks. Civil Air Patrol photo.
