Survey Completed in Pocahontas County

...FINAL DAMAGE SURVEY RESULTS FOR POCAHONTAS COUNTY...

...EF1 TORNADO IN POCAHONTAS...

THE FOLLOWING IS A FINAL ASSESSMENT FOR THE DAMAGE THAT OCCURRED OVER POCAHONTAS COUNTY ON JULY 22, 2010.

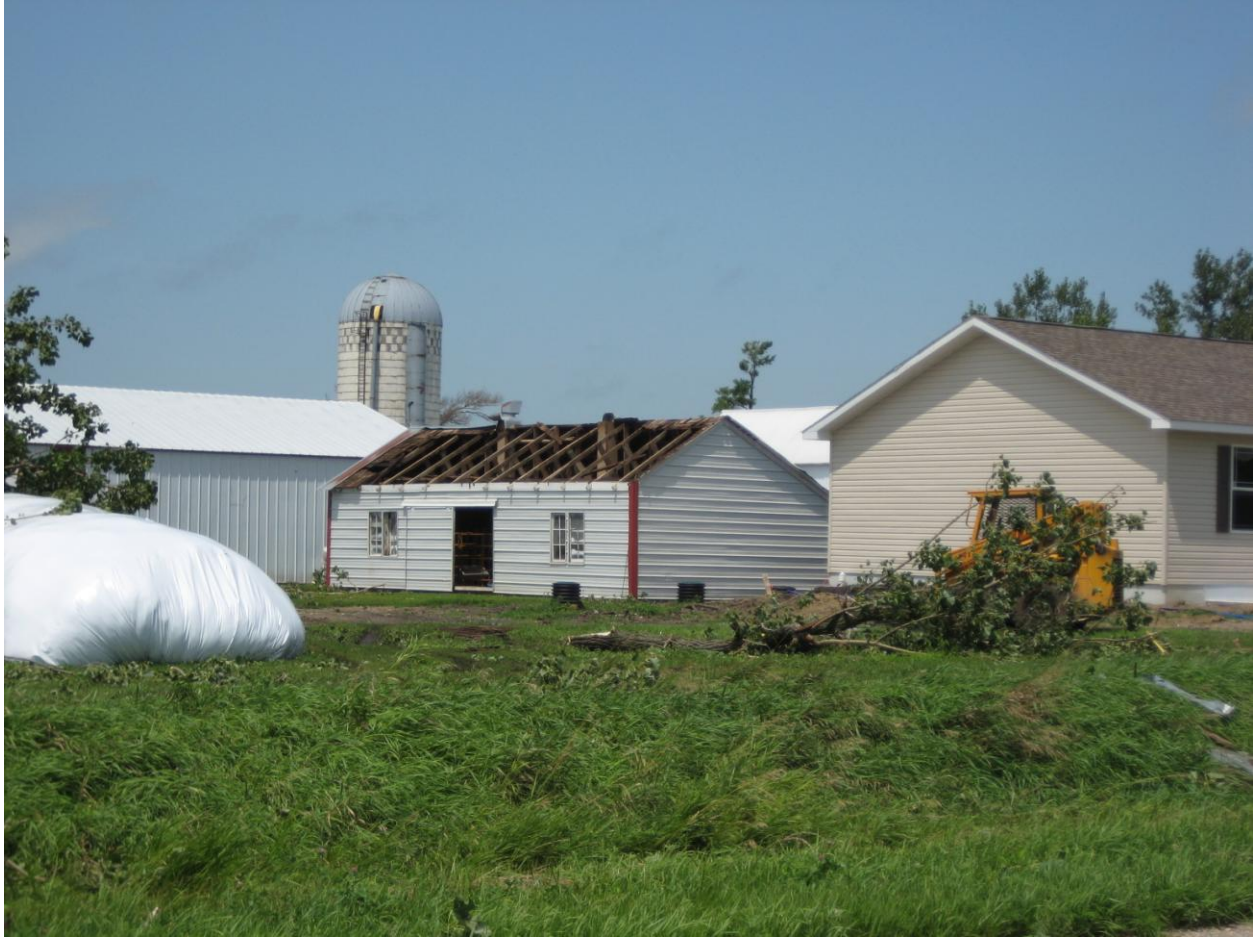
Figure 3. A building with roof damage near on the south end of Pocahontas.

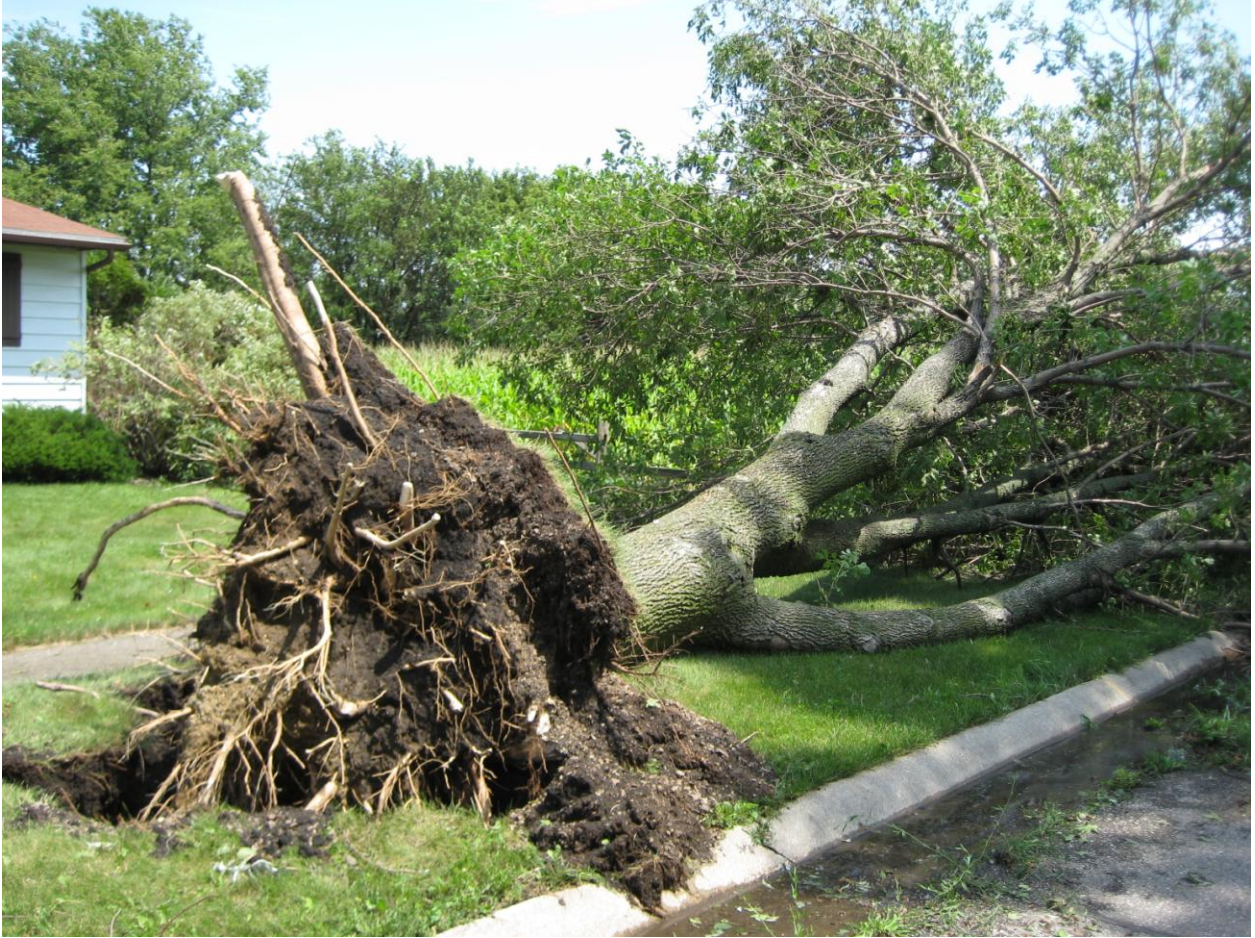
Figure 4. A large tree uprooted on the south end of Pocahontas.

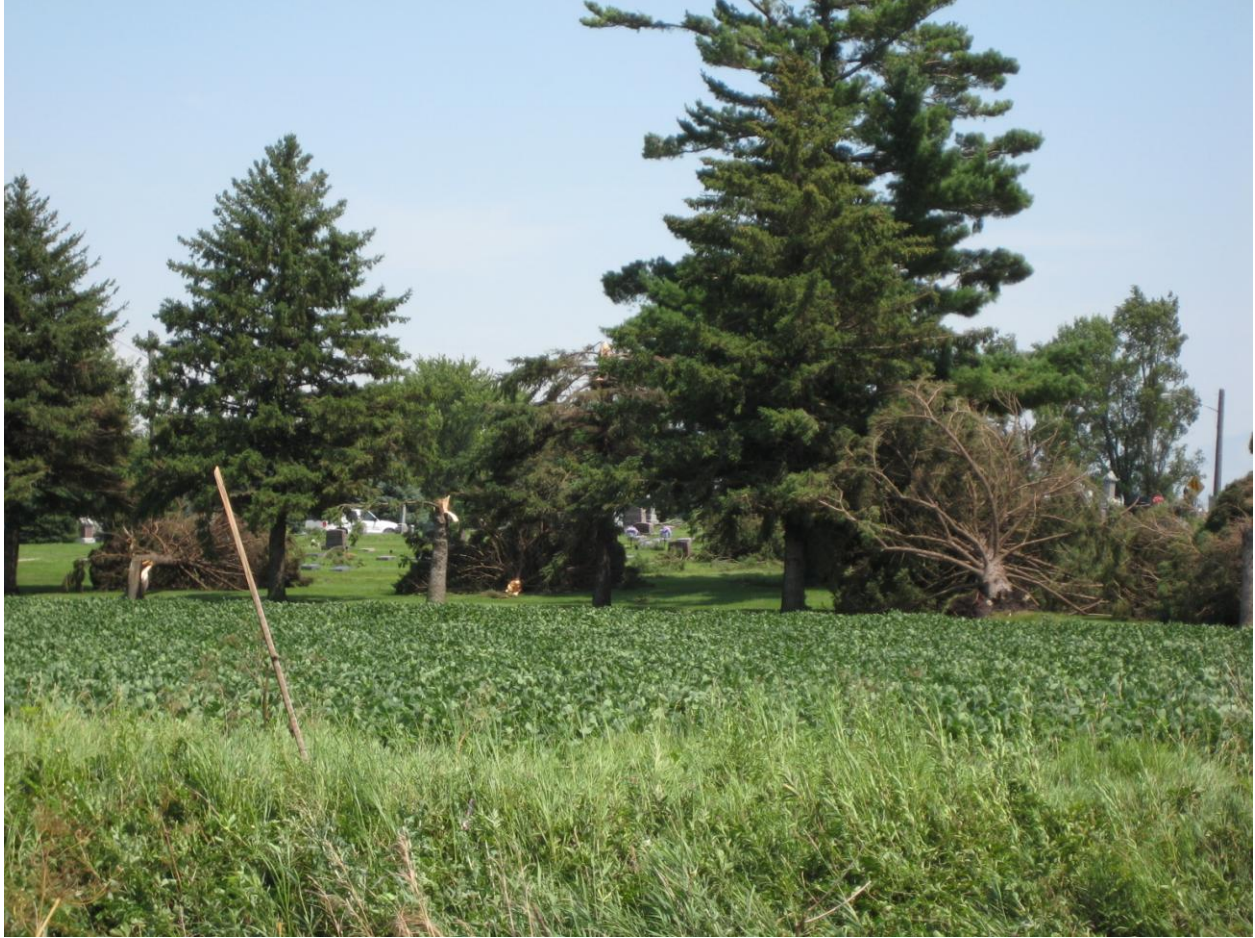
Figure 5. Large trees snapped off near cemetery in southeast Pocahontas.

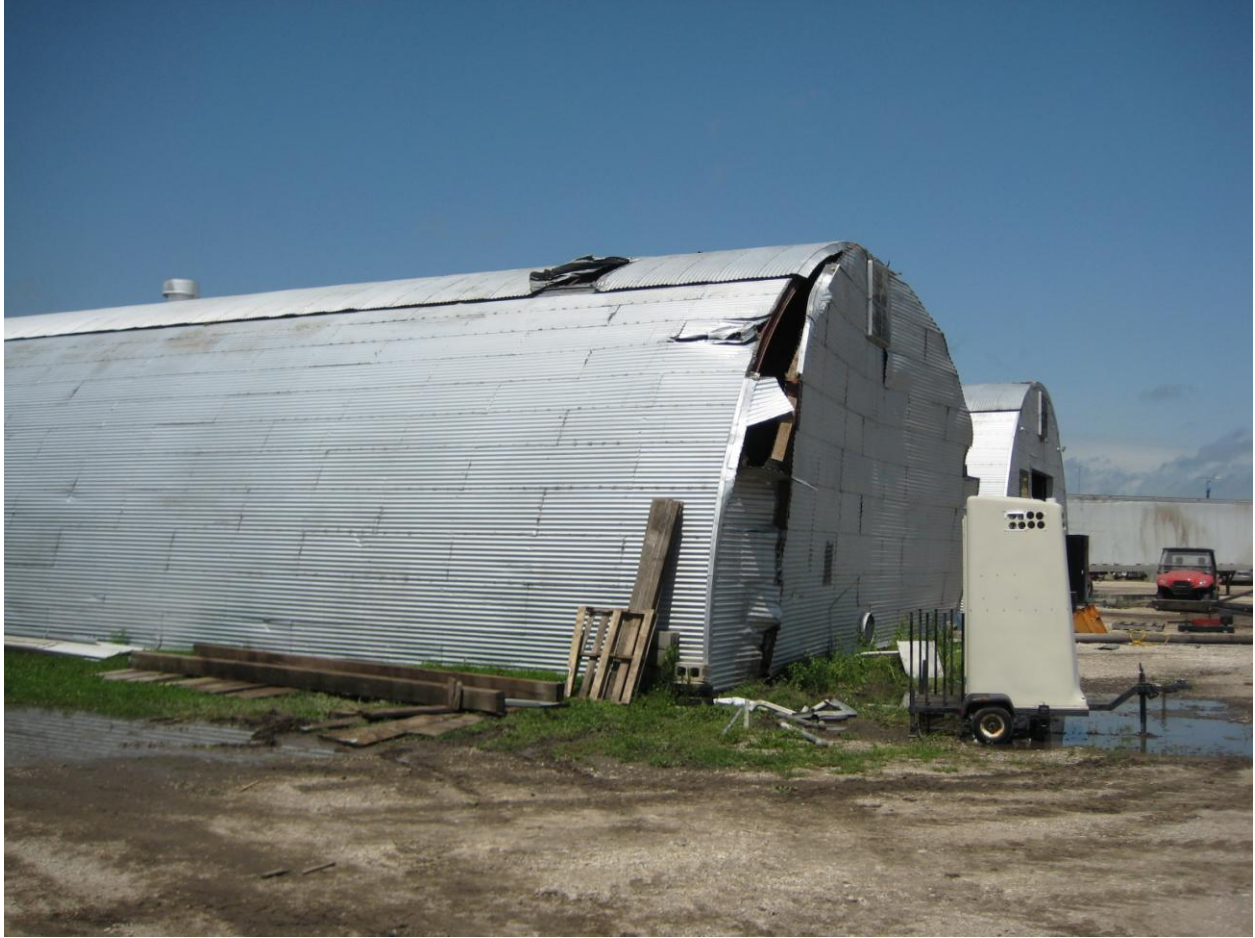
Figure 6. The end of this Quonset hut was blown out and was found laying flat on the ground. Workers had attempted to place the wall back in the vertical position by the time the photo was taken.

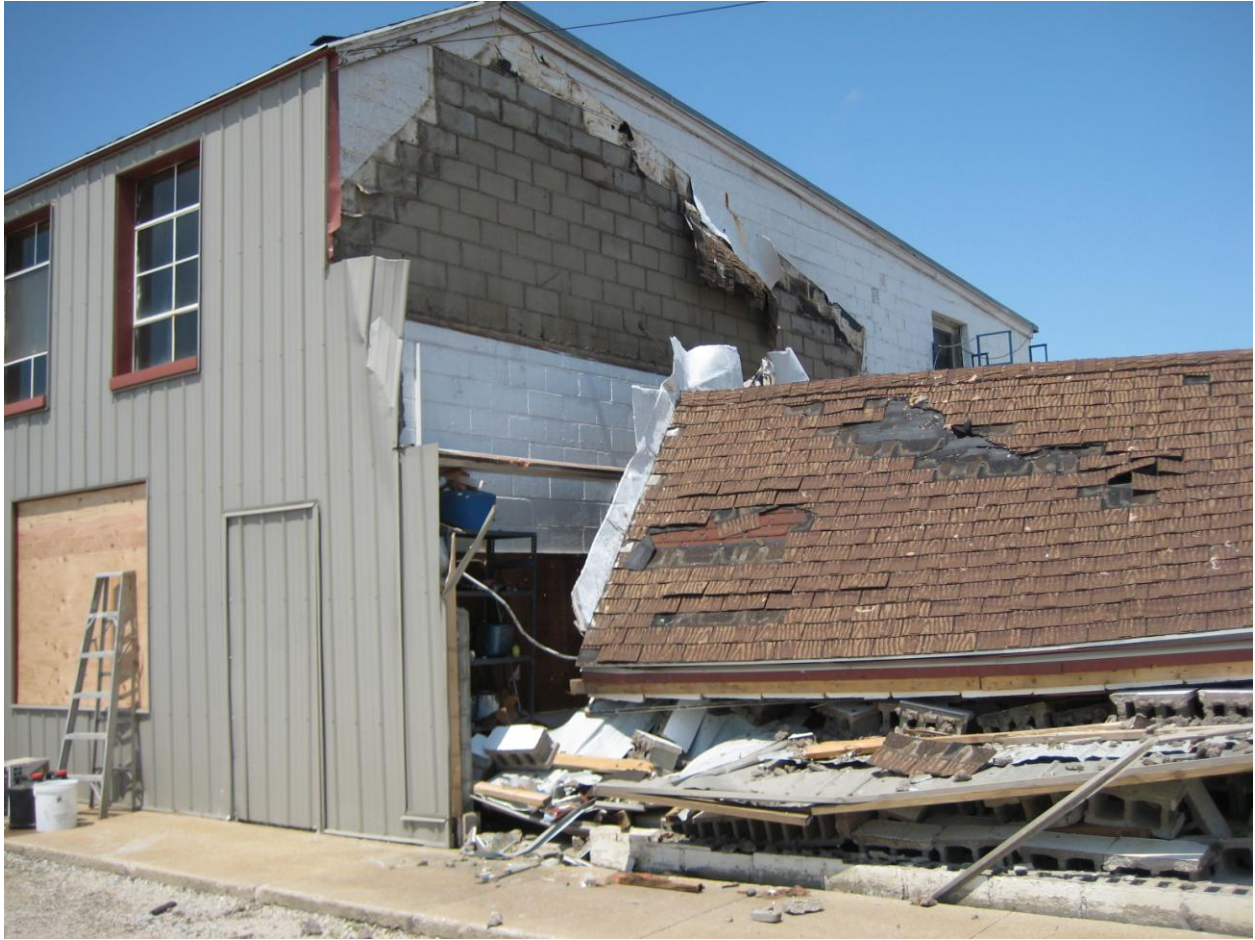
Figure 7. The cinder block wall of this building collapsed and the roof was torn off the side of the parent building in eastern Pocahontas.
