National Weather Service Des Moines

June 12, 2013 Tornado Event Summary

Updated on February 23, 2014

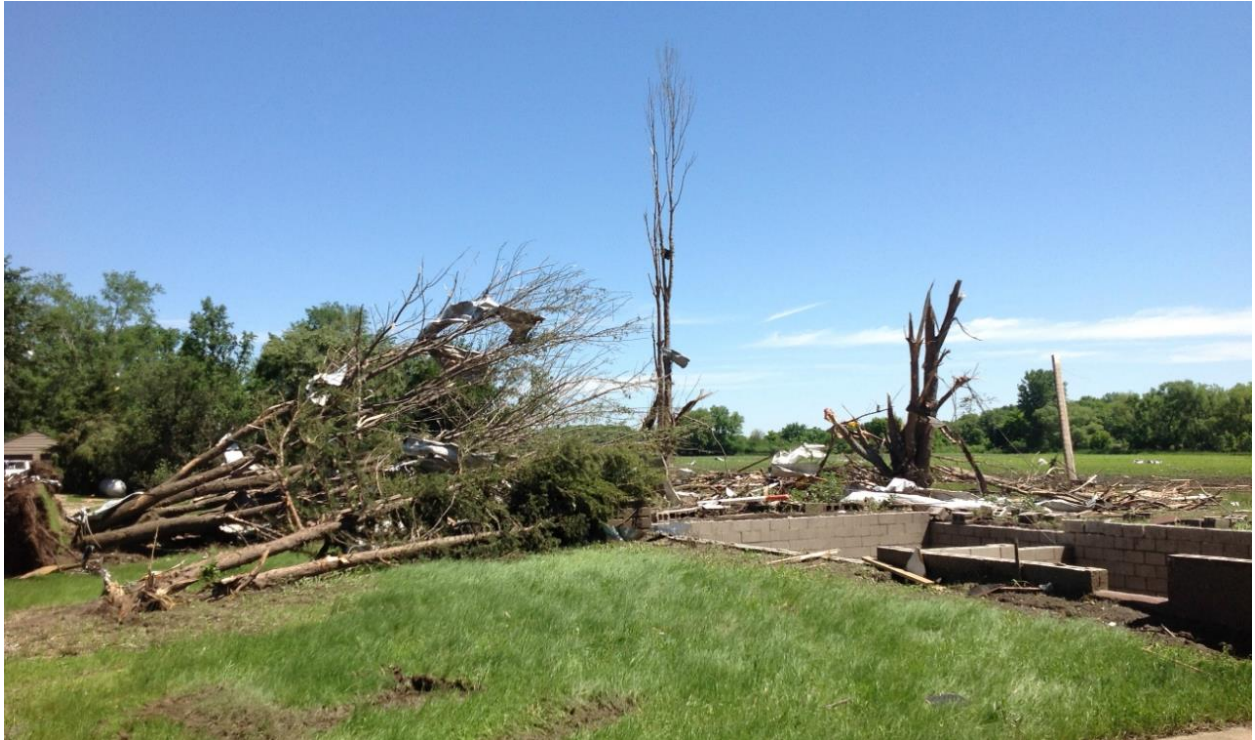
An older house was detached from its cinder block foundation and destroyed on the north side of Belmond. Many trees were uprooted and flattened in this area as well.

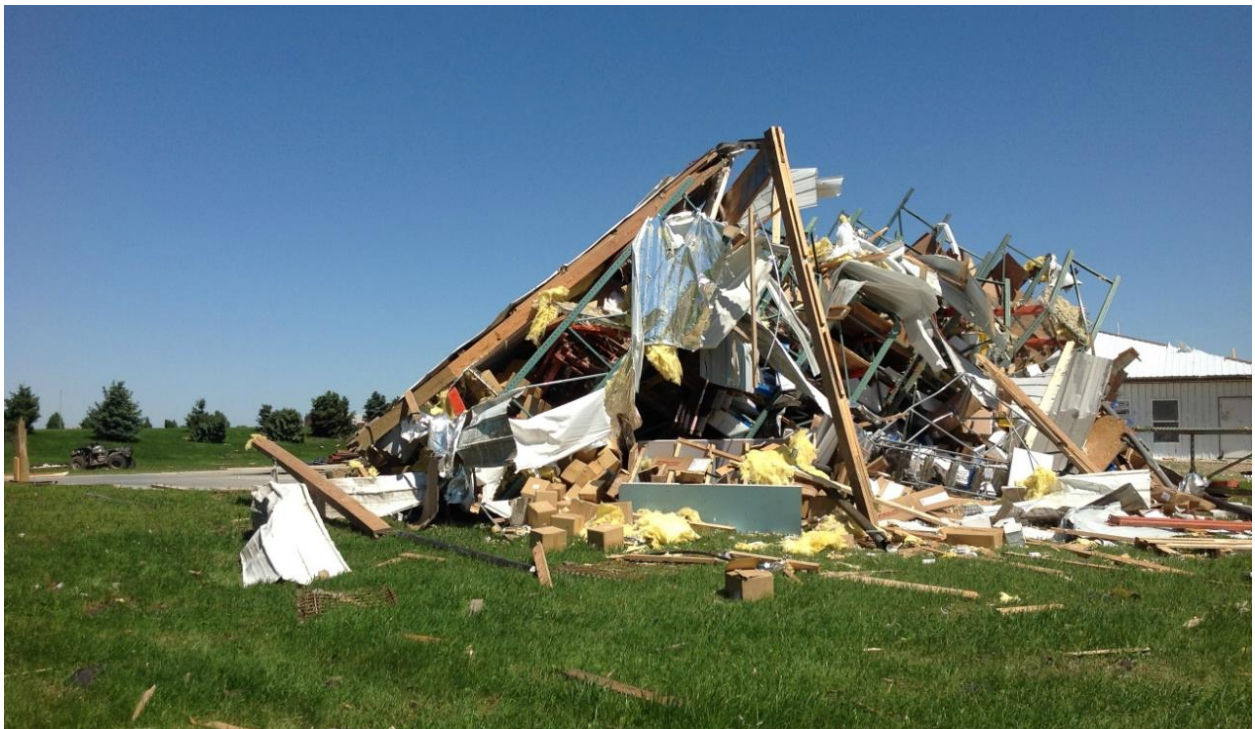
A warehouse was destroyed and partially swept from its foundation on the north side of Belmond.

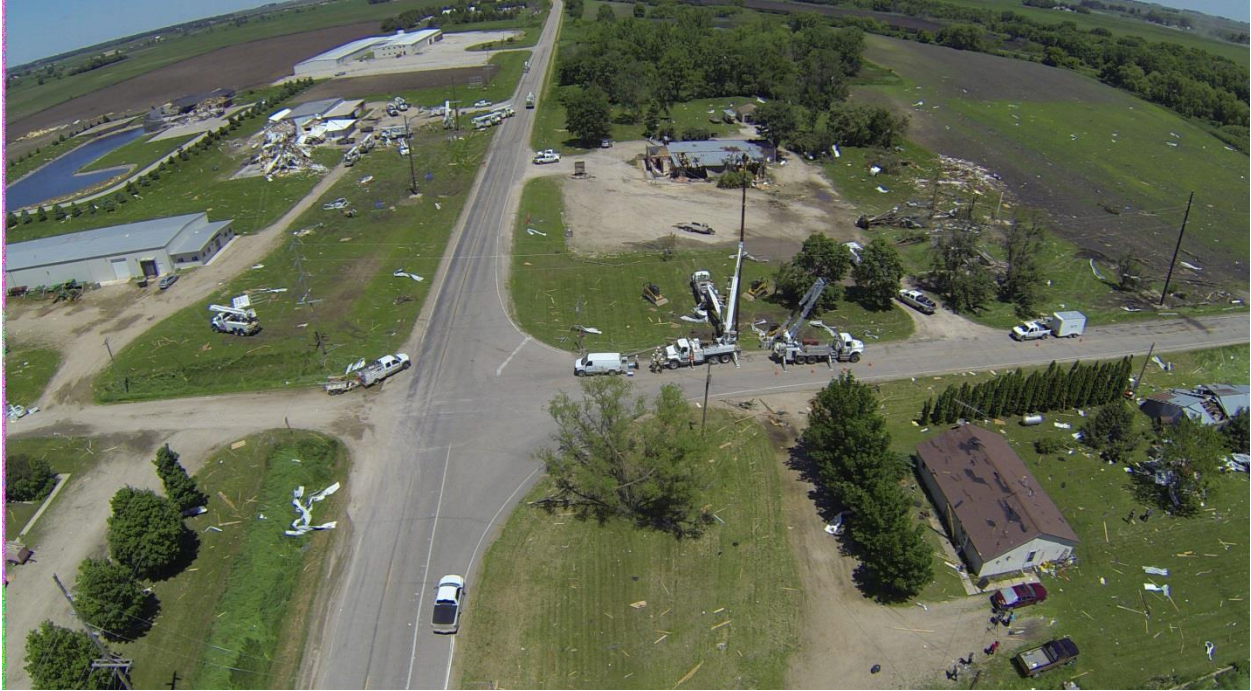
Aerial shot of the damage on the north side of Belmond along US Highway 69. Many of the structures in the photos above are shown in this aerial shot. Photo by Adam Frederick.

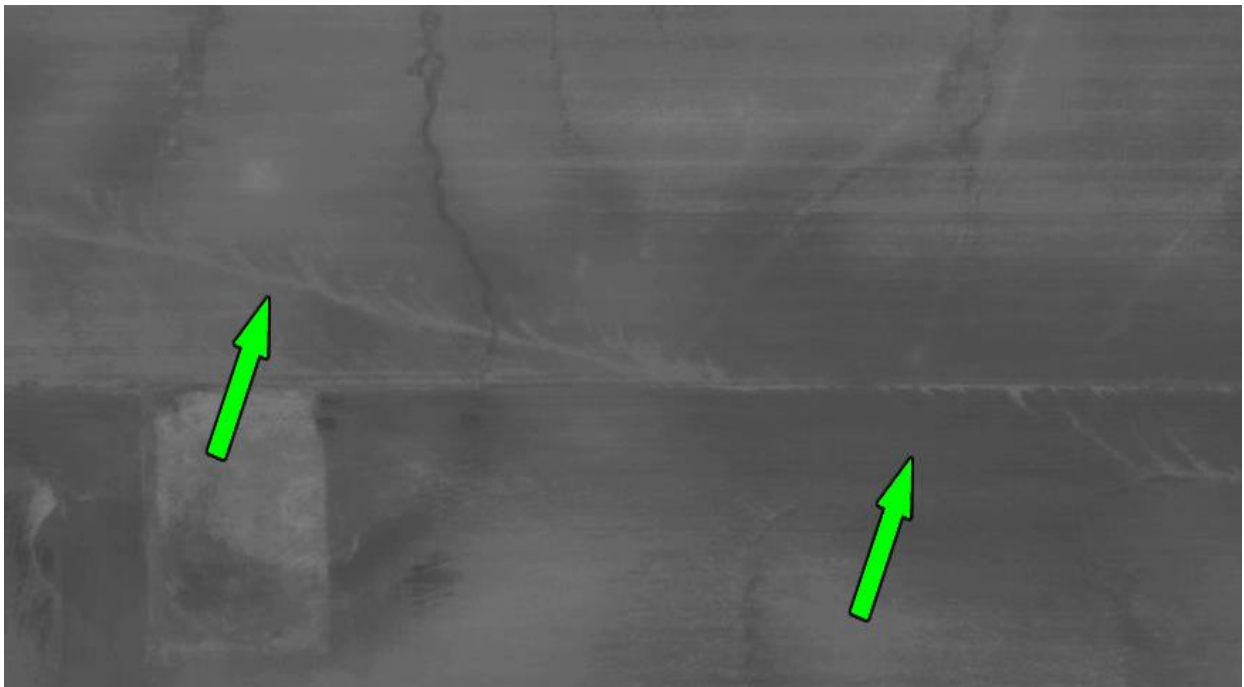
High resolution black and white satellite imagery of cyclonic swirls associated with the tornado as it travelled through a farm field NW of Belmond (green arrows).

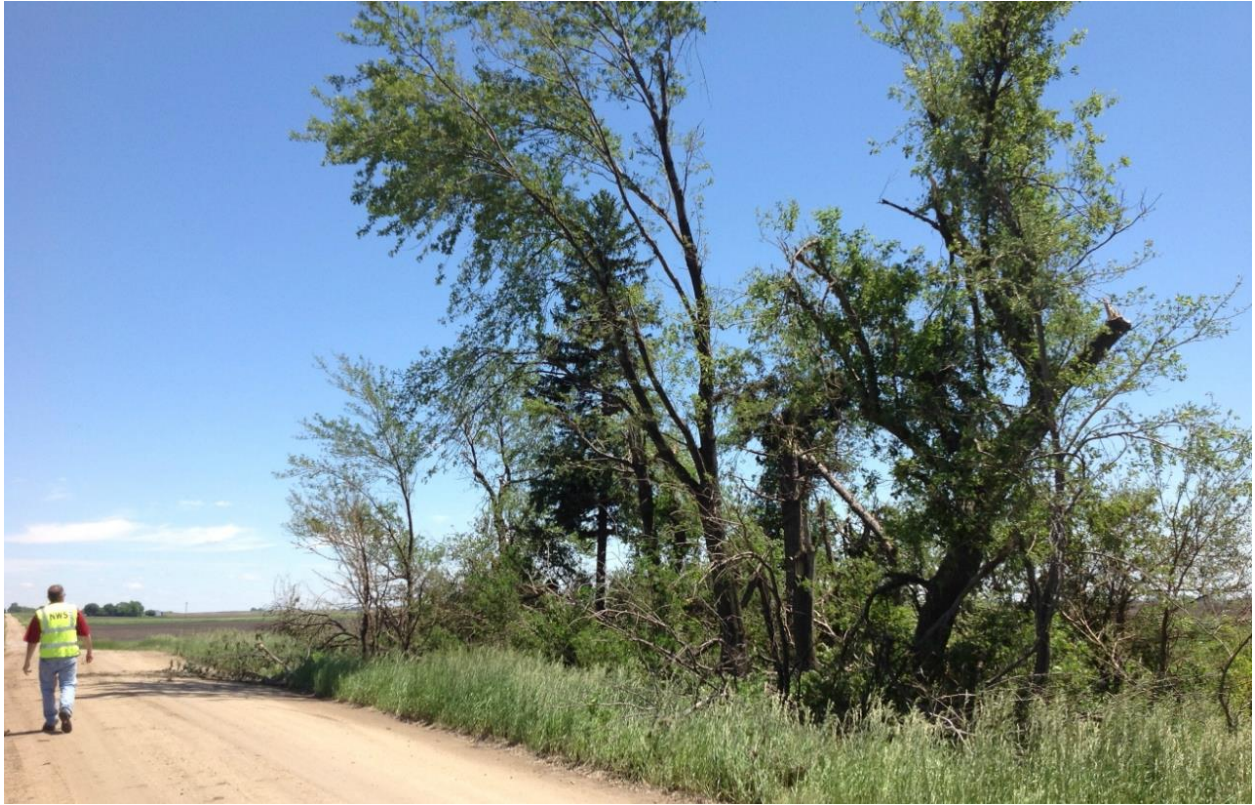
Trees heavily damaged about 3.5 miles southeast of Belmond.

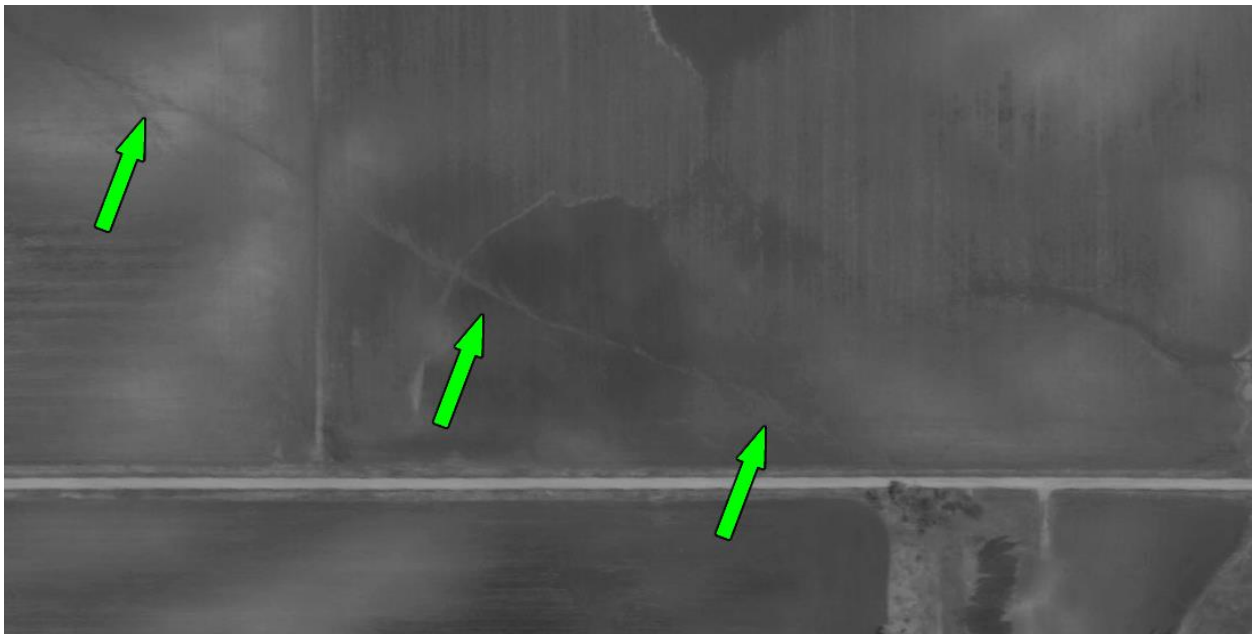
High resolution black and white satellite imagery of cyclonic swirls associated with the tornado as it travelled through a farm field SE of Belmond (green arrows). The trees in the photo above are at the bottom right of this image.

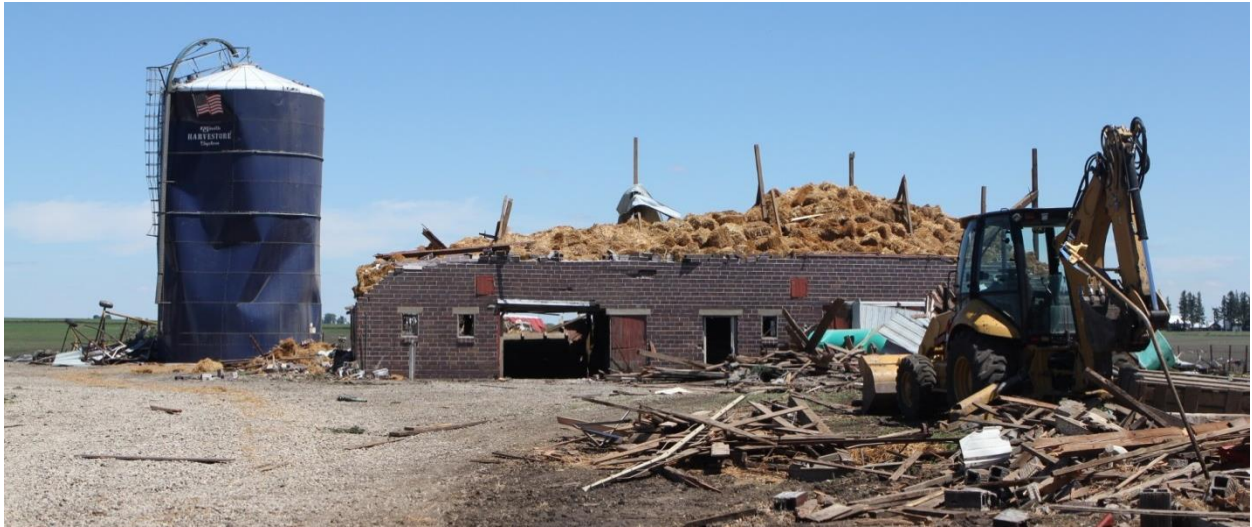
A destroyed barn near the beginning of the track north of Alexander. Photo by Tim McCleary

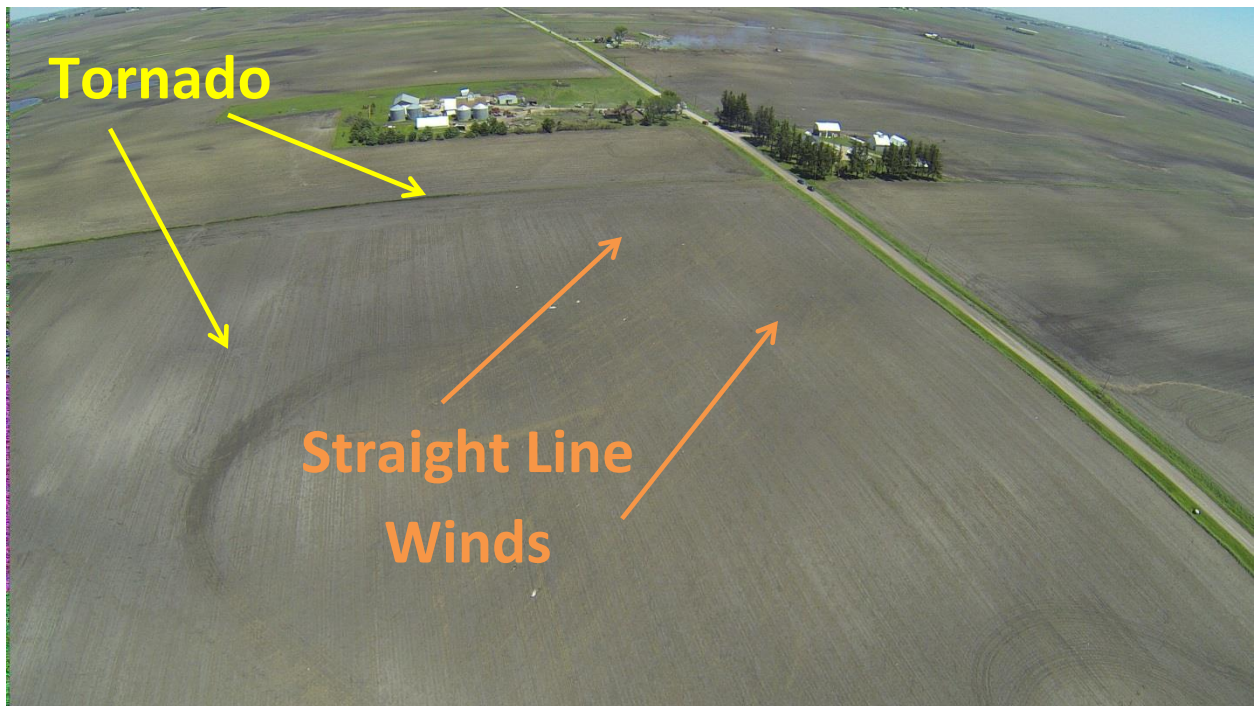
Aerial view of the track as it headed towards another farmstead. The tornado path shows up as the swirls in the field on the left side of the photo while straight-line winds show up in the fields on the right. Image provided by Adam Frederick.

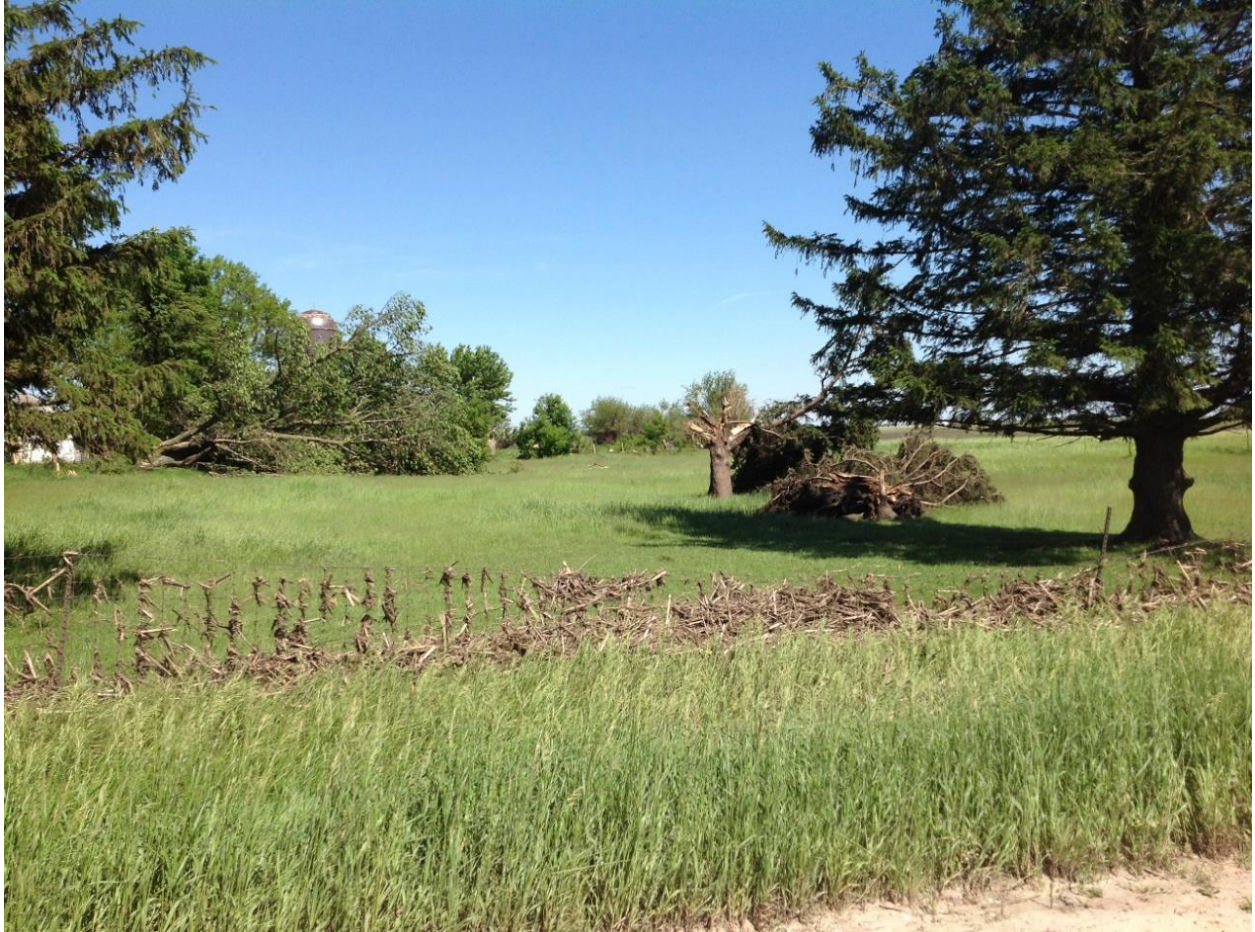
Trees snapped off in the area of EF-1 damage about 3 miles NE of Latimer.
