# The April 27, 2014 Windstorm

## Summary

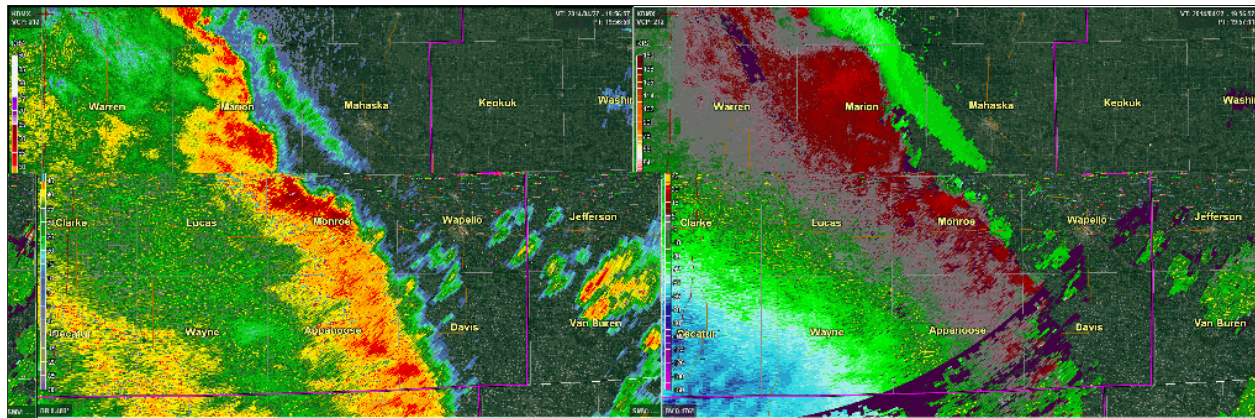
**Radar loop from 2:24pm to 3:36pm CDT on April 27 as the line of thunderstorms raced through southeastern Iowa. The left image is base reflectivity and the right image is base velocity. Note that the radar did a poor job sampling the velocity since the wind vectors were normal to the radar beam. The two areas of higher wind speeds match the damage tracks reasonably well.**

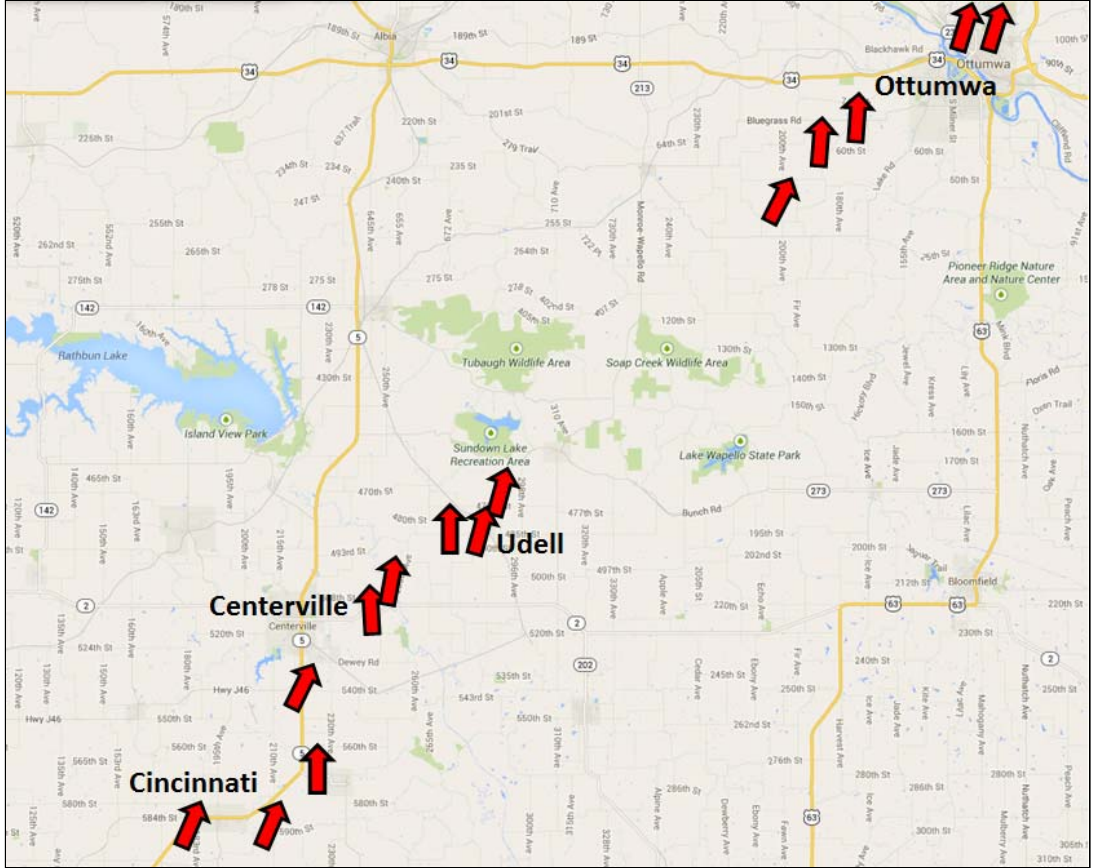
The trail of damage from Cincinnati to northwest Ottumwa was intermittent and broad at best with all of the damage oriented north to northeast (see map below). Old trees and either weak or susceptible outbuildings were the primary targets. One horse barn east of Cincinnati was open to the south and had half of its roof peeled off and deposited 50 yards due north, almost intact. A nearby shed with garage doors facing south had the doors blown in and the roof blown across the street and into a tree due north. The roof was relatively intact. Again, this pattern is very consistent with straight-line winds since there was no convergent debris trail and the buildings failed on their exposed southern sides, which is where the straight-line winds would have been coming from.

**Map of the damage trail found by the survey team from Cincinnati to Ottumwa. The red arrows indicate the direction the debris flew or trees fell.**

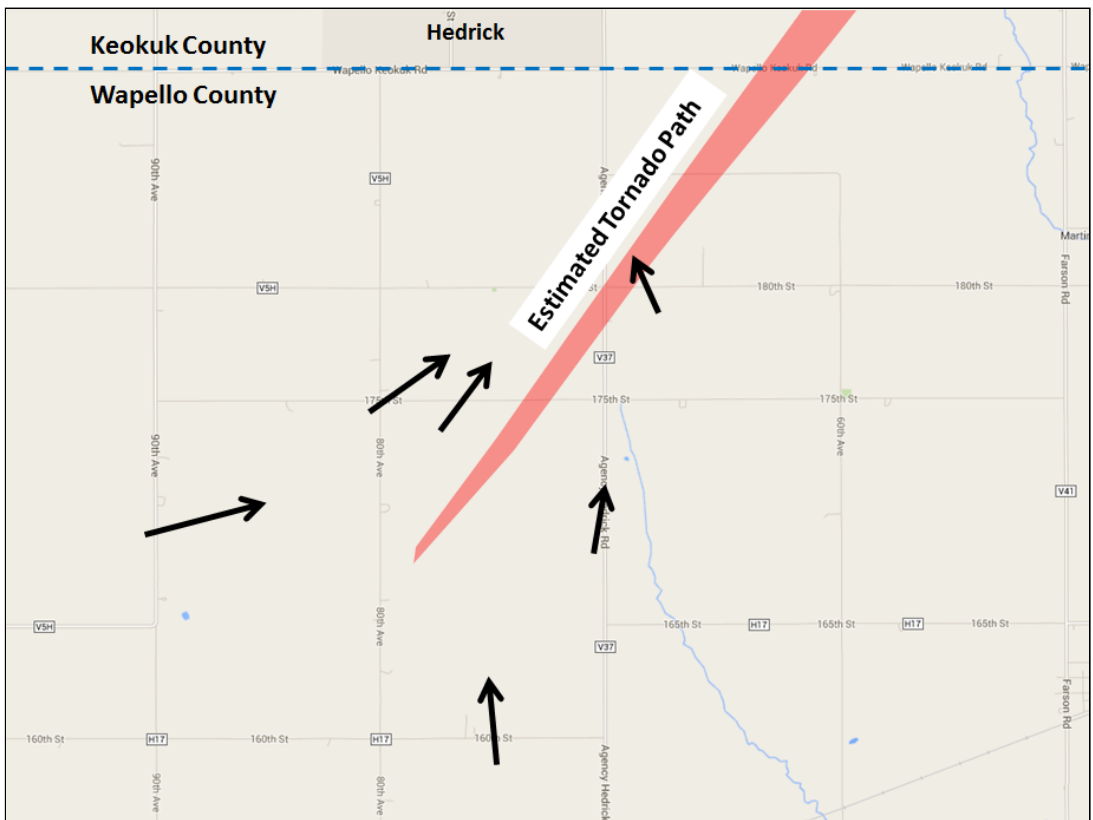
A damage trail was reacquired in far northern Wapello County which possessed several characteristics not observed throughout the survey up to that point, most notably an increase in the concentration of damage and a broad convergent pattern to the debris fields. This was especially noticeable on the southern fringe of the damage with the debris blown just west of due north, while a mile and a half to the northwest, part of a machine shed and a tractor trailer were blown 200-300 yards ENE. To the NE of this point, a grain bin and sections of a hog barn were ripped off and blown in a more NE fashion. Another mile to the NE, two power line poles were bent to the northwest. These wind vectors are plotted on the map below, along with an estimated tornado track based on these fields and an extrapolation of a stronger circulation track that formed as the storm moved into Keokuk County. The derived wind field is missing a strong westward or southward component that would have more firmly solidified the presence of a tornado. However, due to the storm's high rate of speed of 60 mph and the fact that the tornado was embedded in southwesterly straight-line winds of 60-70 mph may have masked this pattern.

**Map of the wind damage patterns near the forming tornado and the estimated tornado path.**
