**Tornado Damage in Tuscaloosa, Alabama,
December 16, 2000**

A report prepared by
Larry J. Tanner, P.E.

Submitted to NIST
May 22, 2001

Wind Science and Engineering Research Center
Texas Tech University
Lubbock, Texas

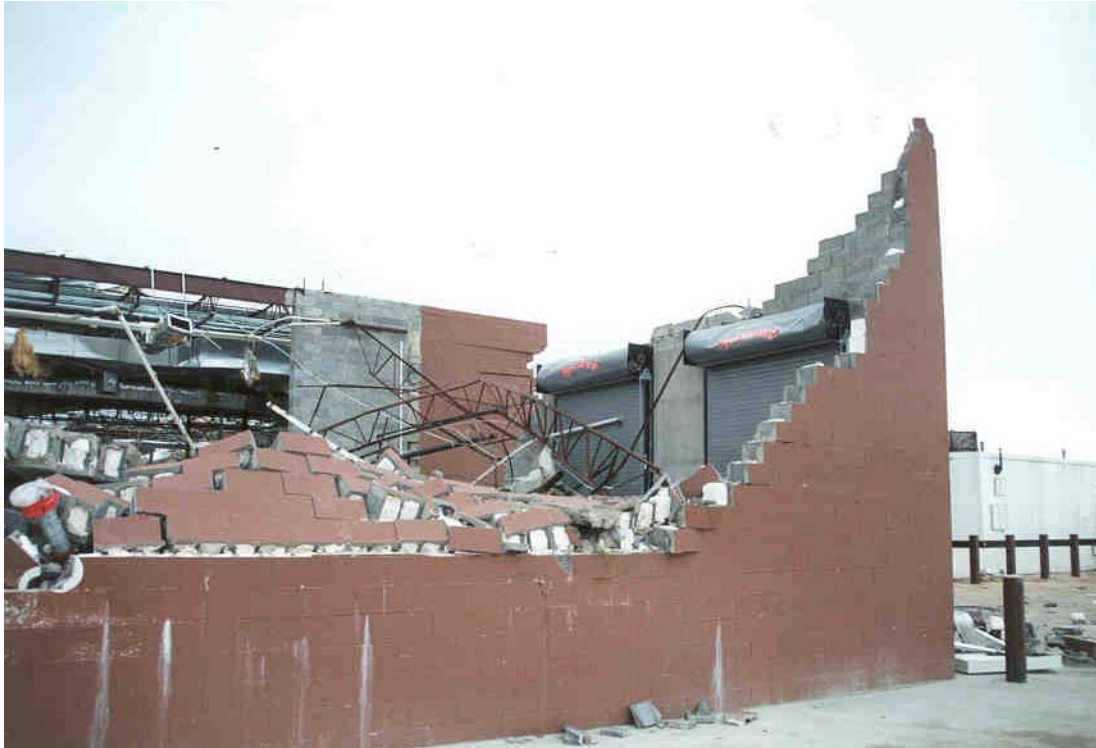
Figure 6. Englewood Village Market Place, internal pressurization

The shopping center building was under construction and was nearly complete; however, the window wall systems had not been installed. Therefore, for wind analysis purposes, the building would be considered as a partially enclosed structure. The wind forces acting upon the structure would have included both external and internal pressures. The combination of these forces tore the decking from the joists, thereby snarling the light steel structural elements and pulling down the URM walls. Further evidence of the internal pressurization is shown in Figure 6. The rolling doors, which would have experienced windward external forces, remained in place due to the negating internal pressures, while the roof deck experienced the combination of internal and external

pressures and was subsequently removed. Per ASCE-7, the internal pressure coefficient for a partially enclosed building would have increased the total roof uplift pressures by about 67%, thereby producing failure at a lower than expected wind load. Therefore, failure of the URM building, as predicted by the scale for an F3 storm, would have occurred at a much a lower wind speed, similar to an F1 or F2 storm.
