**NCHRP REPORT 350 TEST 4-10 OF THE
ALASKA MULTI-STATE BRIDGE RAIL**

Research Project 404311-1
Contract No. T97232

December 1998

**TEXAS TRANSPORTATION INSTITUTE
THE TEXAS A & M UNIVERSITY SYSTEM
COLLEGE STATION, TEXAS**

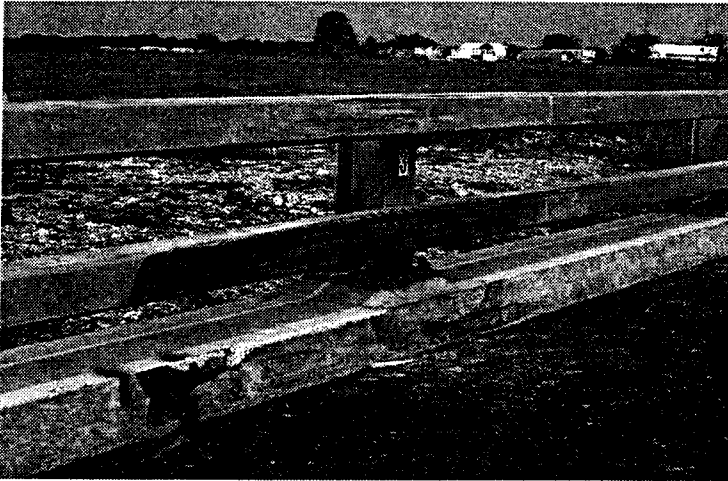
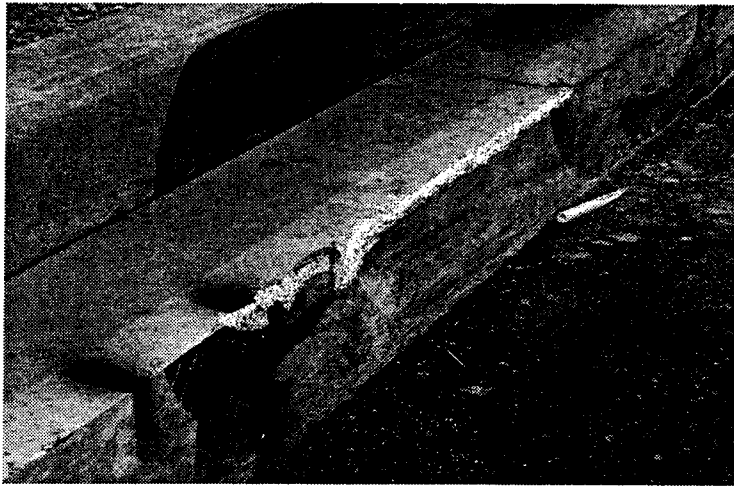
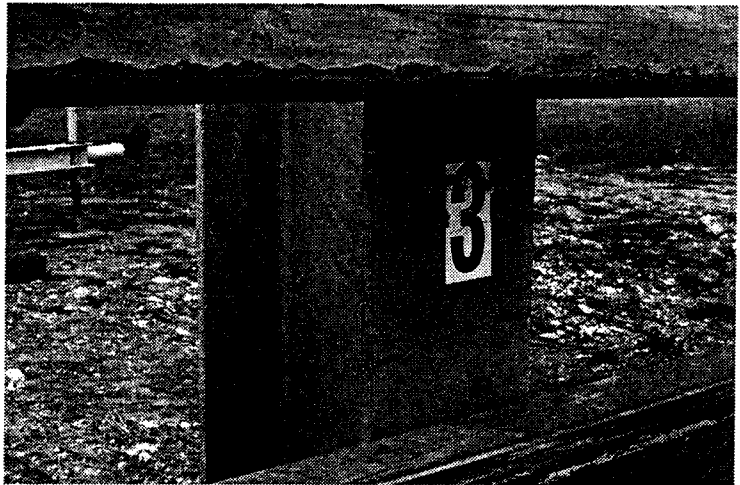
Figure 8. Installation after test 404311-1.

Damage to the Alaska Multi-State Bridge Railing mounted on the curb is shown in figures 7 and 8. At impact the edge of the curb was scraped, and tire marks were along the face of the curb. The front face of post 3 was marred with red paint from the vehicle and the curb was chipped. Cosmetic damage with no measurable deformation occurred to the rail elements. The top rail was contacted, but did not move. Total length of contact of the vehicle with the bridge railing was 4.5 m.

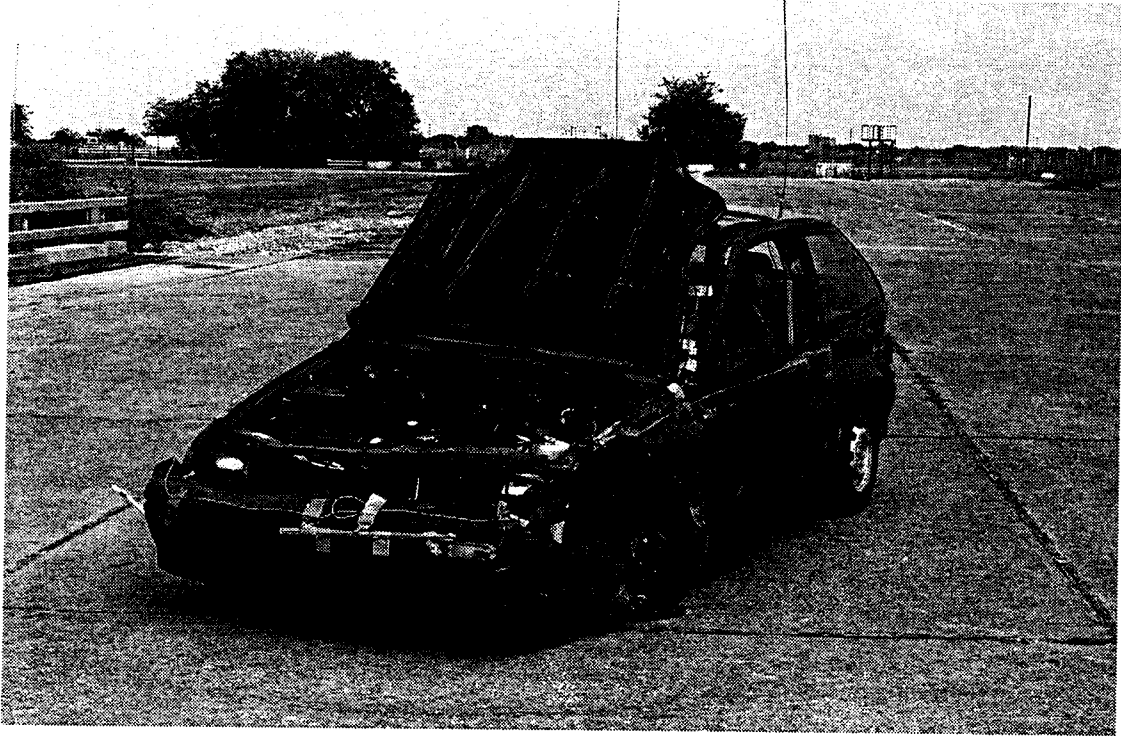
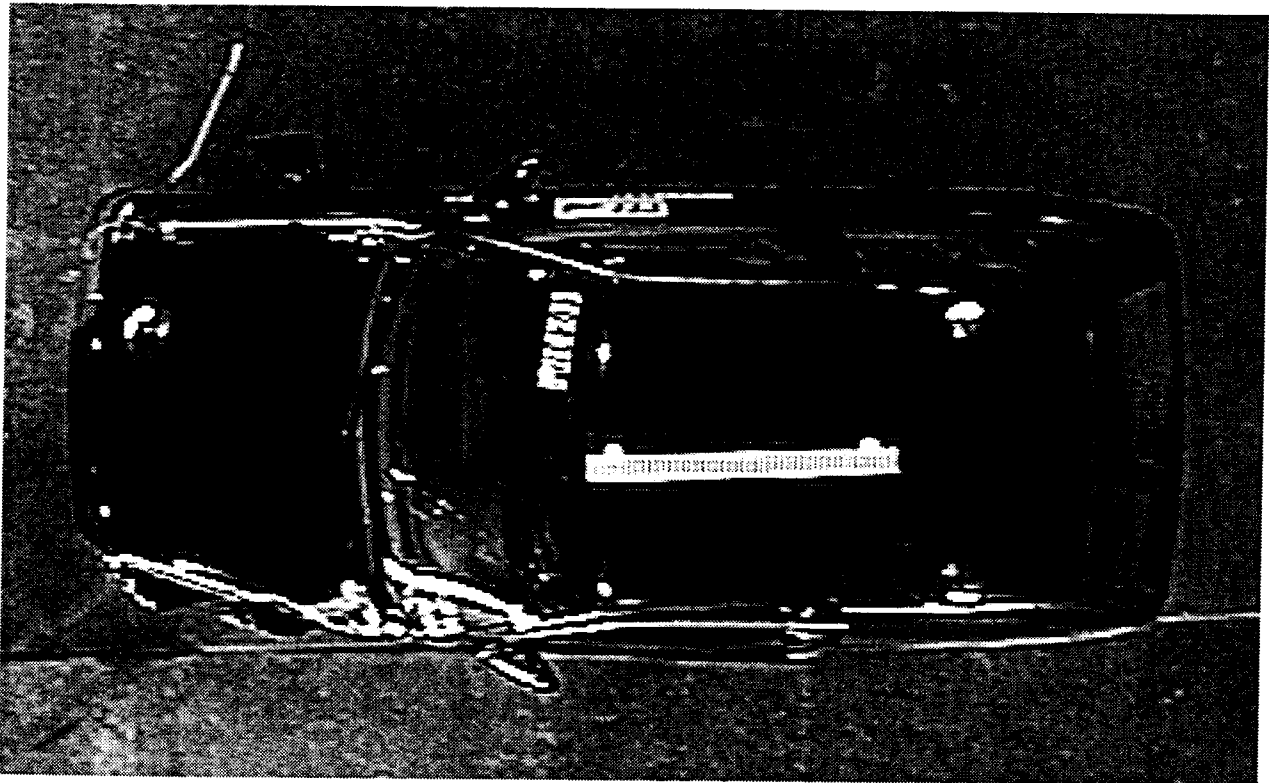
Figure 9. Vehicle after test 404311-1.

The vehicle sustained structural damage on the front left and left side. The left strut, CV joint, A-pillar and A-arm were severely damaged. The front left portion of the bumper, hood, grill, fan, radiator, left front tire and wheel were deformed as shown in figure 9. The windshield was shattered on the driver's side and the left front and rear quarter panels were deformed. The roof was buckled between the A and B pillars and deformed downward 20 mm. The maximum exterior crush to the left side of the bumper 700 mm above the ground was 200 mm. Maximum deformation of the occupant compartment was 47 mm (4 percent reduction in space) in the driver's side door, 36 mm (5 percent reduction in space) in the left firewall area and 30 mm (10 percent reduction in space) in the left floor pan area. The interior of the vehicle is shown in figure 10. Exterior vehicle crush and occupant compartment measurements are shown in appendix C, tables 3 and 4.

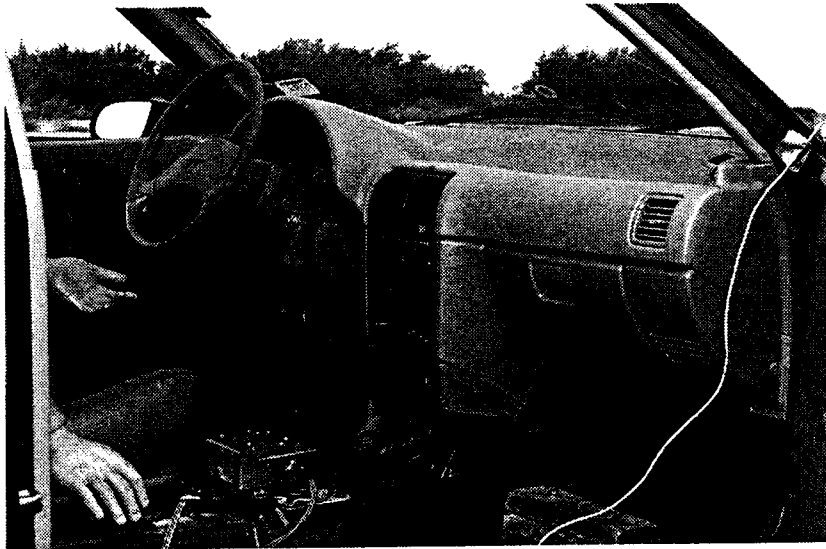
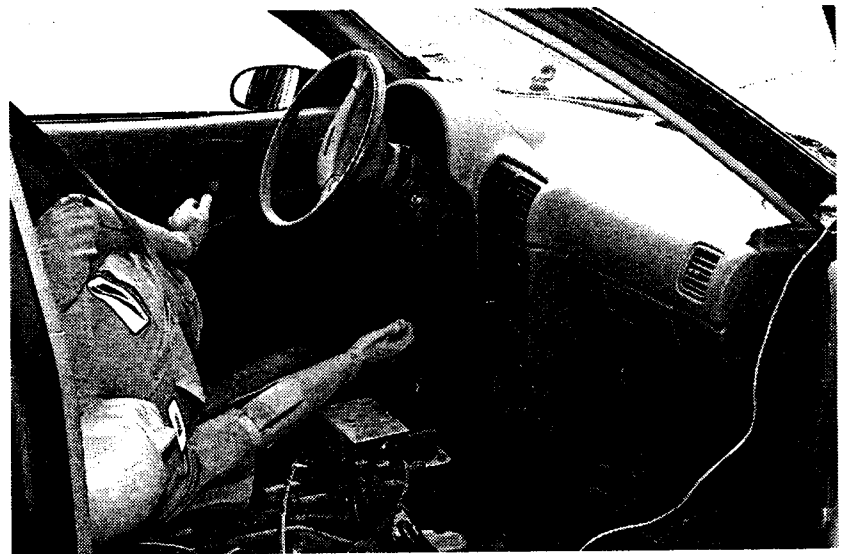
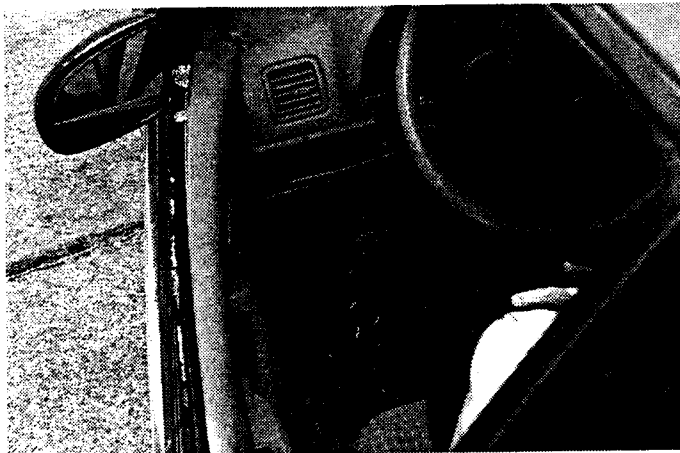
Figure 10. Interior of vehicle for test 404311-1.

No detached elements, fragments or other debris from the test article was present to penetrate or to show potential for penetrating the occupant compartment, nor to present undue hazard to others in the area. Minimal deformations occurred to the occupant compartment and were judged to not cause serious injury.
