POSTFLIGHT EVALUATION OF ATLAS-CENTAUR AC-5

(Launched March 2, 1965)

Lewis Research Center

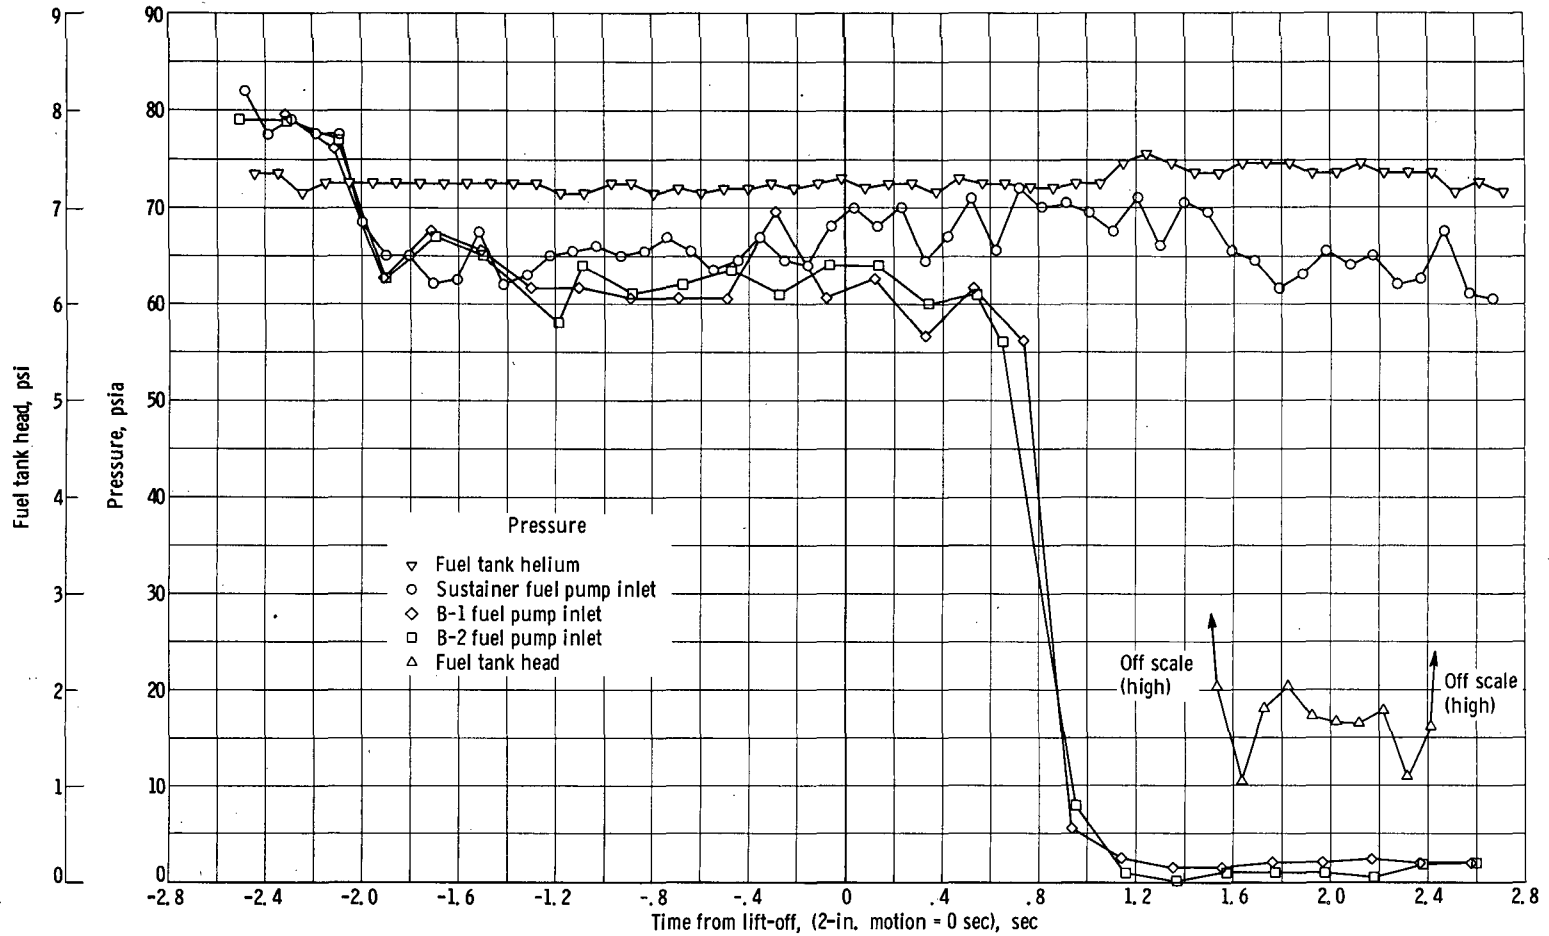
Duct blockage. - Hardware inspection of the pertinent areas uncovered no obstruction considered adequate to block fuel flow. It is highly doubtful that a foreign object could have so completely terminated flow as to result in the rapid pressure decay indicated in figure V-2.

Figure V-2. - Atlas fuel pump inlet and tank pressures as function of time from AC-5 flight data.

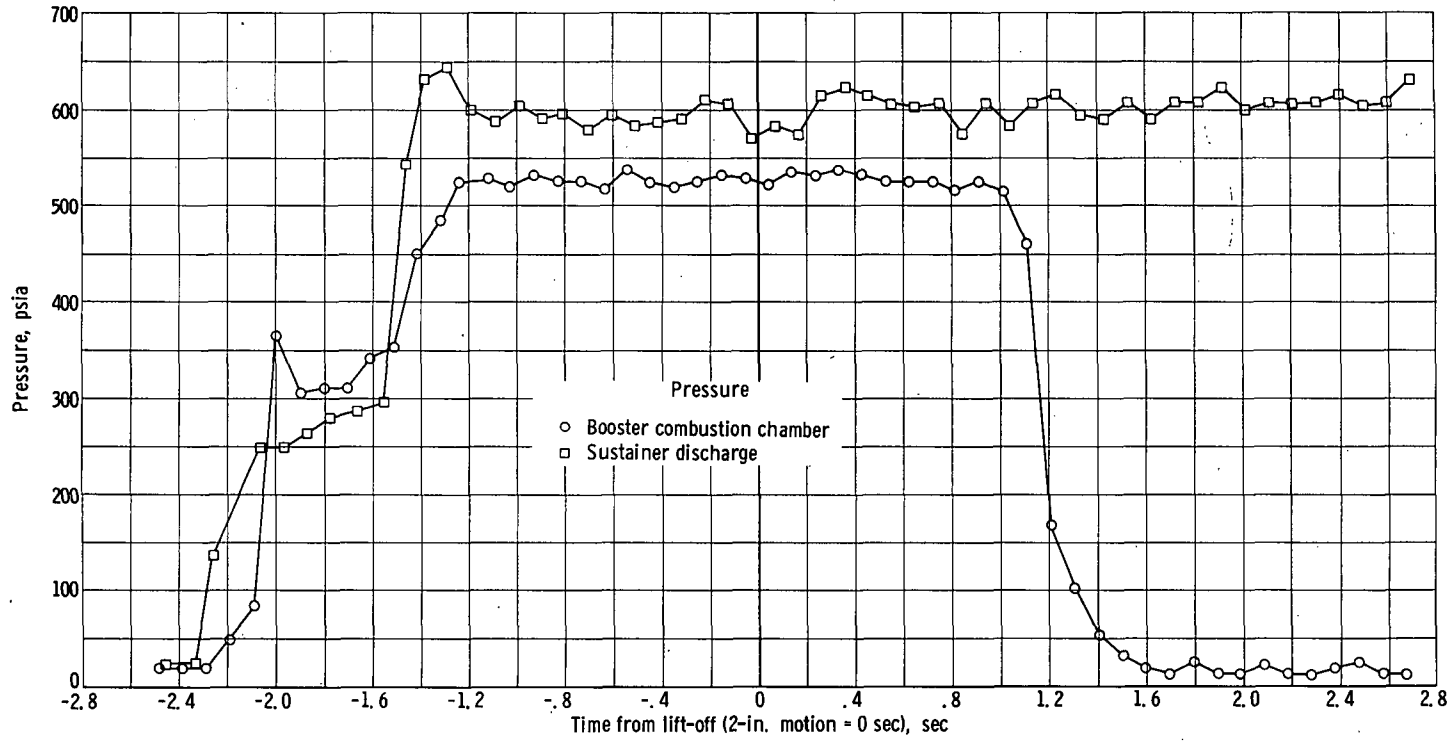
The booster gas generator chamber pressure (fig. V-4) was 515 psia at 1.0 second and decayed to 30 psia by 1.5 seconds. The gas generator should have reverted to start tank operation but did not. For gas generator operation the gas generator blade valve is in the open position. Hardware recovery indicated the blade valve was in the closed position. Two theories have been advanced as to why the blade valve closed. One states that following the loss of fuel at the turbopump inlets, the ducts collapsed severing the electrical connection to the blade valve solenoid control. The other states that the overspeeding of the turbopumps loosened the electrical connections. In either case, the closure of the gas generator blade valve is considered a result of the vehicle failure.

Figure V-4. - Atlas gas generator pressure for AC-5 flight.

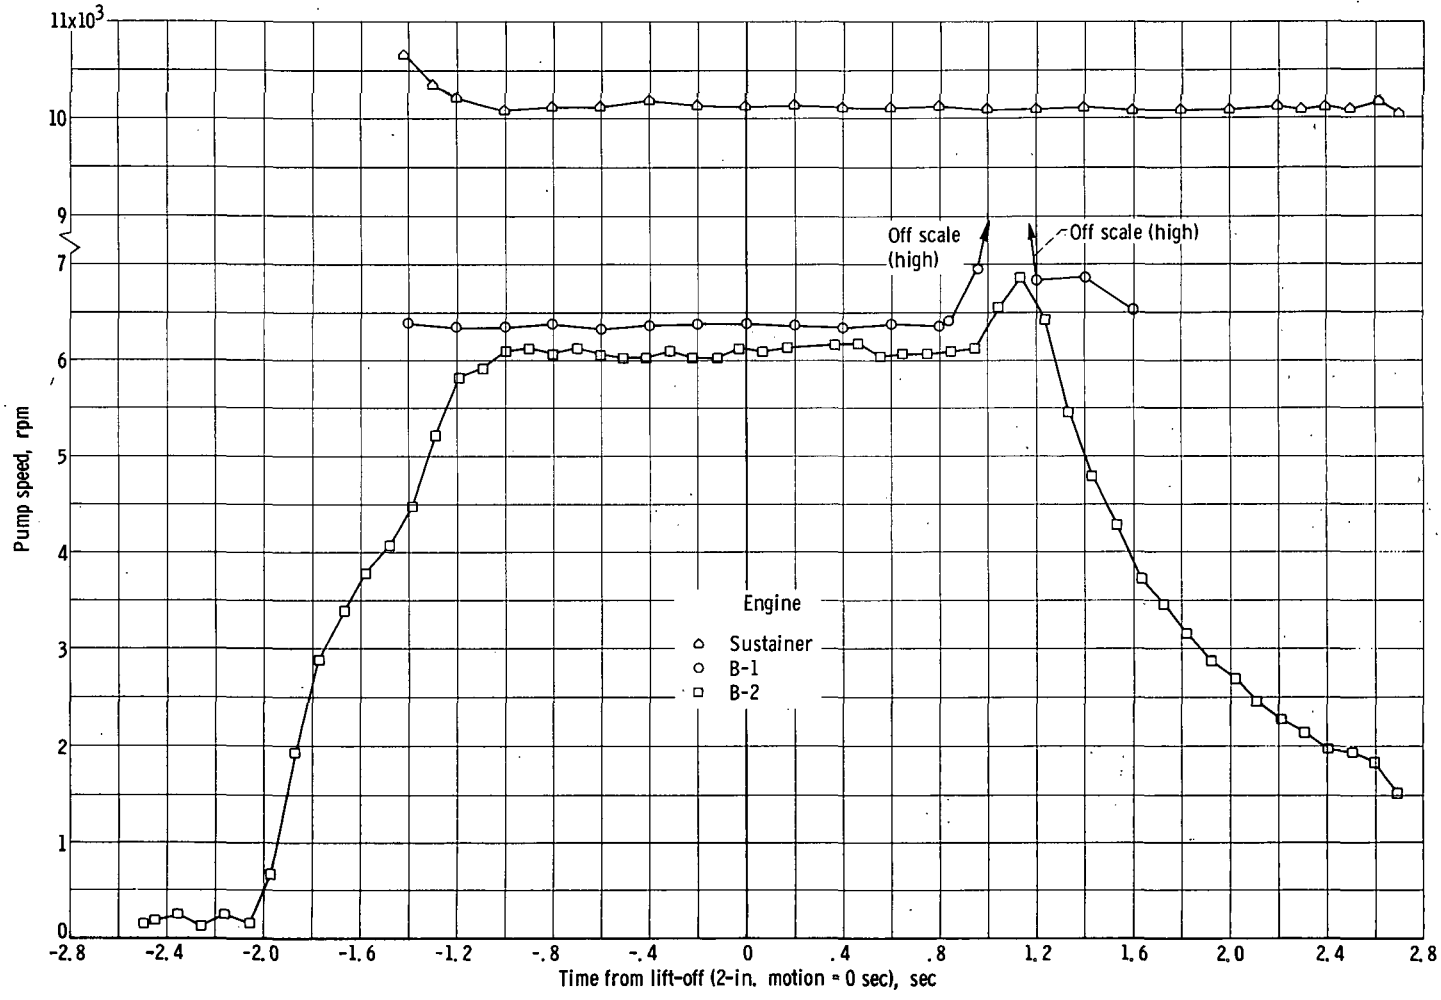
The B-1 turbopump started to overspeed from its normal speed of 6350 rpm at 0.8 second (see fig. V-5). The B-2 turbopump started to overspeed at 0.95 second with a value of 6150 rpm, reached a peak value of 6850 rpm at 1.1 seconds, and decayed to 1500 rpm by 2.7 seconds. The turbopumps initially oversped because the loss of fuel unloaded the system. The only discrepancies in the sustainer system and the booster LOX system performance (fig. V-6) are considered a result of the vehicle failure.

Figure V-5. - Atlas engine rpm as function of time for AC-5 flight.

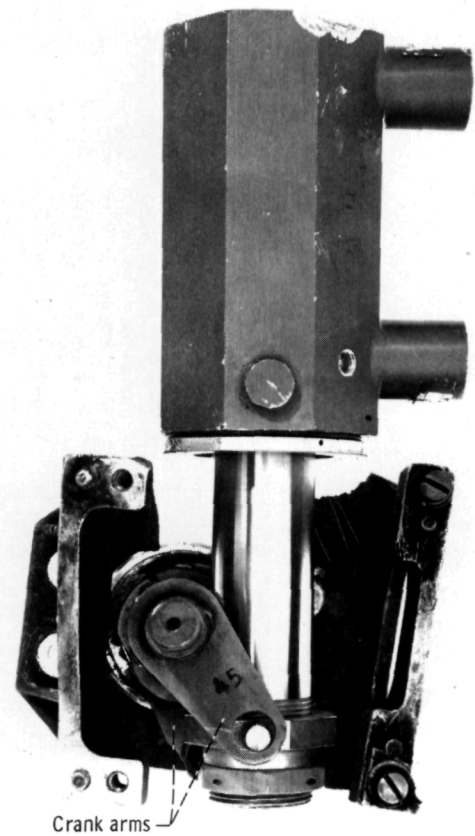
The AC-5 prevalve actuator was recovered, disassembled, and examined for failure analysis. Testing and examination of the components were compared with failure history reports on other actuators. The only significant anomaly was the presence of a foreign fluid behind the actuator piston. The fluid was analyzed and found to be a mixture of RP-1 fuel and "firex" water. Firex water was used to quench the flames after vehicle impact. The fluid is assumed to have entered the actuator following vehicle destruction.

Figure V-9. - Recovered AC-5 actuator and crank arm assembly. (Actuator in the open position).

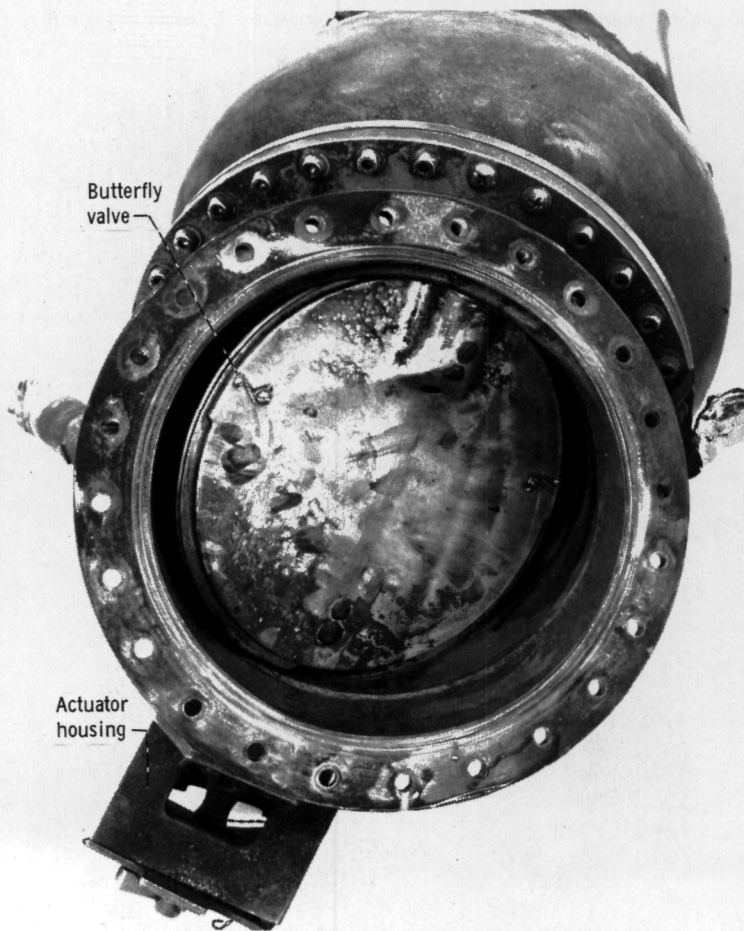
Prevalve. - Examination of hardware after the fire indicated that the pre-valve actuator was unlocked and the butterfly valve was near the closed position. Evaluation of data revealed there was no command given to close the pre-valve. Flow tests indicated the maximum torque that fuel flow can exert on the butterfly valve was approximately 260 inch-pounds. With the prevalve in the locked open position the minimum torque required to cause system failure was de-

Figure V-10. - Recovered AC-5 booster fuel pre-actuator valve (still assembled to staging valve) showing butterfly position.

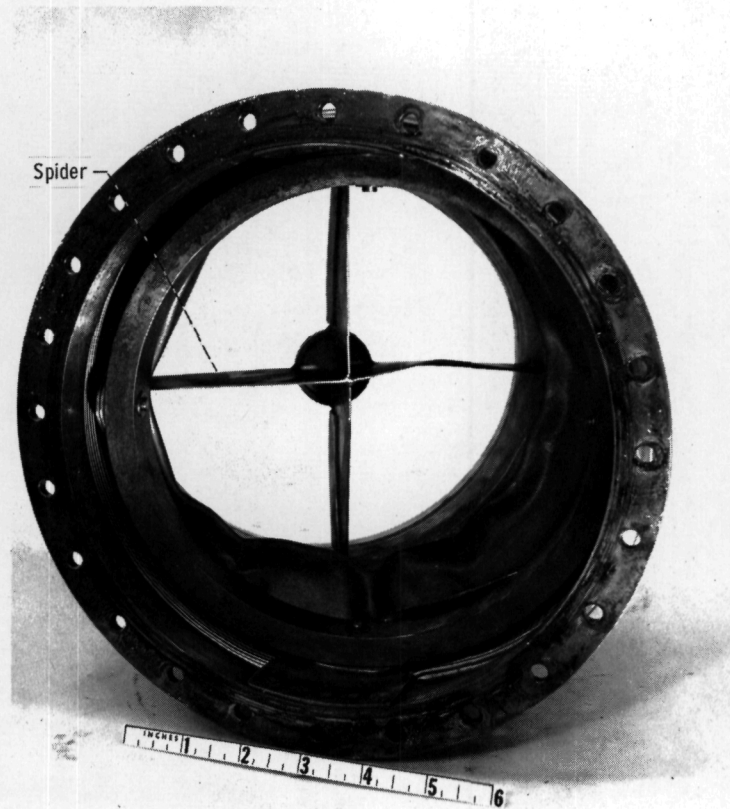
Figure V-II. - Rear view of recovered staging disconnect showing spider still intact.

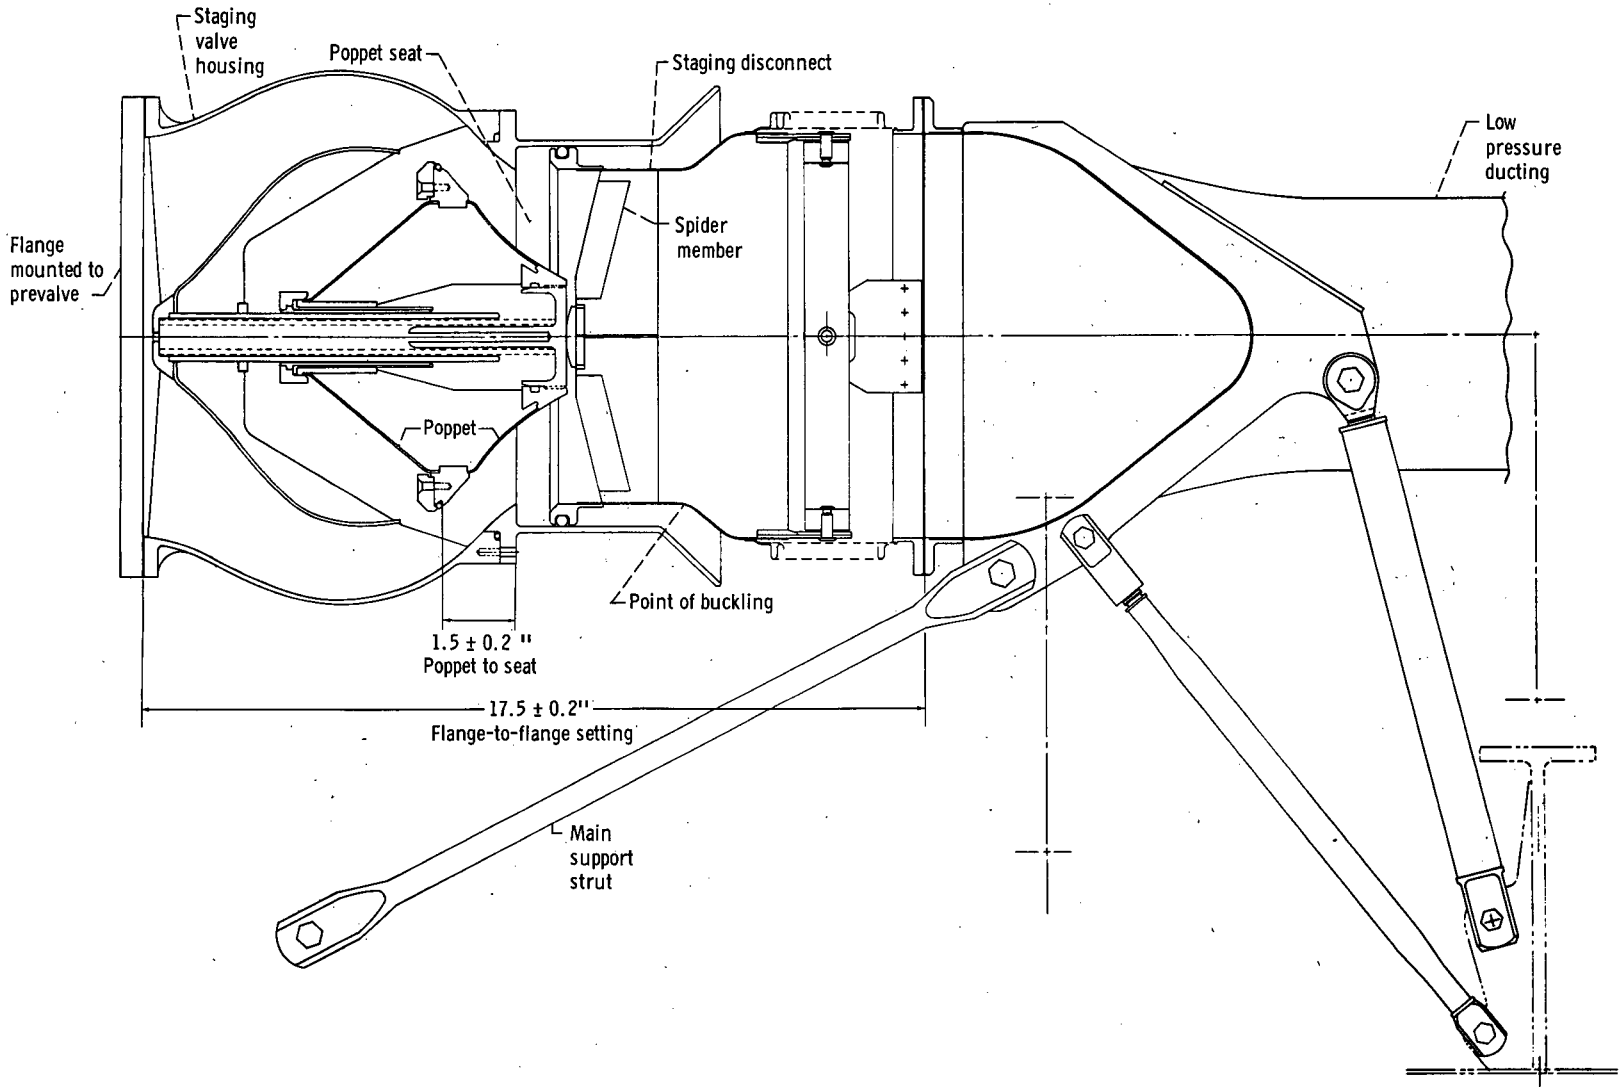
Closure of the staging valve can be accomplished by buckling of the spider member, buckling of the staging disconnect, failure of the main support, displacement of the booster structure, or combinations of these (see fig. V-12). Results of unpublished GD/C analysis have eliminated displacement of the booster structure alone as a possible failure mode. Investigations have been conducted to evaluate the remaining failure modes.

Figure V-12. - Schematic drawing of Atlas Fuel staging valve and staging disconnect.

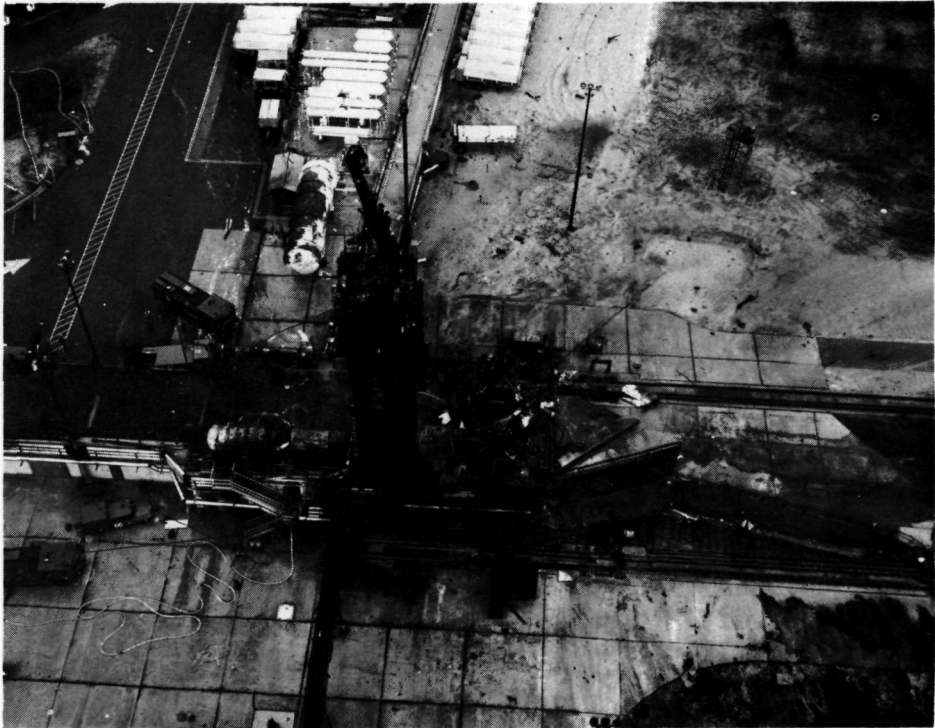
Figure XII-1. - Aerial view showing general damage to pad area.

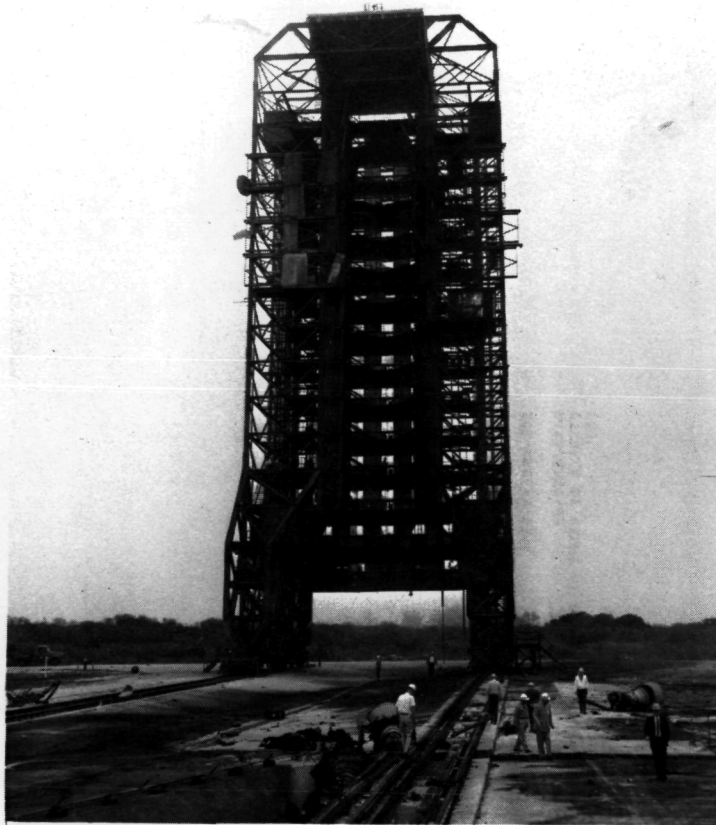
Figure XII-2. - View of service tower showing damage to Fiberglass panels.

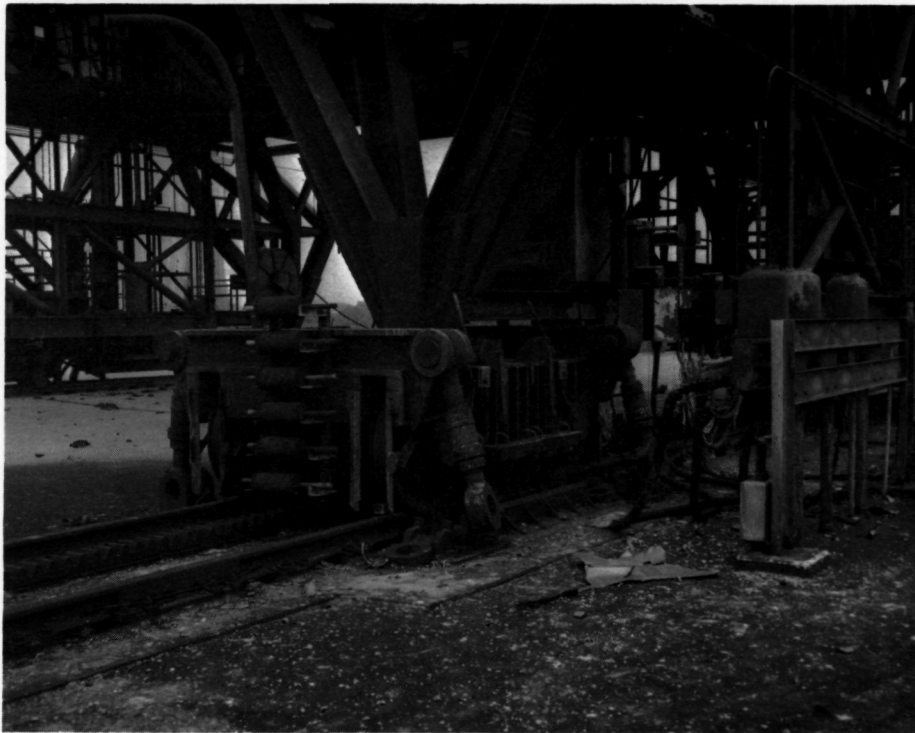
Figure XII-3. - View of southeast corner of service tower showing heat damage to electrical wiring.

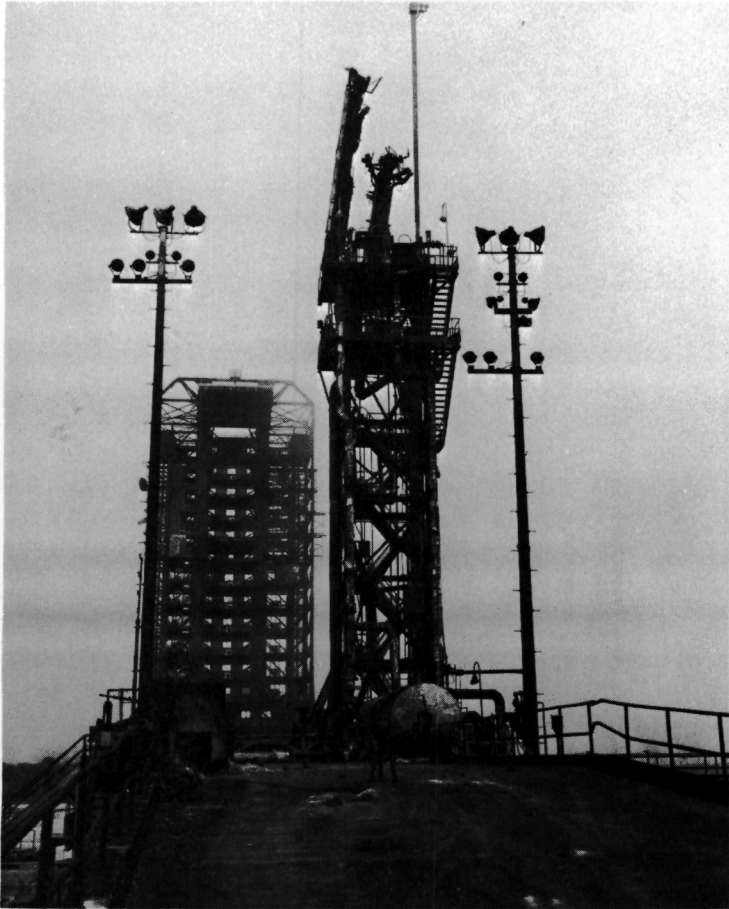
Figure XII-4. - View from ramp showing general damage to umbilical tower.

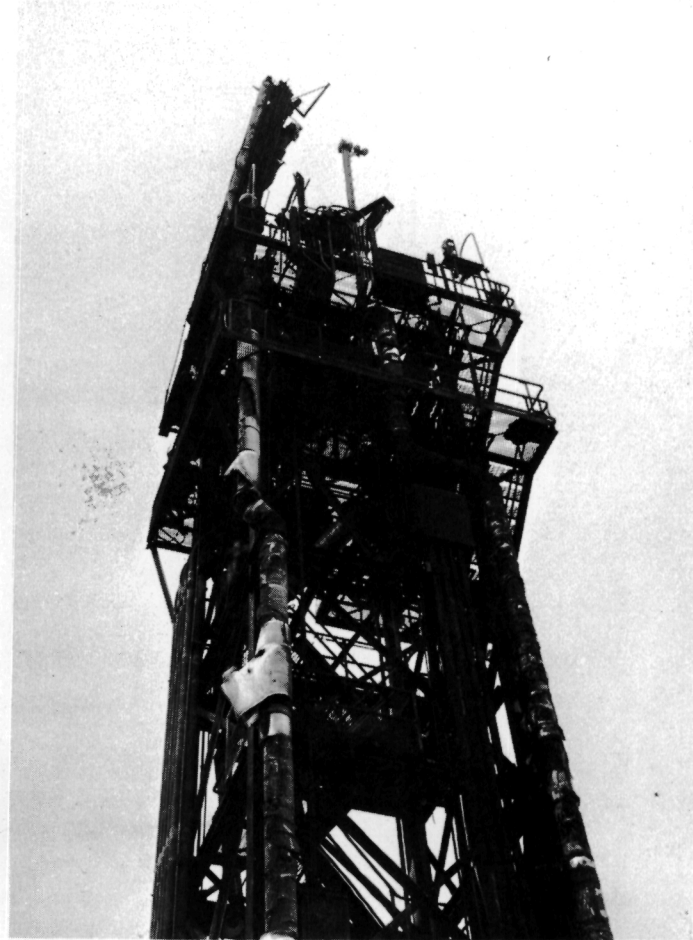
Figure XII-5. - Closeup view of umbilical tower showing damage to air-conditioning ducts.

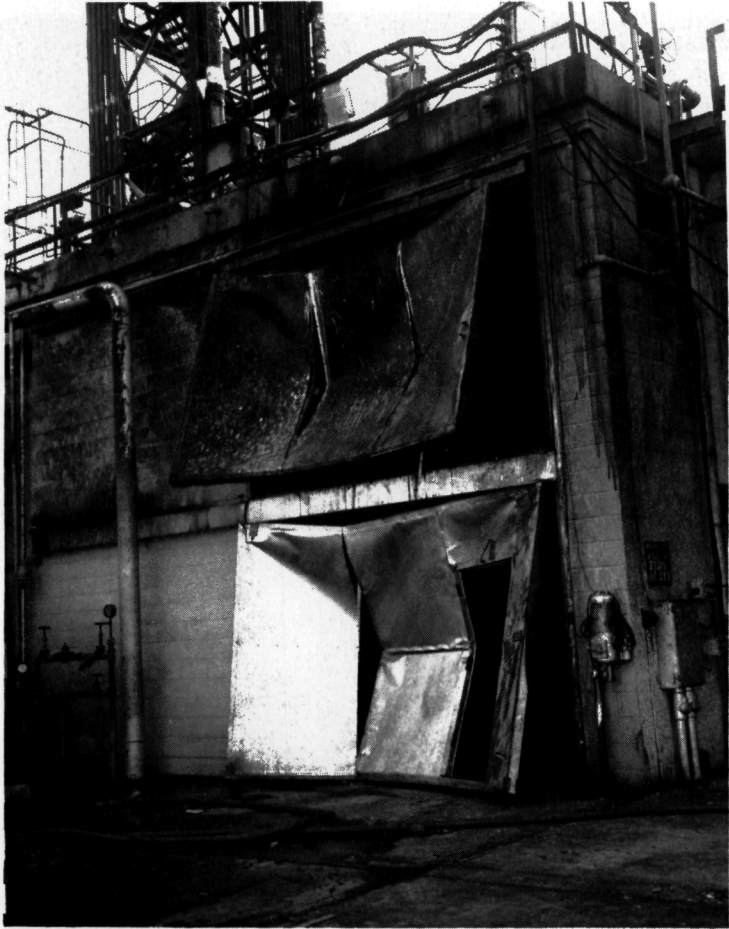
Figure XII-6. - View of launch and service building showing damaged doors.

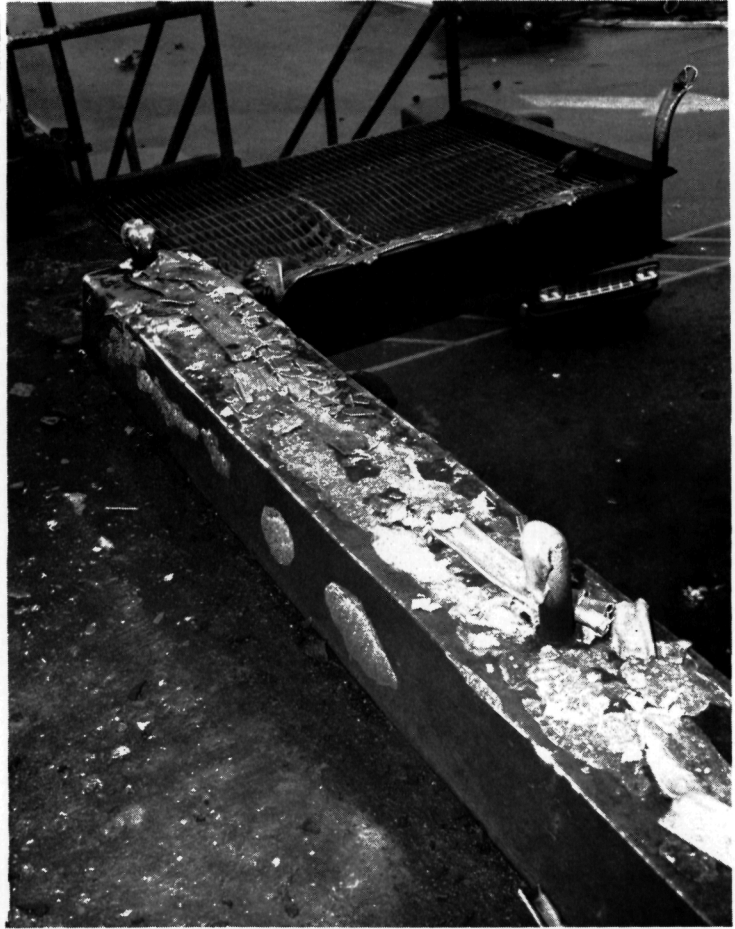
Figure XII-7. - View at top of ramp showing melted aluminum handrails and damage to grating.

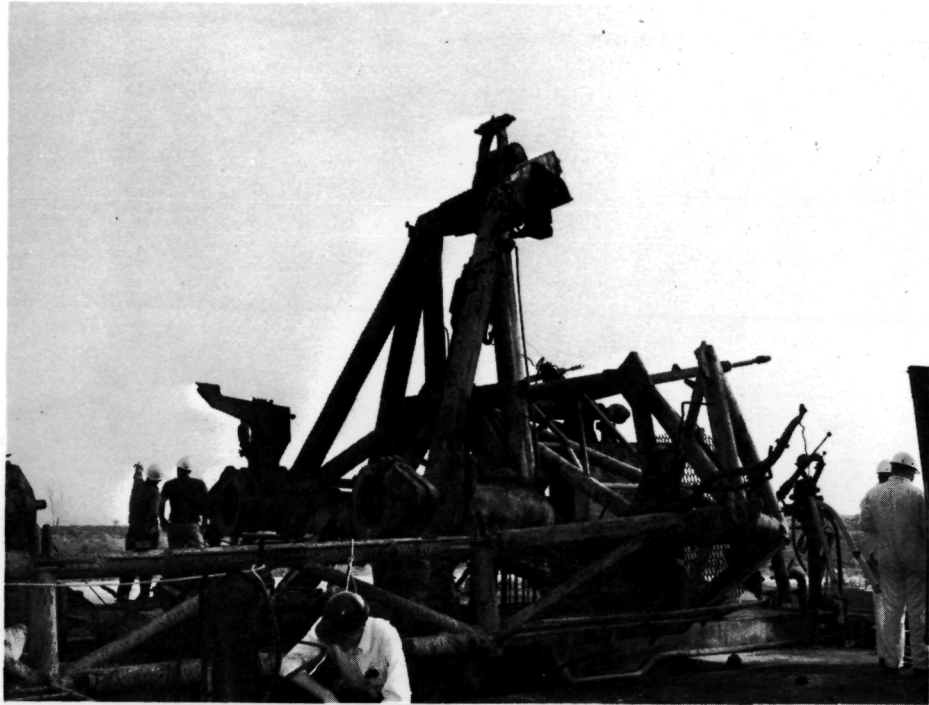
Figure XII-8. - Closeup view of damaged Atlas-Centaur launcher.

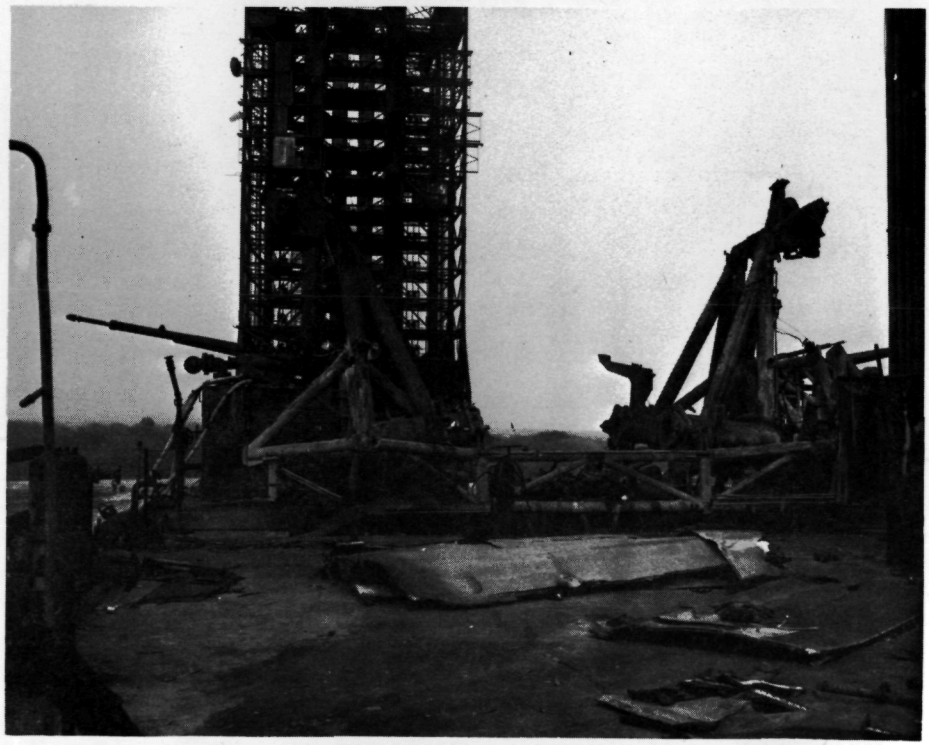
Figure XII-9. - Damaged launcher with vehicle debris in foreground.

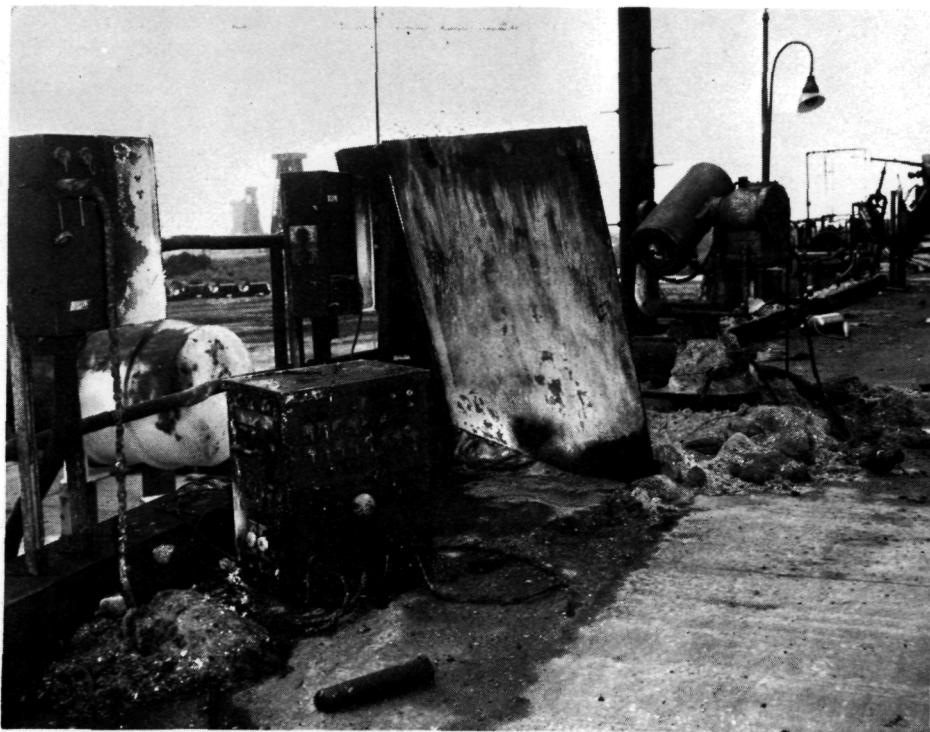
Figure XII-10. - View at top of ramp showing typical destruction of electrical equipment and cameras.
