PB91-910409
NTSB/AAR-91/08

AIRCRAFT ACCIDENT REPORT

RUNWAY COLLISION
OF USAIR FLIGHT 1493, BOEING 737
AND SKYWEST FLIGHT 5569 FAIRCHILD METROLINER
LOS ANGELES INTERNATIONAL AIRPORT
LOS ANGELES, CALIFORNIA
FEBRUARY 1, 1991

**Adopted: October 22, 1991
Notation 5461A**

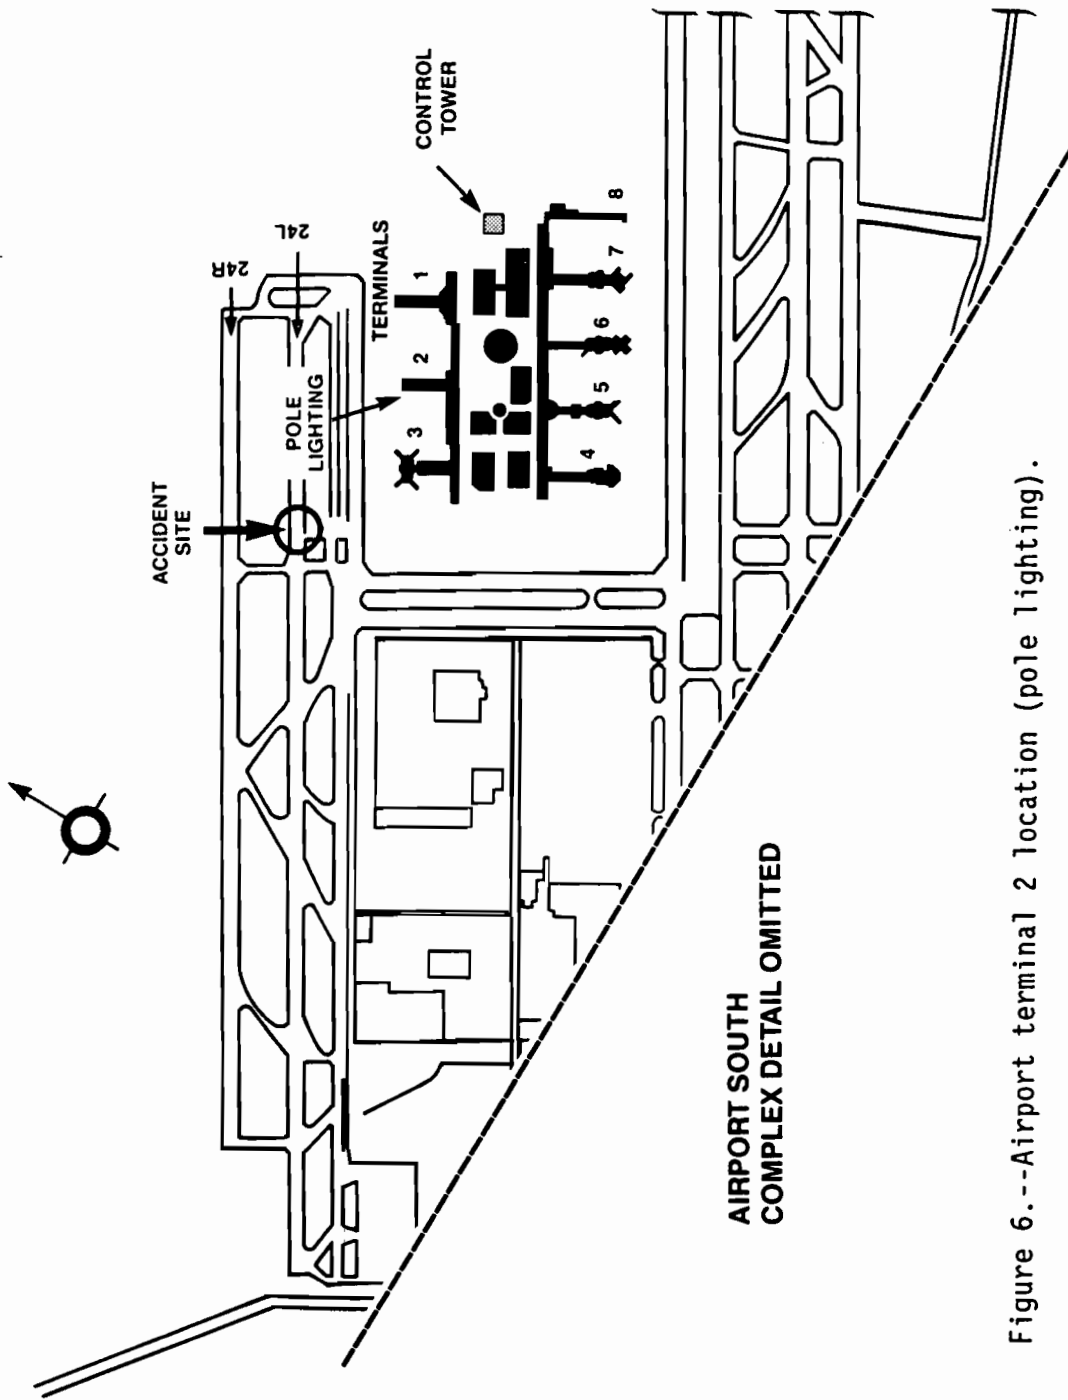
Figure 6.--Airport terminal 2 location (pole lighting).

During interviews, tower personnel stated that a series of four ramp lights on the northernmost portion of the Terminal 2 complex were a restriction to vision during the hours of darkness because of their height, brightness, and relative line-of-sight location to taxiways 45 and 47 and runway 24 left.

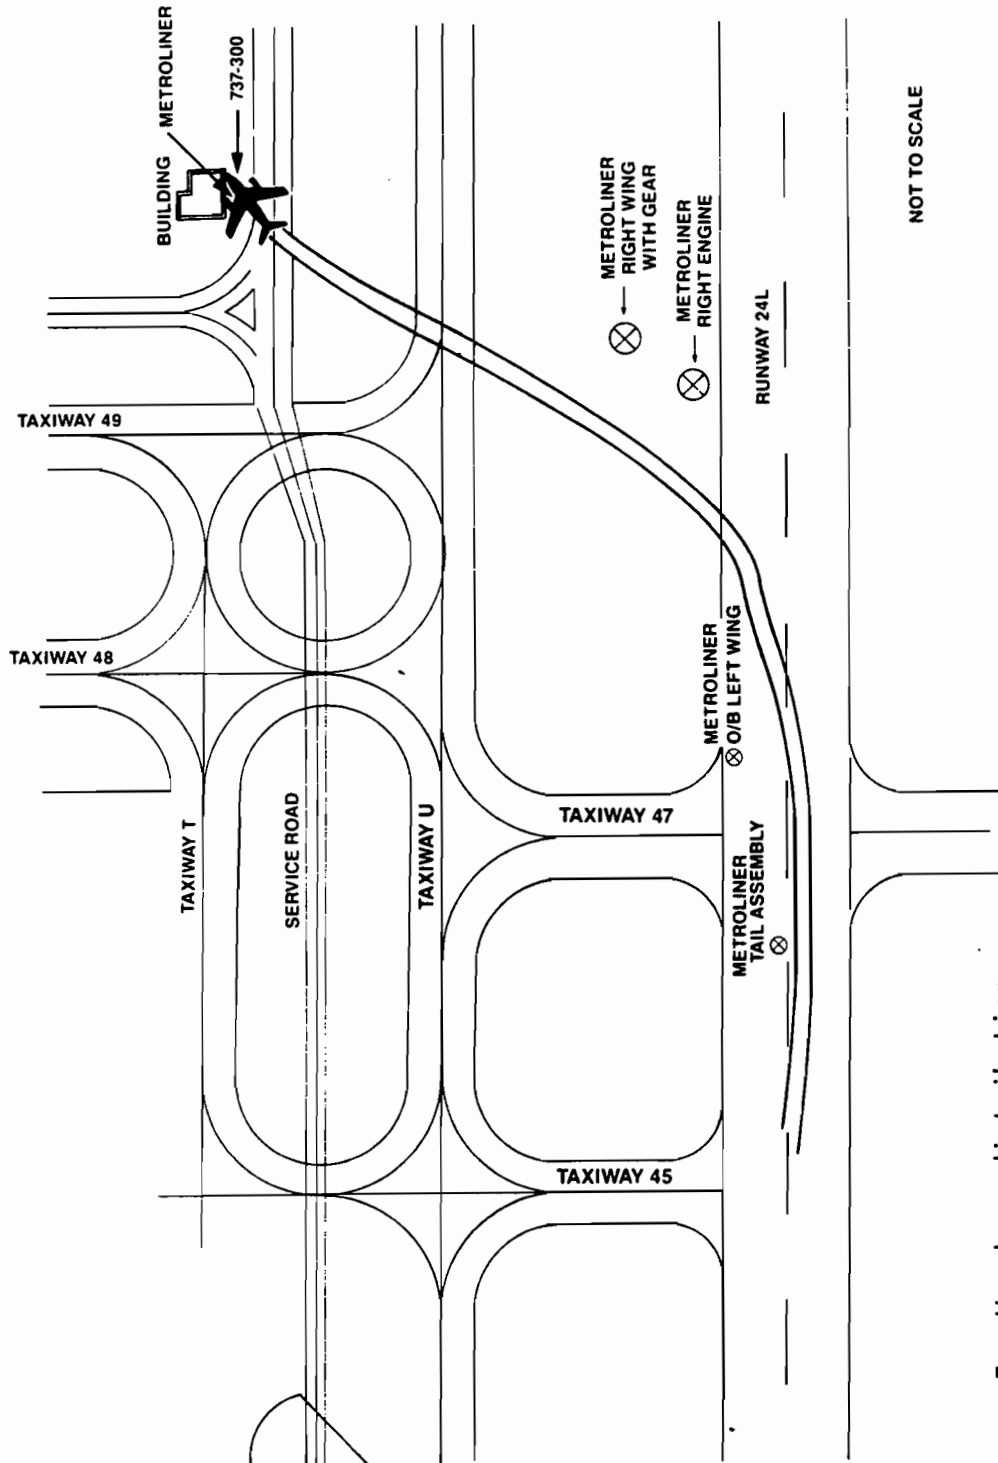
Figure 7.--Wreckage distribution.

The empennage with the vertical stabilizer, rudder and left horizontal stabilizer were located approximately 240 feet from the initial impact location. The left wing section outboard of the engine was located at the intersection of taxiway 47 and the runway. The right wing separated at the root and was found, with the right landing gear attached, between the runway and taxiway Uniform.

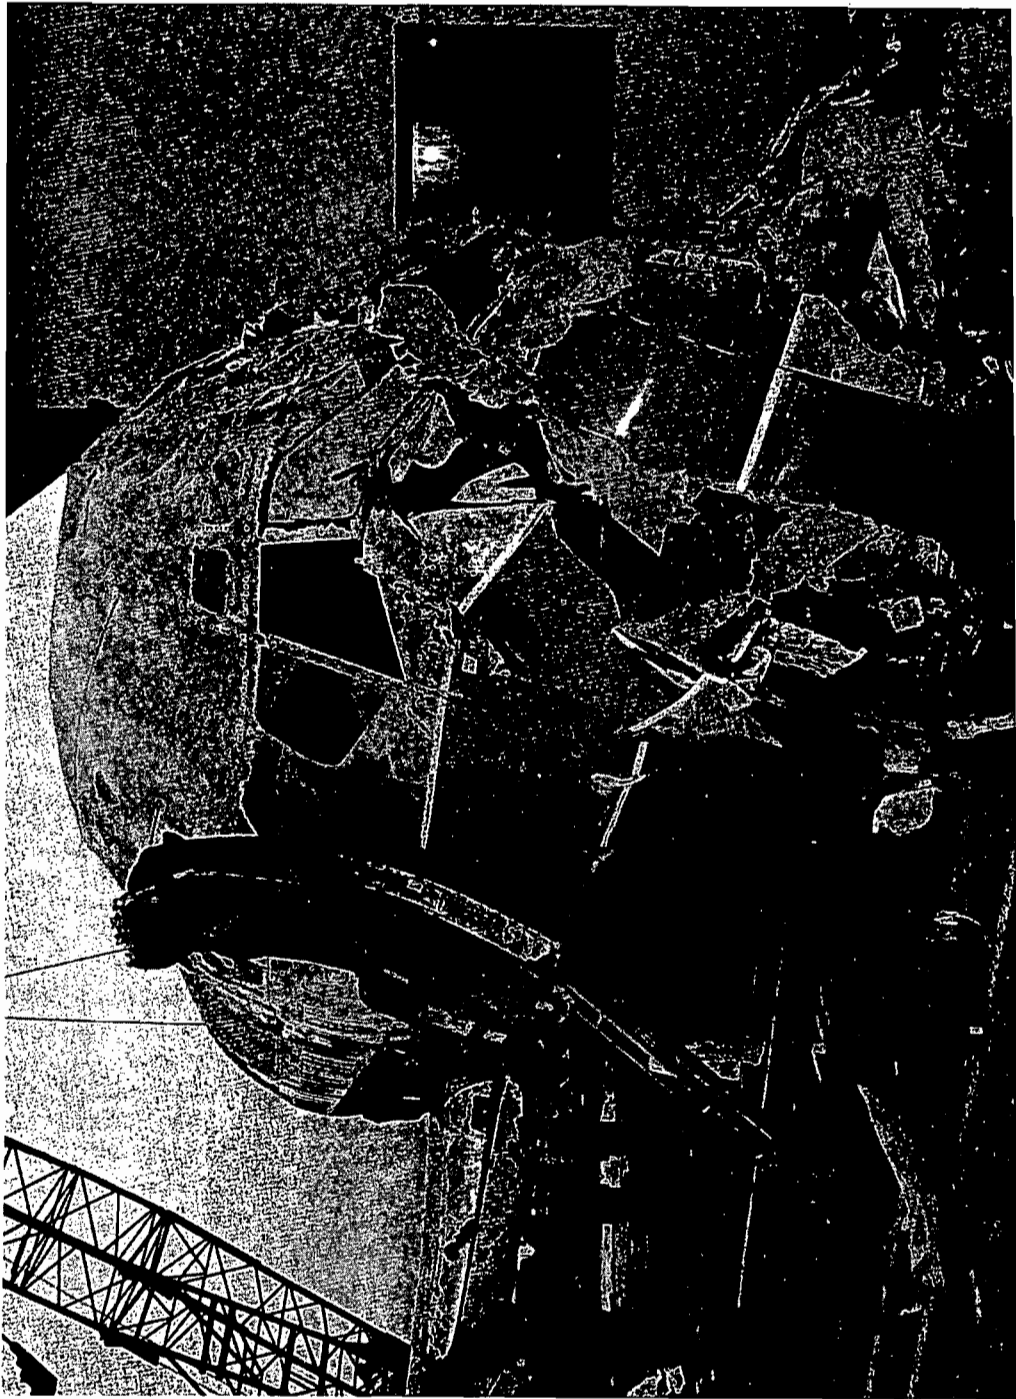
Figure 9.--Damage related to building impact.

The burned area in the top of the B-737's fuselage was in the forward cabin between the first-class and coach sections. Interior fire damage in this area was extensive. The right forward area of the forward cargo compartment, including the cargo liners, the cargo floor, and the cabin floor, was also severely damaged by fire. Several small holes in the right side of the fuselage below the floor line indicated inward penetrations and fire damage. This area also housed the crew oxygen cylinder, which was found loose. The cylinder contained heavy amounts of soot, except for the area of an attaching strap. The pressure gauge and regulator were extensively fire damaged, and the overpressure and supply lines were broken (See section 1.16.2 for further information).

Soot and fire had damaged both sides of the fuselage exterior from the forward area to the break in the fuselage aft of the wing. The most severe fire damage was on the left side of the fuselage around the wing, where much of the skin below the window line had burned through.

The top of the fuselage was also burned away from just aft of the wing to the aft doors. The fuselage along the floor beams was still attached near the fuselage break aft of the wing. However, the entire tail section drooped to the ground.

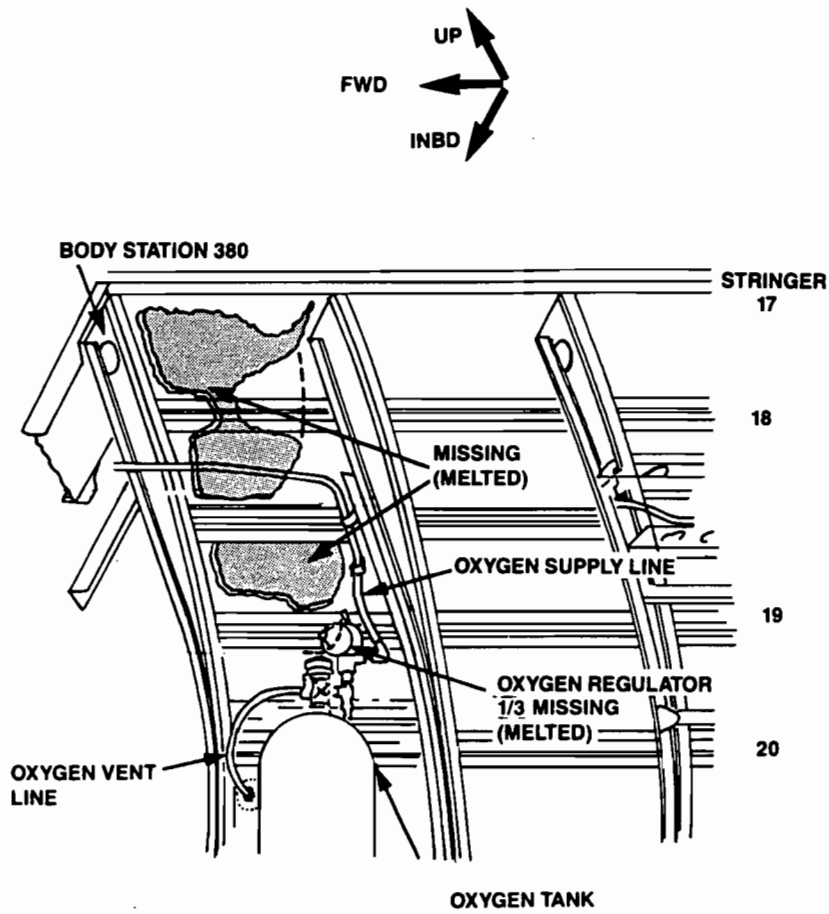
Figure 12.--Fuselage damage/crew oxygen system installation.

The fuselage skin near the oxygen system installation was damaged mechanically, prior to high temperature exposure.
