December 18, 2023

MIR-23-27

Collision between Containership *MSC Rita* and Fishing Vessel *Tremont*

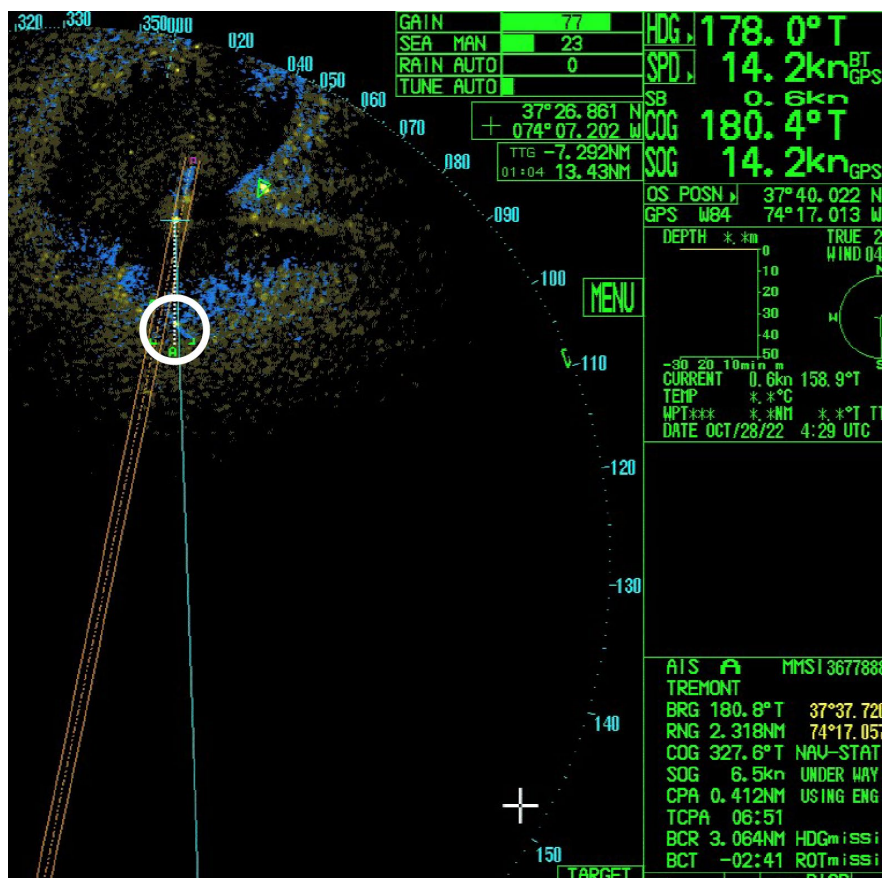
At 0029, the *Tremont* passed ahead of the *MSC Rita* at a distance of 2.3 miles (see figures 3 and 4). At 0032:20, however, while 1.3 miles away on the containership's starboard bow, the *Tremont* turned back to starboard toward the *MSC Rita* on a course of about 080°. The *MSC Rita* lookout (an able seafarer) told investigators he saw a green light, then both sidelights, then just a red light on the *Tremont* at this time. The second officer told investigators he sounded a whistle

Figure 3. *Tremont* (circled in white) crossing ahead of *MSC Rita* at 0029:17 as seen on the containership's X-band radar. (Source: *MSC Rita*)

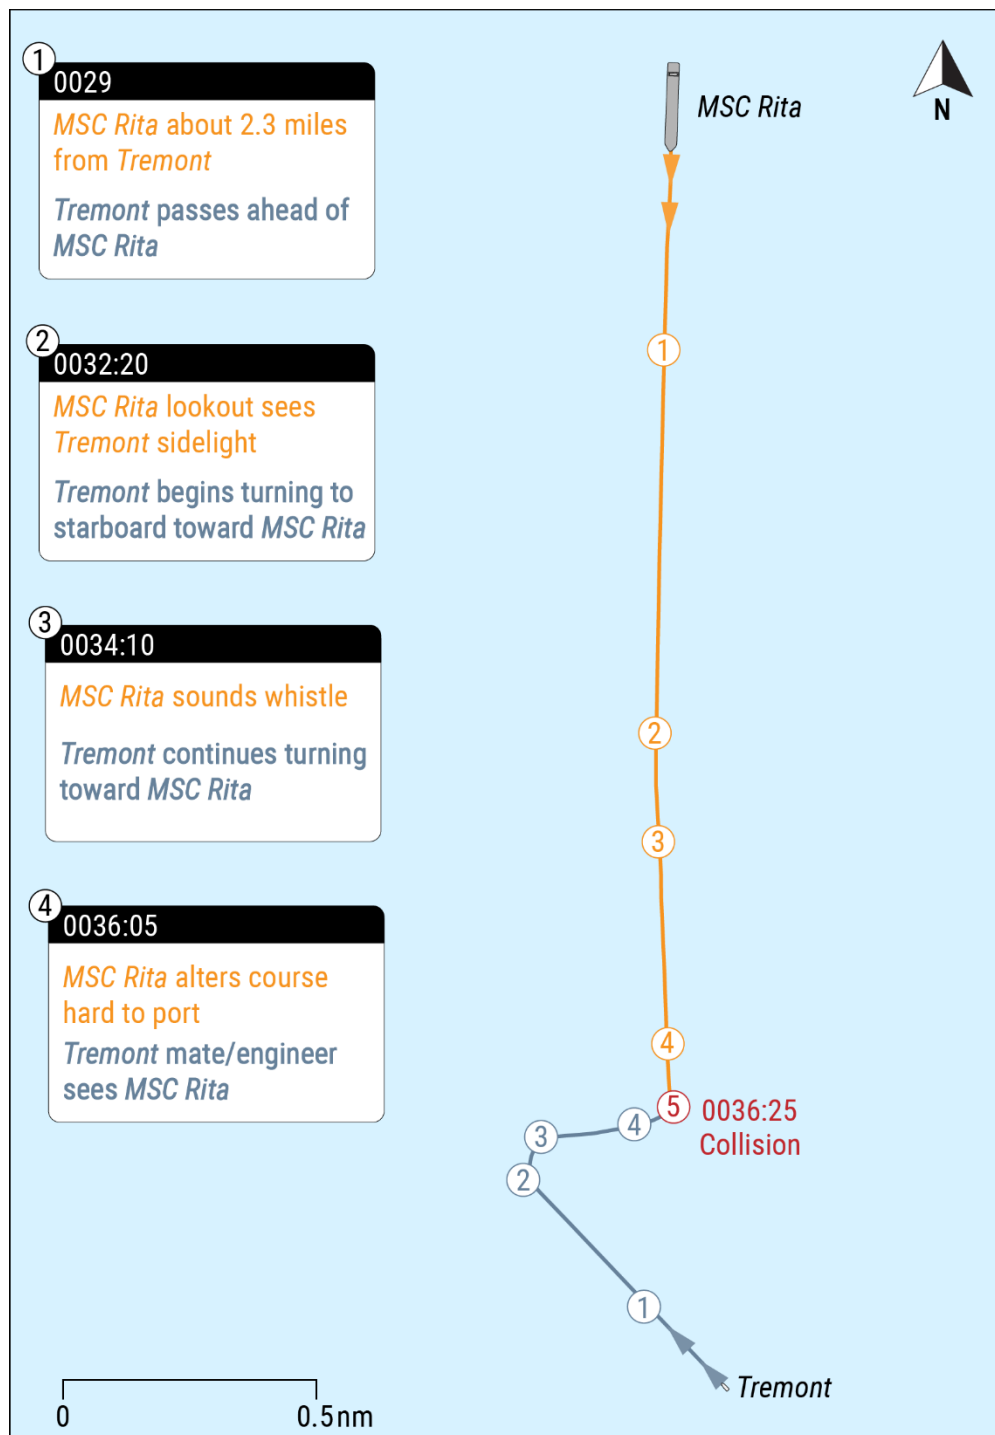
Figure 4. *Tremont* (blue) and *MSC Rita* (orange) tracklines leading up to the collision.

While the containership *MSC Rita* was transiting southbound in the Atlantic Ocean, southeast of Chincoteague, early in the morning, the fishing vessel *Tremont* was transiting north-northeast in the same area. Shortly after the *Tremont* passed ahead of the *MSC Rita*, the *Tremont* suddenly turned back toward the containership. At that time, the mate on board the *Tremont* was operating the vessel and attempting to fix the vessel's gyrocompass, which the captain stated had been off by 10° since 4–5 days into the trip (investigators were unable to determine what was wrong with the gyrocompass). As he worked to fix the gyrocompass, the mate left the vessel's autopilot engaged. The *Tremont's* autopilot required heading feedback from the vessel's gyrocompass and a user to input the heading setpoint (desired course). As a result of this heading feedback and user input, the *Tremont's* autopilot then output the calculated rudder commands to correct any heading deviation. The amount of rudder used was a function of heading setpoint deviation, the rate of change in the deviation, and the mean deviation. Therefore, as the mate adjusted the gyrocompass to troubleshoot the cause of its error, the autopilot processed the heading feedback, causing the vessel to turn to starboard and toward the *MSC Rita*, striking the containership on its starboard bow.

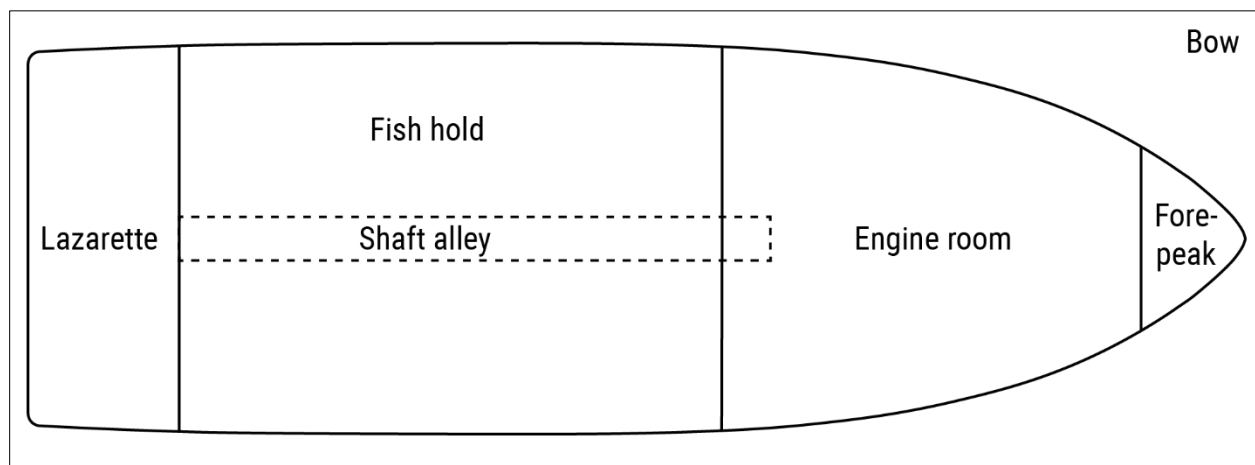
Below the main deck on the *Tremont* was a forepeak, the engine room, a single fish hold, and the lazarette. There was no access to the forepeak from the engine room. The mate recalled that a bilge alarm for the shaft alley, which ran below the fish hold, sounded. Sea water later flooded the engine room.

Figure 5. *Tremont* below-deck general arrangement. (Background source: Tremont Fisheries, LLC)

The collision resulted in hull damage to the *Tremont* on its port side and bow. The crew found water in the engine room, a bilge alarm went off in the shaft alley, and within 10 minutes of the collision, flooding was found to have reached the main deck above the fish hold. The crew did not determine the source of the rapid flooding and subsequently abandoned the vessel. Based on witness statements and photographs of the vessel before it sank, the flooding was likely caused by port side shell damage at the engine room and/or the vessel's forepeak.

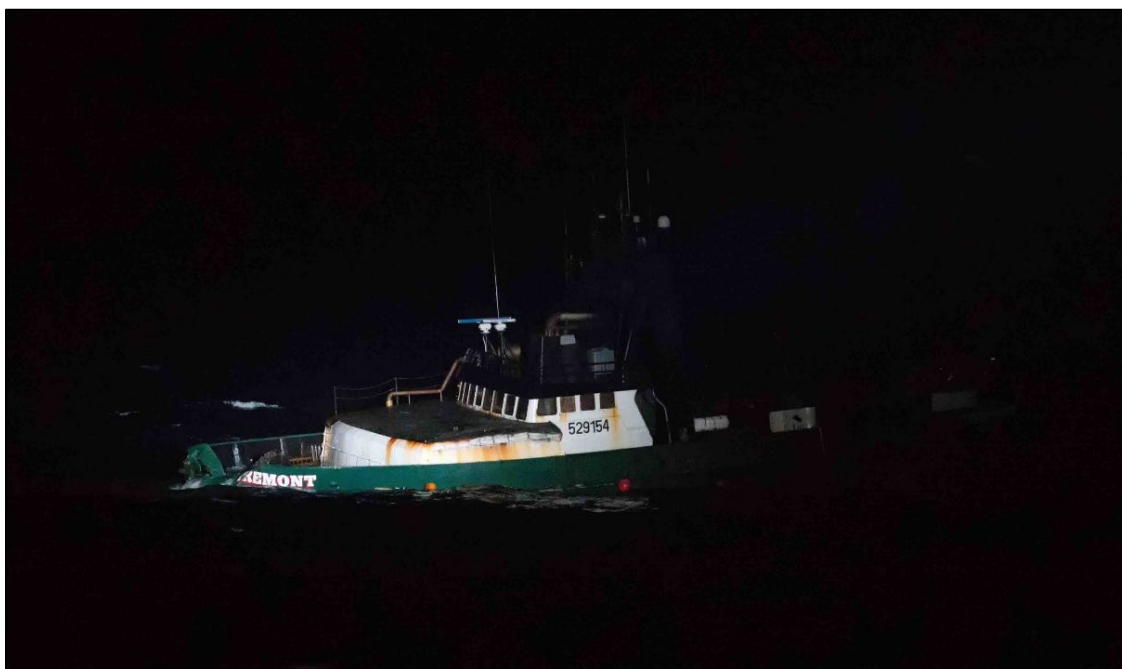
The *MSC Rita*, overhearing the *Tremont*'s VHF mayday call, turned around at 0214 and returned to the scene. The Coast Guard dispatched a C-130 aircraft, an MH-60 Jayhawk helicopter, a Coast Guard Station Chincoteague 47-foot-long motor lifeboat (CG-47277), and the 154-foot-long fast response cutter *Rollin Fritch*. Upon arrival at the scene at 0320, the crew aboard the Coast Guard C-130 noted visible damage to *Tremont*'s port bow, a list to port, and the vessel down by the bow.

Figure 6. The *Tremont* with damaged bow as seen from the *Atlantis*. (Source: Lance Wills)

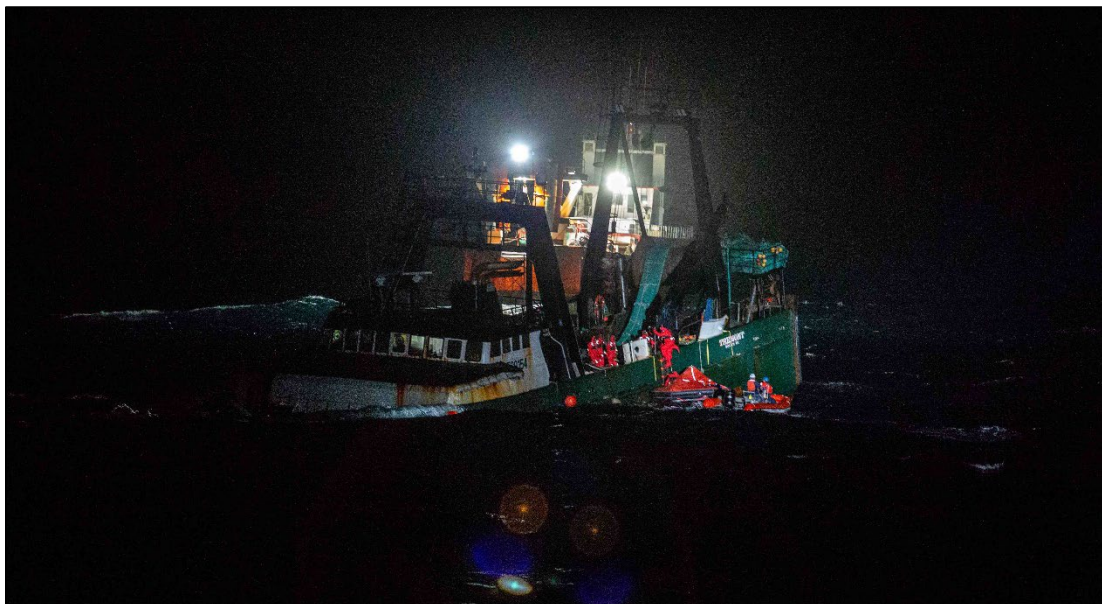
The *Tremont* then listed further, the bow submerged, and the mate was washed overboard. The Jayhawk helicopter crew deployed their rescue swimmer and hoisted the mate (uninjured) aboard and flew him to Coast Guard Base Portsmouth in Virginia. The *Tremont* sank at 0420, bow first. The *Tremont* was equipped with a

Figure 7. *Tremont* bow awash during the abandonment as seen from the *Atlantis*. (Source: Lance Wills)

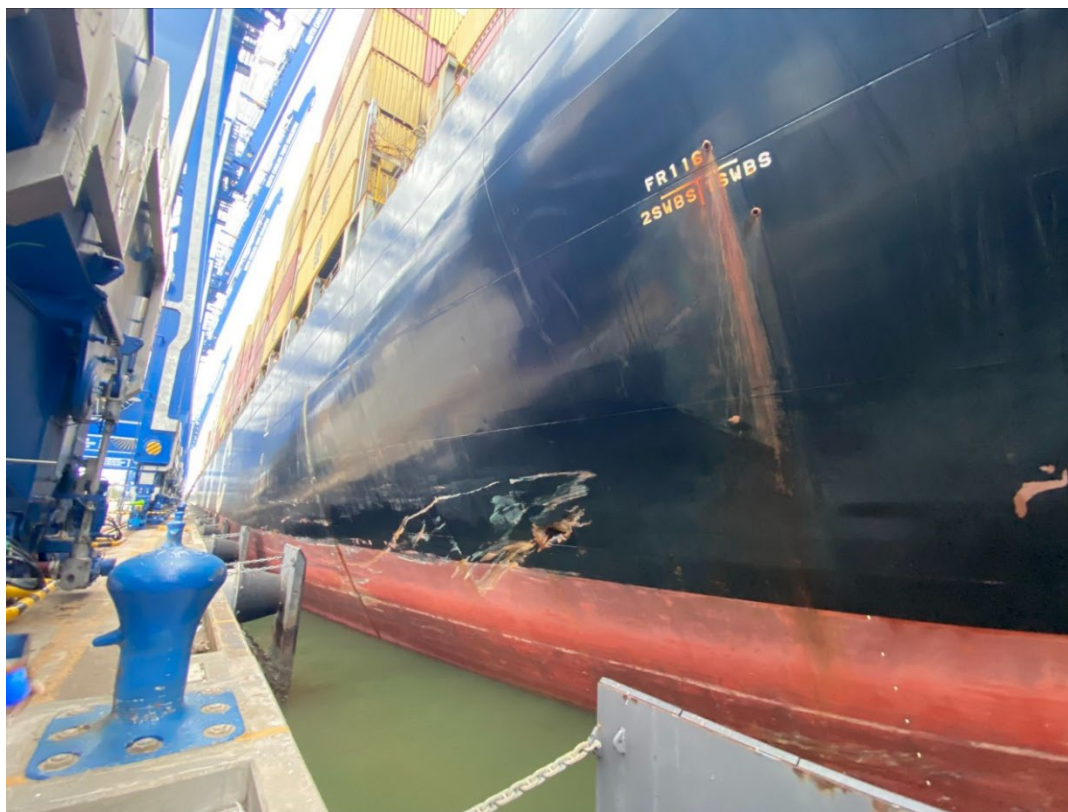
The *MSC Rita* suffered an estimated \$1.5 million in damage, including buckled sideshell plating, distorted longitudinal framing, and a 600-millimeter-by-400-millimeter (1.3-foot-by-2.0-foot) hole in the shell plating of the no. 2 water ballast tank.

Figure 8. Damage to the *MSC Rita*'s starboard hull. (Source: Coast Guard)
