**NATIONAL
TRANSPORTATION
SAFETY
BOARD**

RAILROAD ACCIDENT REPORT

**DERAILMENT OF
SOUTHERN PACIFIC TRANSPORTATION COMPANY
FREIGHT TRAIN ON MAY 12, 1989
AND SUBSEQUENT RUPTURE OF
CALNEV PETROLEUM PIPELINE ON MAY 25, 1989
SAN BERNARDINO, CALIFORNIA**

1. Report No. NTSB/RAR-90/02	2. Government Accession No. PB90-916302	3. Recipient's Catalog No.	
4. Title and Subtitle Railroad Accident Report-- Derailment of Southern Pacific Transportation Company Freight Train on May 12, 1989, and Subsequent Rupture of Calnev Petroleum Pipeline on May 25, 1989, San Bernardino, California		5. Report Date June 19, 1990

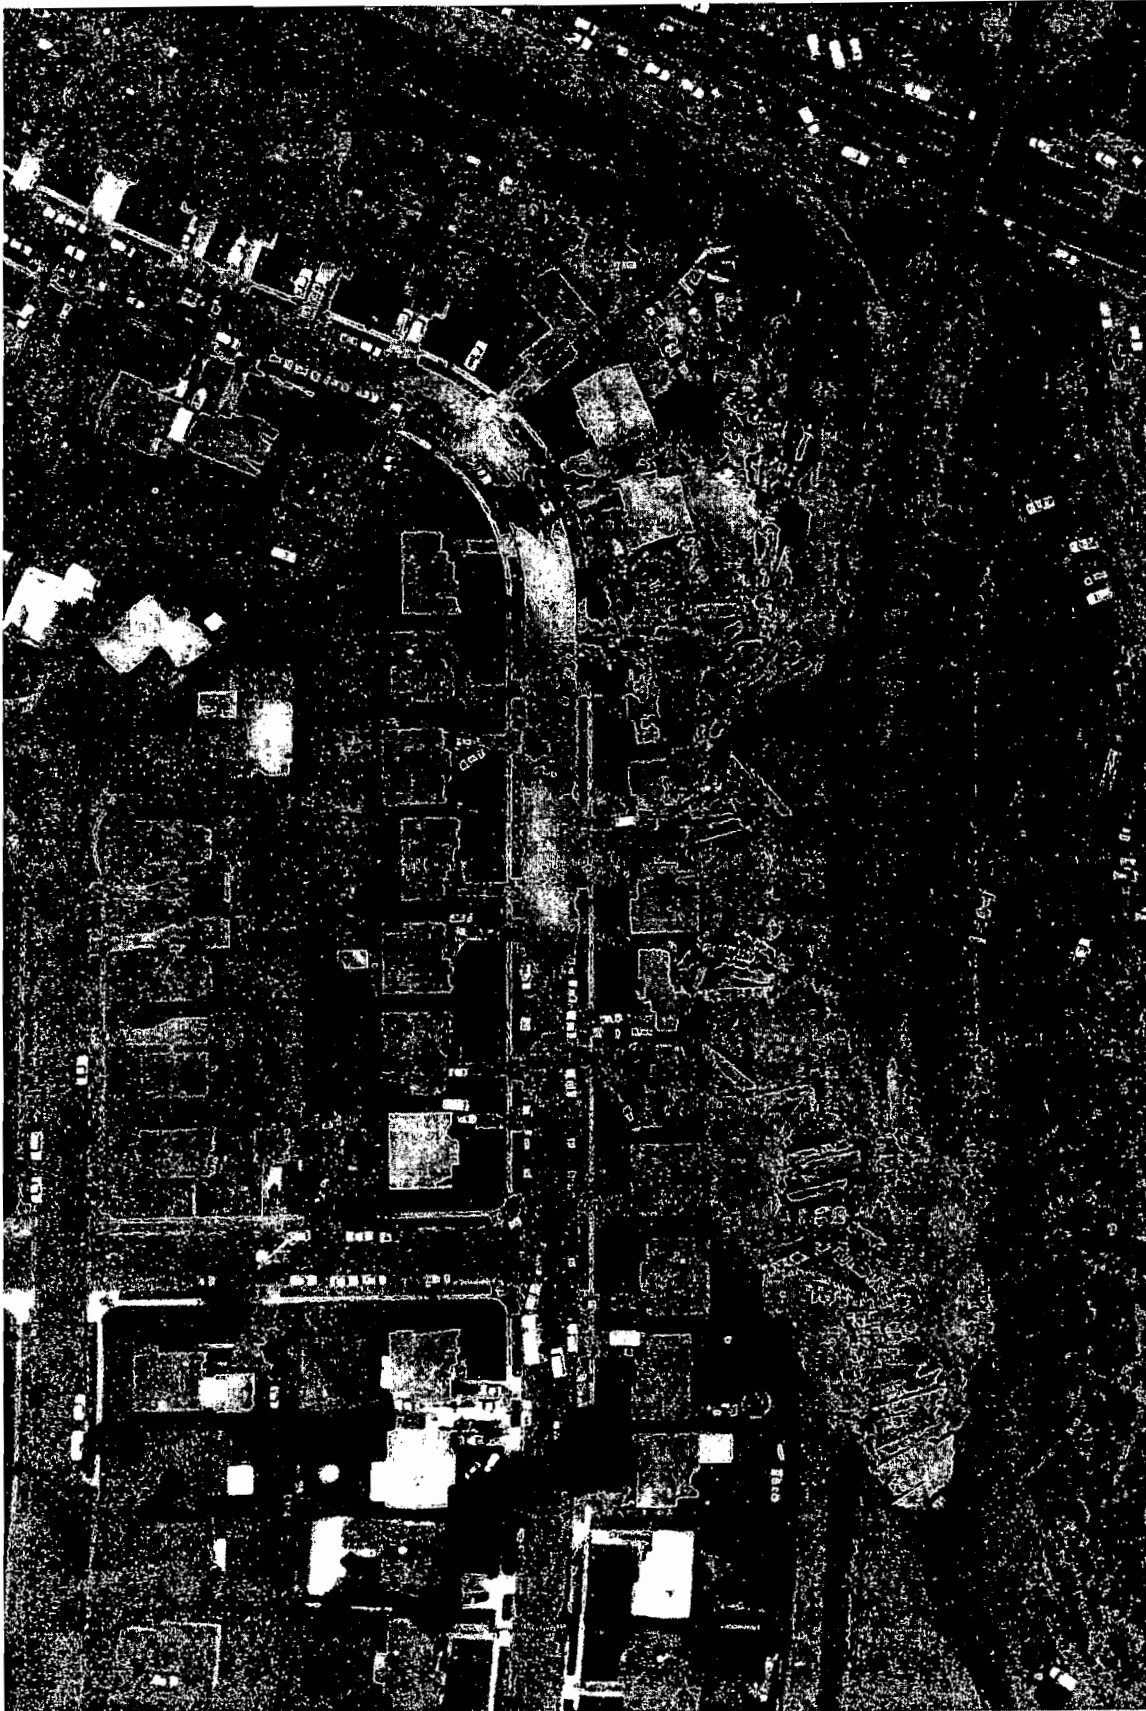
Figure 3.--Aerial view of train derailment.

Shortly after 7:30 a.m., two San Bernardino police detectives, who were traveling westbound on Highland Avenue approaching California Street, observed what they stated appeared to be a large flash of light and a large cloud of dust come from the area of Highland Avenue and west of Macy Street. They continued westbound on Highland Avenue, and as they drove past Macy Street, they observed that an SP train had derailed and had crashed into several houses on Duffy Street. One of the detectives used his police radio to advise his dispatcher of the situation and to request emergency personnel. They parked their vehicle on the north side of Highland Avenue and ran up the railroad levee¹¹ to evaluate the damage. Several other people had also stopped their vehicles and ran up the levee.

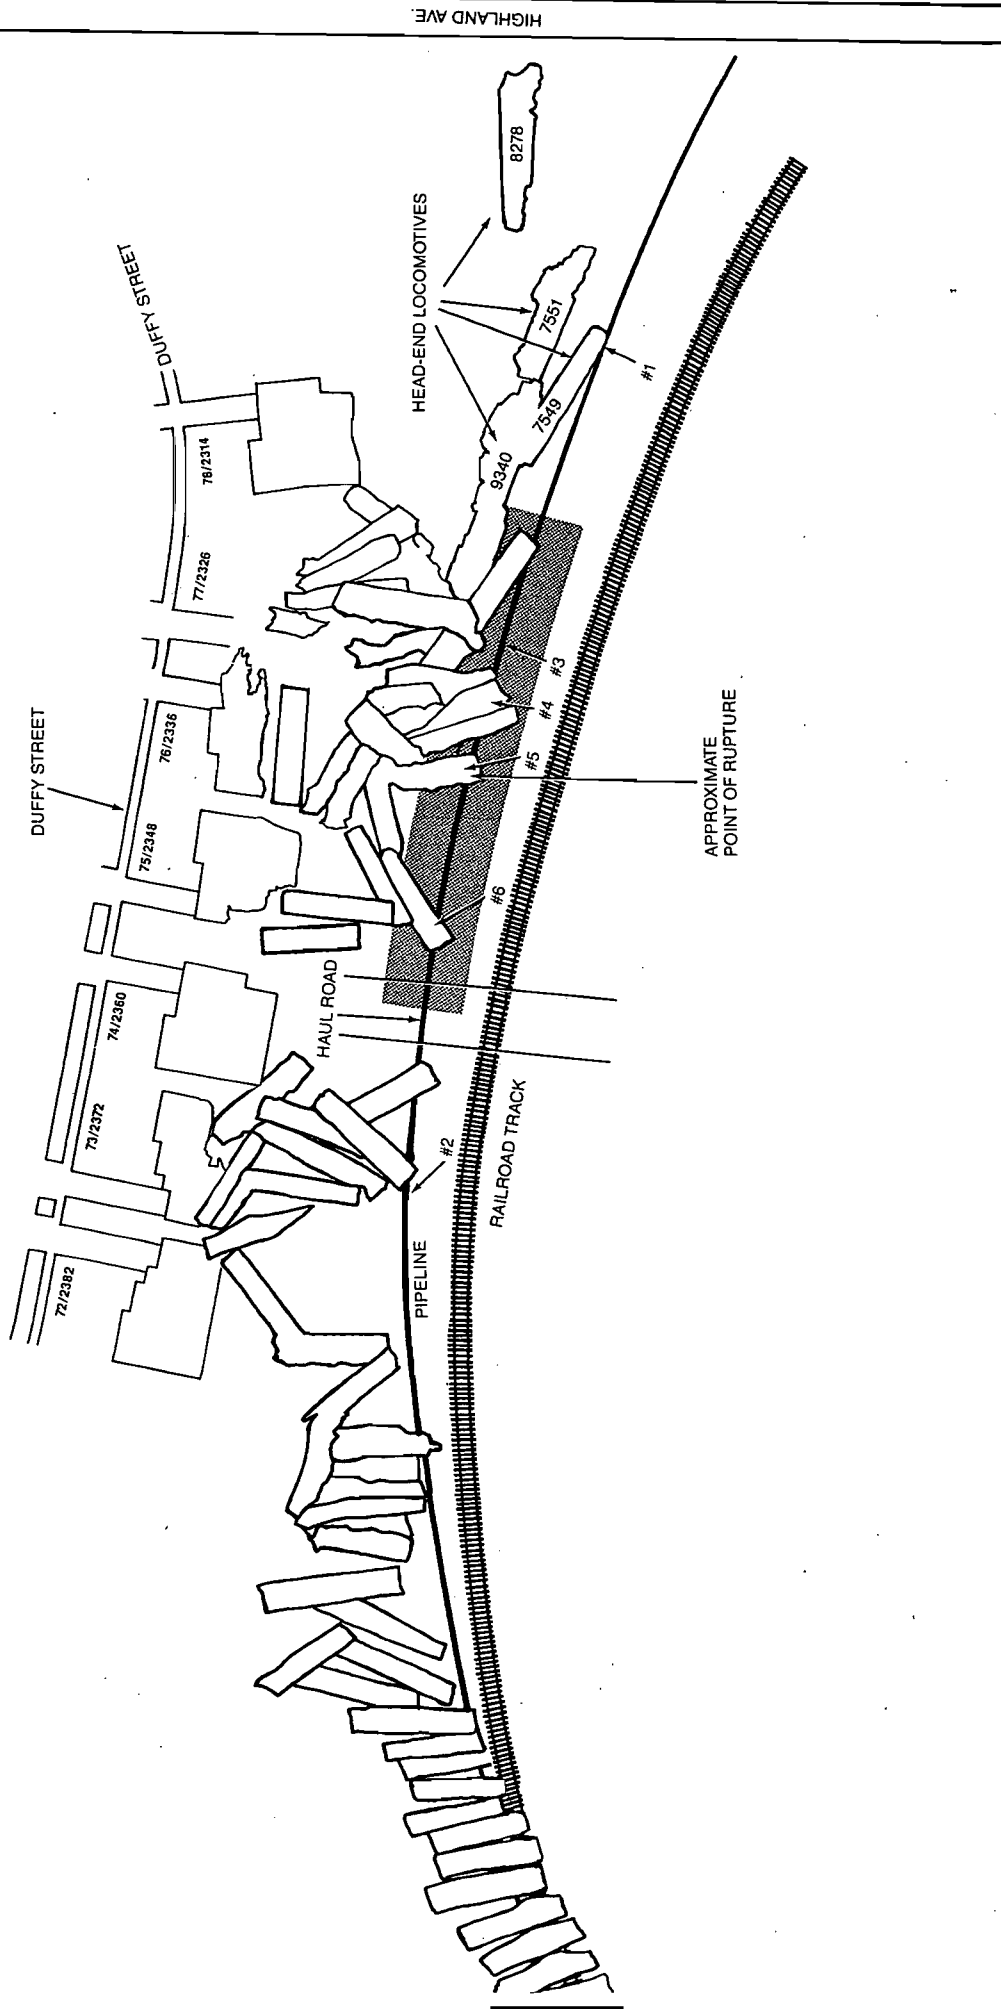
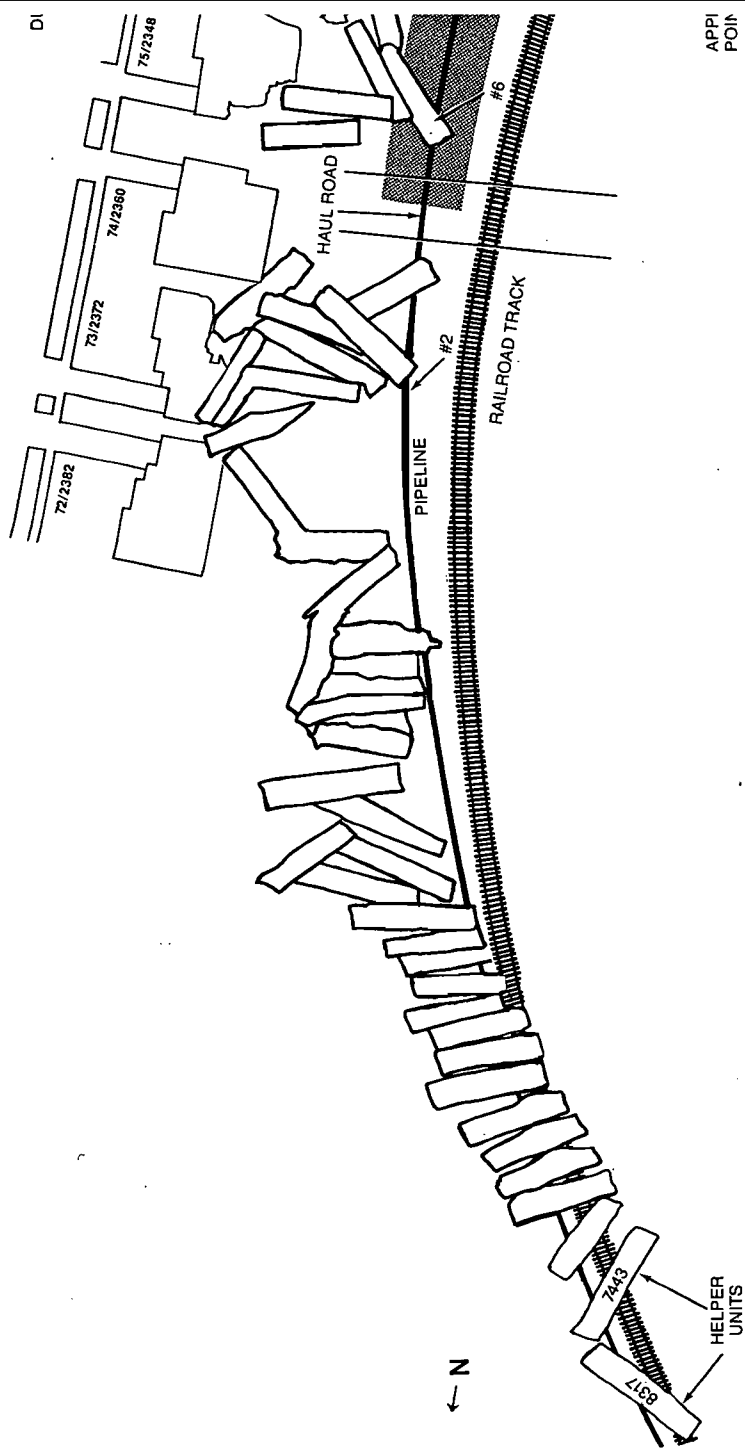
Figure 4. --- Wreckage distribution and location of Calnev excavations.

- PORTION OF AREA WHERE CALNEV MADE AN 8 FOOT-WIDE PATH THROUGH THE TRONA
- #1-6 APPROXIMATE LOCATION OF SELECTED EXCAVATIONS

Calnev officials then decided to excavate in an area north of the breach where, according to Calnev's manager of operations, "...bulldozers had been repeatedly going off the end of the haul road" (figure 4, excavation # 2). According to the Arizona Pipe Line Company foreman, who performed the excavation, about 1 foot of pipe length was exposed from the 1 o'clock to 3 o'clock position looking north. When asked if any damage to the coating or pipe was noted, the foreman replied, "Couldn't really tell by a visual look, and we didn't bother exposing anymore due to our objective was to determine depth and alignment of the pipeline at that time." The depth of the pipe at this location was determined to be about 7 feet. With respect to the depth of the pipe, Calnev's manager of operations testified, "...it was sufficient to where I was no longer concerned about any damage from the bulldozer activity."

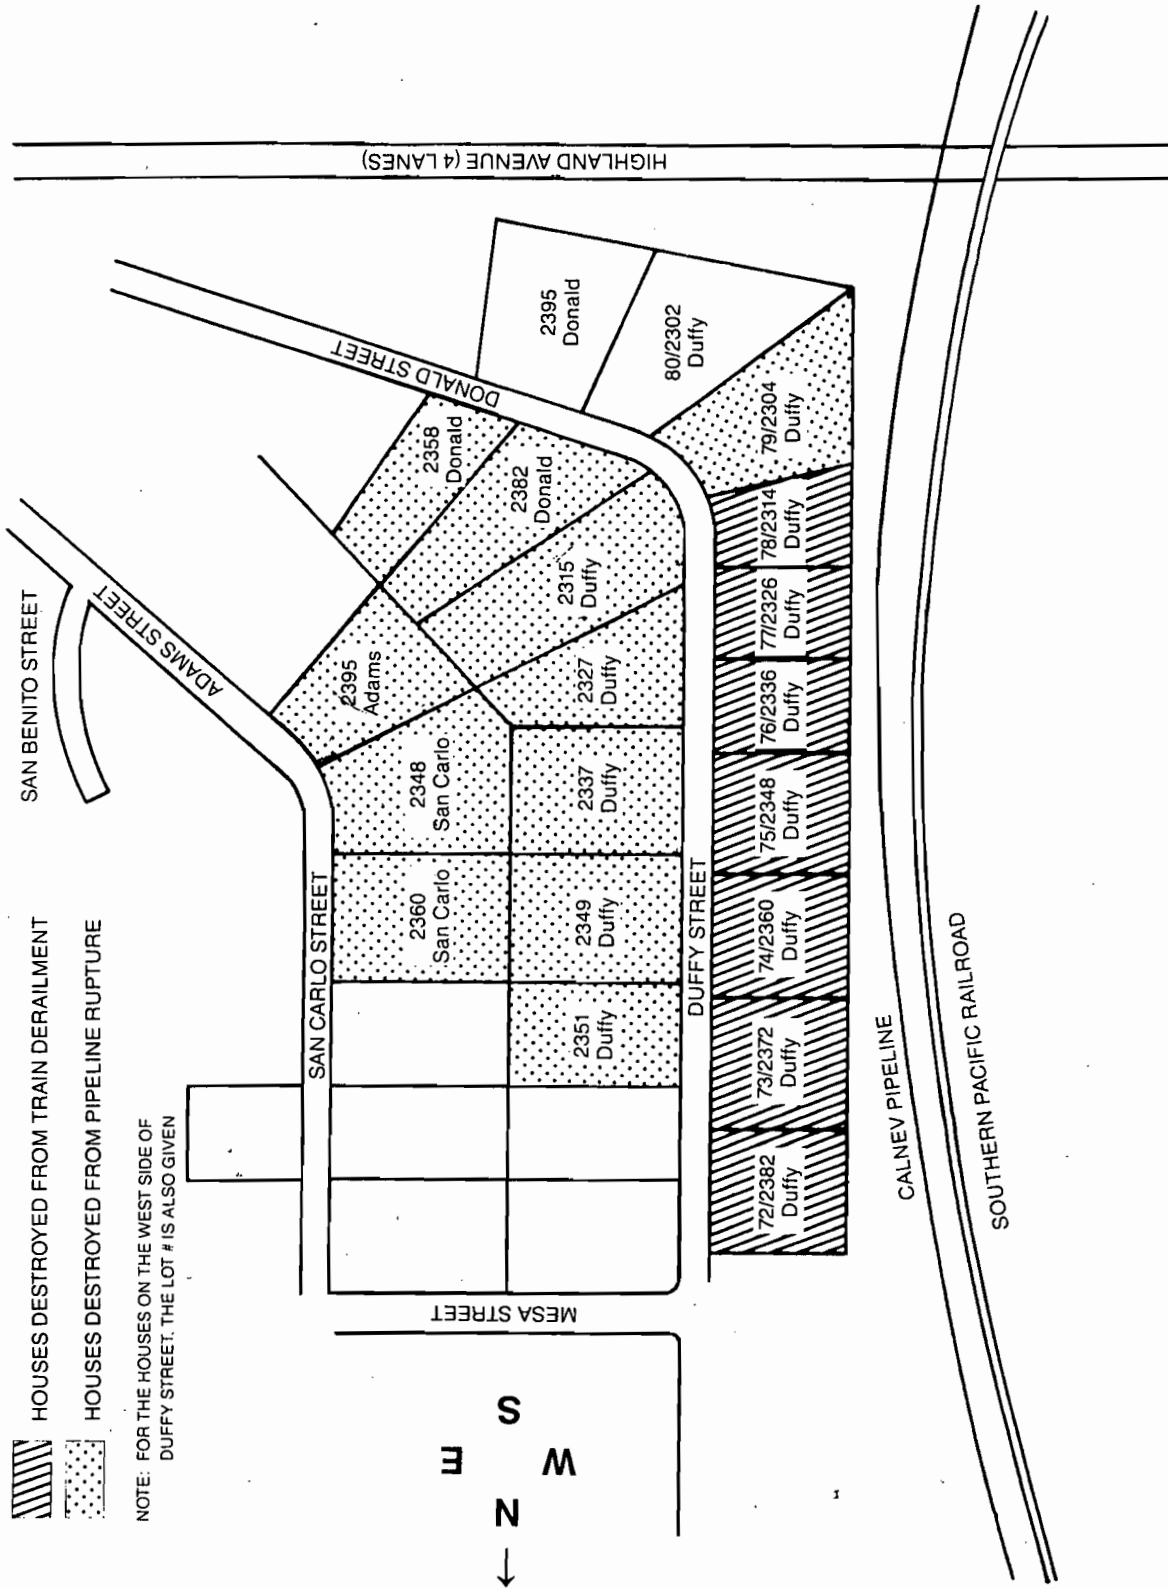
Figure 11.--Damages to residences.

Following the derailment, a building inspector from the City of San Bernardino Department of Building and Safety inspected the houses that incurred damages as a result of the derailment. The inspector's assessment of damages is listed in Appendix F. The inspector recommended that dwellings at 2314 Duffy Street through 2382 Duffy Street be demolished immediately (figure 11).

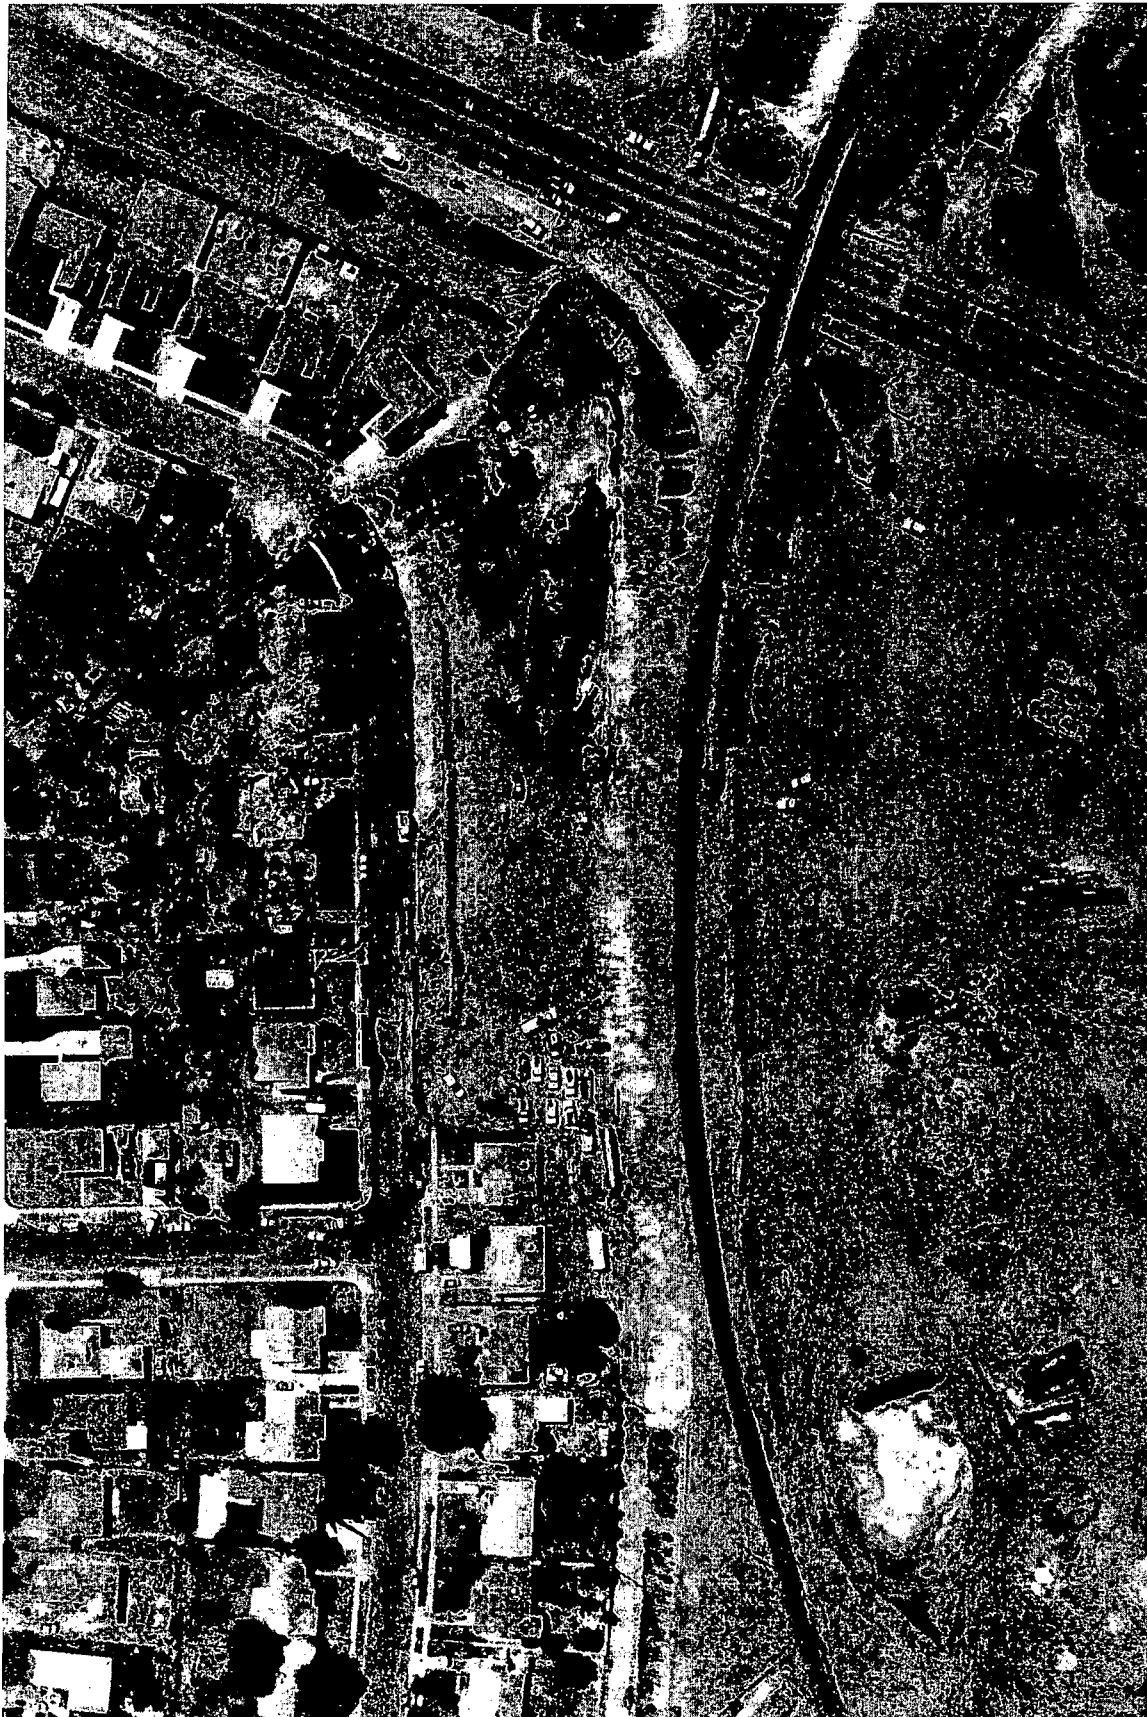
Figure 12.--Damages to residences following pipeline rupture.

Pipeline Rupture.--Eleven houses and 21 motor vehicles were destroyed by fire from the pipeline rupture and fire (figures 11 and 12). Four houses received moderate fire and smoke damage, and three houses received smoke damage only. Appendix F lists the residences and the damages incurred.

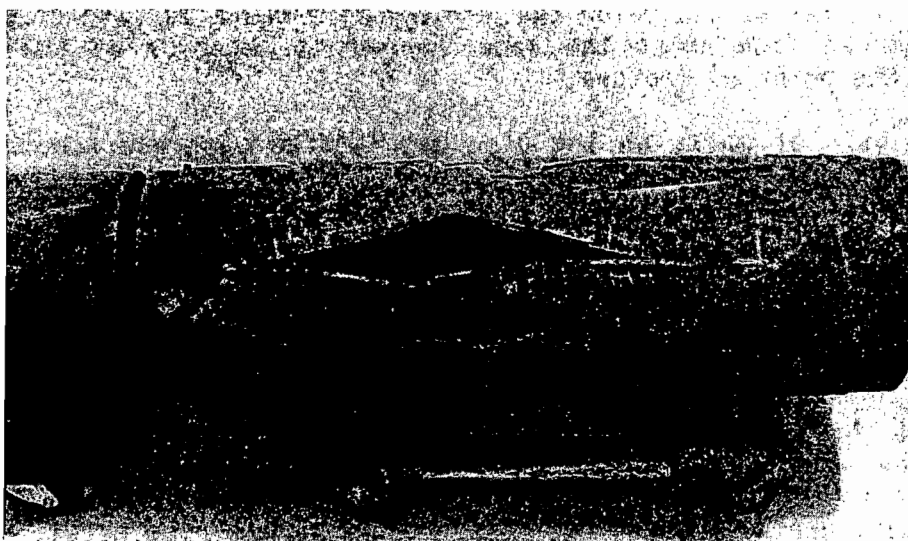
Figure 14.--Section of pipe containing the point of rupture.

The rupture was about 29 inches long and, with respect to the circumference, was located about 5 inches to the east of the top of the pipe as installed (about the 1:30 o'clock position looking north). The electric resistance welded seam was located about at the top of the pipe. Examination of the area indicated that there was plastic deformation (bulging of the pipe) associated with the rupture and that the rupture produced a "fish mouth" type opening of about 4.2 inches at its widest point (see figure 14). There was no apparent visual evidence of pipe material or manufacturing deficiencies.

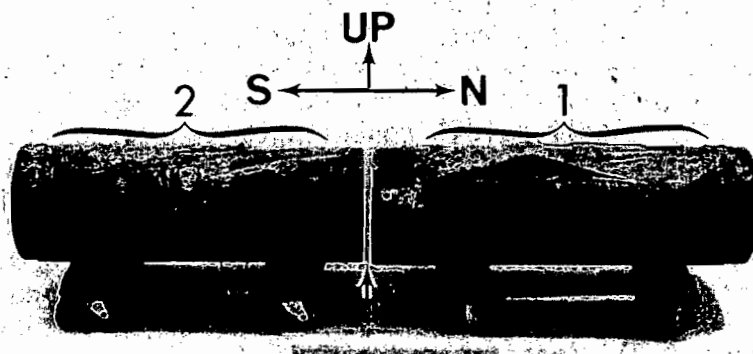
Metallurgical Testing.--Two 14-inch outside diameter (OD) pipe sections, one measuring 44 inches long and containing a rupture and one about 41 inches long, were taken to the Safety Board's materials laboratory in Washington, D.C., for examination. The two sections of pipe had been adjacent to each other before they were cut apart. As received in the Board's laboratory, the pipe contained directional arrows and a marking along the top of the section to indicate orientation of the pipe in the ground before removal. Arrows "N" and "S" denoted the north and south directions, respectively (figure 17). A longitudinal marking across the sections at the transverse cut signified the top of the pipe and the matching rotational positions of the two sections relative to each other. Yellow grid line markings had been made on the OD surface around the rupture area. Subsequent notes supplied by Failure Analysis Associates (the metallurgical consultants contracted by the SP to examine the pipe) indicated that these markings denoted positions where thickness measurements had been made on the pipe. Arrow "x" in figure 18 indicates a location where the wall thickness measured the thinnest at about 0.249 inch, which was confirmed by micrometer measurements in the Safety Board's laboratory. Wall thicknesses of 0.254 inch were also found in the origin area of the fracture. The wall thickness away from the fracture measured about 0.312 inches.

Figure 17.--Overall view of the pipe sections as submitted for examination. Approximately 1/24 magnification.

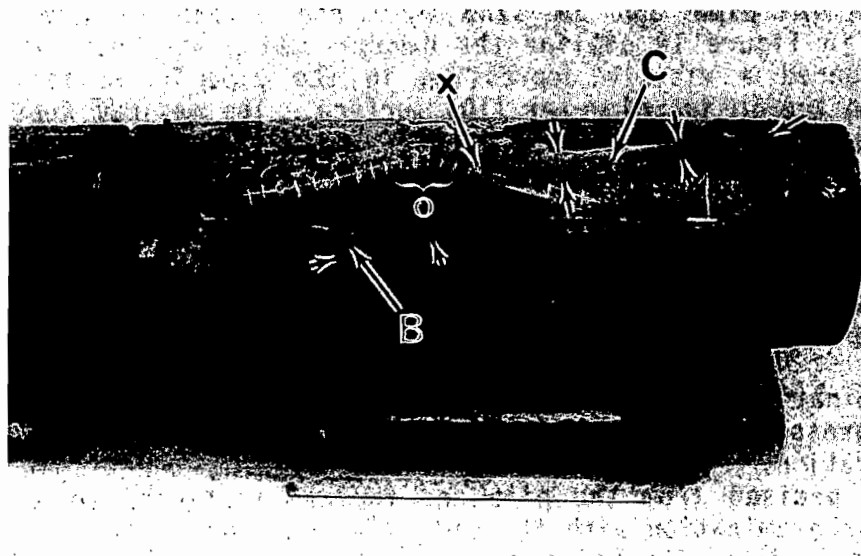
Visual examination of the fracture surface of the rupture disclosed no evidence of progressive cracking. All fracture features were typical of an overstress separation. A pie-shaped section containing the origin area of the rupture was excised from the pipe and further sectioned to a specimen size suitable for examination with the aid of a scanning electron microscope (SEM). SEM examination disclosed dimple rupture features throughout the fracture area that were typical of a ductile overstress separation. There was no evidence of crack arrest markings or oxidation areas that would indicate a progressive separation.

Figure 18.--Higher magnification view of northern pipe section containing the rupture (indicated by bracket 1, figure 17).

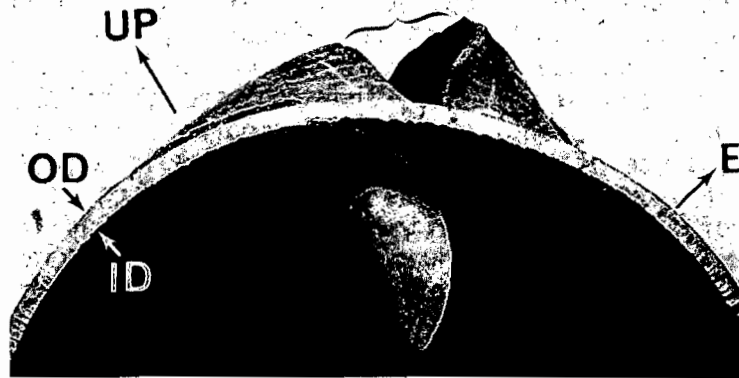
Figure 19.--Looking north on north section of pipe showing bulge in the pipe at the rupture. Bracket locates gap in rupture.

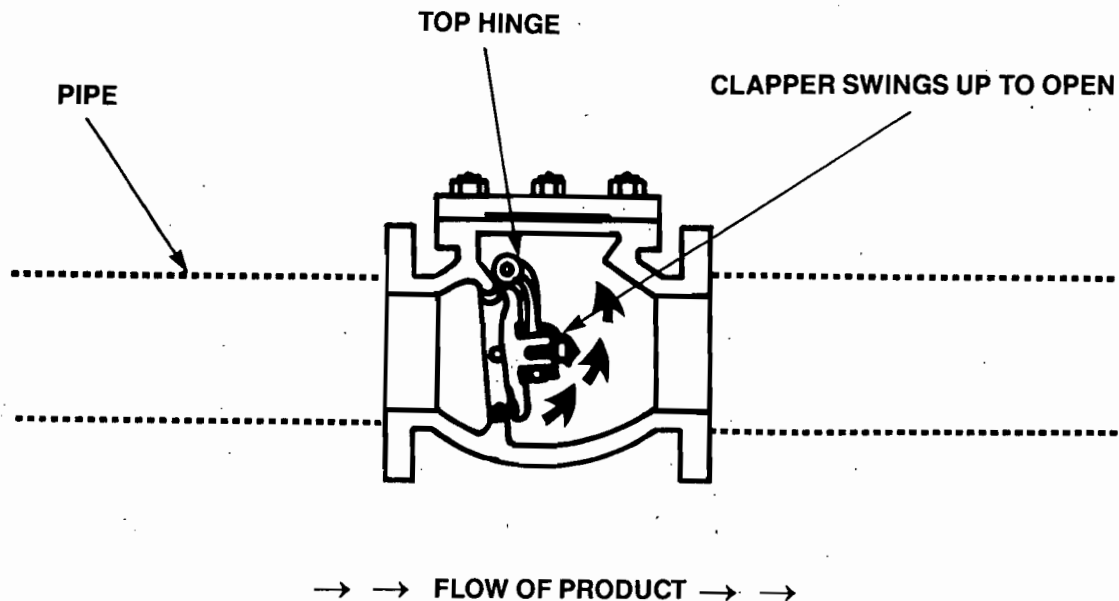
Figure 22.--Sketch of typical top-hinged check valve.

The top-hinged valves incorporate the clapper as an integral part of the hinge, which places the hinging mechanism further out of the product stream. The placement makes the hinge less susceptible to fouling by product impurities and uses the full weight of the clapper to achieve positive closure (figure 22). The Board understands the desire to take advantage of the advertised benefits of the side-hinged valves: less pressure drop through the valve and improved ability to pass cleaning instruments. However, the Safety Board was unable to locate any documentation regarding reliability tests on which pipeline designers based their selection of the side-hinged check valves in 1969. Because of its concern that other malfunctioning check valves may be installed in other pipeline systems, the Safety Board issued Safety Recommendation P-89-5 to RSPA. In response to the recommendation, RSPA issued an alert bulletin to operators of all liquid pipeline operators advising them to test for proper closure all check valves in critical locations and to replace any valves that fail to close properly.
