F-1 Tornado at Palm Bay

Several long track supercell thunderstorms moved eastward across central Florida during the afternoon of **February 27, 2005**. At least one storm produced a damaging (F1) tornado that moved through a residential area of NW Palm Bay at approximately 345-350 pm.

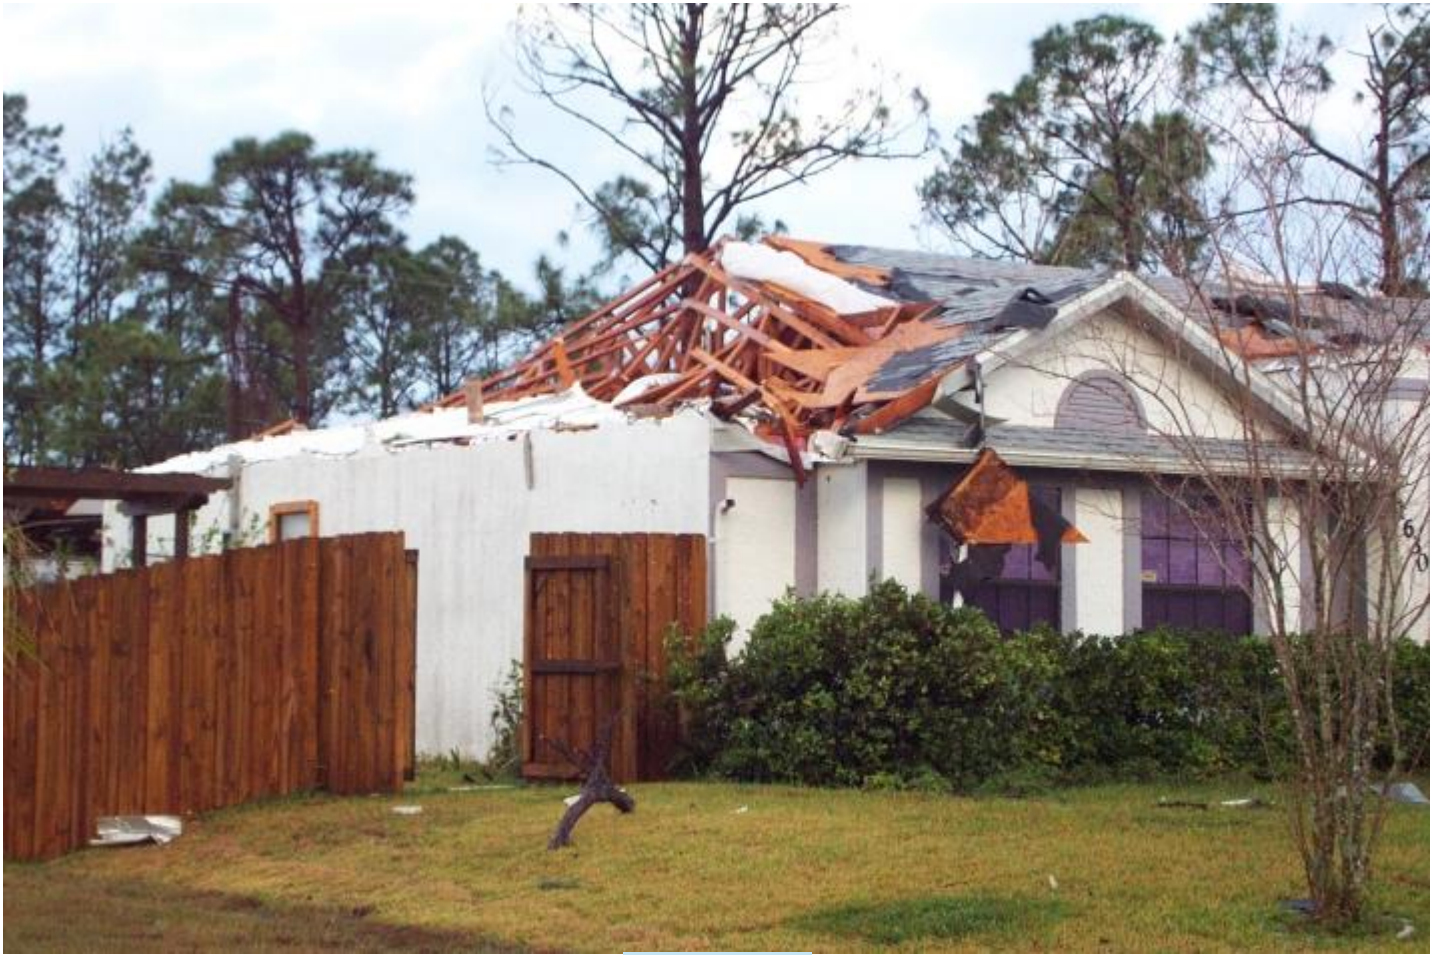
Damaged Roof

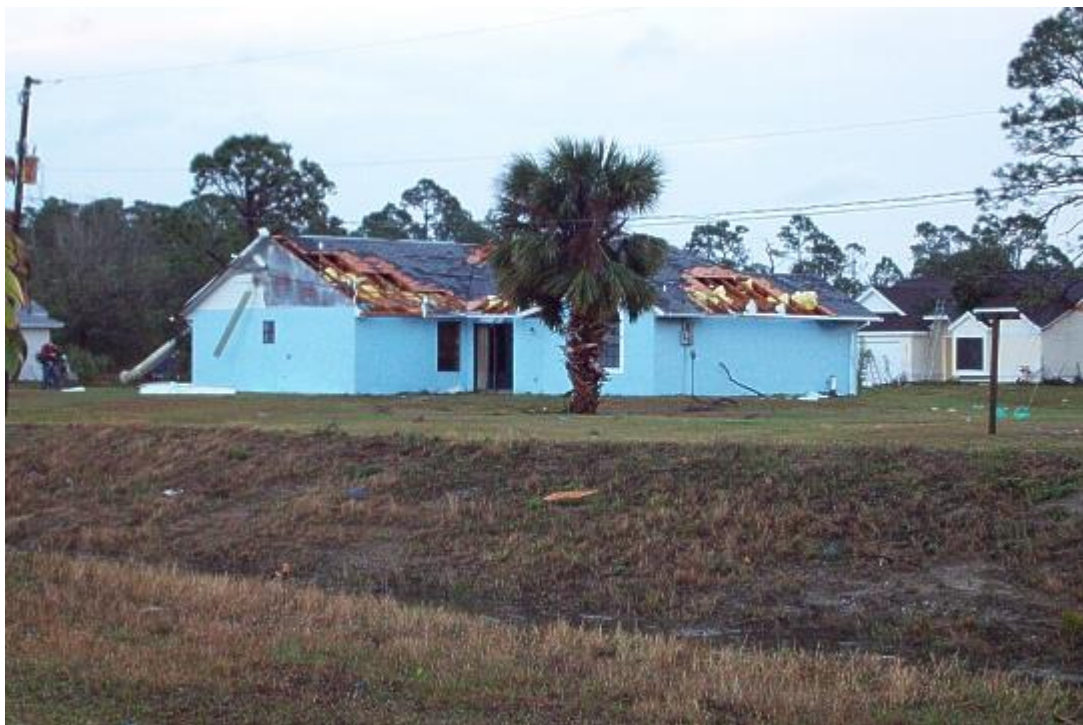
Damaged Roof

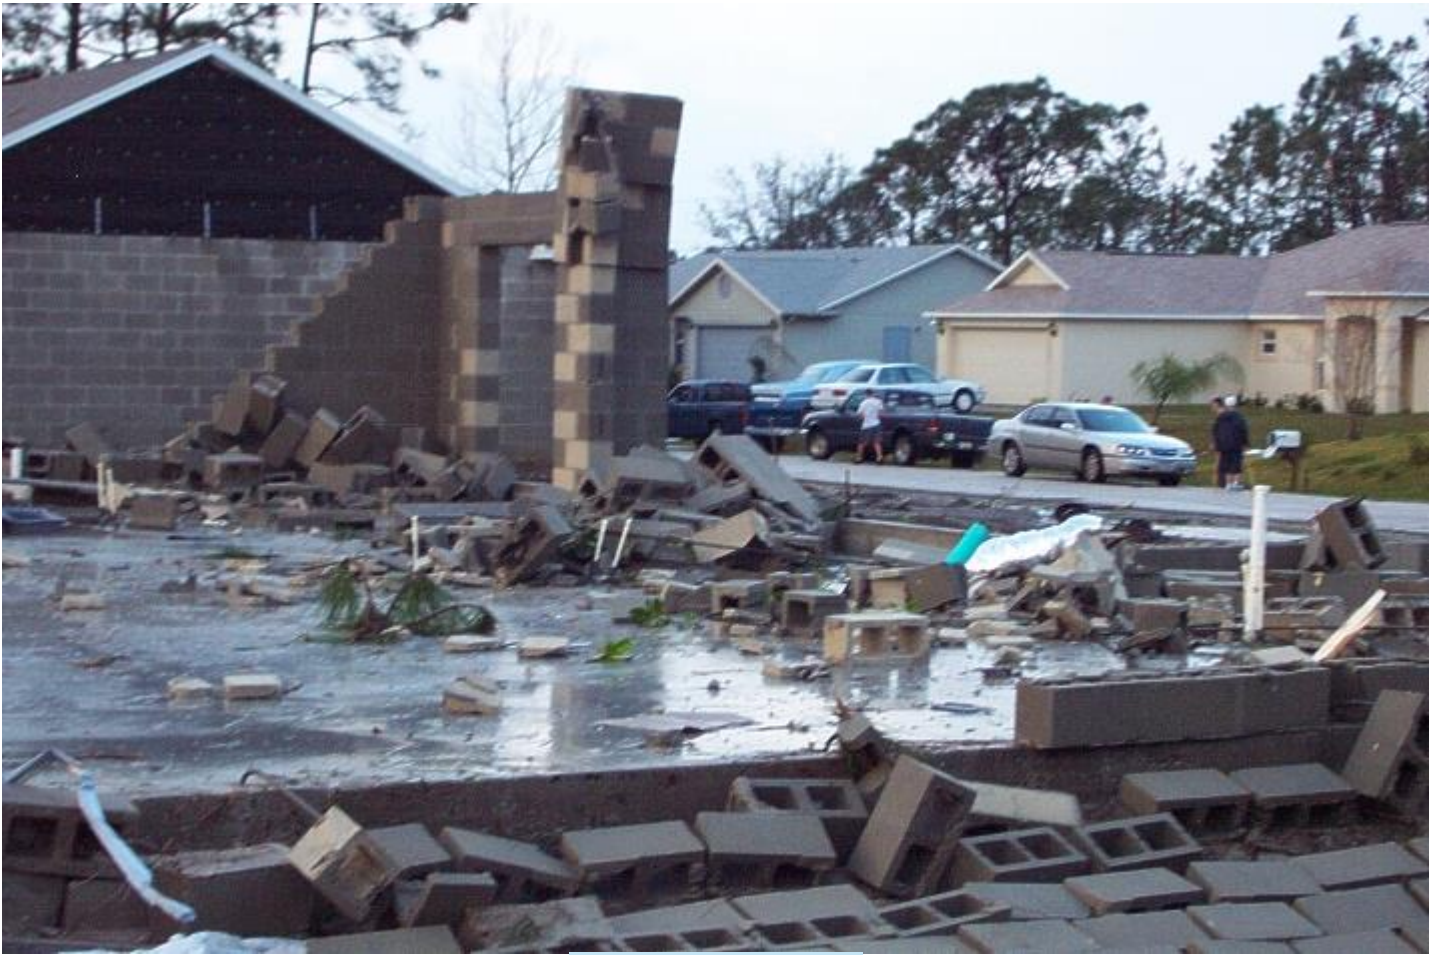
Damaged Construction
