FLOWER GARDEN BANKS NATIONAL MARINE SANCTUARY DRAFT - POST HURRICANE IKE QUICK LOOK CRUISE REPORT

OCTOBER 17, 2008

Prepared by Emma L. Hickerson

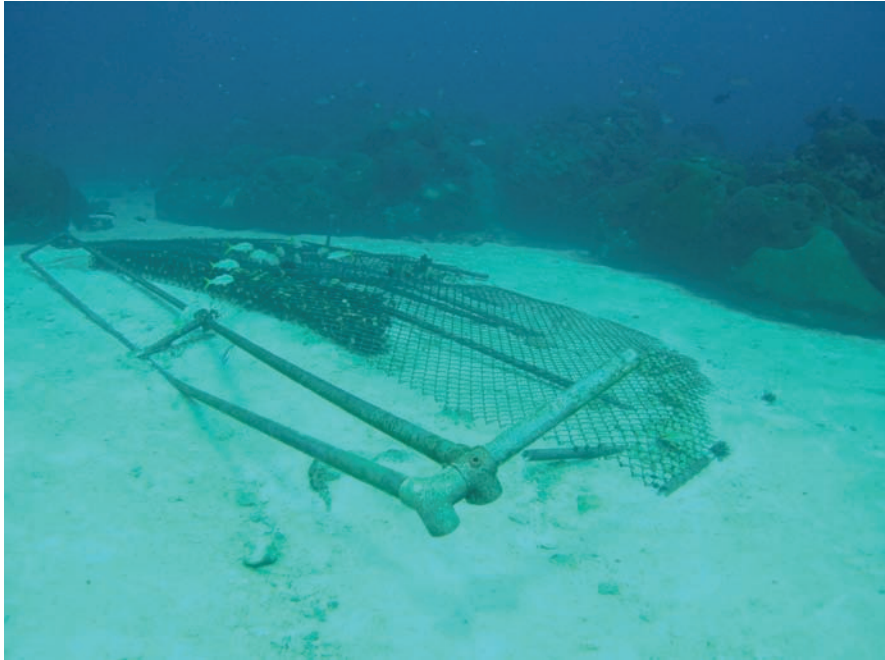
Figure 14. *Remains of recruitment rack, study site for University of Calgary student, Sarah Davies (October 2008).*

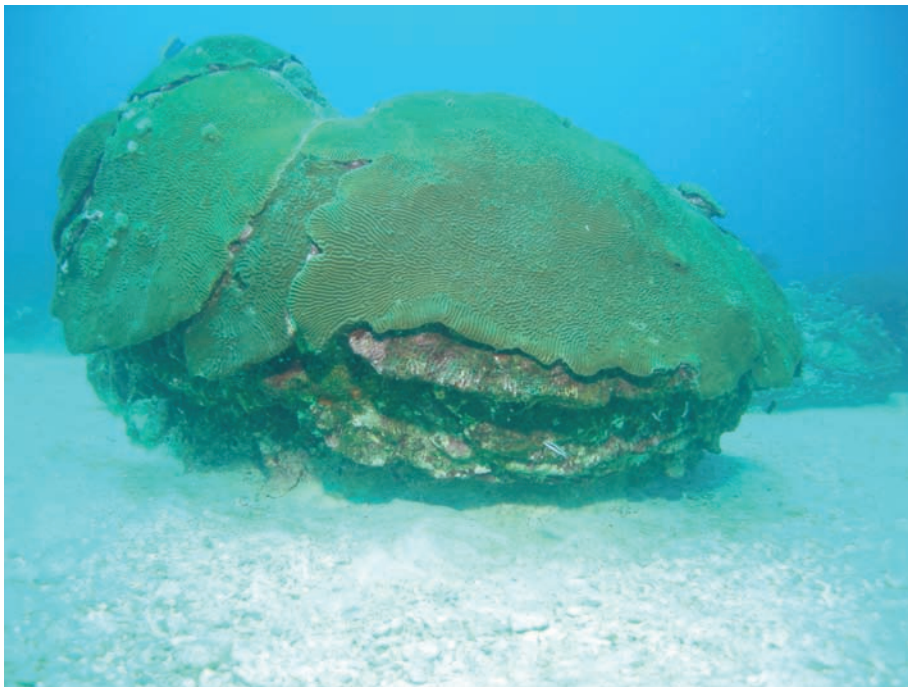
Figure 17. *Scouring around a large coral outcropping on the sand flat between buoy numbers 4 and 5 at the EFGB (October 2008).*

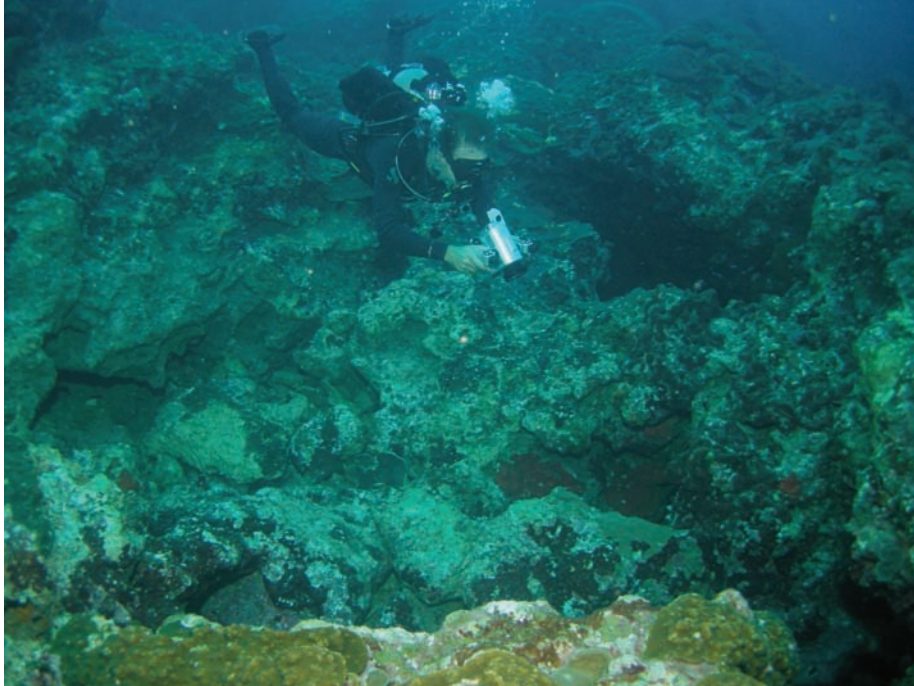
Figure 26. *Eric McHugh shoots video inside a crater left behind by a dislodged boulder coral (October 2008).*

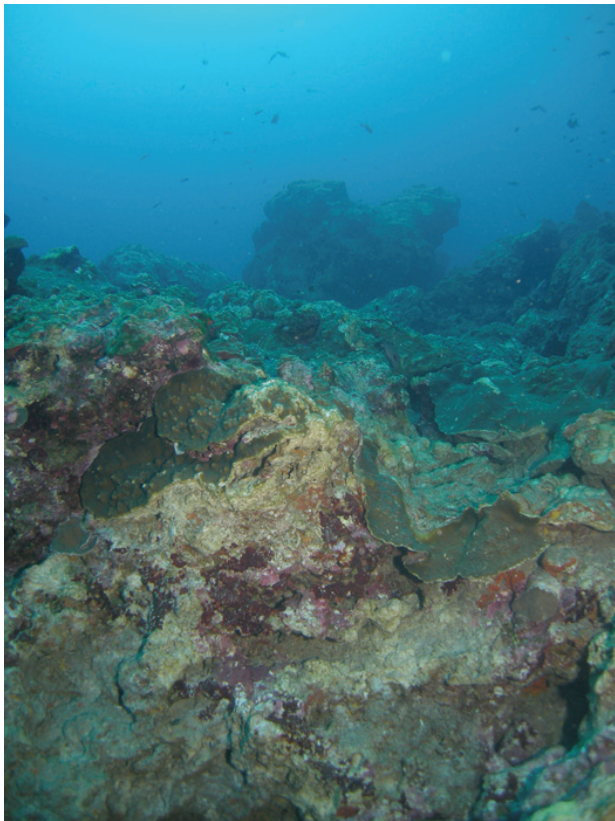
Figure 27. *Inside the crater looking southwest towards the coral colony that was dislodged, approximately 25 feet away (October 2008).*
