COMMISSION ON WATER RESOURCE MANAGEMENT  
 STATE OF HAWAII

PETITION TO AMEND INTERIM	)	Case No.: CCH-MA13-01
INSTREAM FLOW STANDARDS FOR	)	
HONOPOU, HUELO (PUOLUA),	)	OBJECTIONS, IN PART, OF
HANEHOI, WAIKAMOI, ALO,	)	MAUI TOMORROW TO
WAHINEPEE, PUOHOKAMOA,	)	HEARINGS OFFICER'S
HAIPIUAENA, PUNALAU/KOLEA,	)	AMENDED RECOMMENDATION
HONOMANU, NUAAILUA, PIINAAU,	)	RE INTERIM RESTORATION OF
PALAUHULU, 'OHI'A (WAIANU),	)	STREAM FLOW; EXHIBIT "A";
WAIOKAMILO, KUALANI,	)	MT EXHIBITS "1" – "40"; MT
WAILUANUI, WEST WAILUAIKI, EAST	)	MAPS "1" – "4"; CERTIFICATE
WAILUAIKI, KOPILIULA, PUAKEA,	)	OF SERVICE
WAIOHUE, PAAKEA, WAIAAKA,	)	
KAPAUULA, HANAWI and MAKAPIPI	)	
STREAMS	)	
	)

**OBJECTIONS, IN PART, OF MAUI TOMORROW TO HEARINGS OFFICER'S  
 AMENDED RECOMMENDATION RE INTERIM RESTORATION OF STREAM  
 FLOW**

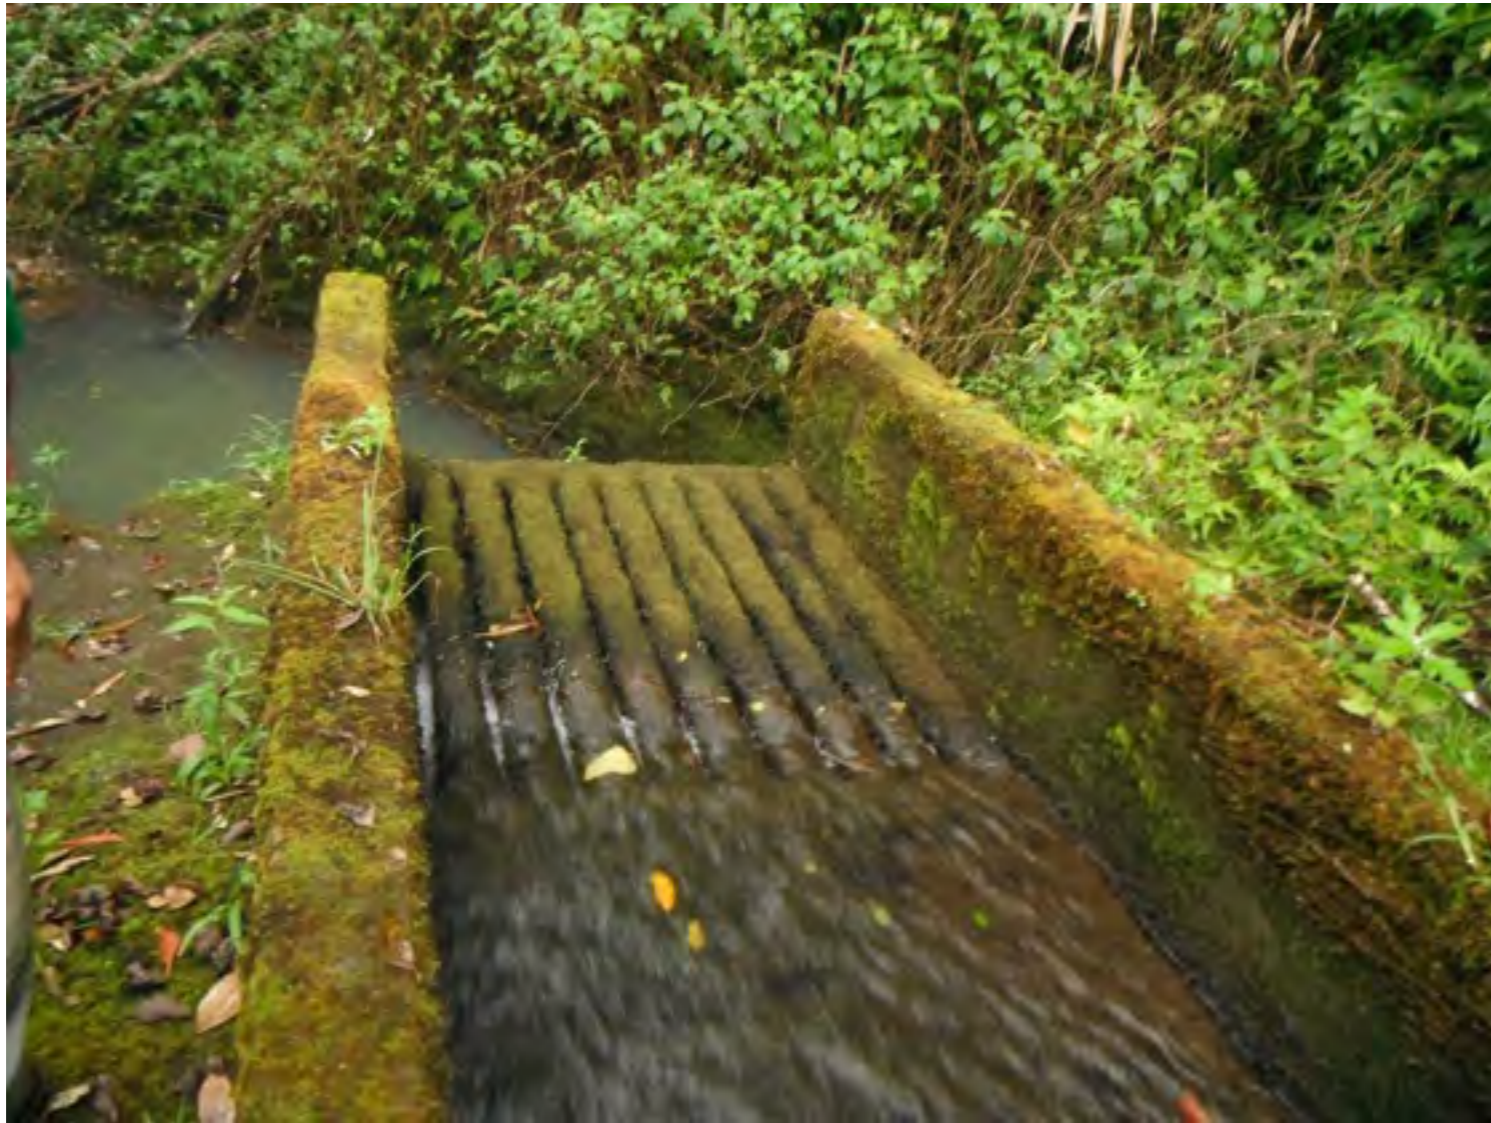
**MT EX #1**  
5/2016

Water collected  
thru diversion grate  
(57" wide x 78" long)  
Grate could be sealed  
with iron plate w/  
no modification in  
stream channel.  
View downstream

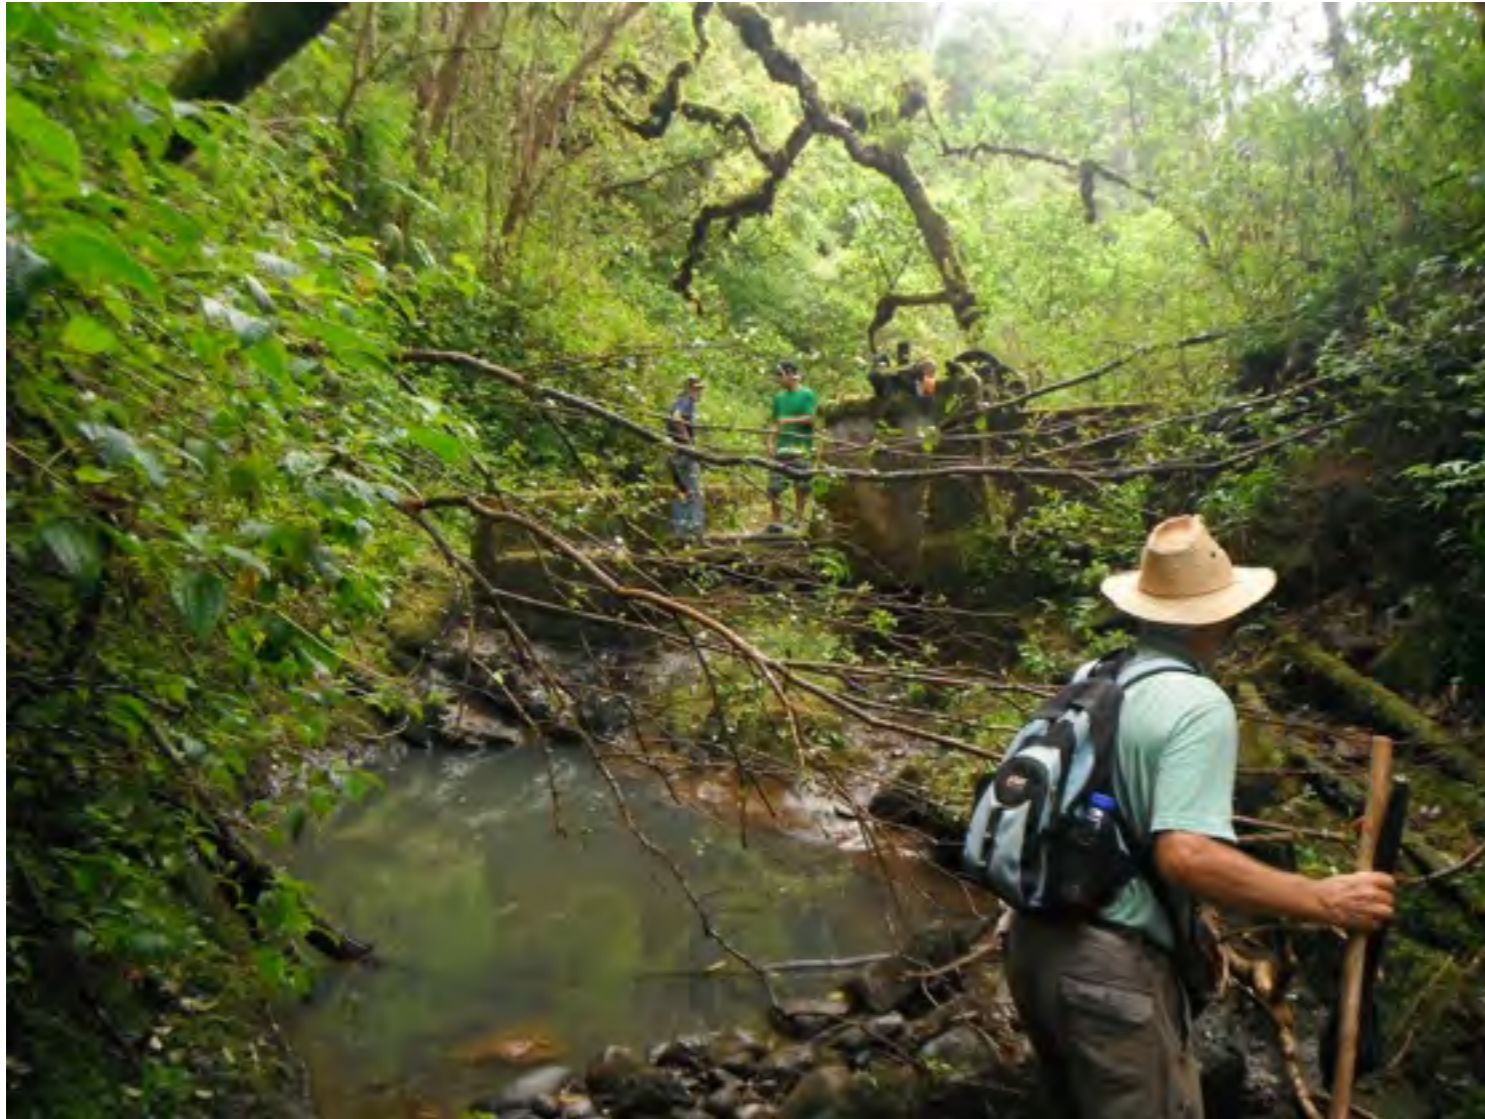
MT EX #2  
5/2016

Diversion structure W-18 spans Hanehoi stream channel. Minimal flow in stream past ditch structure beyond stagnant pond in foreground of picture

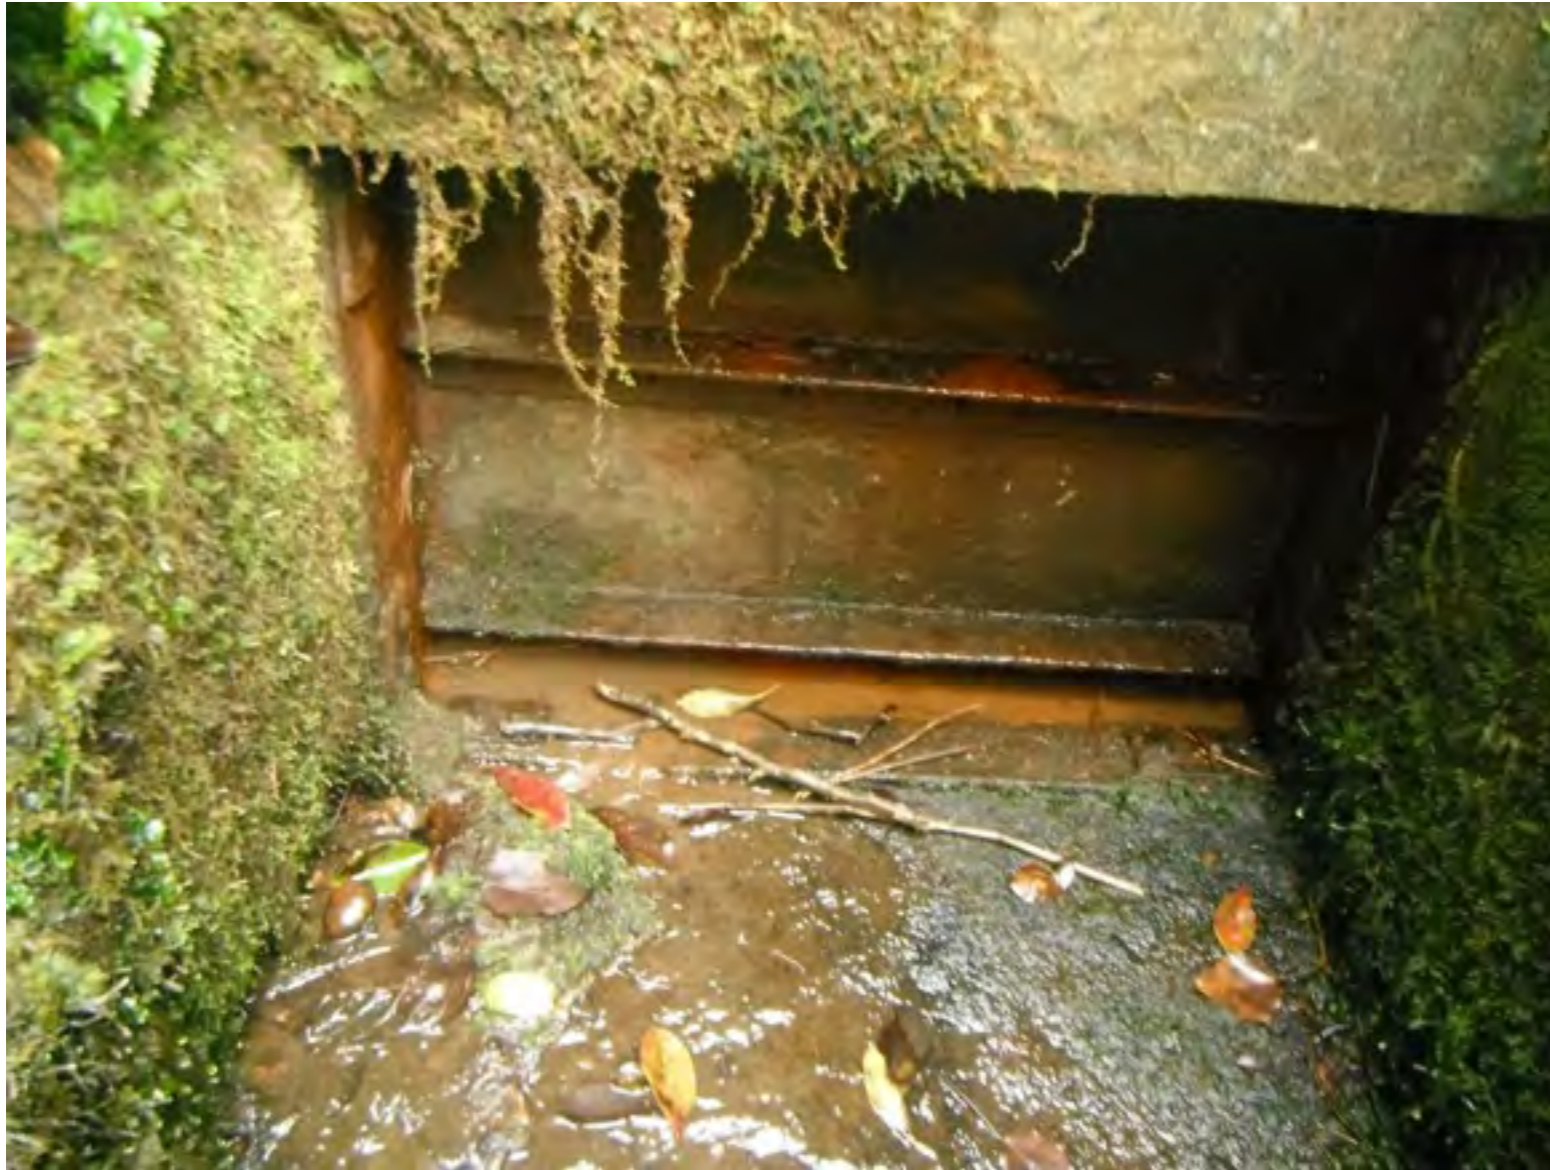
## **Diversion structure W-18 Hanehoi Stream**

Sluice gate on stream  
channel.

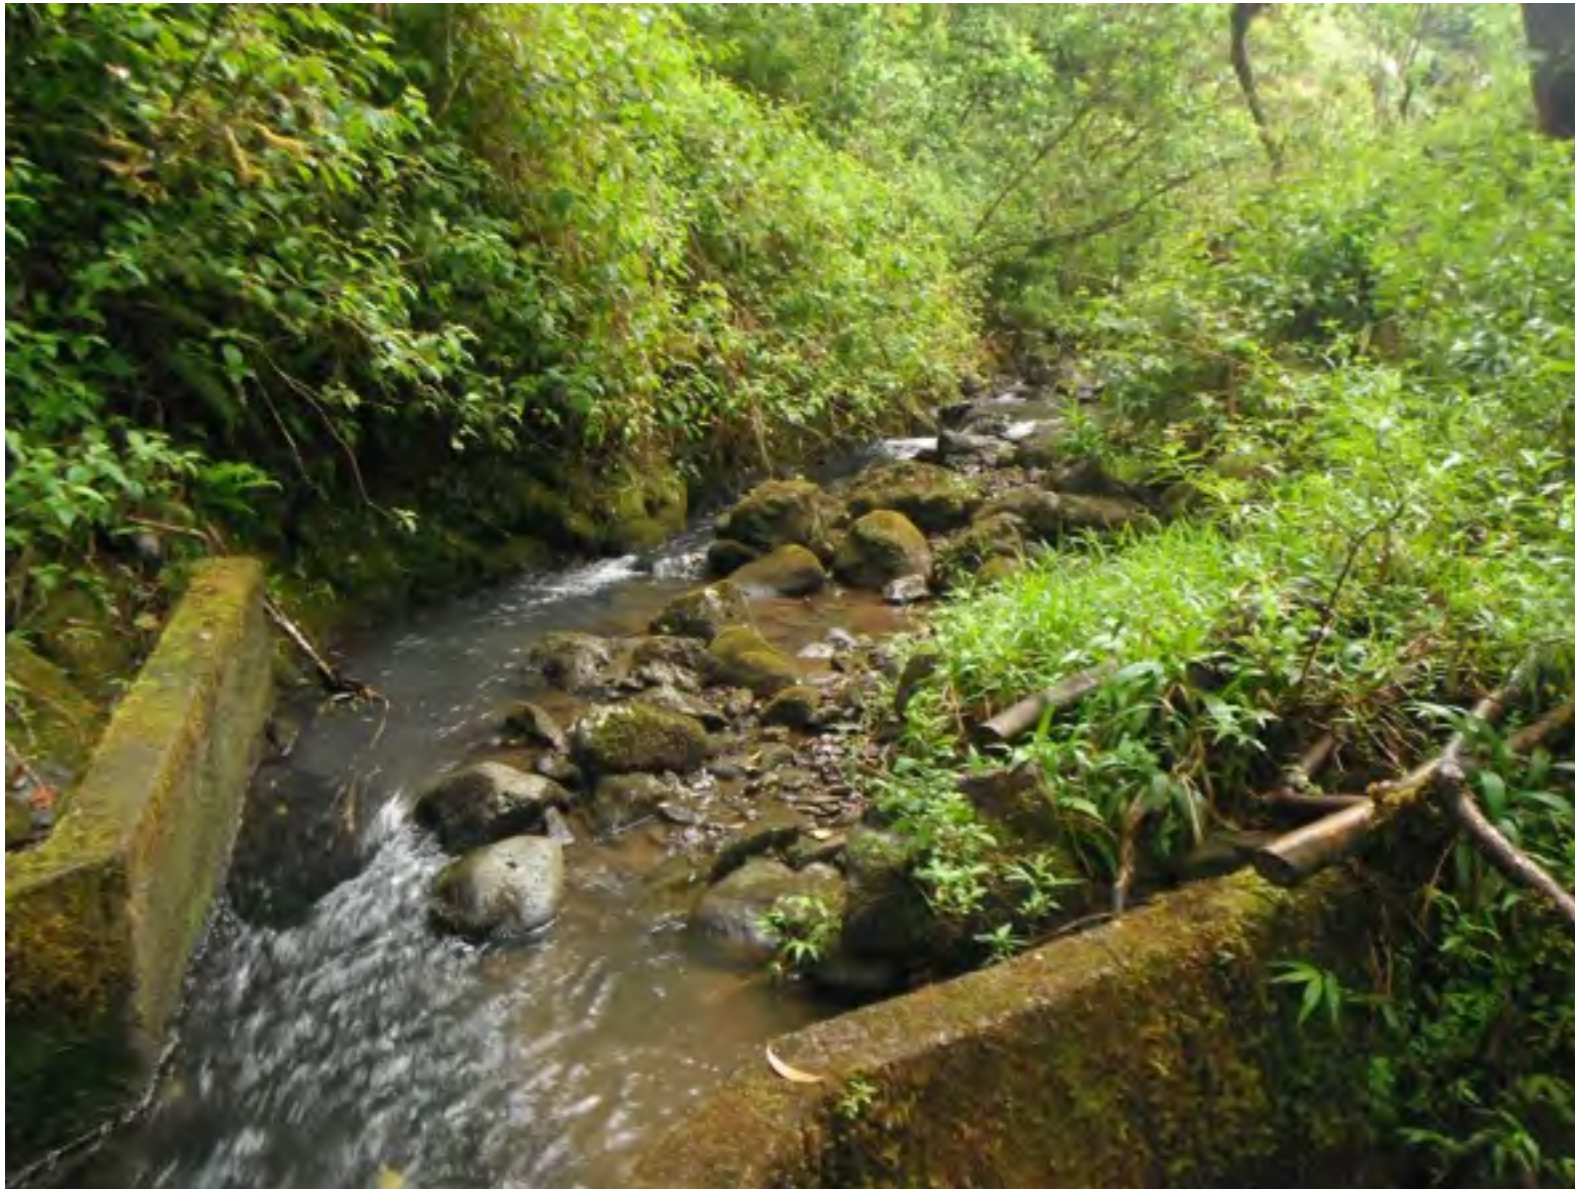
Diversion structure  
W-18- showing East  
Hanehoi natural  
stream flow.

View is upstream of  
diversion structure

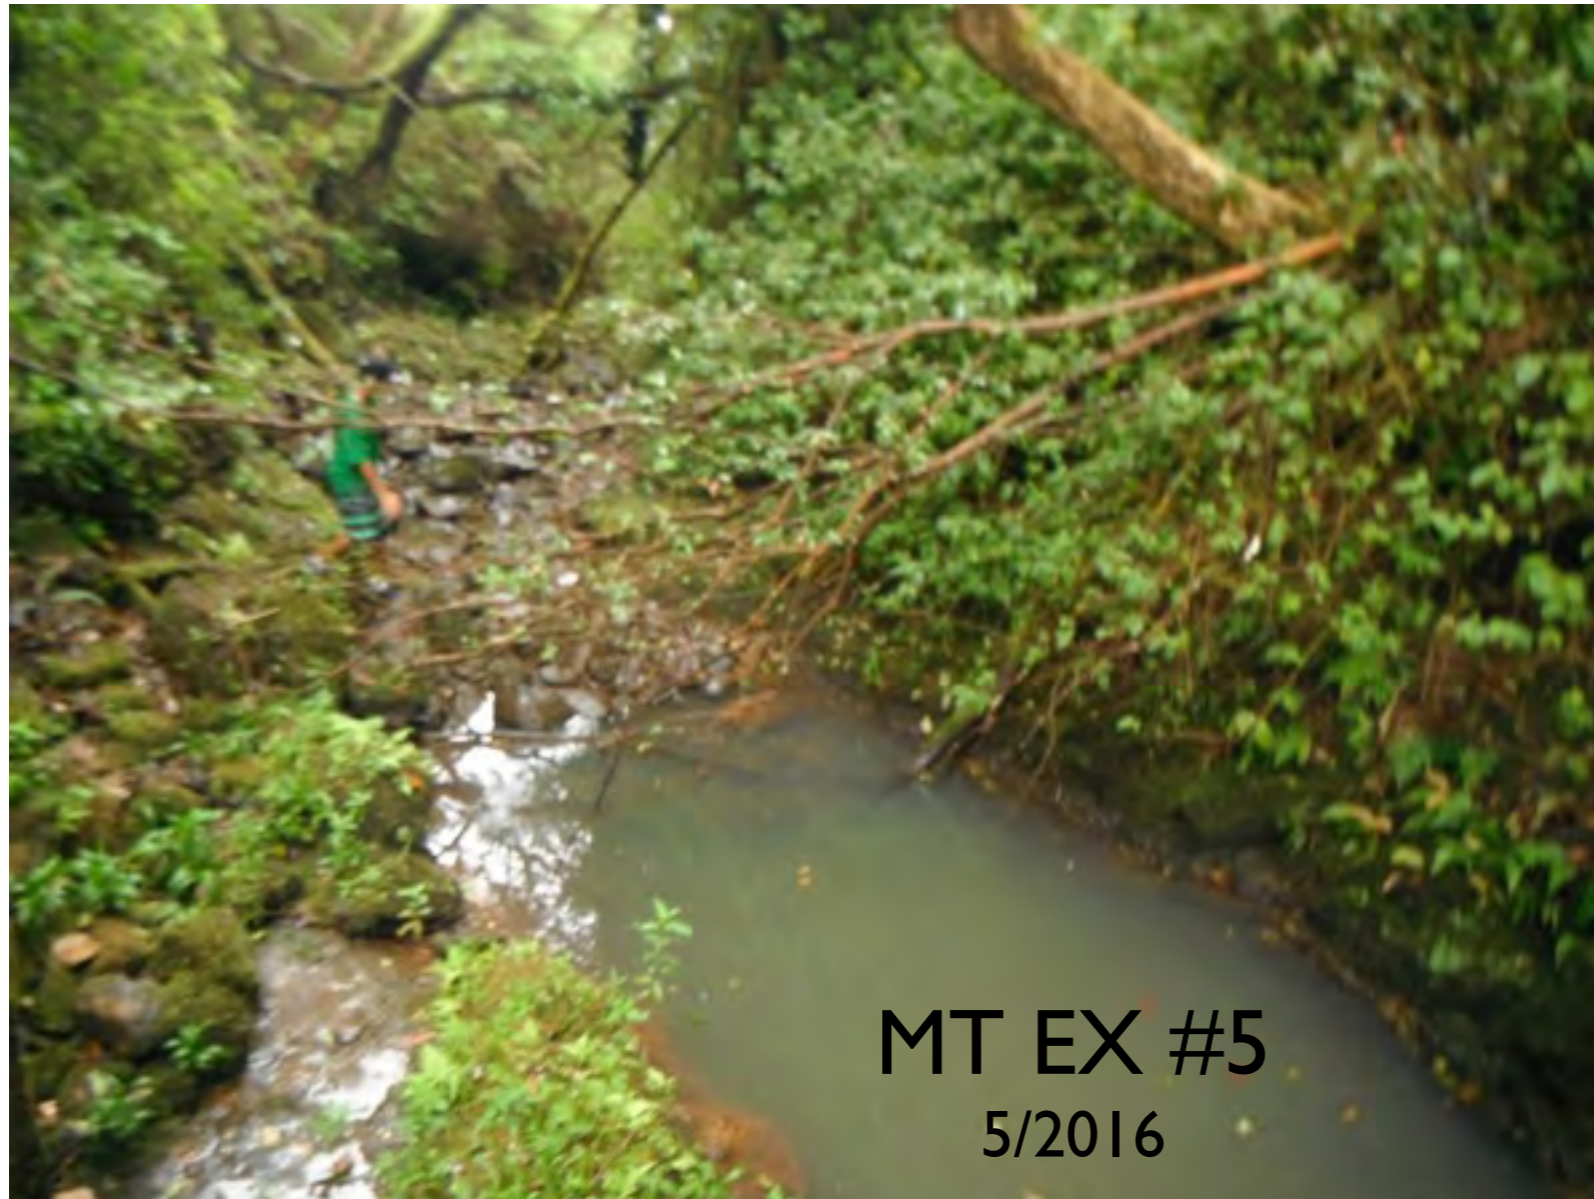
E. Hanehoi stream immediately below Diversion structure W-18- showing stream bed with little flow except wet rocks downstream of diversion structure and stagnant pond

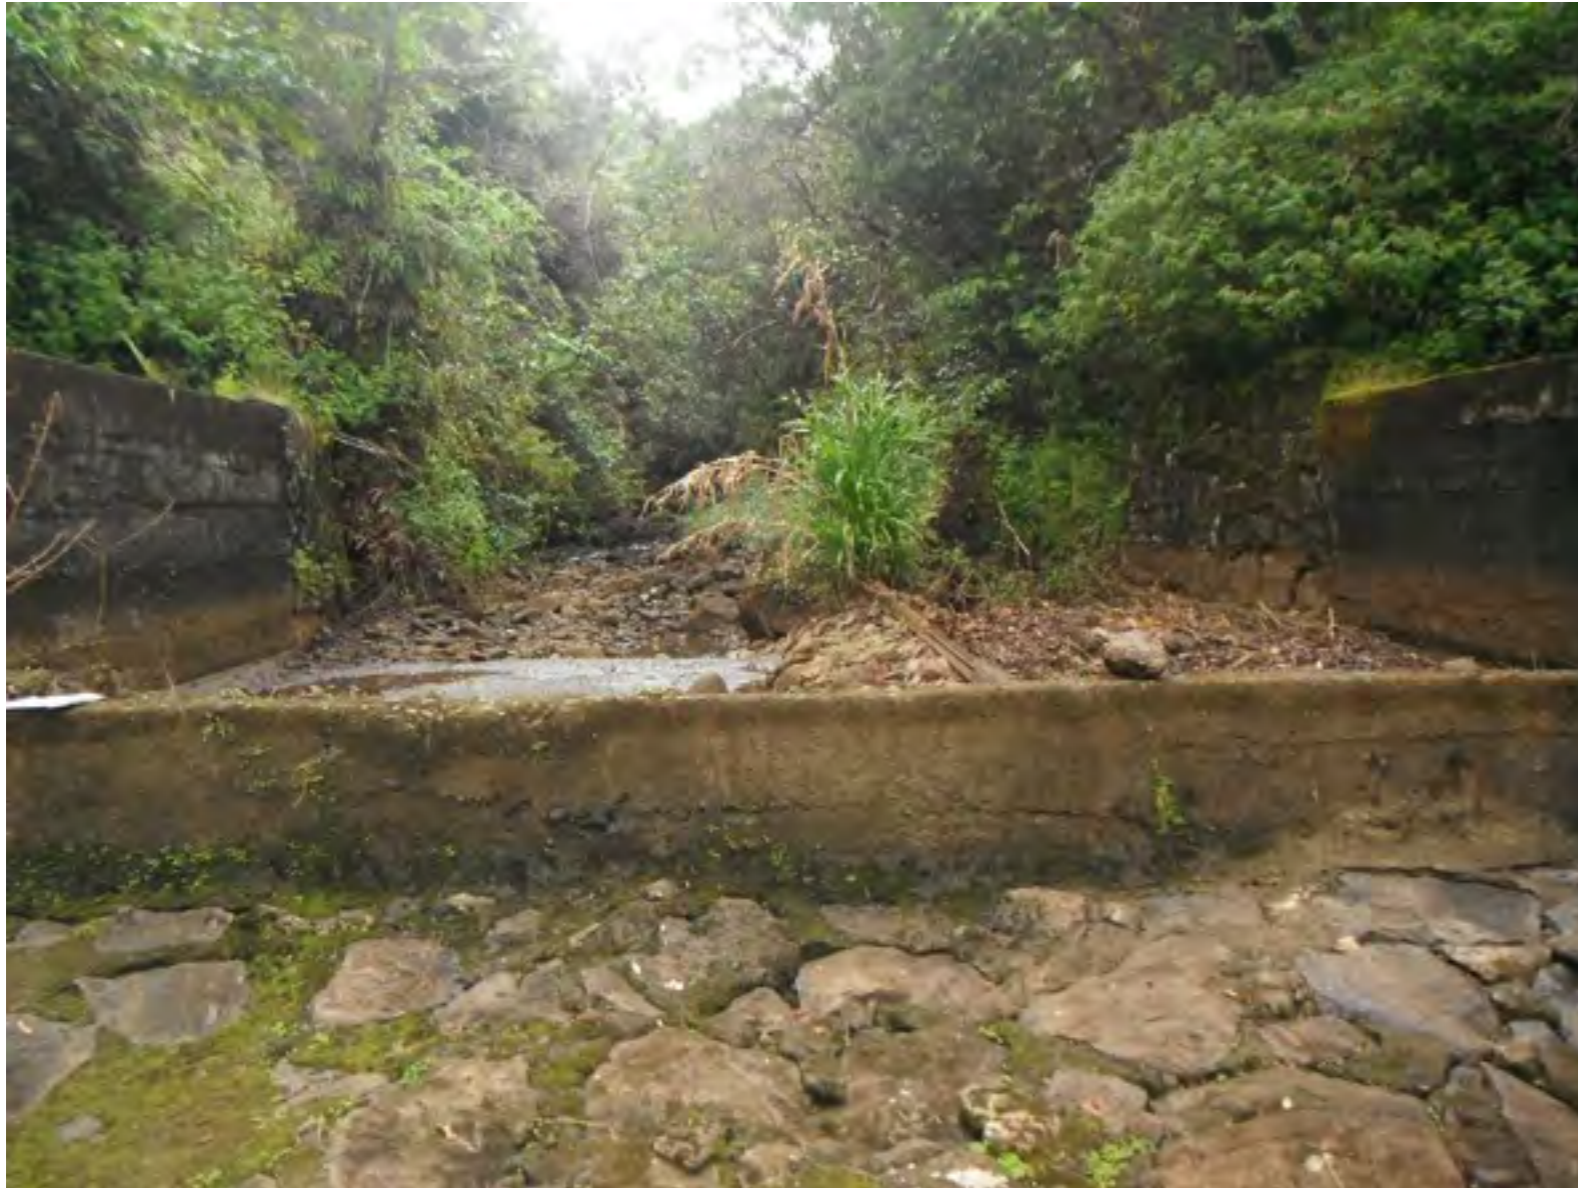
**MT EX #6**  
5/2016

### **Hanehoi Diversion structure NH-17/ 264.6**

Appears this intake has not had regular flows to divert. Grate covered in debris (right side behind dam wall-see next slide)

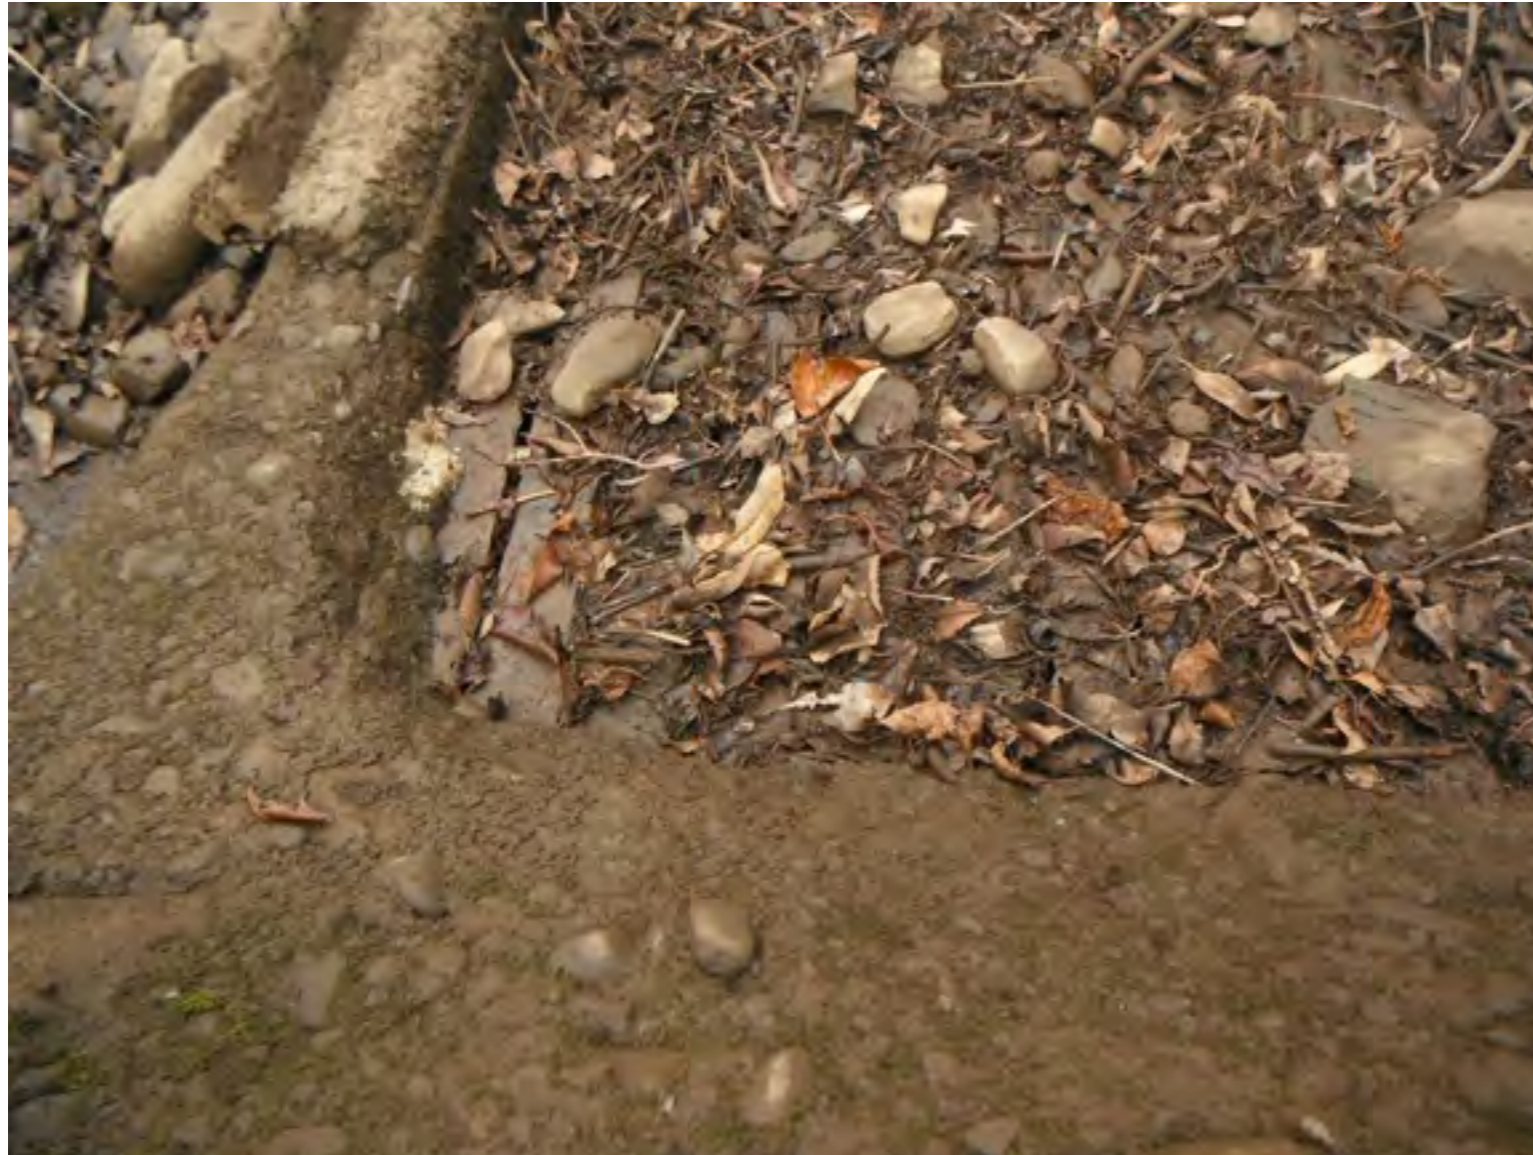
**MT EX #7**  
5/2016

## **Diversion structure NH-17/ 264.6**

Diversion could be bypassed by covering grate.

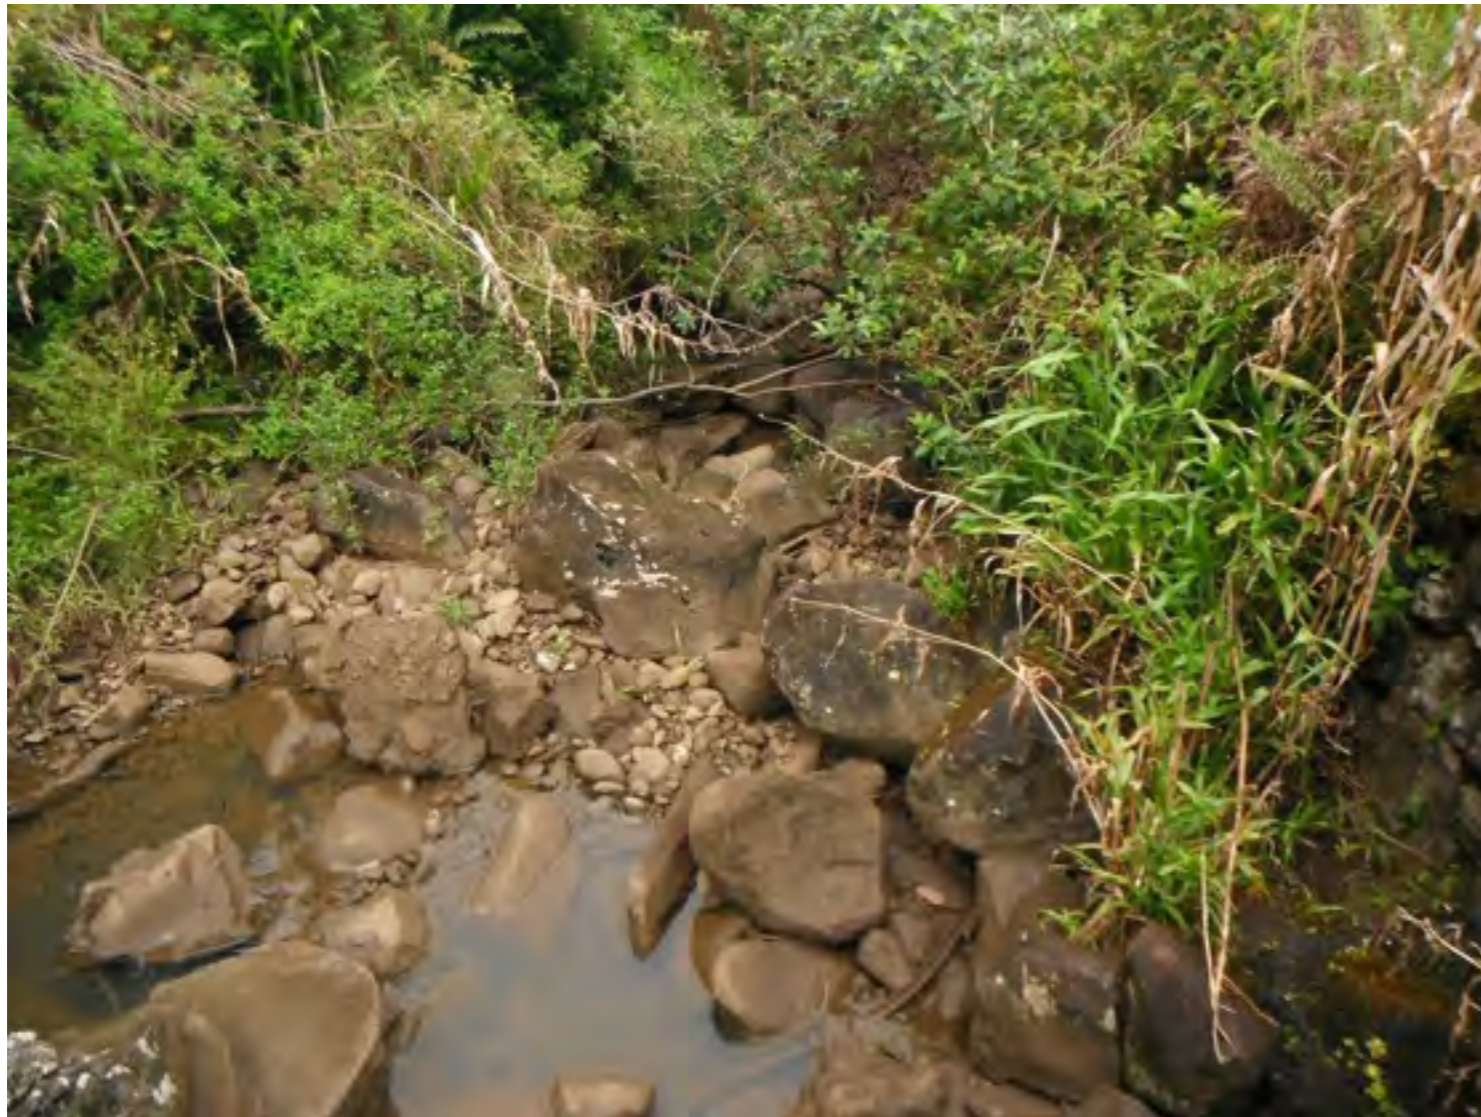
**MT EX #8**  
5/2016

Hanehoi stream,  
immediately  
upstream of  
Diversion structure  
NH-17/ 264.6 on  
East Hanehoi stream  
channel. Stream  
bed overgrown w/  
invasive plants w/  
little flow

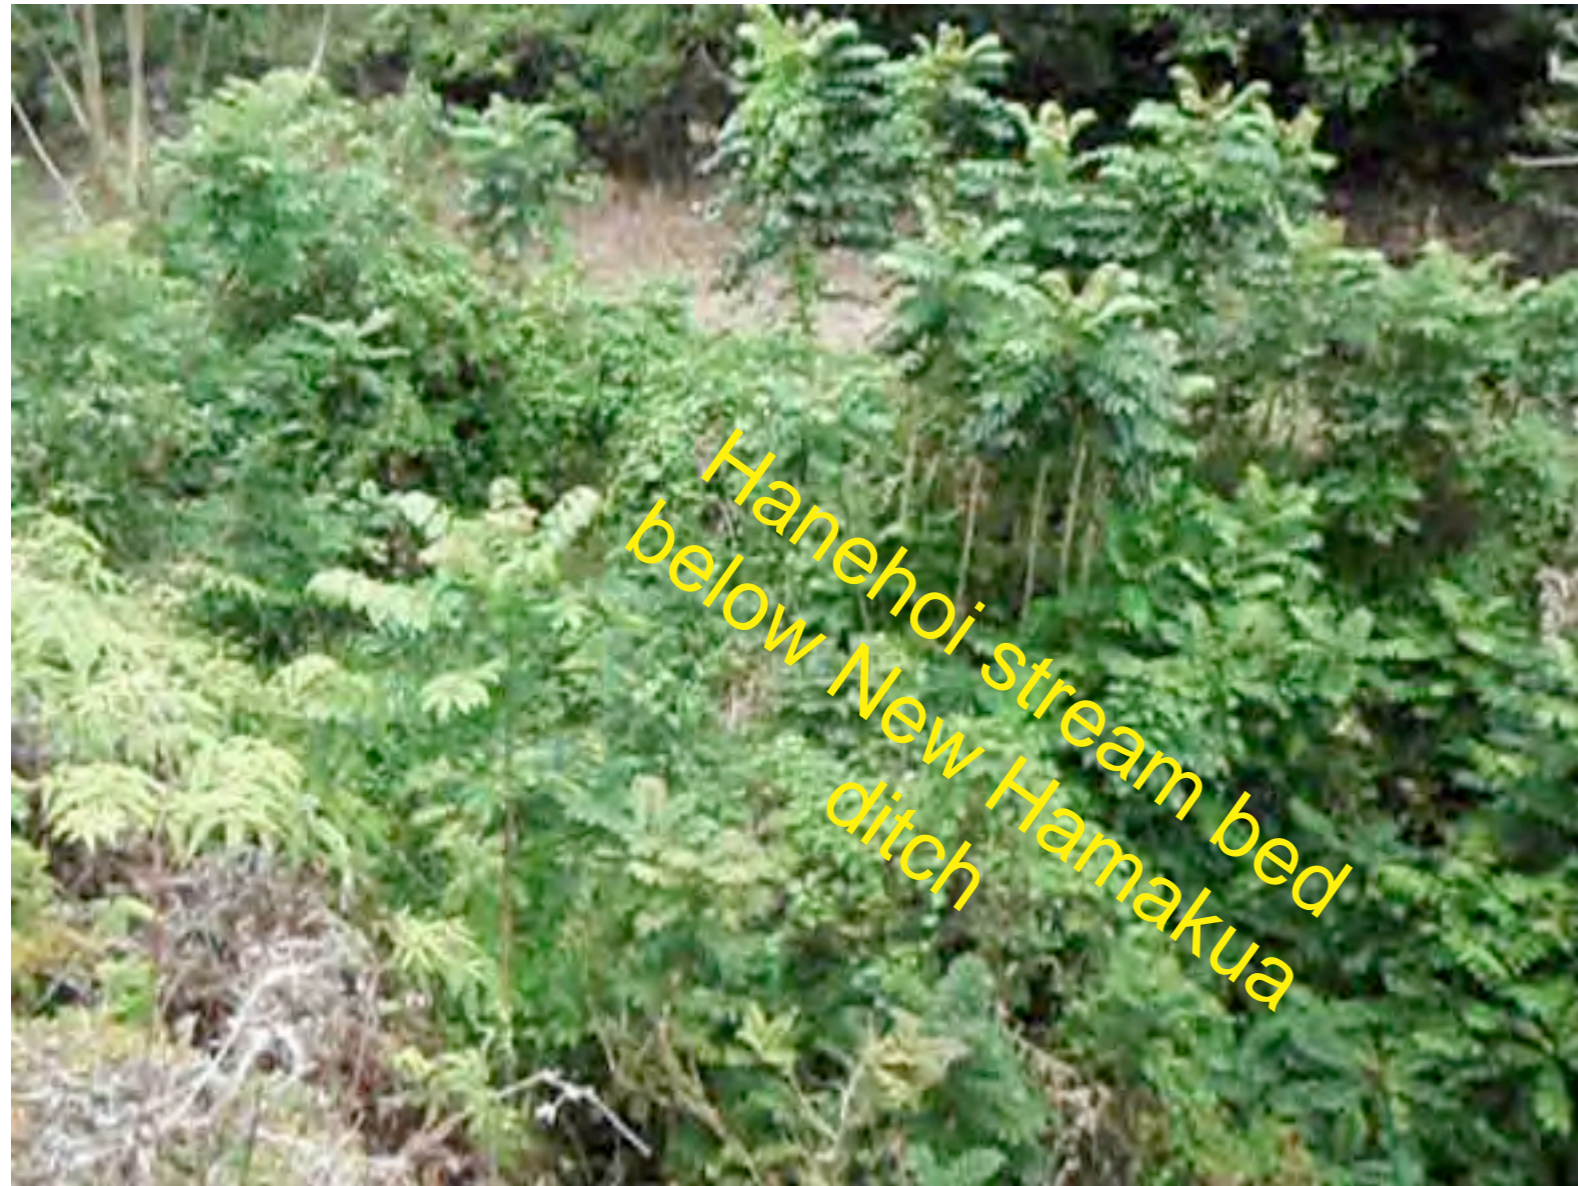
East Hanehoi stream immediately downstream of Diversion structure NH-17/ 264.6 on East Hanehoi stream channel.

Stream bed overgrown w/ invasive trees and plants.

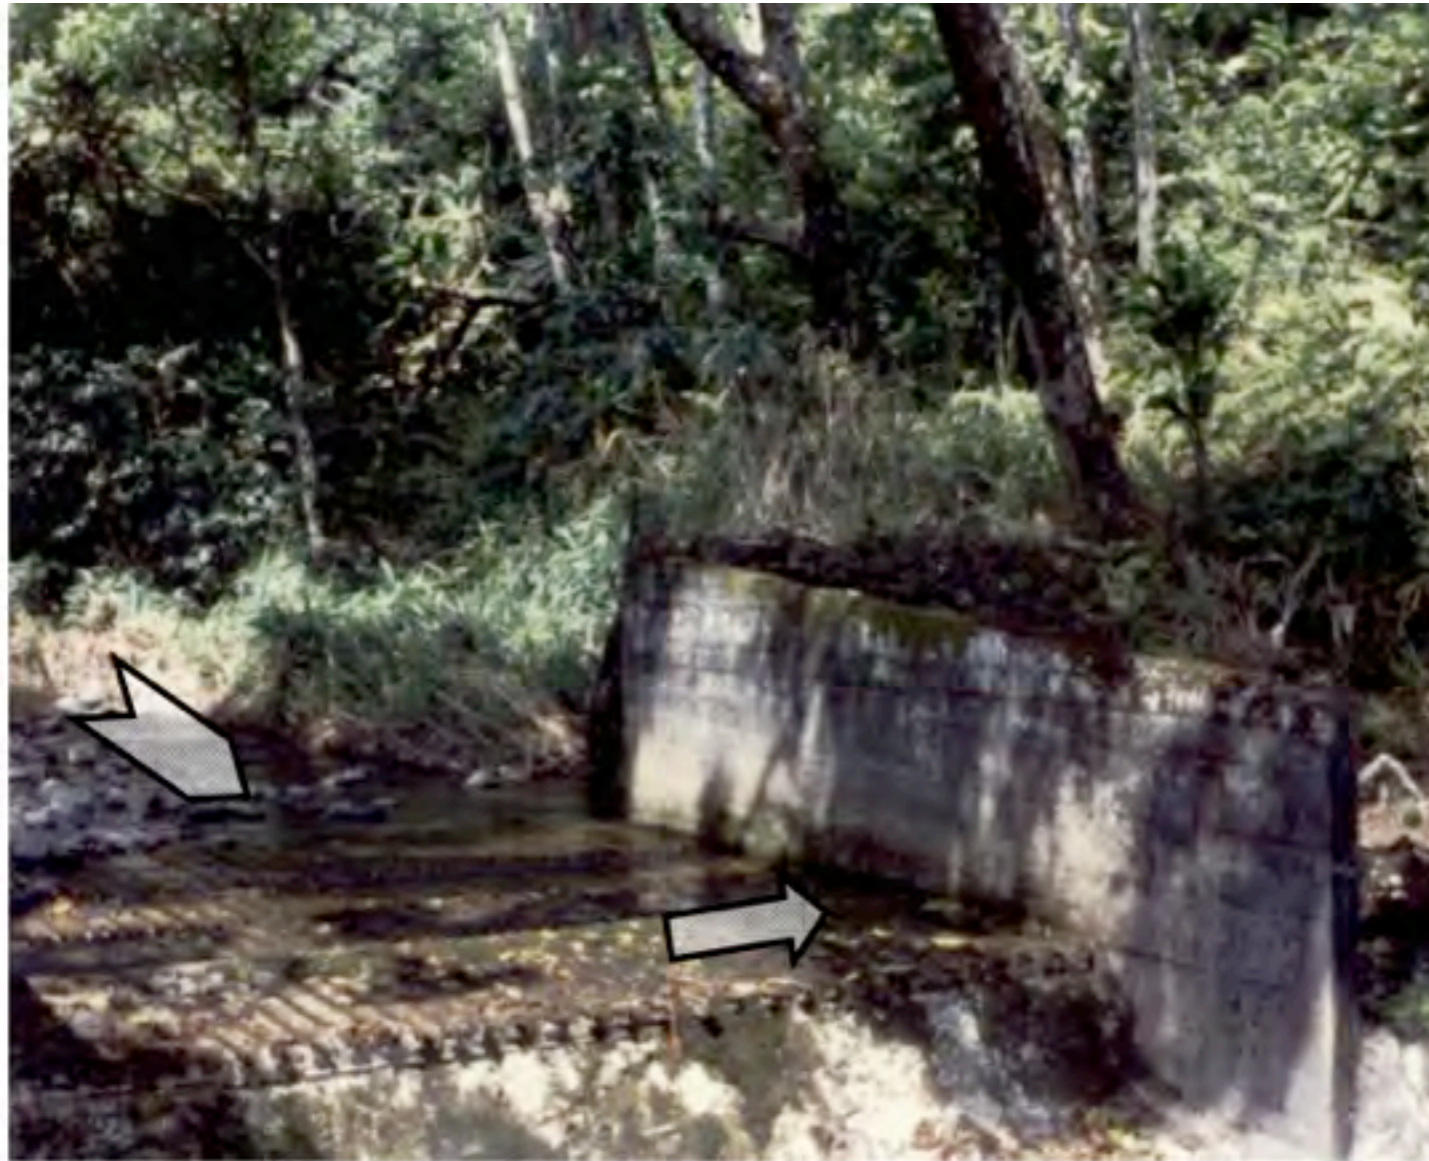
**MT EX #10**  
5/1989

### East Hanehoi stream at Lowrie Ditch

Diversion structure L-5/ 240.6 on East Hanehoi stream channel. Huelo Community pipe (Intake 538.6) located upstream a few hundred yards.

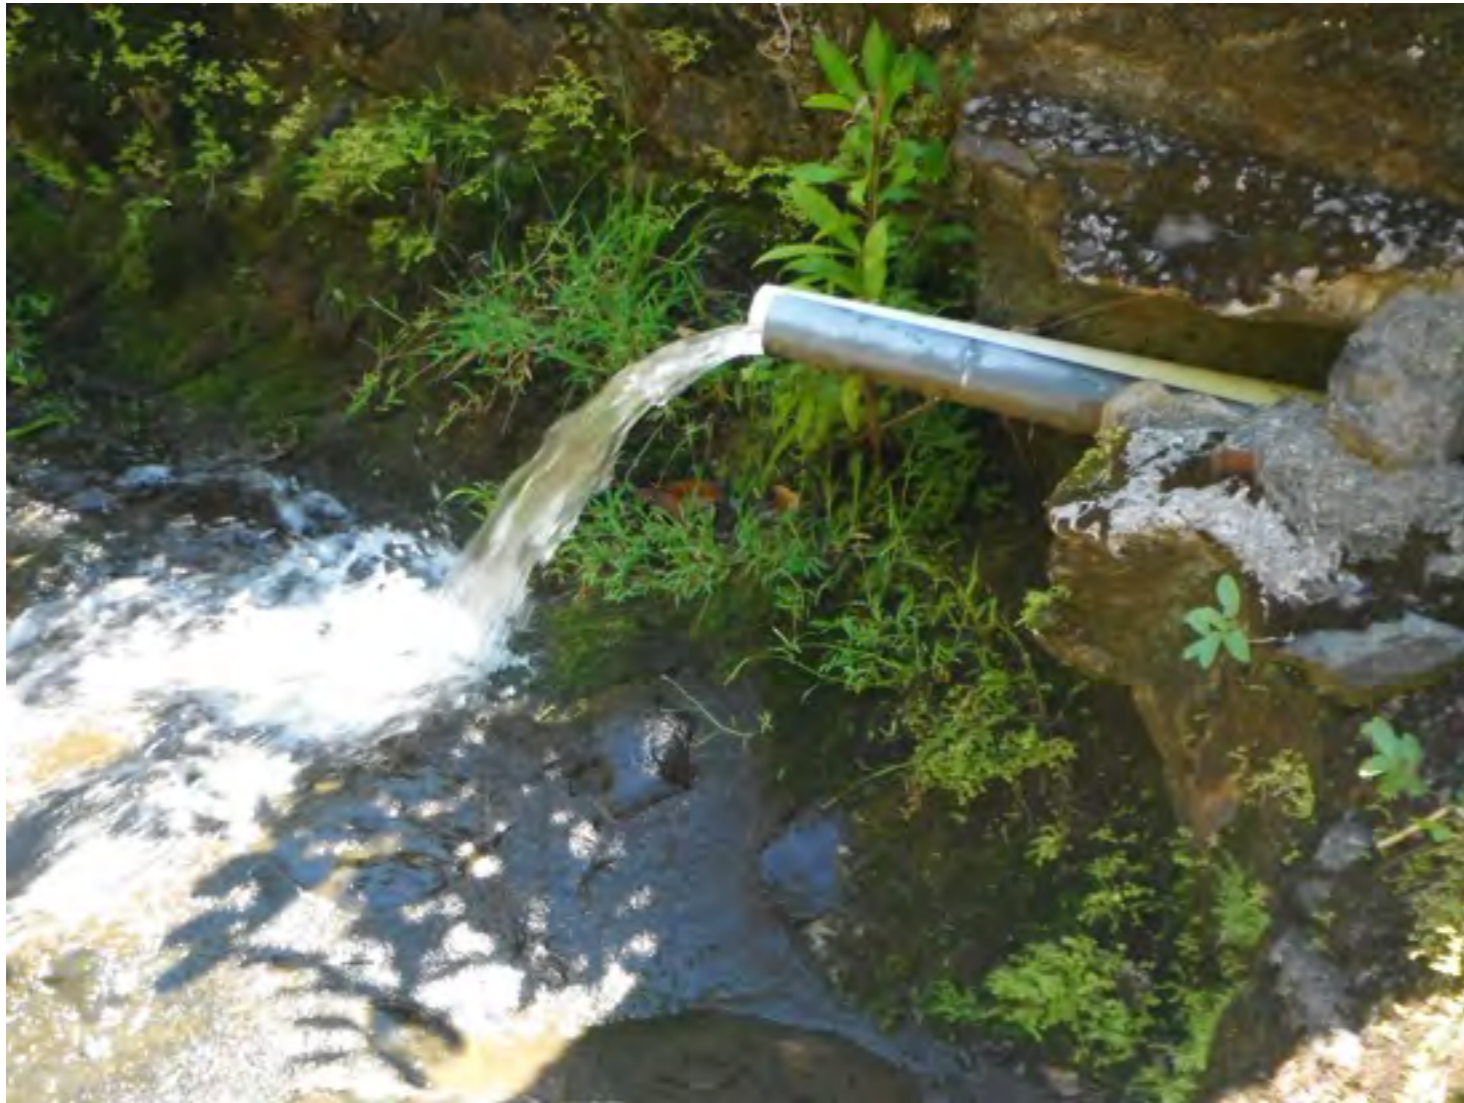
**MT EX #11**  
8/2013

## East Hanehoi stream Lowrie Ditch intake

bypass pipes in Diversion  
structure  
L-5/ 240.6 on East Hanehoi  
stream channel. Pipes are  
subject to blockage on  
upstream side.

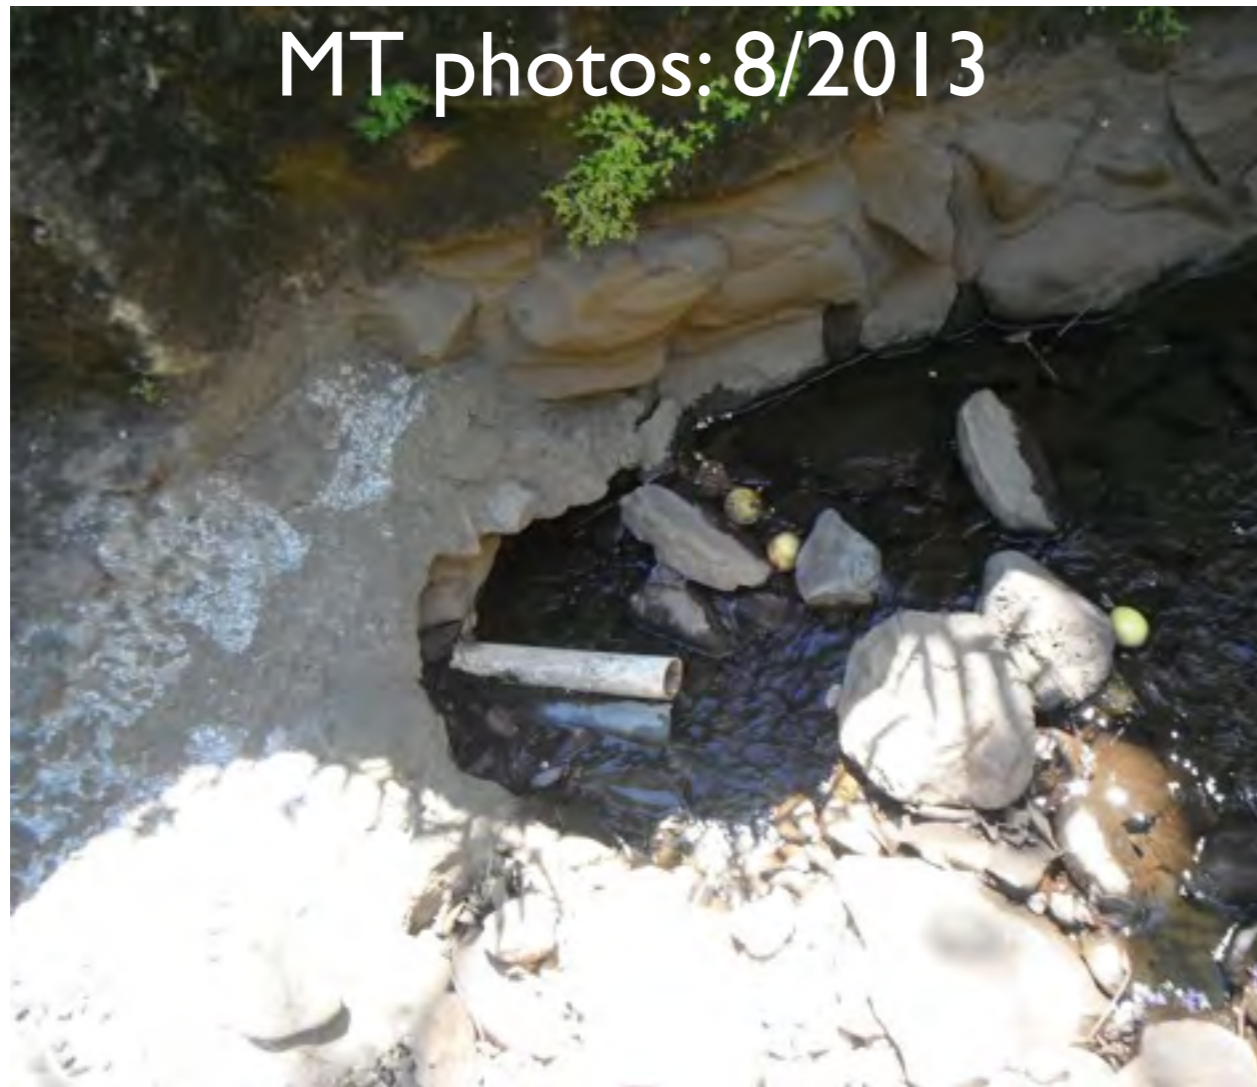
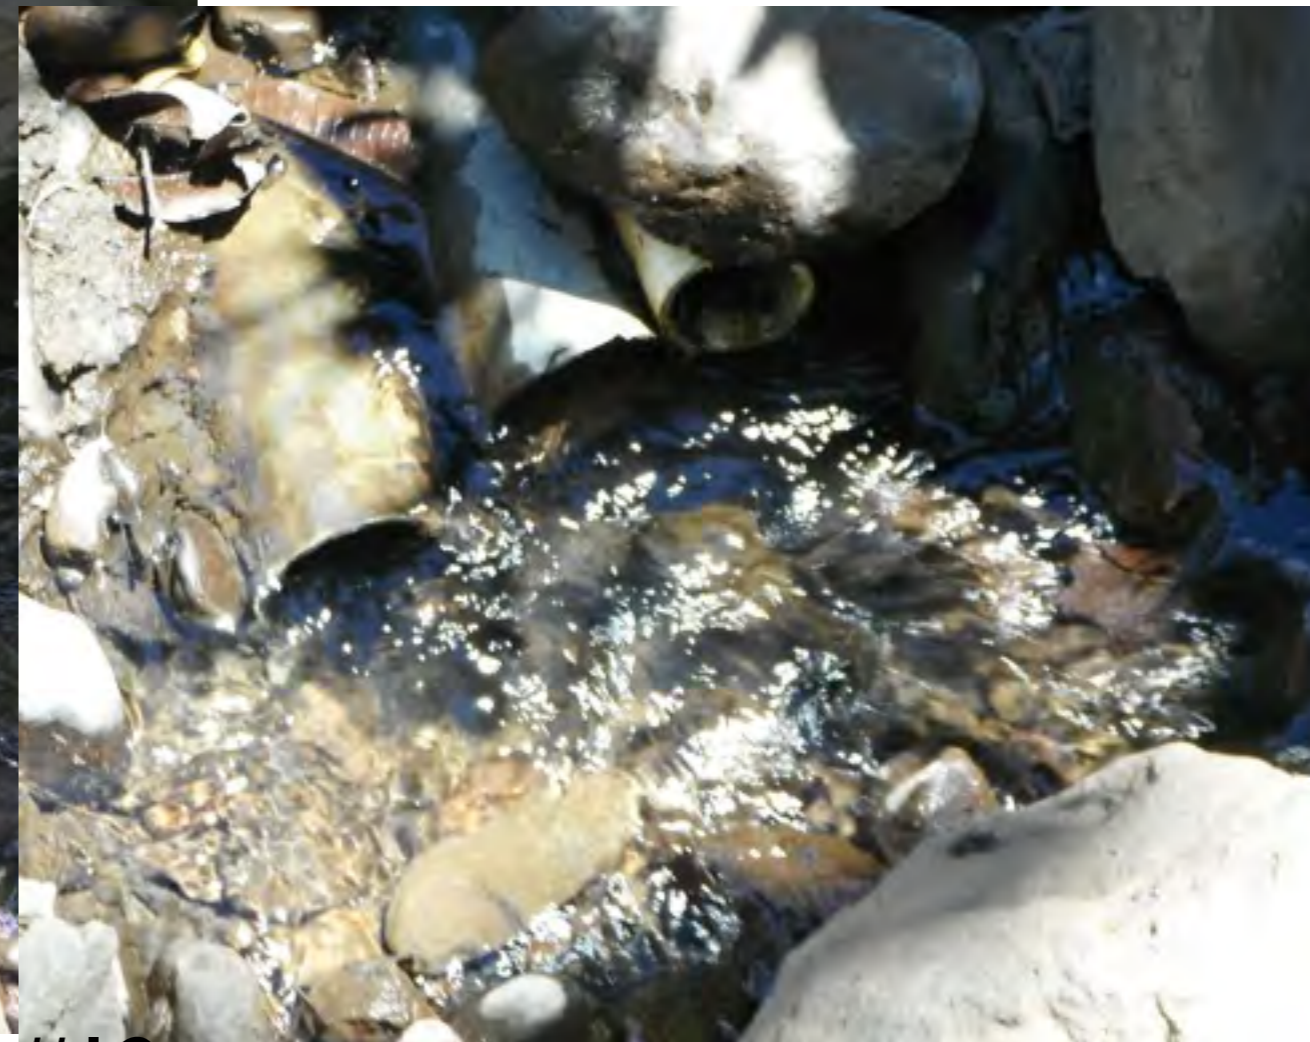
MT EX #12  
8/2013

Lowrie Ditch Diversion- E. Hanehoi Stream (L-5) intake 240.6  
Close up of bypass pipes shown in previous slide.  
Pipes commonly get clogged.
