COMMISSION ON WATER RESOURCE MANAGEMENT  
 STATE OF HAWAII

PETITION TO AMEND INTERIM	)	Case No.: CCH-MA13-01
INSTREAM FLOW STANDARDS FOR	)	
HONOPOU, HUELO (PUOLUA),	)	OBJECTIONS, IN PART, OF
HANEHOI, WAIKAMOI, ALO,	)	MAUI TOMORROW TO
WAHINEPEE, PUOHOKAMOA,	)	HEARINGS OFFICER'S
HAIPIUAENA, PUNALAU/KOLEA,	)	AMENDED RECOMMENDATION
HONOMANU, NUAAILUA, PIINAAU,	)	RE INTERIM RESTORATION OF
PALAUHULU, 'OHI'A (WAIANU),	)	STREAM FLOW; EXHIBIT "A";
WAIOKAMILO, KUALANI,	)	MT EXHIBITS "1" – "40"; MT
WAILUANUI, WEST WAILUAIKI, EAST	)	MAPS "1" – "4"; CERTIFICATE
WAILUAIKI, KOPILIULA, PUAKEA,	)	OF SERVICE
WAIOHUE, PAAKEA, WAIAAKA,	)	
KAPAUULA, HANAWI and MAKAPIPI	)	
STREAMS	)	
	)

**OBJECTIONS, IN PART, OF MAUI TOMORROW TO HEARINGS OFFICER'S  
 AMENDED RECOMMENDATION RE INTERIM RESTORATION OF STREAM  
 FLOW**

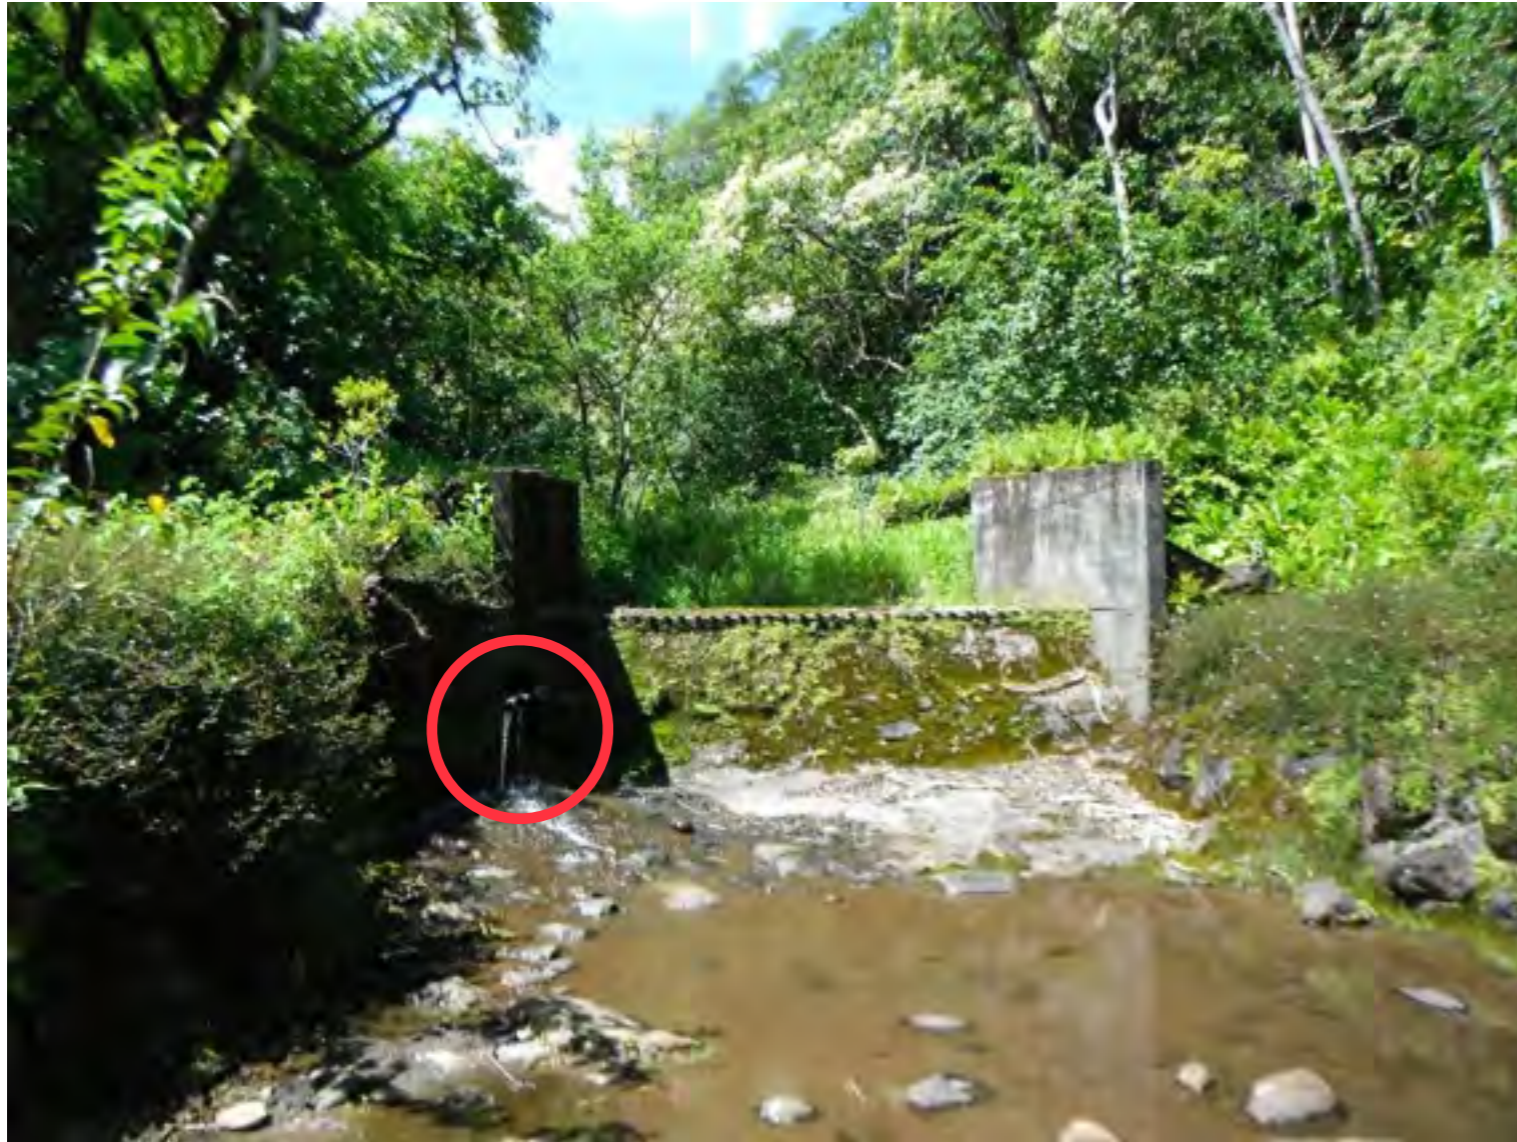
**MT EX #13**  
7/2012

### East Hanehoi stream at Lowrie Diversion structure

L-5/ 240.6 on East Hanehoi  
stream channel. View  
upstream.

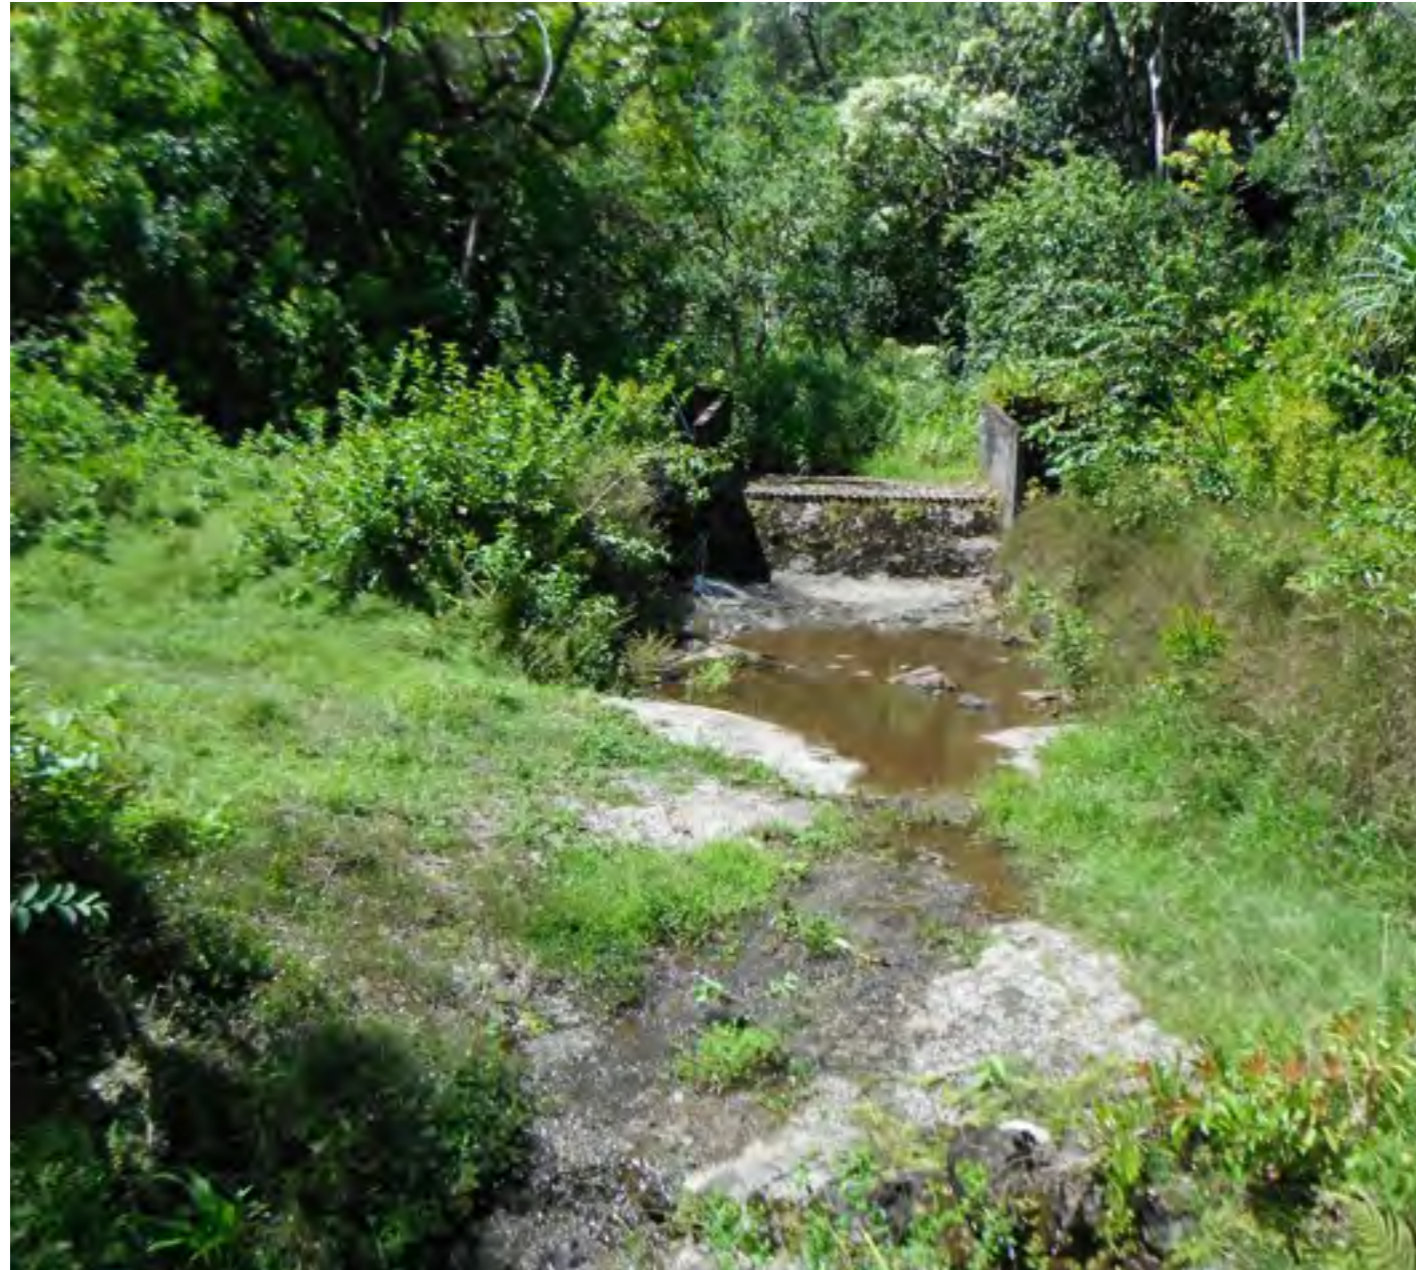
### **East Hanehoi stream Intake Lowrie Ditch**

Far view, immediately downstream of Diversion structure L-5/ 240.6 on East Hanehoi stream channel. Stream bed overgrown w/ invasive plants.

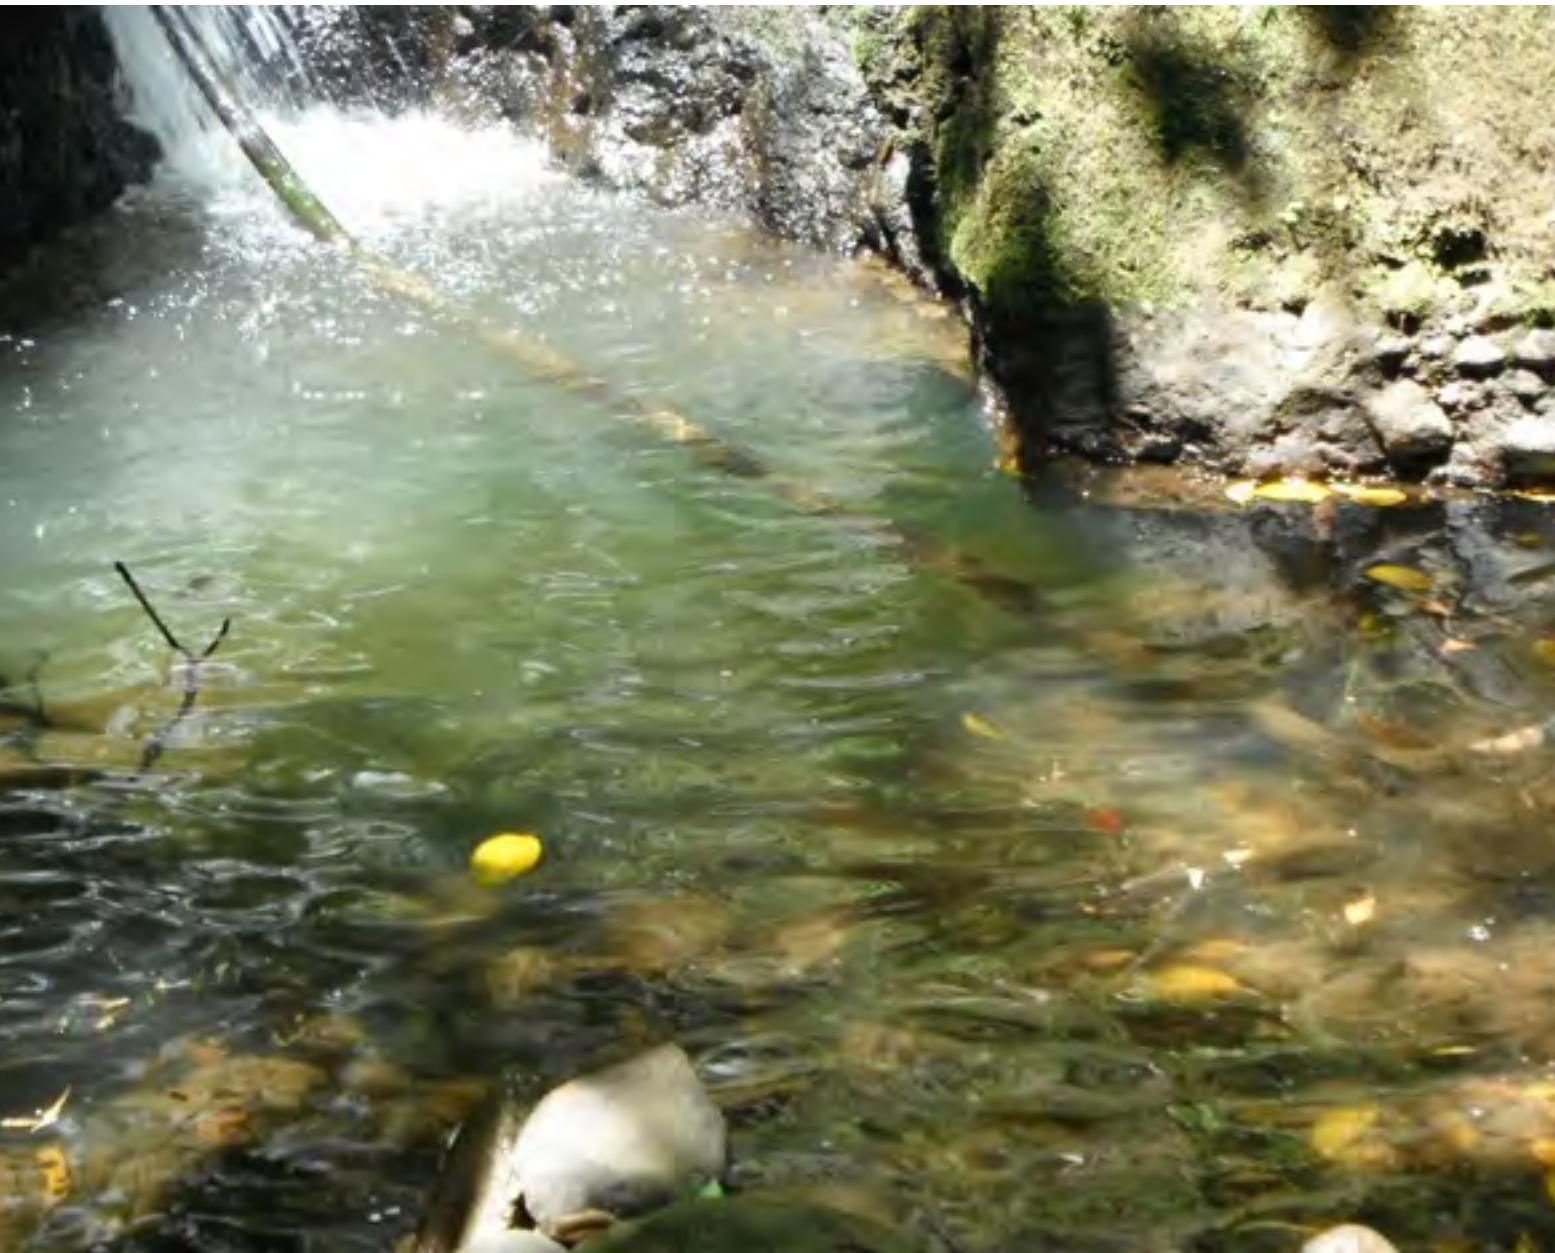
East Hanehoi stream  
pool above Diversion  
structure

L-5/ 240.6 on East  
Hanehoi stream  
channel. Huelo  
Community pipe  
(Intake 538.6)

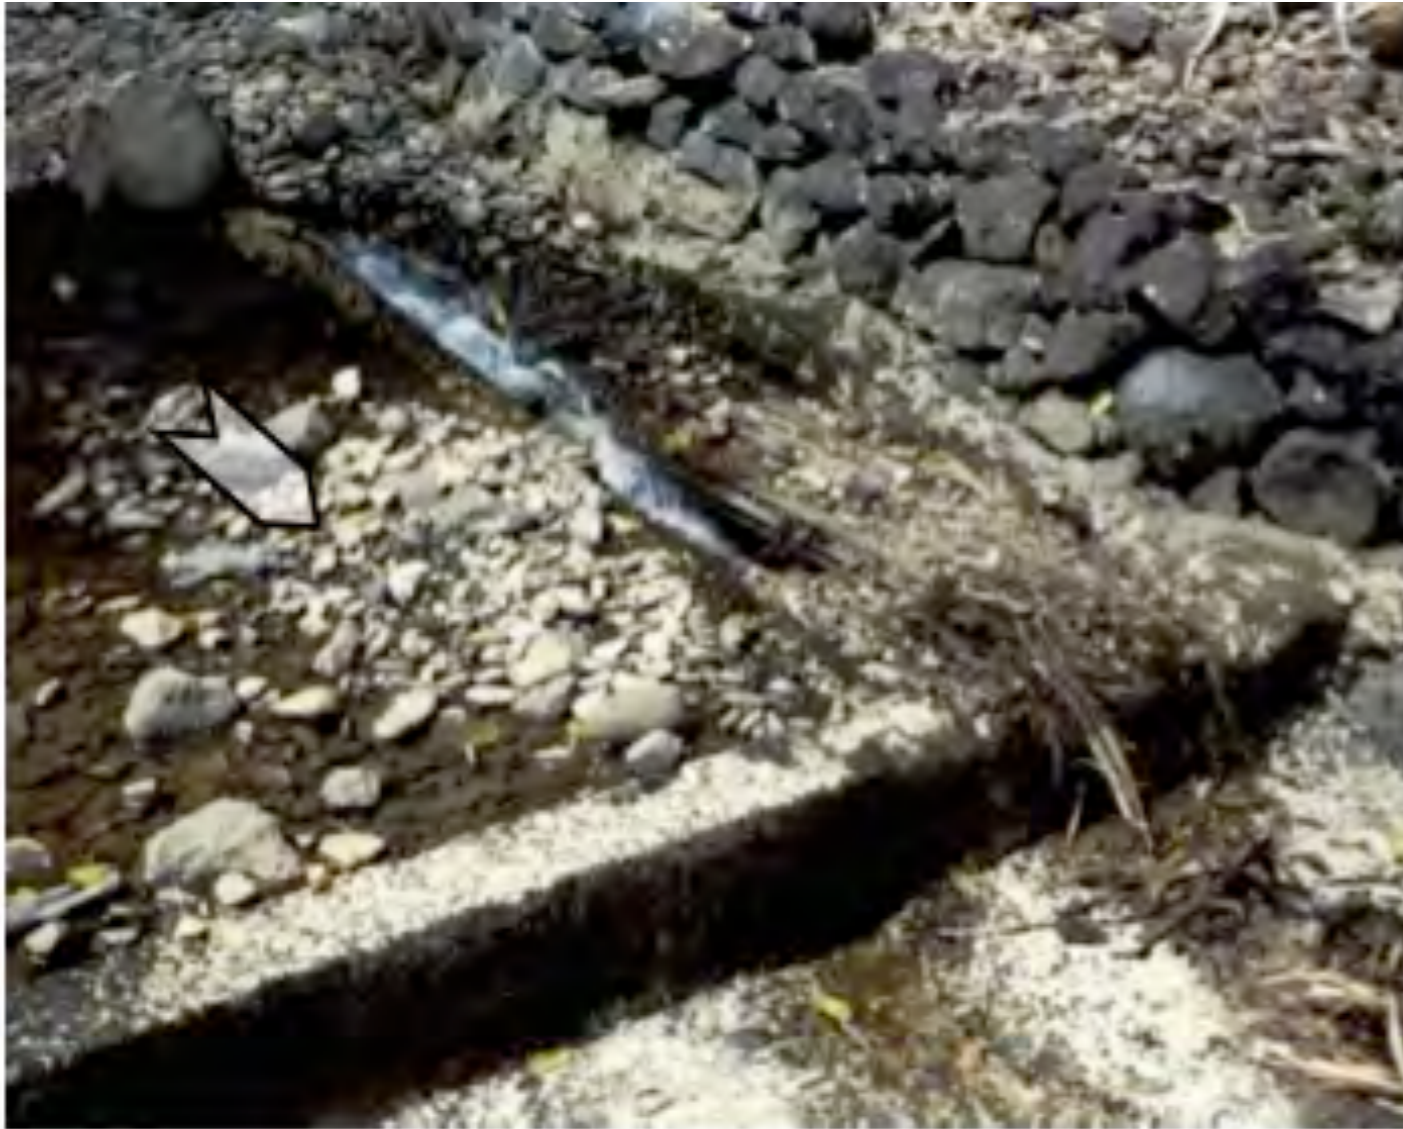
### West Hanehoi stream intake at Lowrie ditch

Diversion structure L-6/ 242.6 on West Hanehoi stream channel.

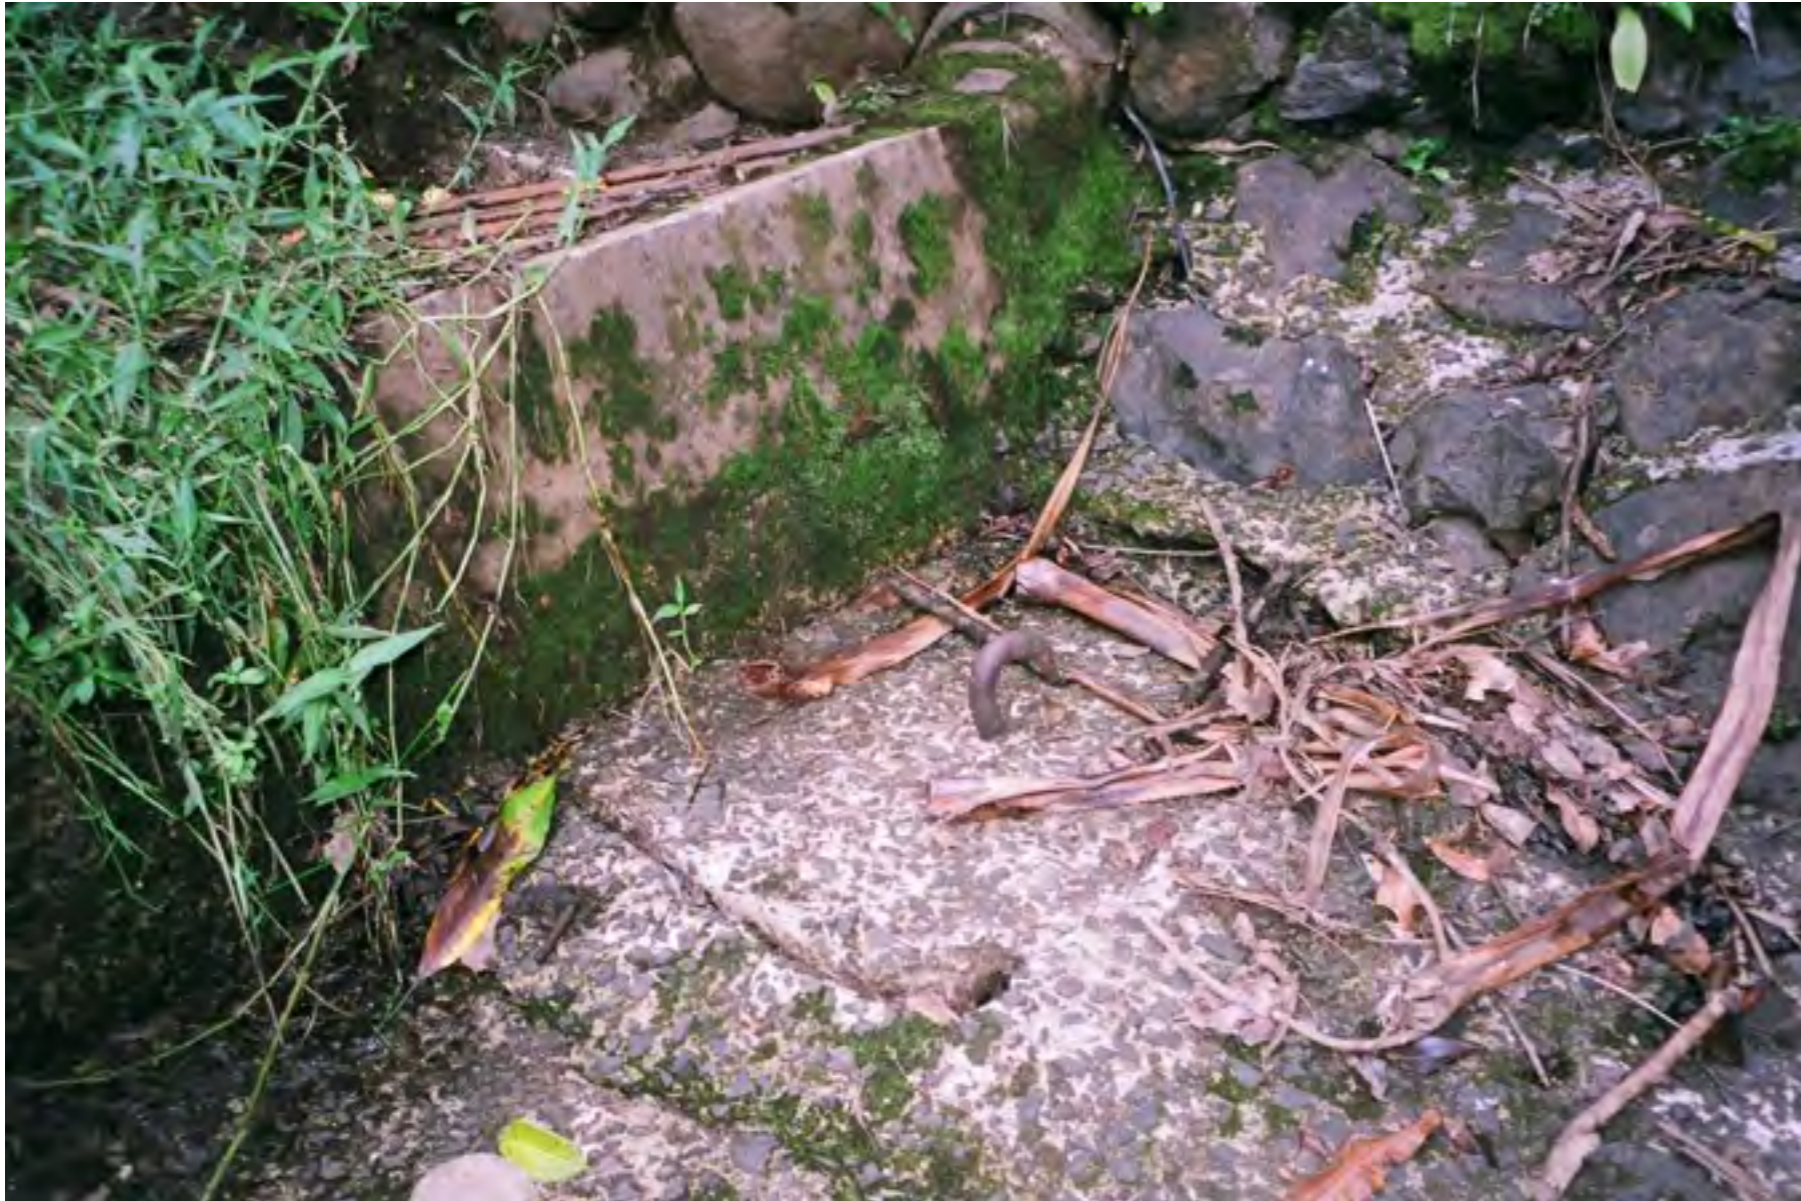
**West Hanehoi stream  
intake at Lowrie ditch**

Closeup of Diversion  
structure  
L-6/ 242.6 on West  
Hanehoi stream  
channel.

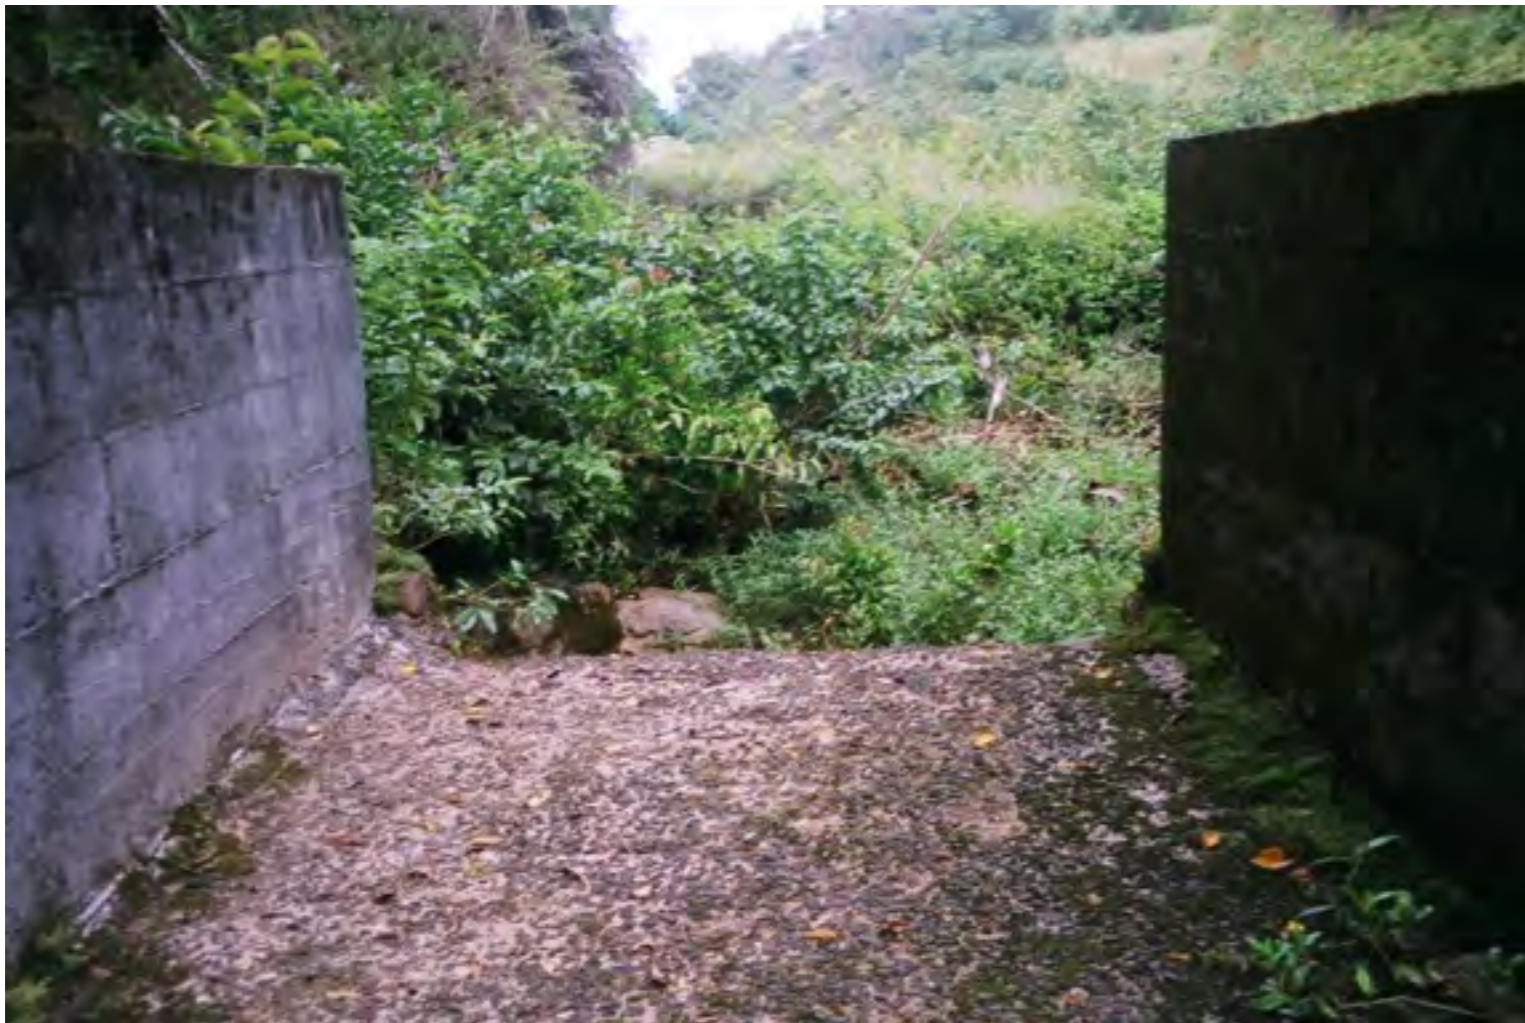
**MT EX #18**

Spillway crossing at  
W. Hanehoi Stream  
over Lowrie Ditch  
makai view

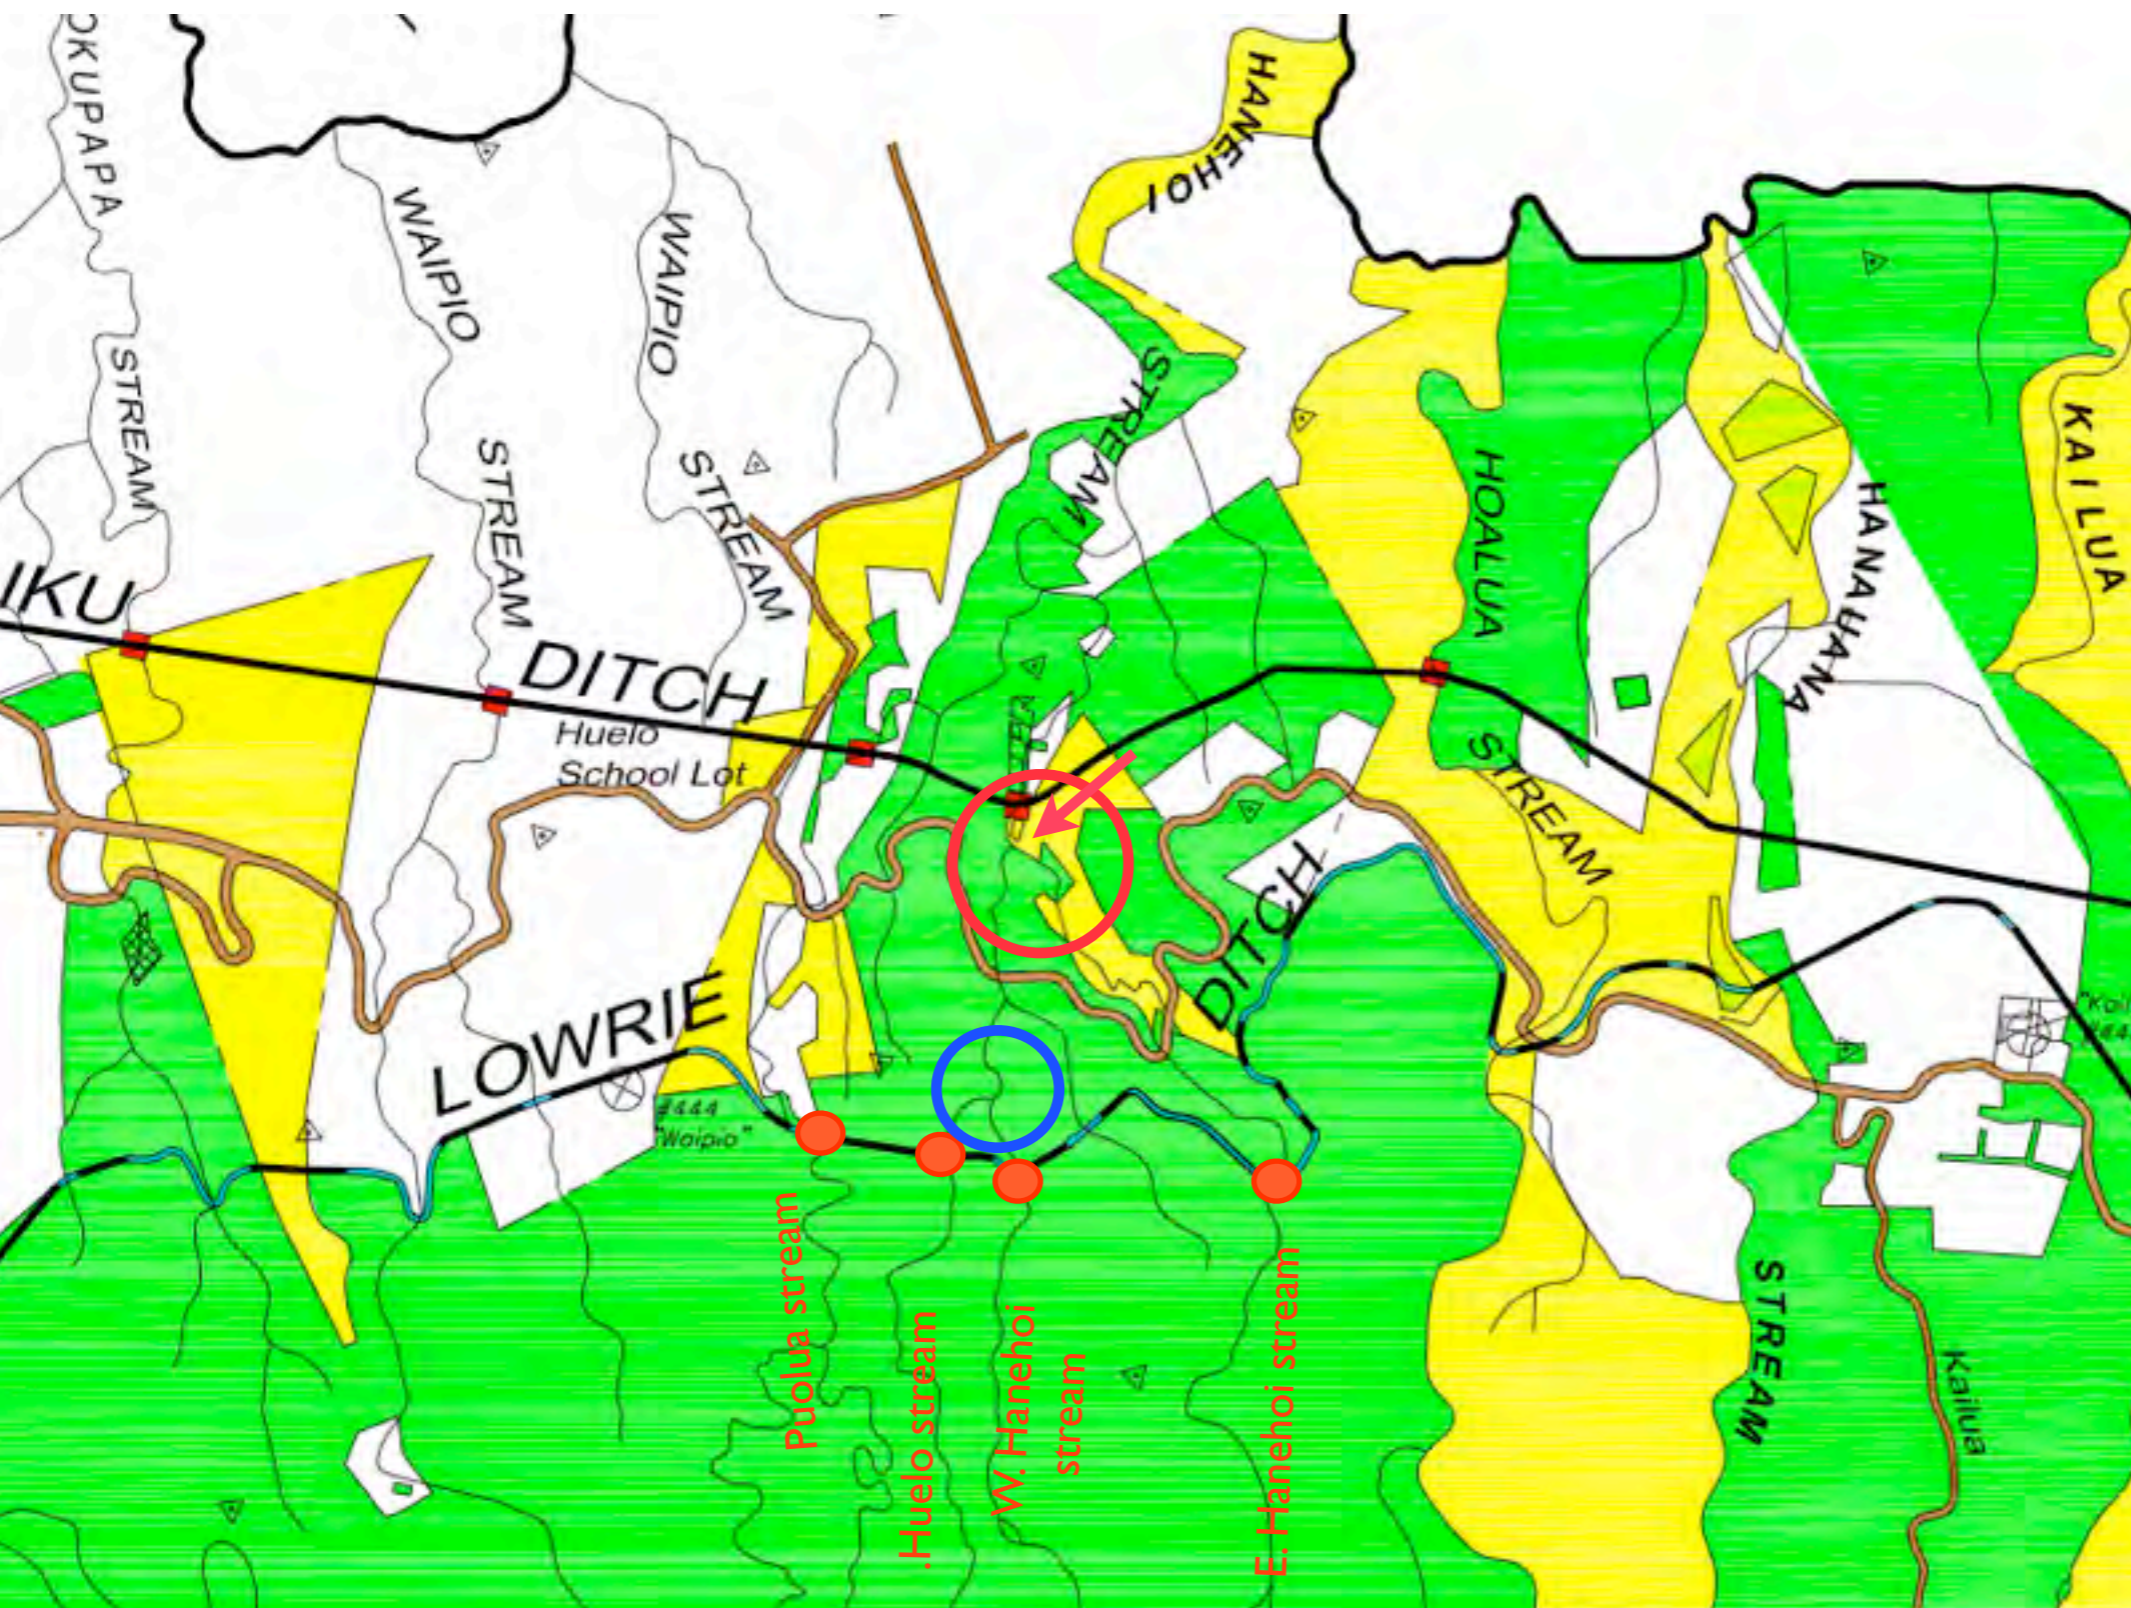
**A&B EXH C-01 Map**

**Red circle** shows where E. & W. Hanehoi Streams meet, just mauka of Haiku ditch.

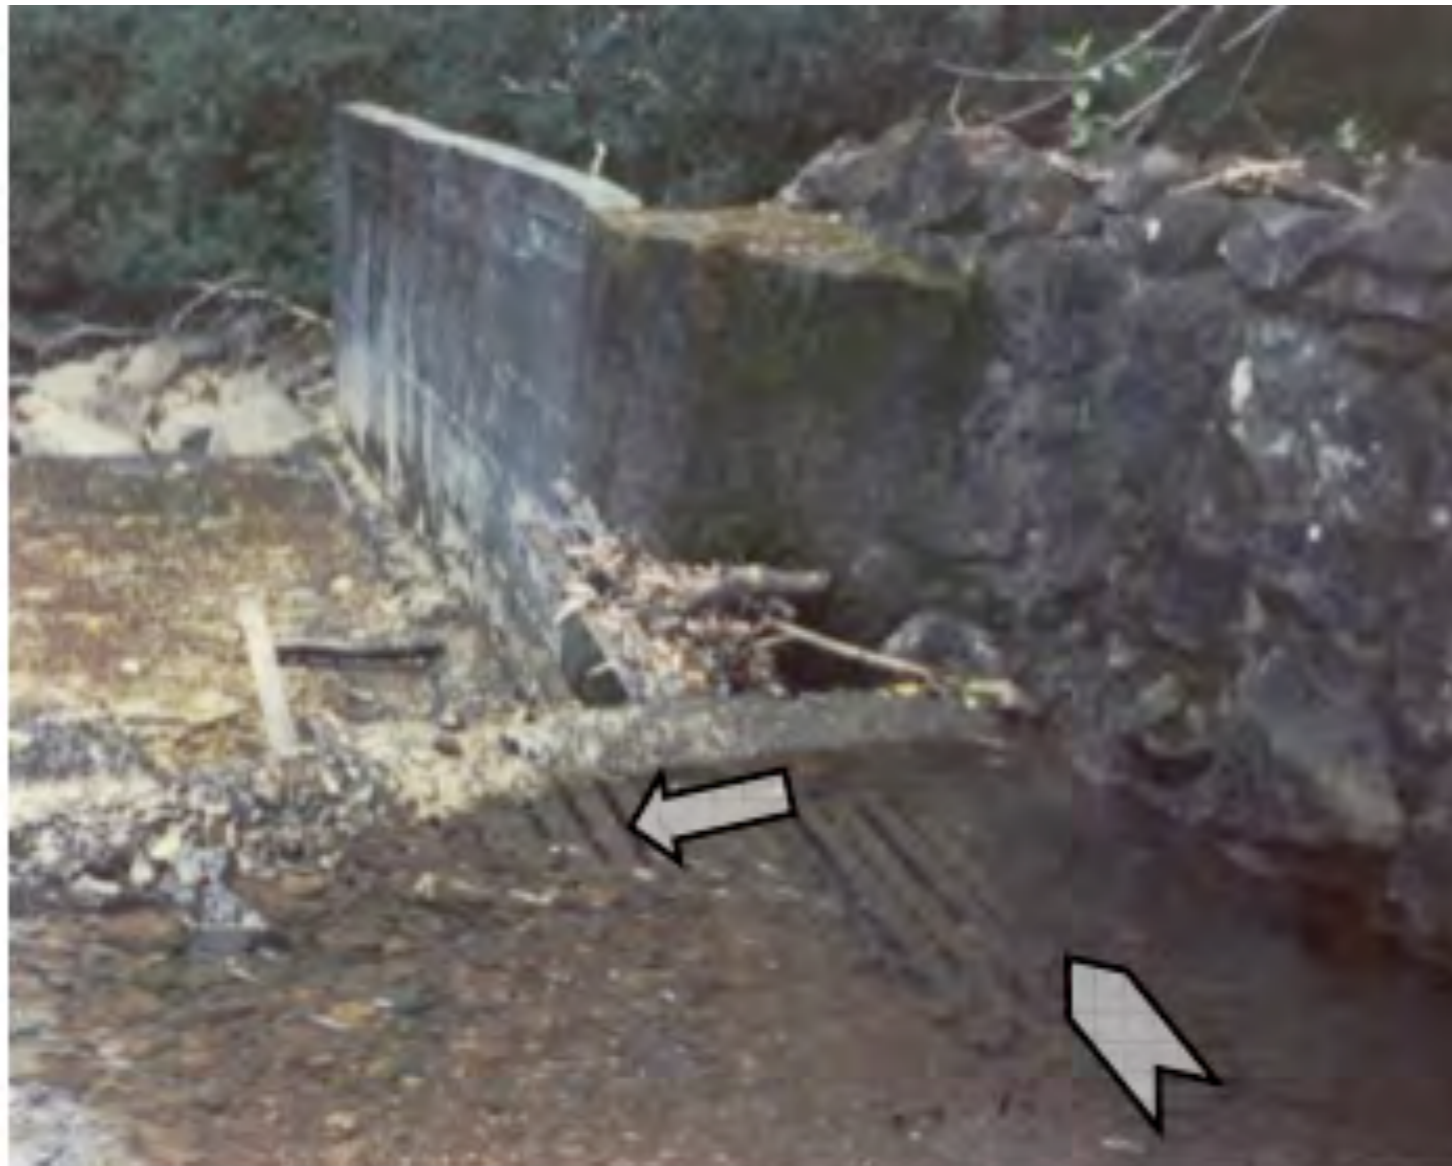
Diversion structure L-7/ 155.6 on Huelo stream channel.

This diversion is not discussed in A&B's first draft plan for stream restoration of Hanehoi stream, yet Huelo is a tributary of the Hanehoi stream. Huelo stream joins W. Hanehoi stream just makai of the Lowrie Ditch.

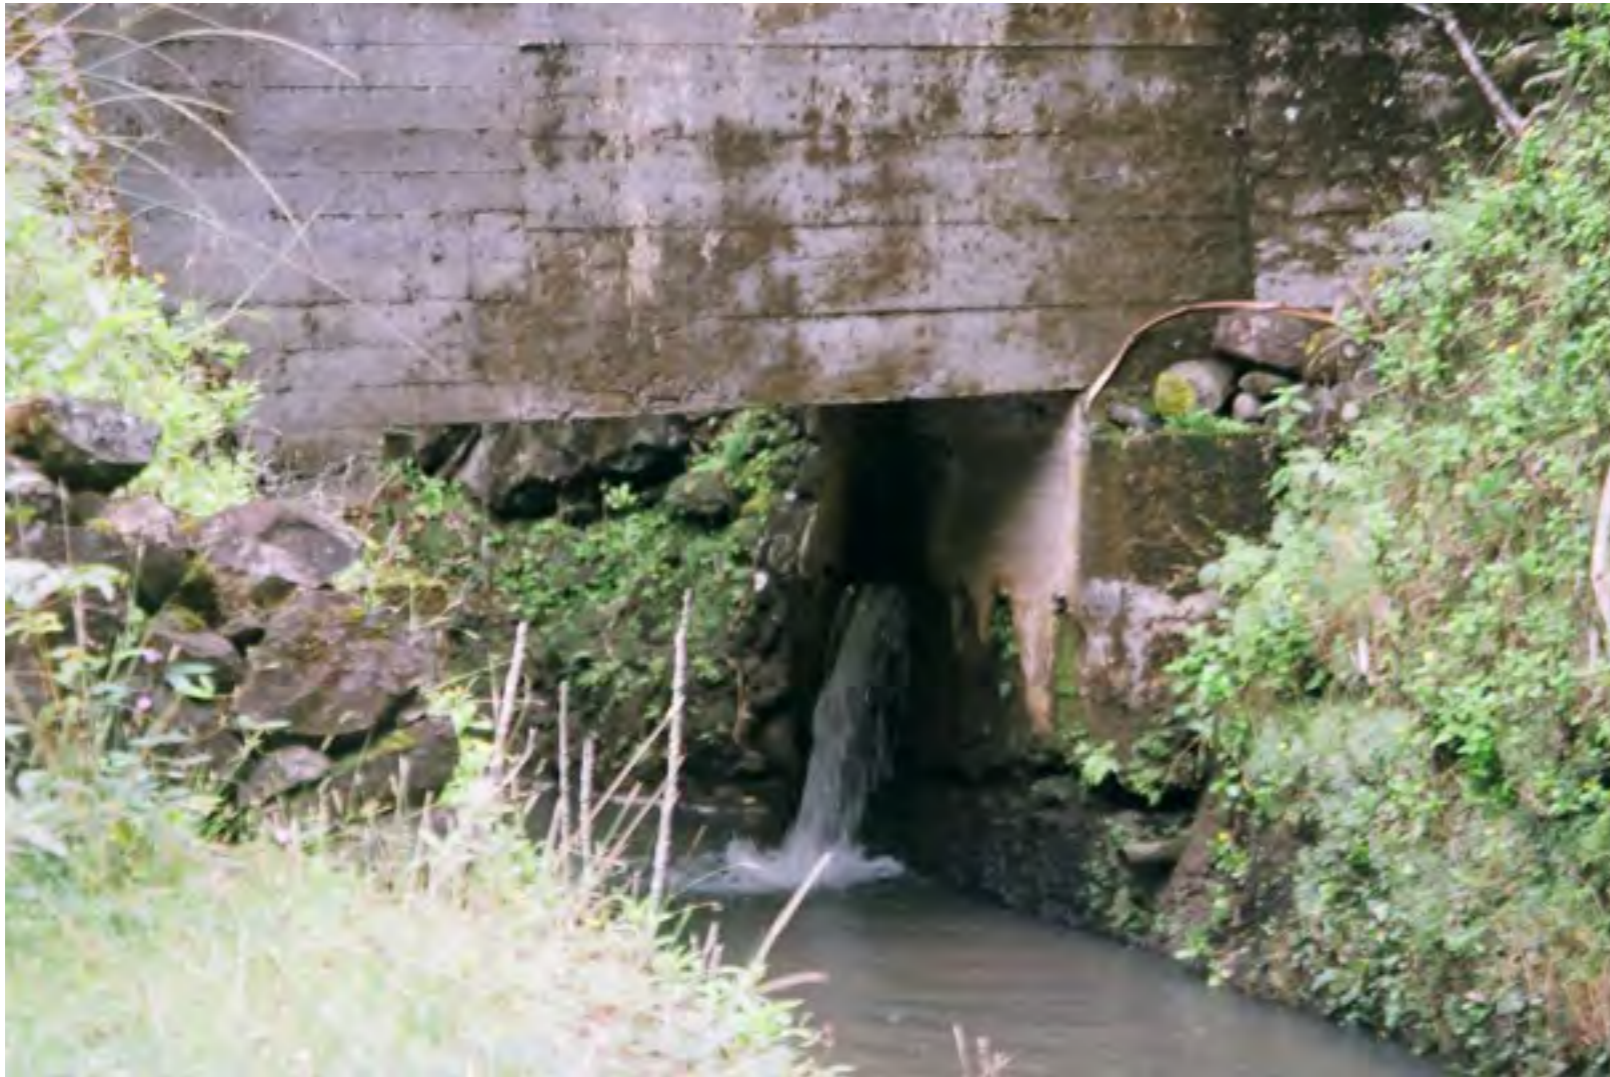
### **Huelo stream intake at Lowrie ditch**

View down Lowrie ditch  
of diversion structure  
L-7/ 155.6 on Huelo  
stream channel.

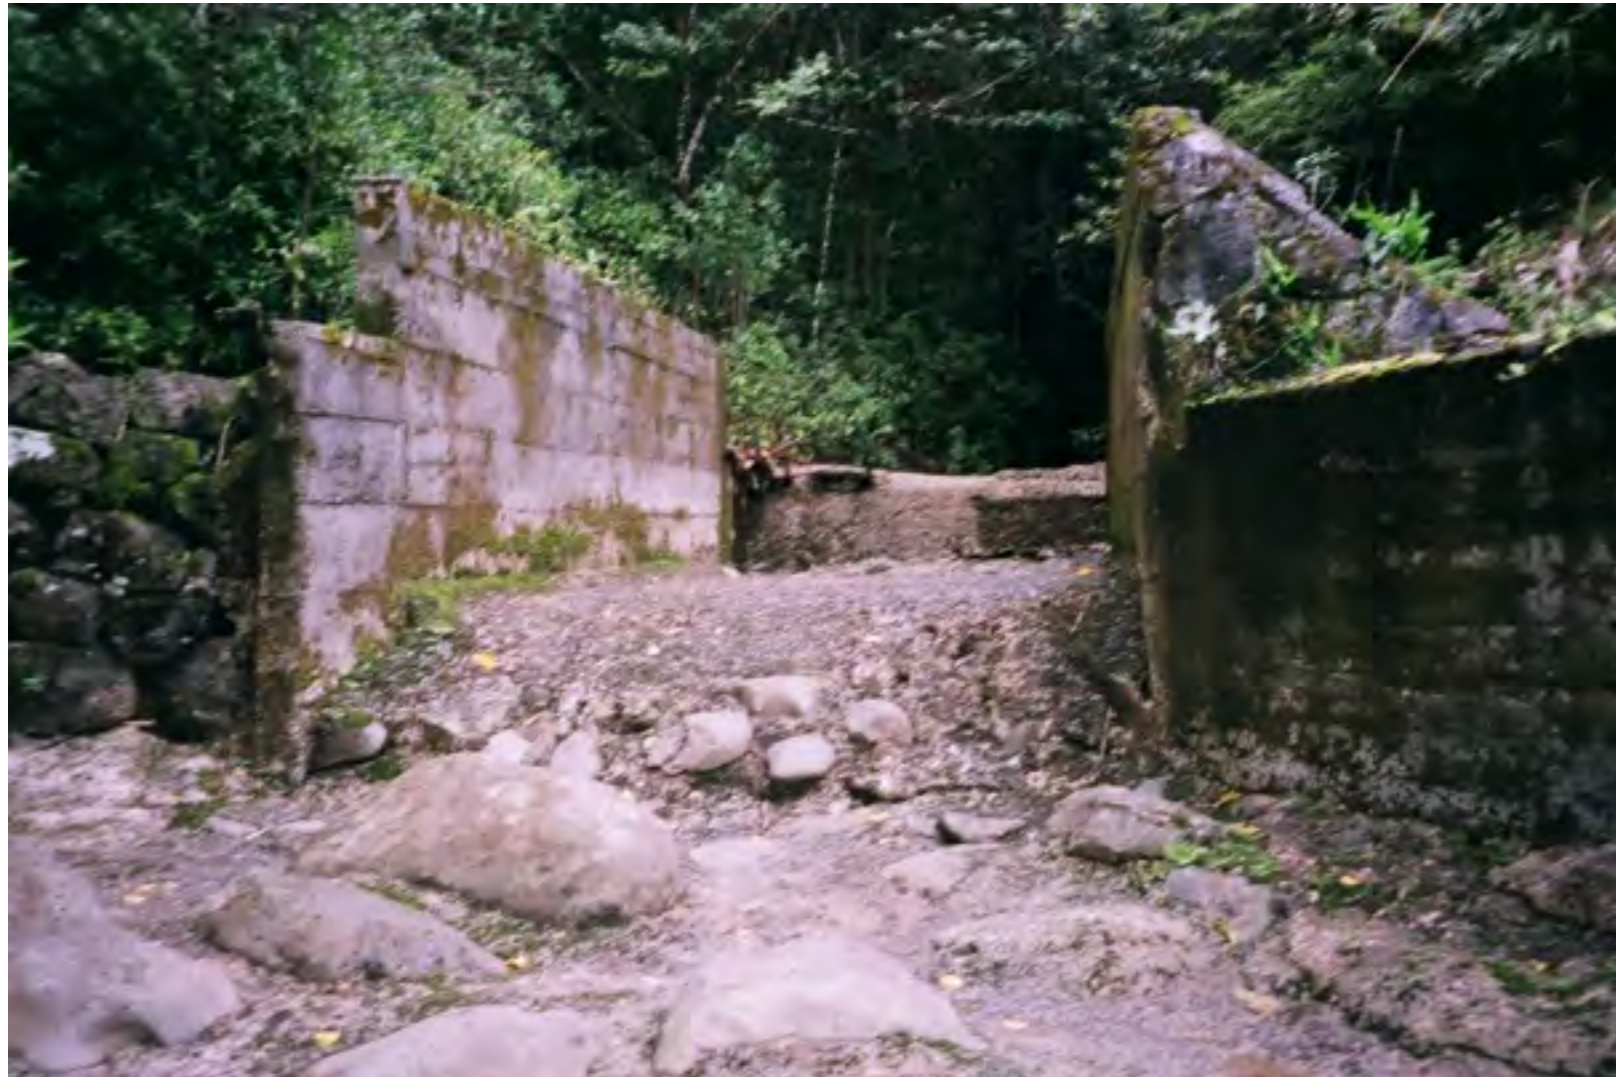
**MT EX #21  
10/2009**

**Huelo stream intake at  
Lowrie Ditch**

**Spillway over  
Lowrie Ditch  
mauka view**

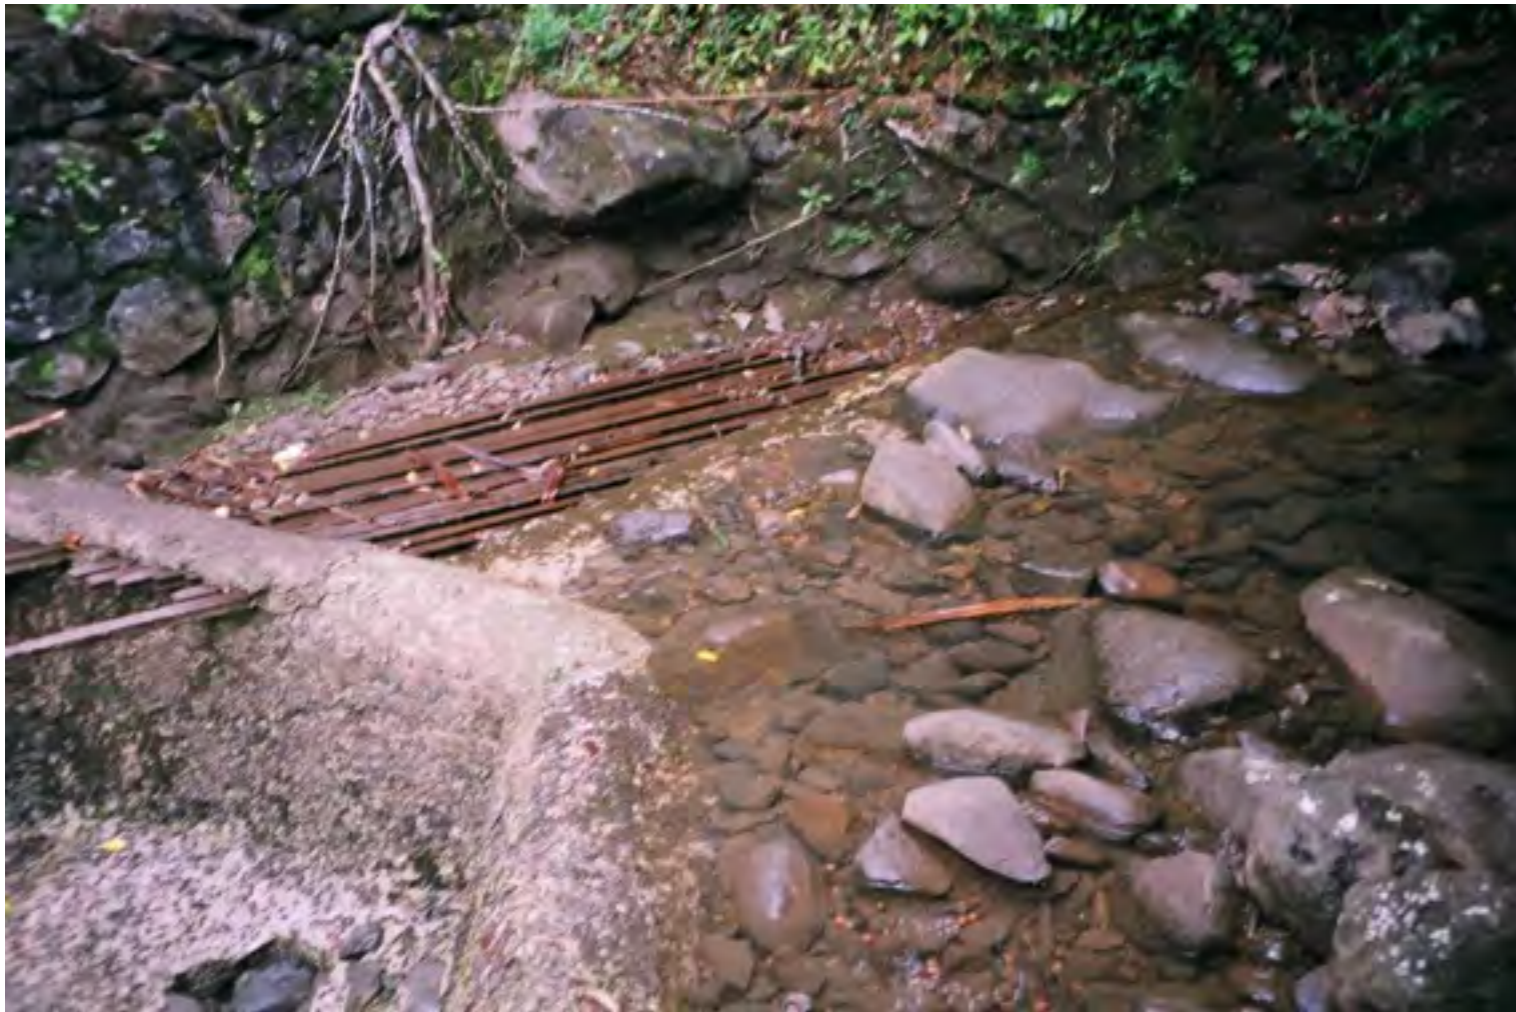
### Huelo stream intake at Lowrie ditch

View of Lowrie ditch intake grate L-7/ 155.6 on Huelo stream channel.
