COMMISSION ON WATER RESOURCE MANAGEMENT  
 STATE OF HAWAII

PETITION TO AMEND INTERIM	)	Case No.: CCH-MA13-01
INSTREAM FLOW STANDARDS FOR	)	
HONOPOU, HUELO (PUOLUA),	)	OBJECTIONS, IN PART, OF
HANEHOI, WAIKAMOI, ALO,	)	MAUI TOMORROW TO
WAHINEPEE, PUOHOKAMOA,	)	HEARINGS OFFICER'S
HAIPIUAENA, PUNALAU/KOLEA,	)	AMENDED RECOMMENDATION
HONOMANU, NUAAILUA, PIINAAU,	)	RE INTERIM RESTORATION OF
PALAUHULU, 'OHI'A (WAIANU),	)	STREAM FLOW; EXHIBIT "A";
WAIOKAMILO, KUALANI,	)	MT EXHIBITS "1" – "40"; MT
WAILUANUI, WEST WAILUAIKI, EAST	)	MAPS "1" – "4"; CERTIFICATE
WAILUAIKI, KOPILIULA, PUAKEA,	)	OF SERVICE
WAIOHUE, PAAKEA, WAIAAKA,	)	
KAPAUULA, HANAWI and MAKAPIPI	)	
STREAMS	)	
	)

**OBJECTIONS, IN PART, OF MAUI TOMORROW TO HEARINGS OFFICER'S  
 AMENDED RECOMMENDATION RE INTERIM RESTORATION OF STREAM  
 FLOW**

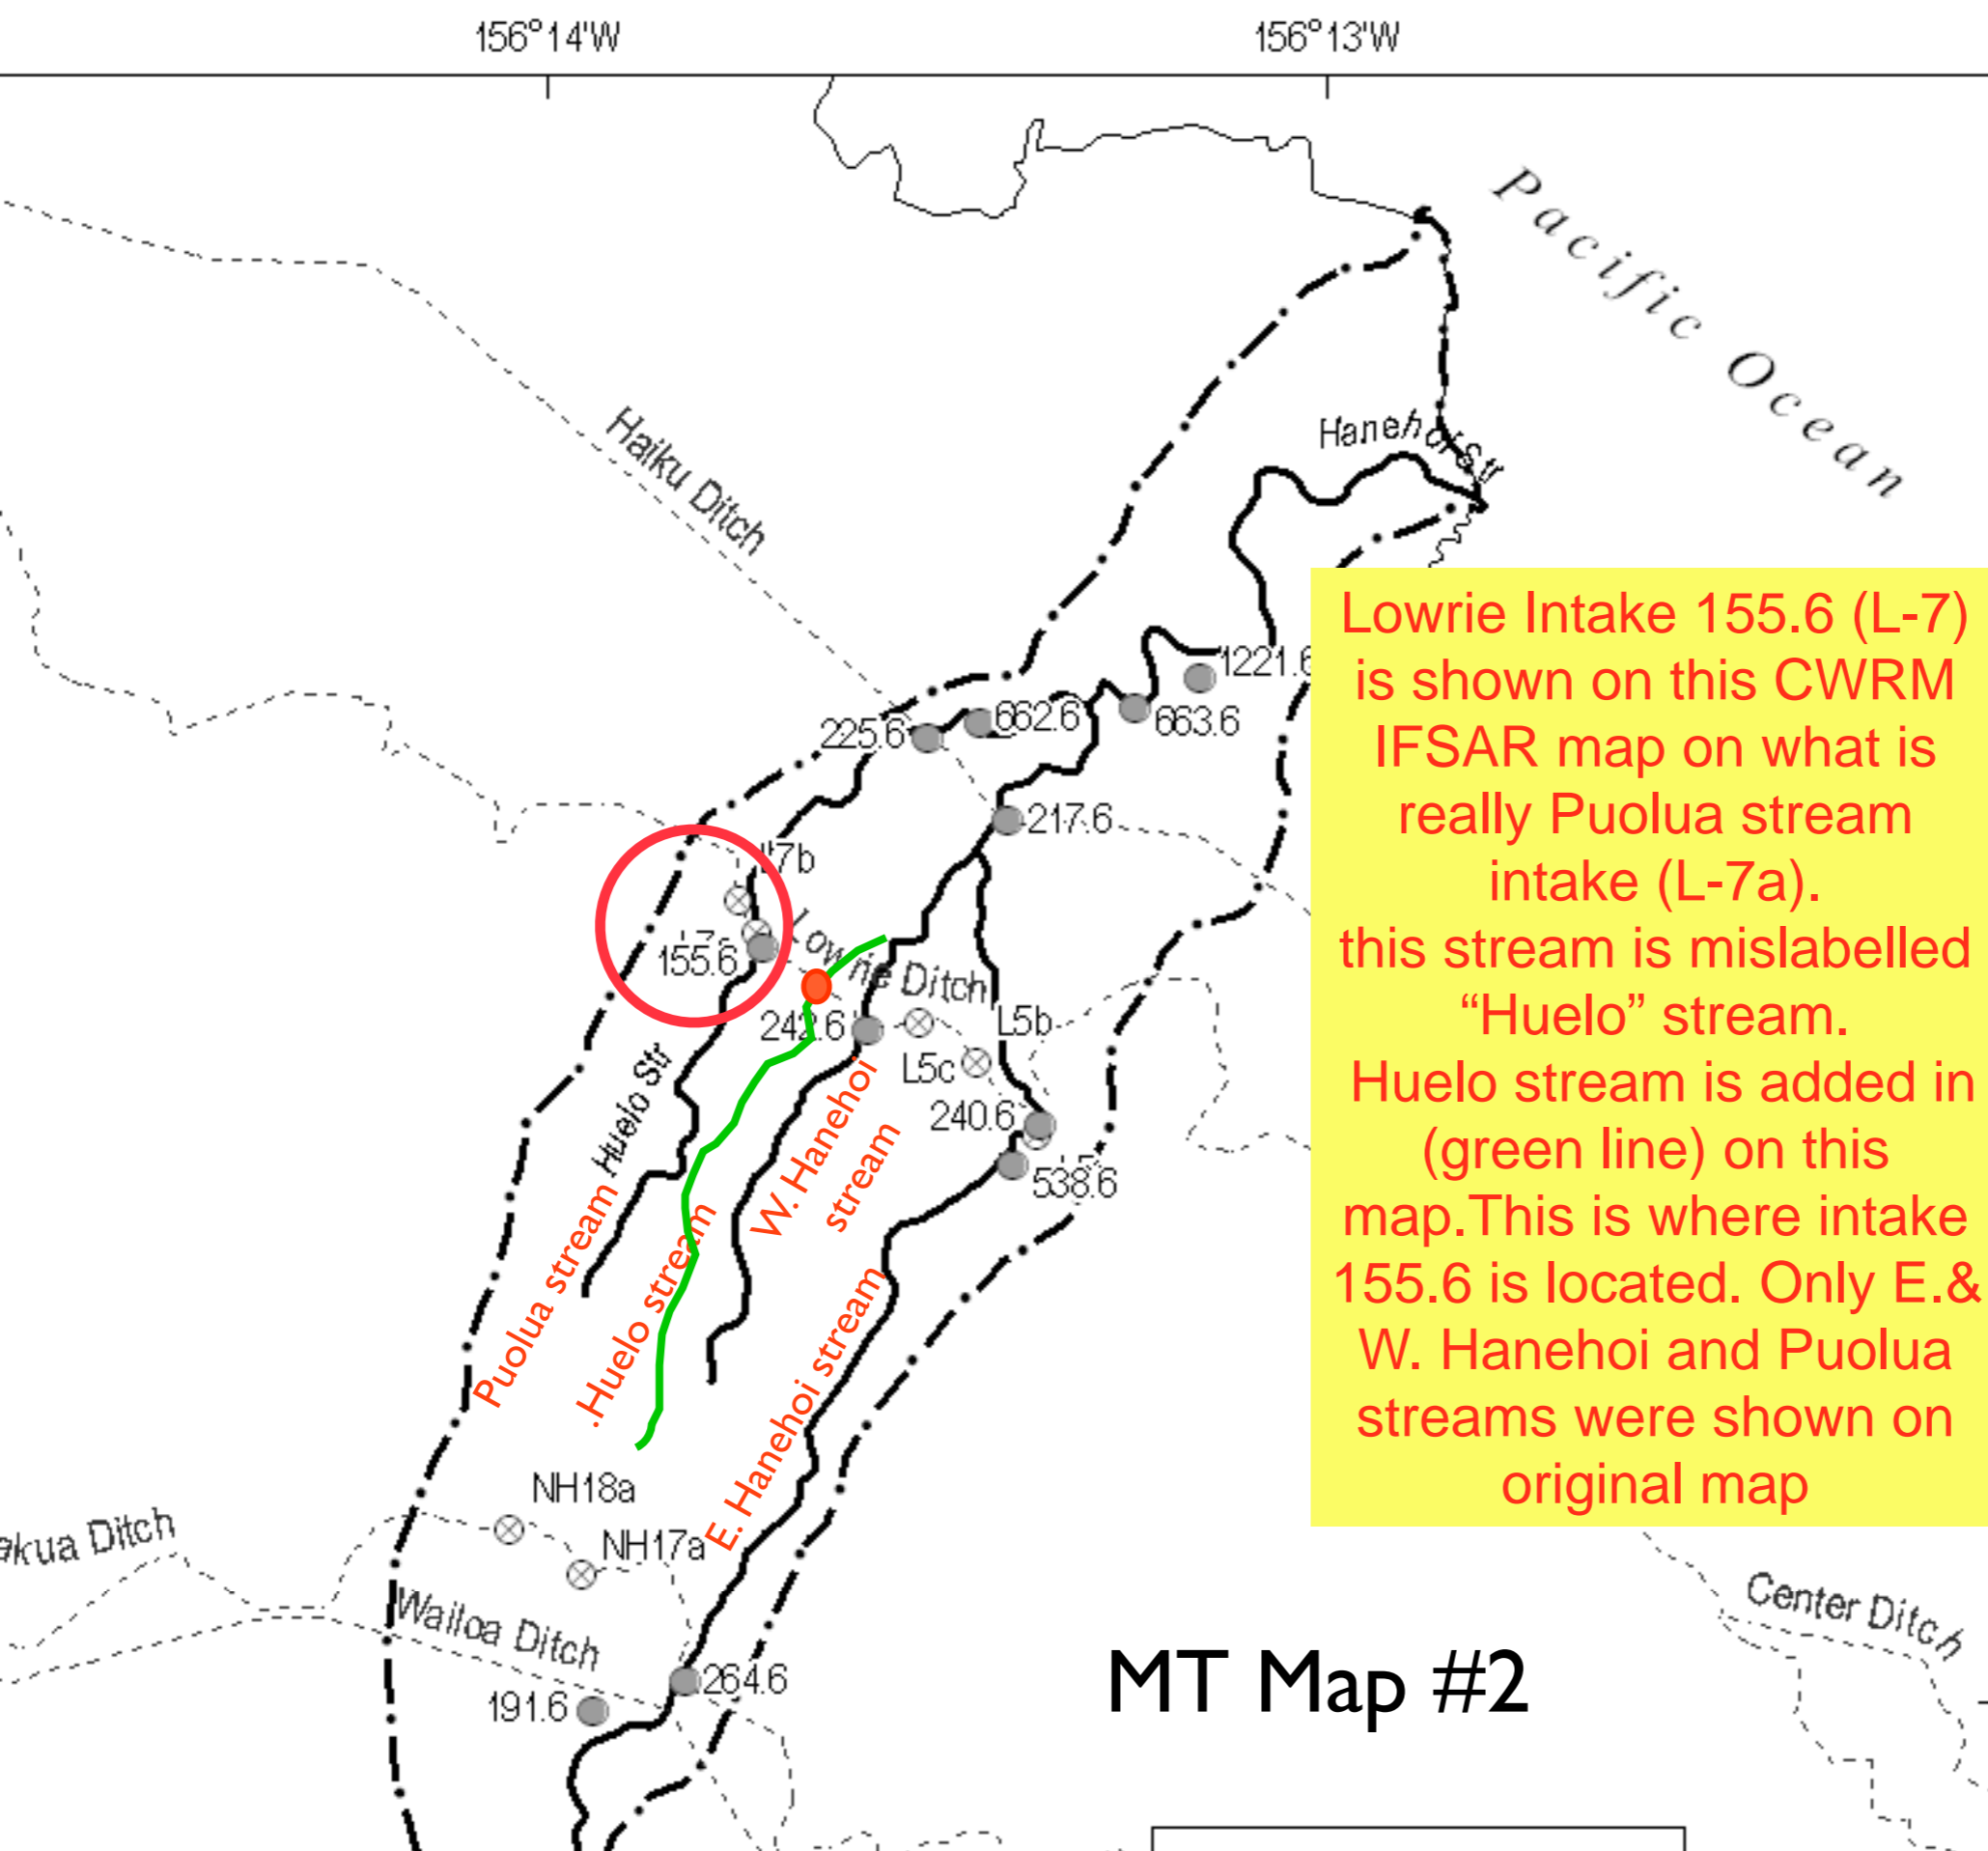
Huelo stream & intake actually exists, but is mislocated on CWRM's IFSTAR Map for Hanehoi Unit (2008).

Puolua stream is incorrectly labelled "Huelo Stream" on this map. They are not the "same stream"

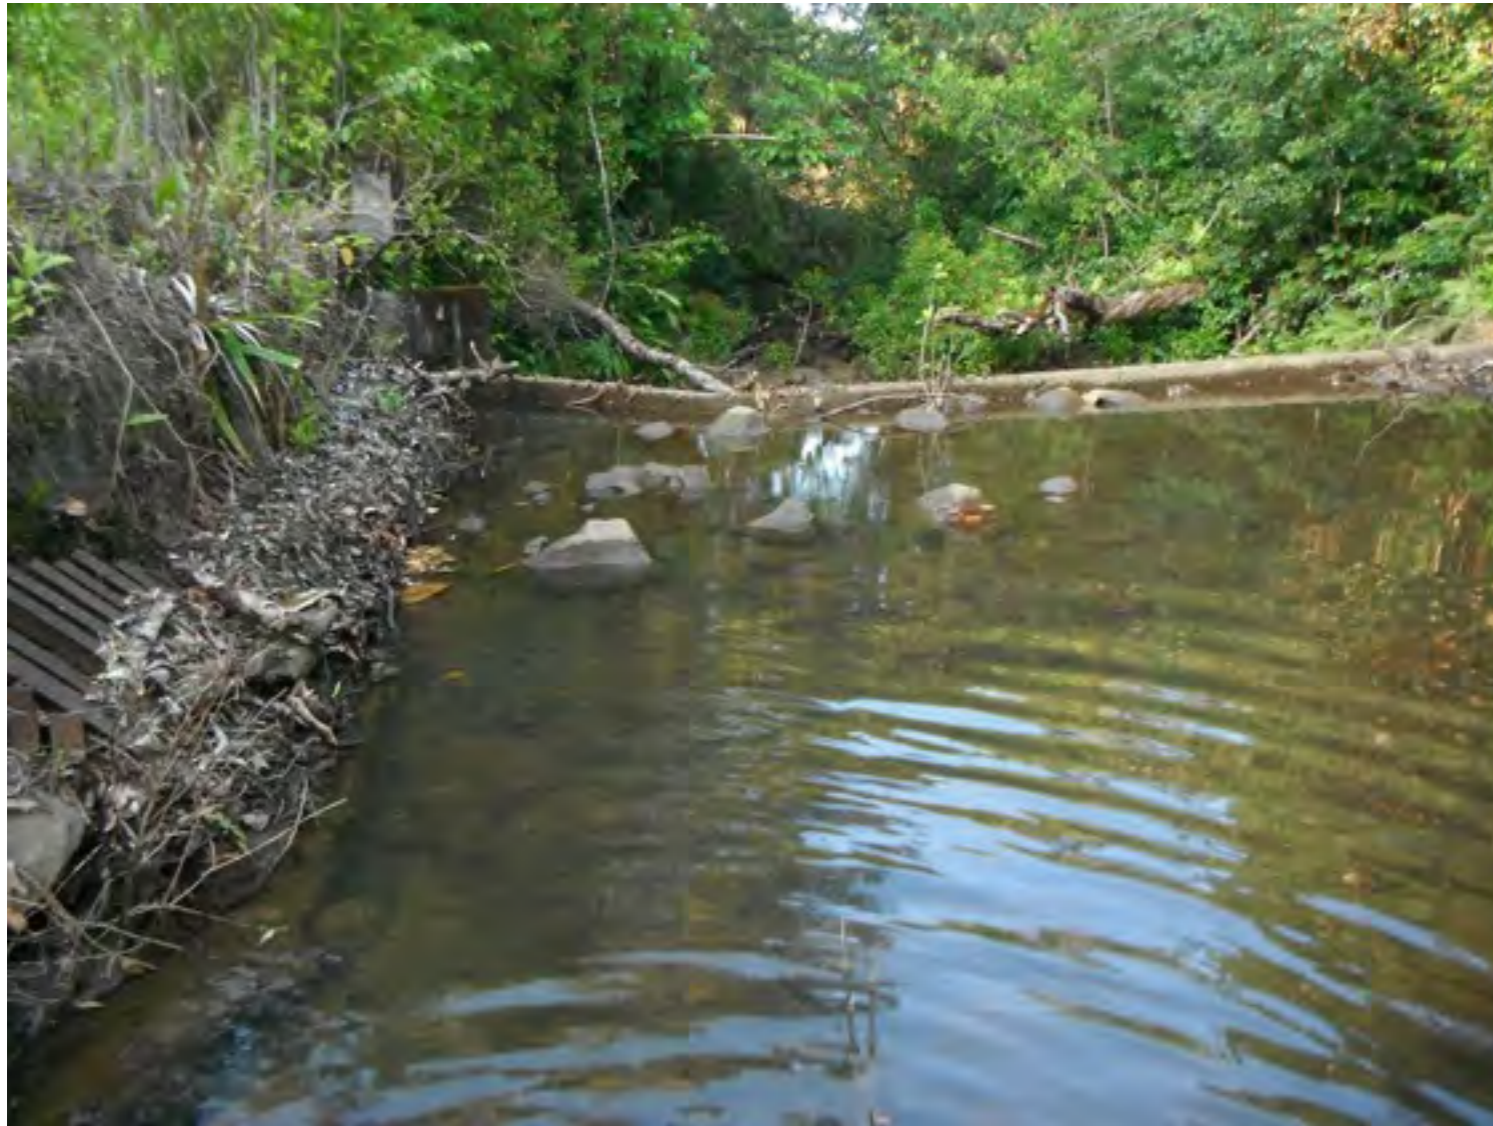
Hanehoi stream immediately up stream of Diversion structure H-3/ 217.6 on Hanehoi stream channel. Grate on left transports stream water to New Haiku Ditch tunnel.

Concrete dam blocks downstream flow and becomes filled up with large rocks.

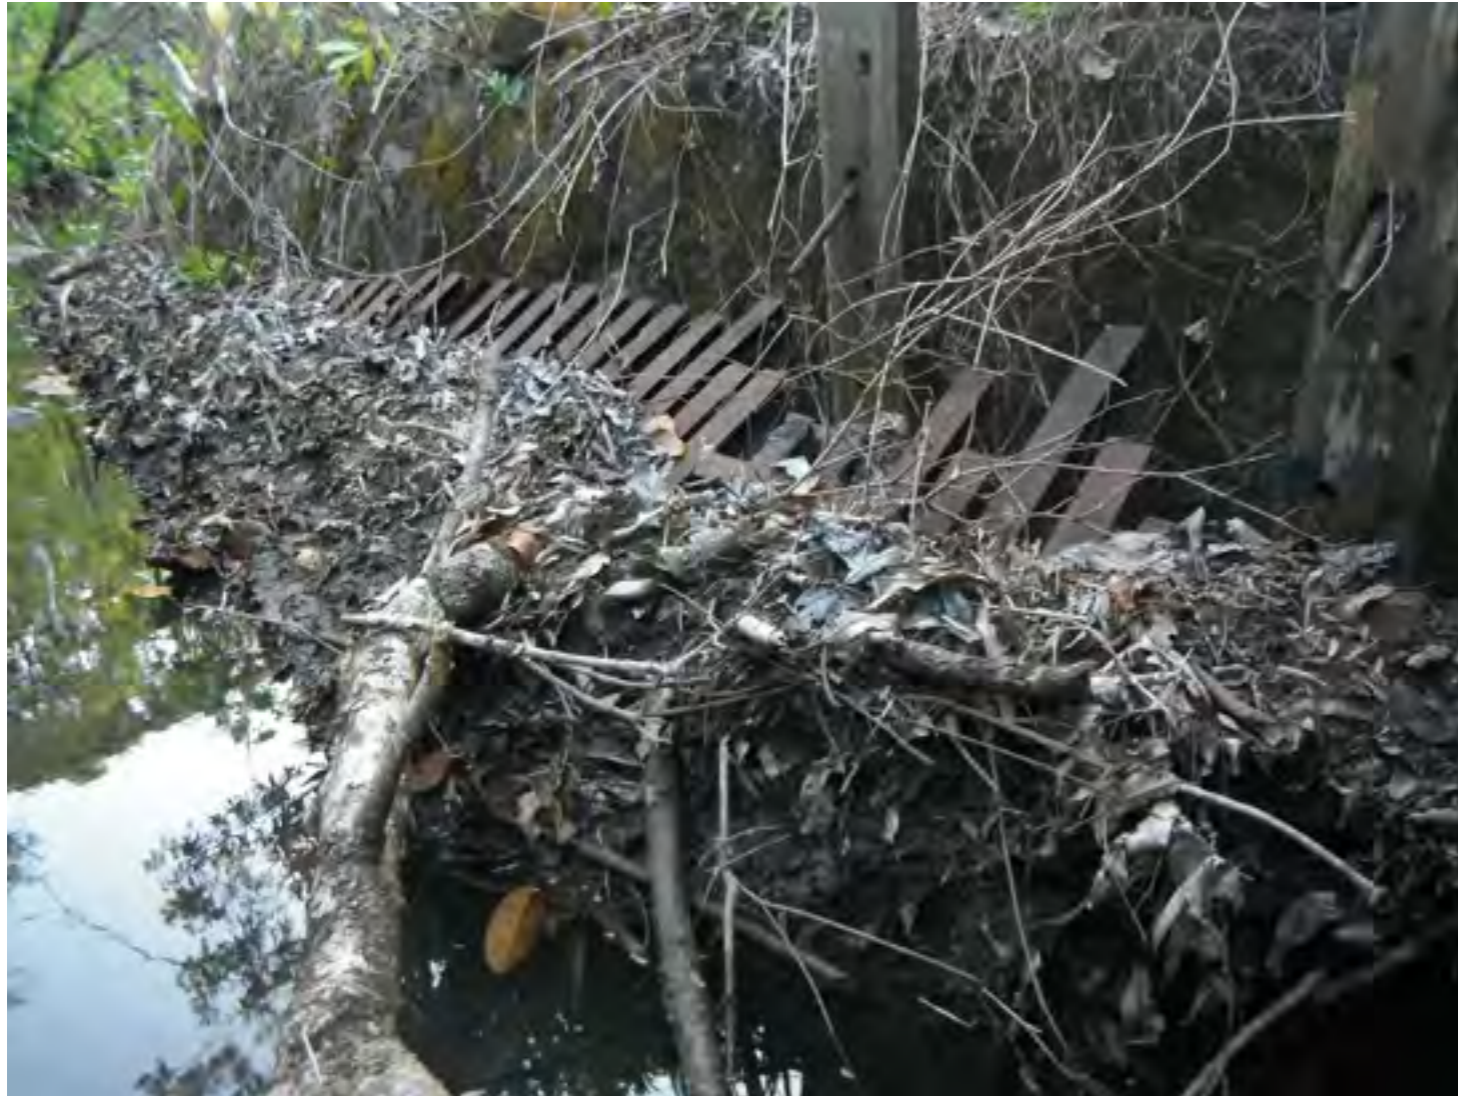
Close view of Haiku intake grate on Hanehoi stream. Part of Diversion intake structure H-3/ 217.6 on Hanehoi stream channel.

If grate was sealed water could not enter New Haiku Ditch tunnel intake channel and would overflow dam into stream bed, but dam may need modification to allow large rocks to move naturally downstream.

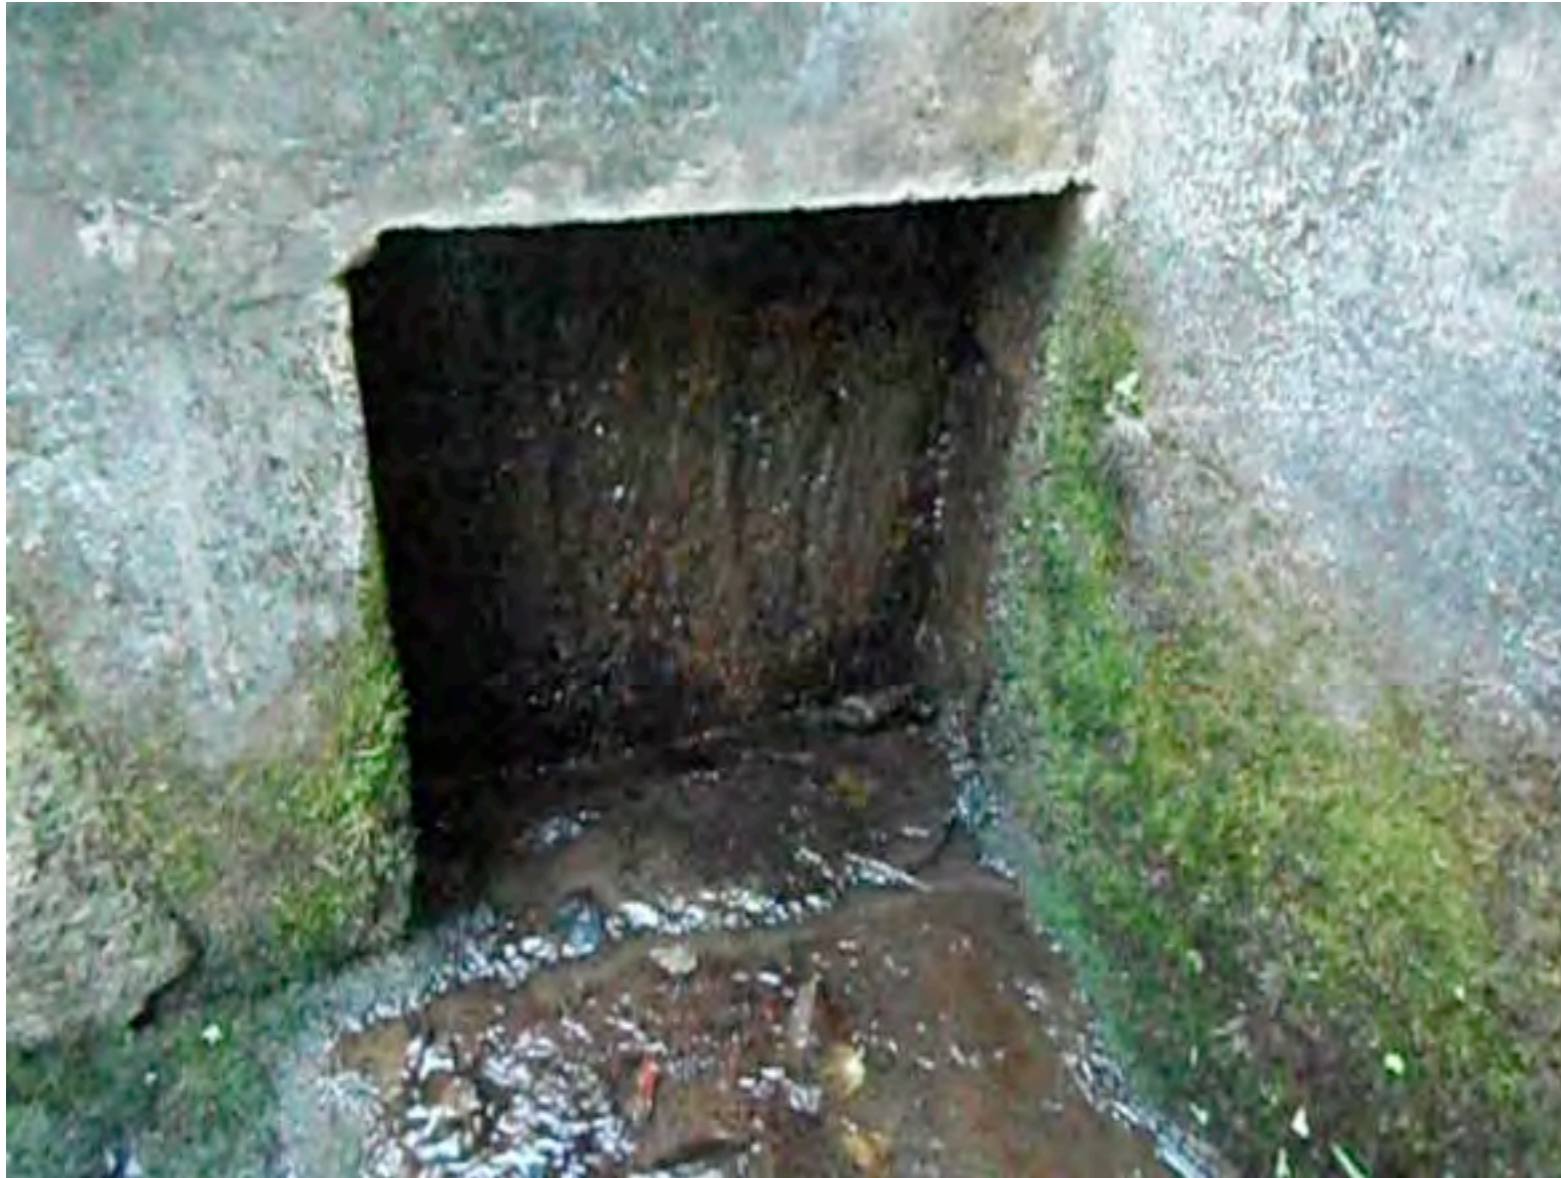
## New Haiku Ditch

Hanehoi stream  
Diversion structure  
H-3/ 217.6 on Hanehoi  
stream channel. Sluice  
gate completely closed.  
(May 2016) Only minimal  
flows bypasses H-3  
diversion structure.

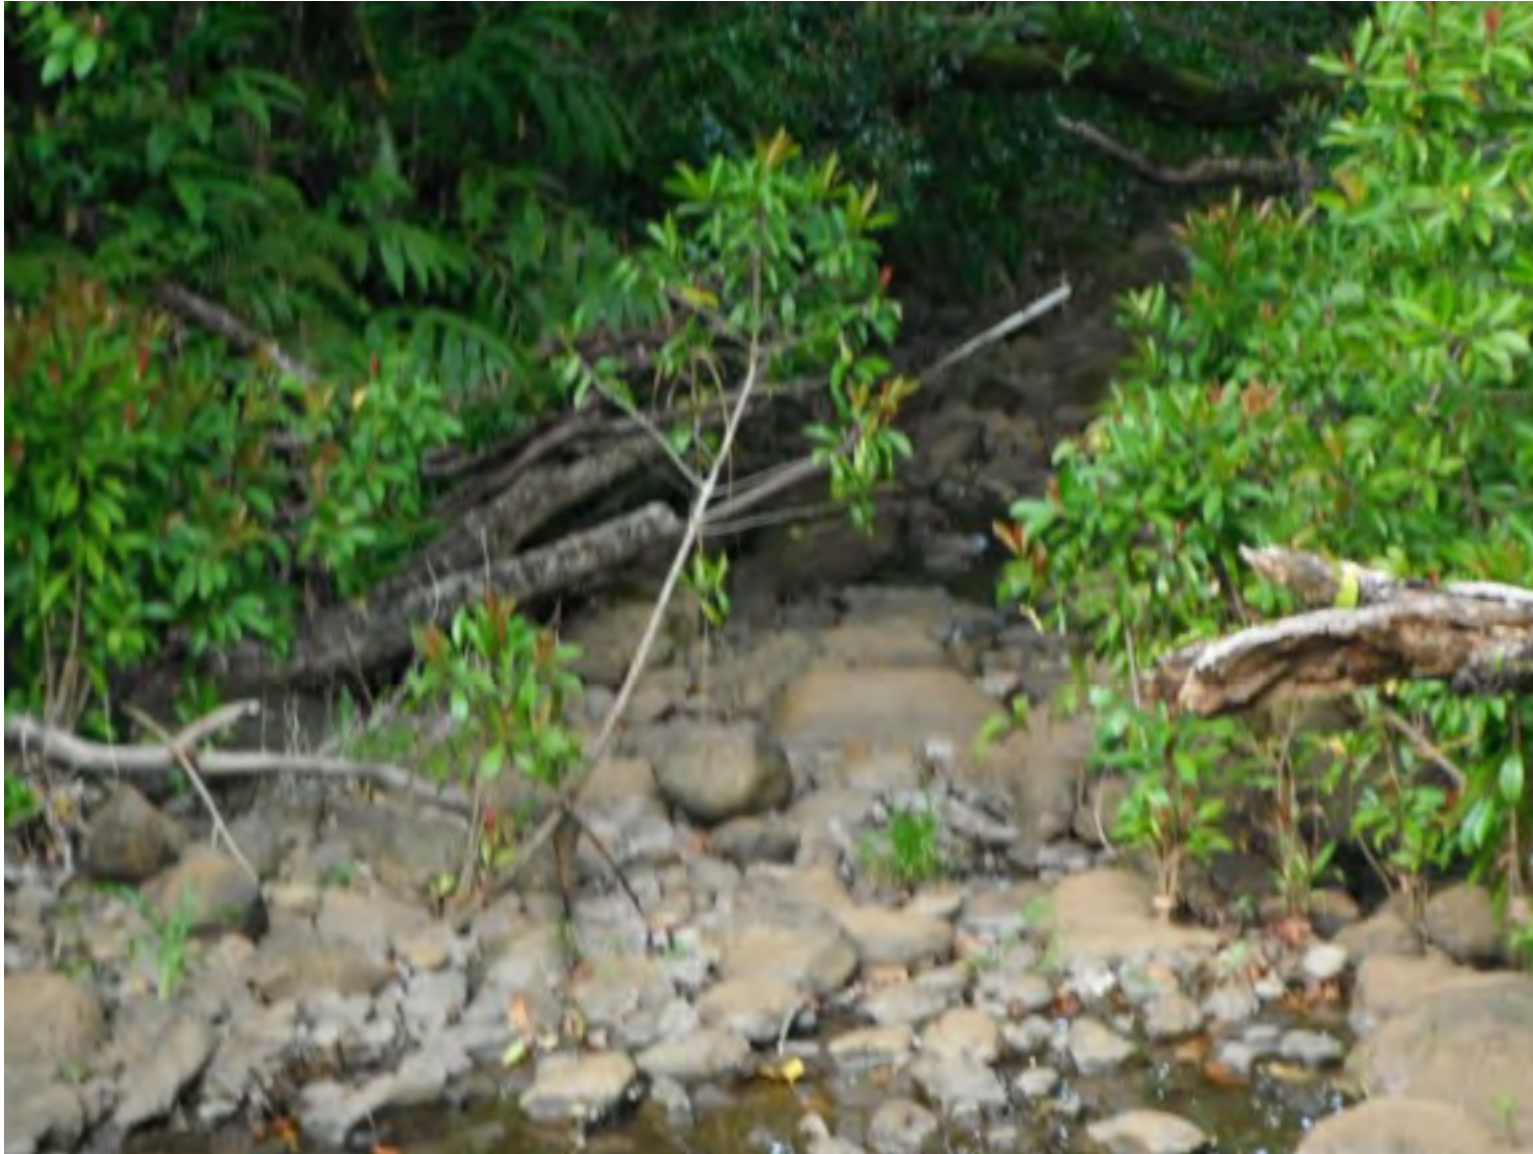
## **New Haiku Ditch Hanehoi stream**

Makai view of dry Hanehoi stream immediately downstream of New Haiku diversion intake 217.6 (H-3).

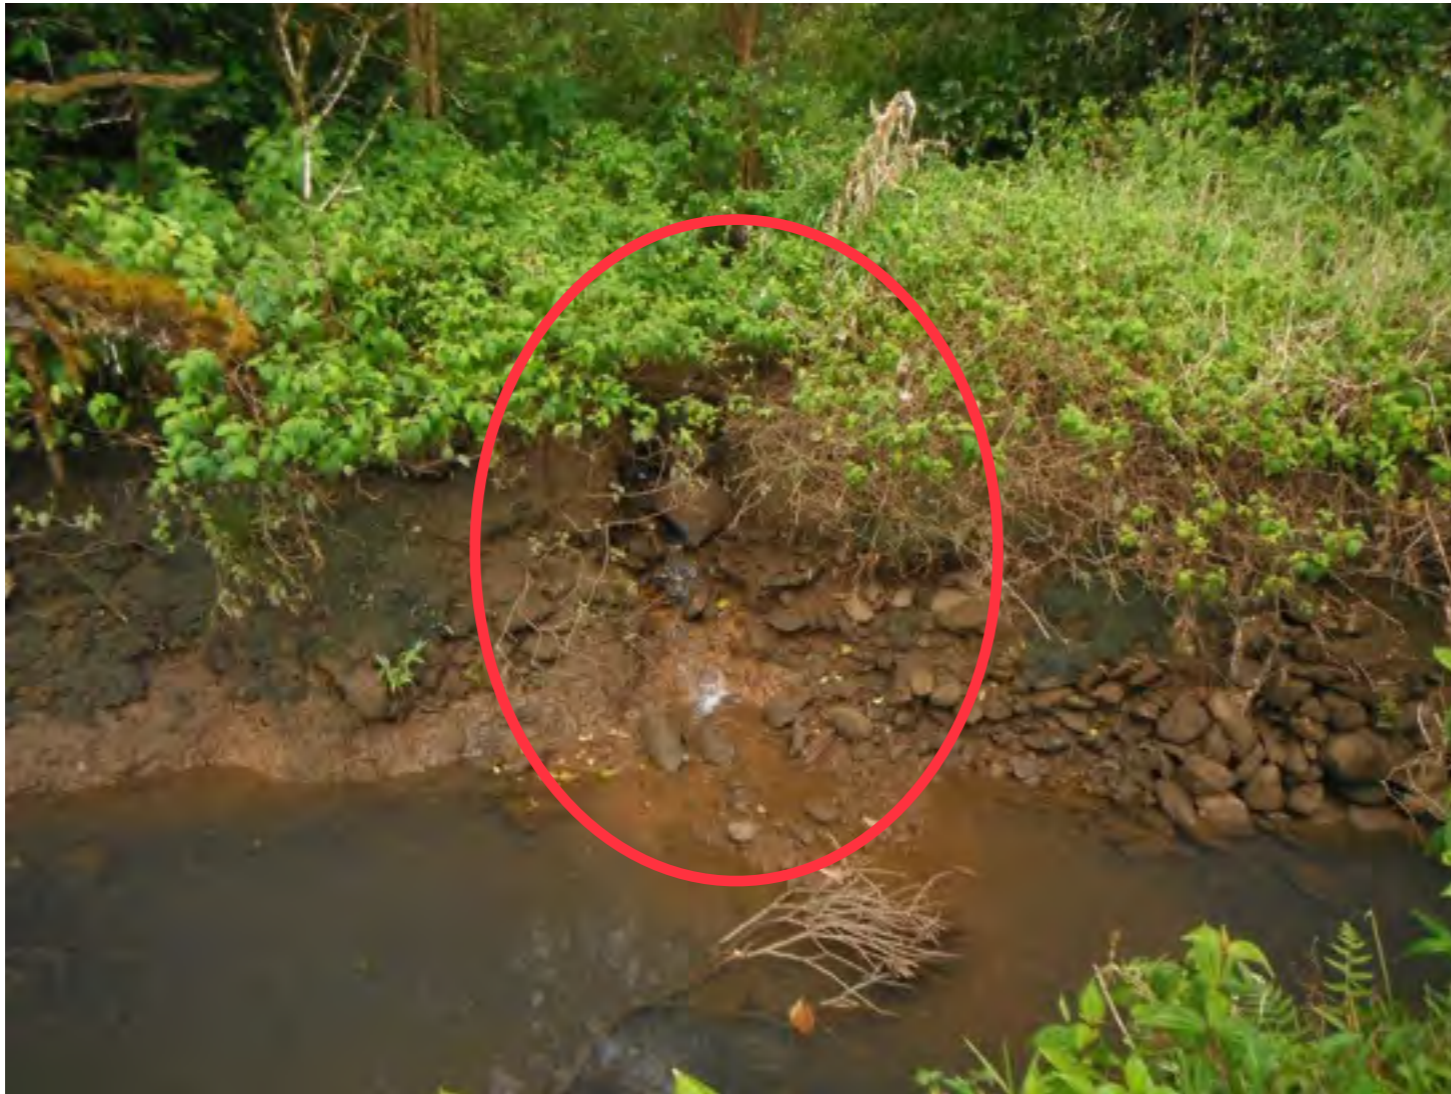
**MT EX #27**  
5/2016

### **New Hamakua Ditch Puolua stream**

Puolua flow is captured directly into the New Hamakua Ditch.

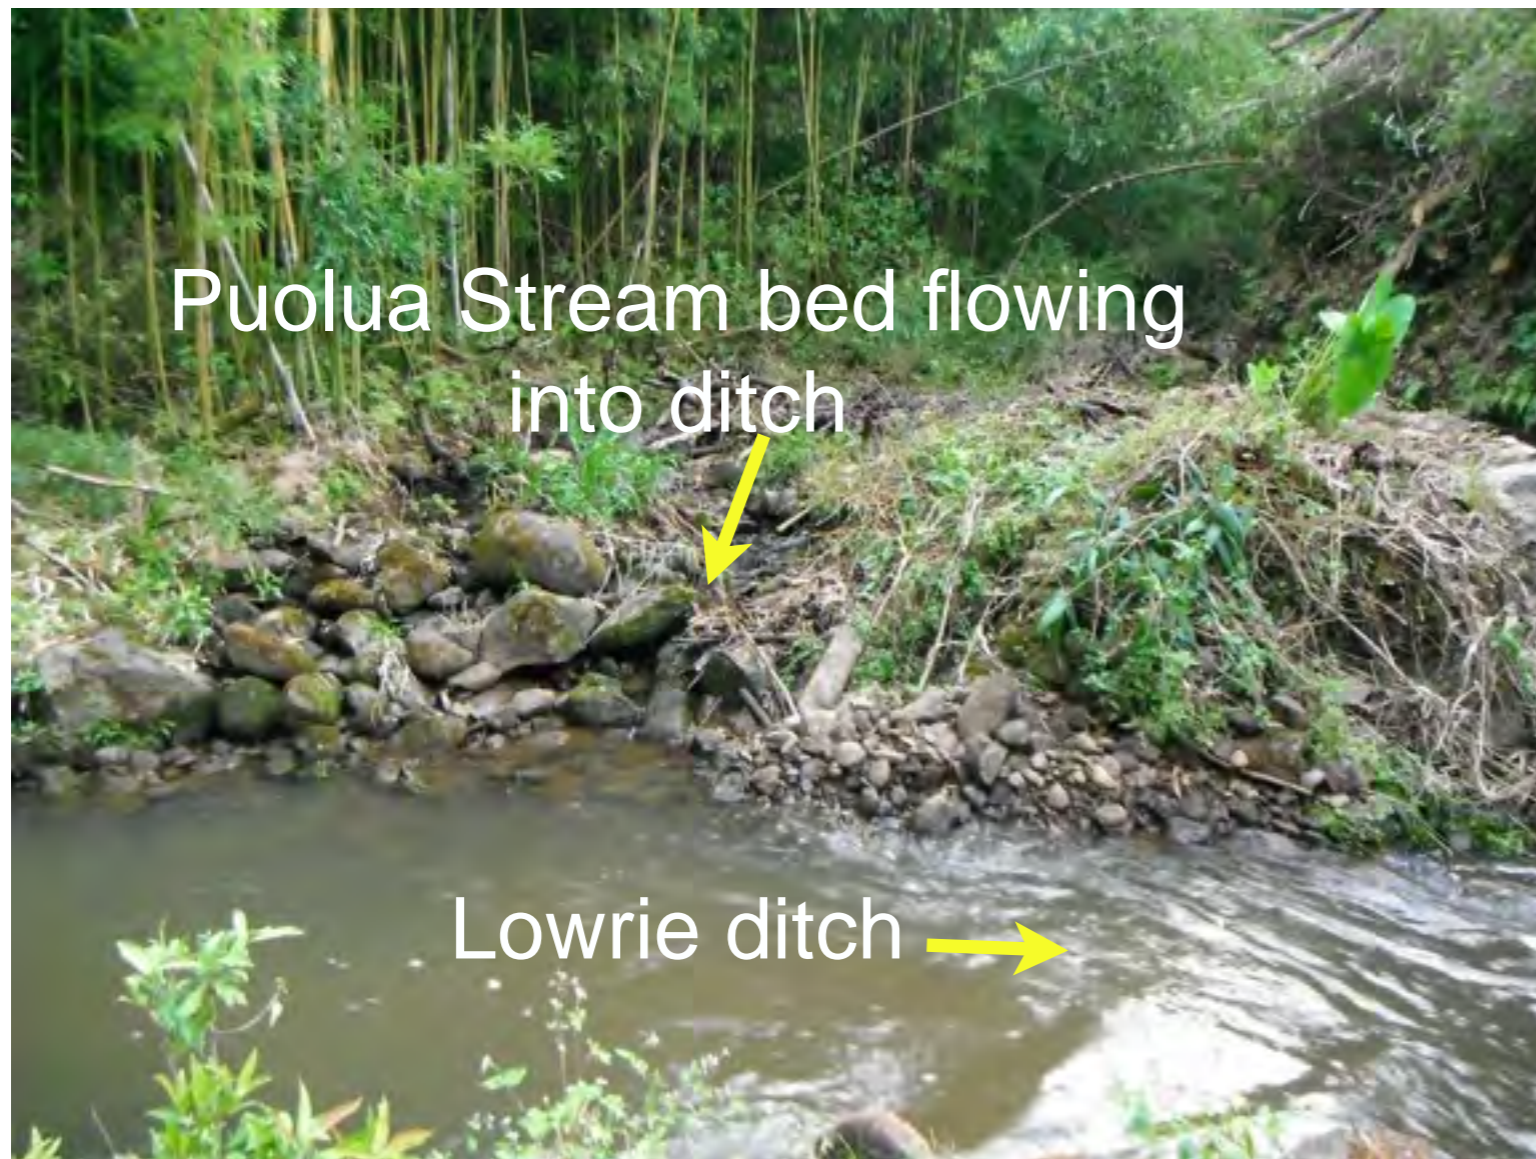
**MT EX #28**  
3/2015

### Lowrie Ditch Puolua stream

Puolua flow is captured directly into the Lowrie Ditch with no grate structure

Lowrie Ditch and EMI service road would need modification to allow flow to continue makai

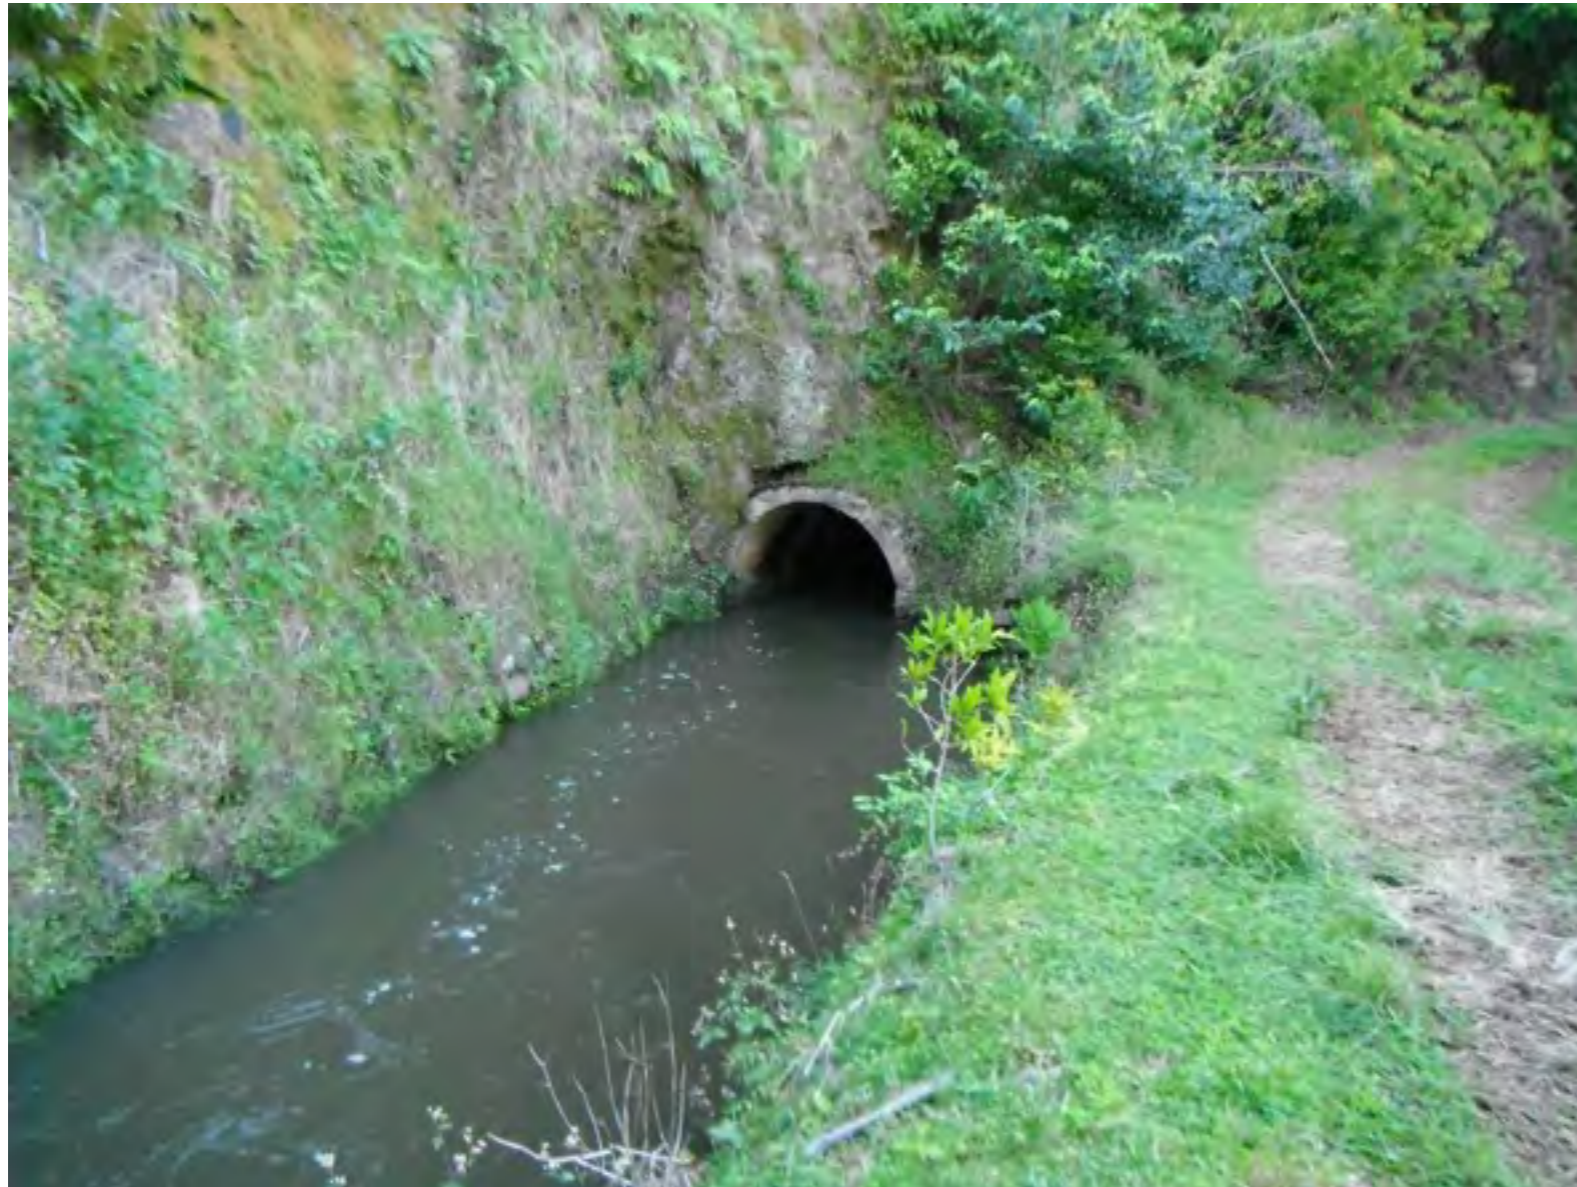
## **Lowrie Ditch near Puolua stream**

Lowrie Ditch has open sections and tunnel sections.

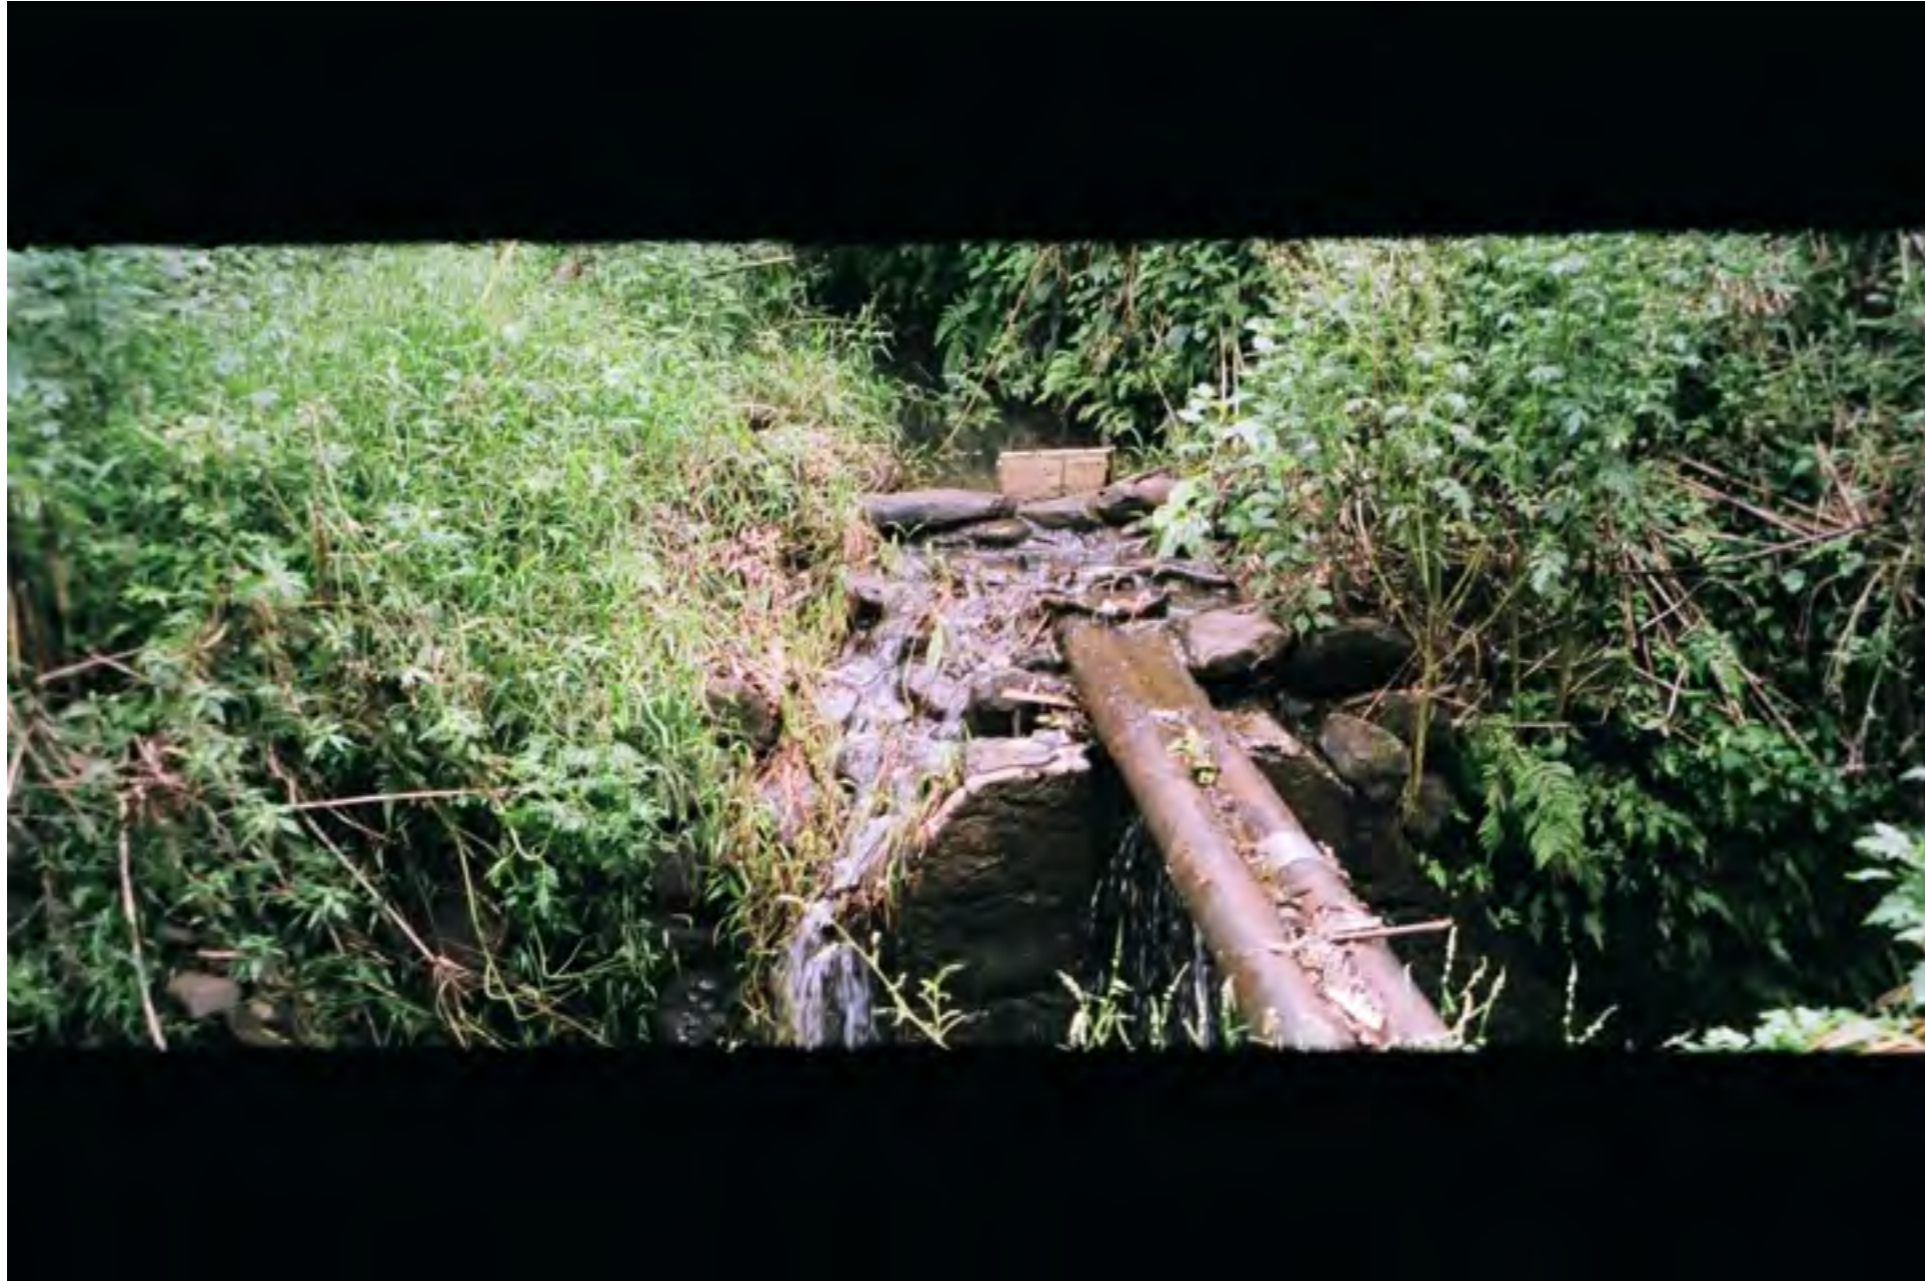
**MT EX #30**  
10/2009

### **Lowrie Ditch Puolua stream**

For decades these two leaky 4" pipes ran under EMI service road to a 8" PVC pipe and provided the only downstream flow into Puolua stream past Lowrie Ditch intake. Pipes were often clogged.

EMI replaced pipes with 8 inch pipe in 2015

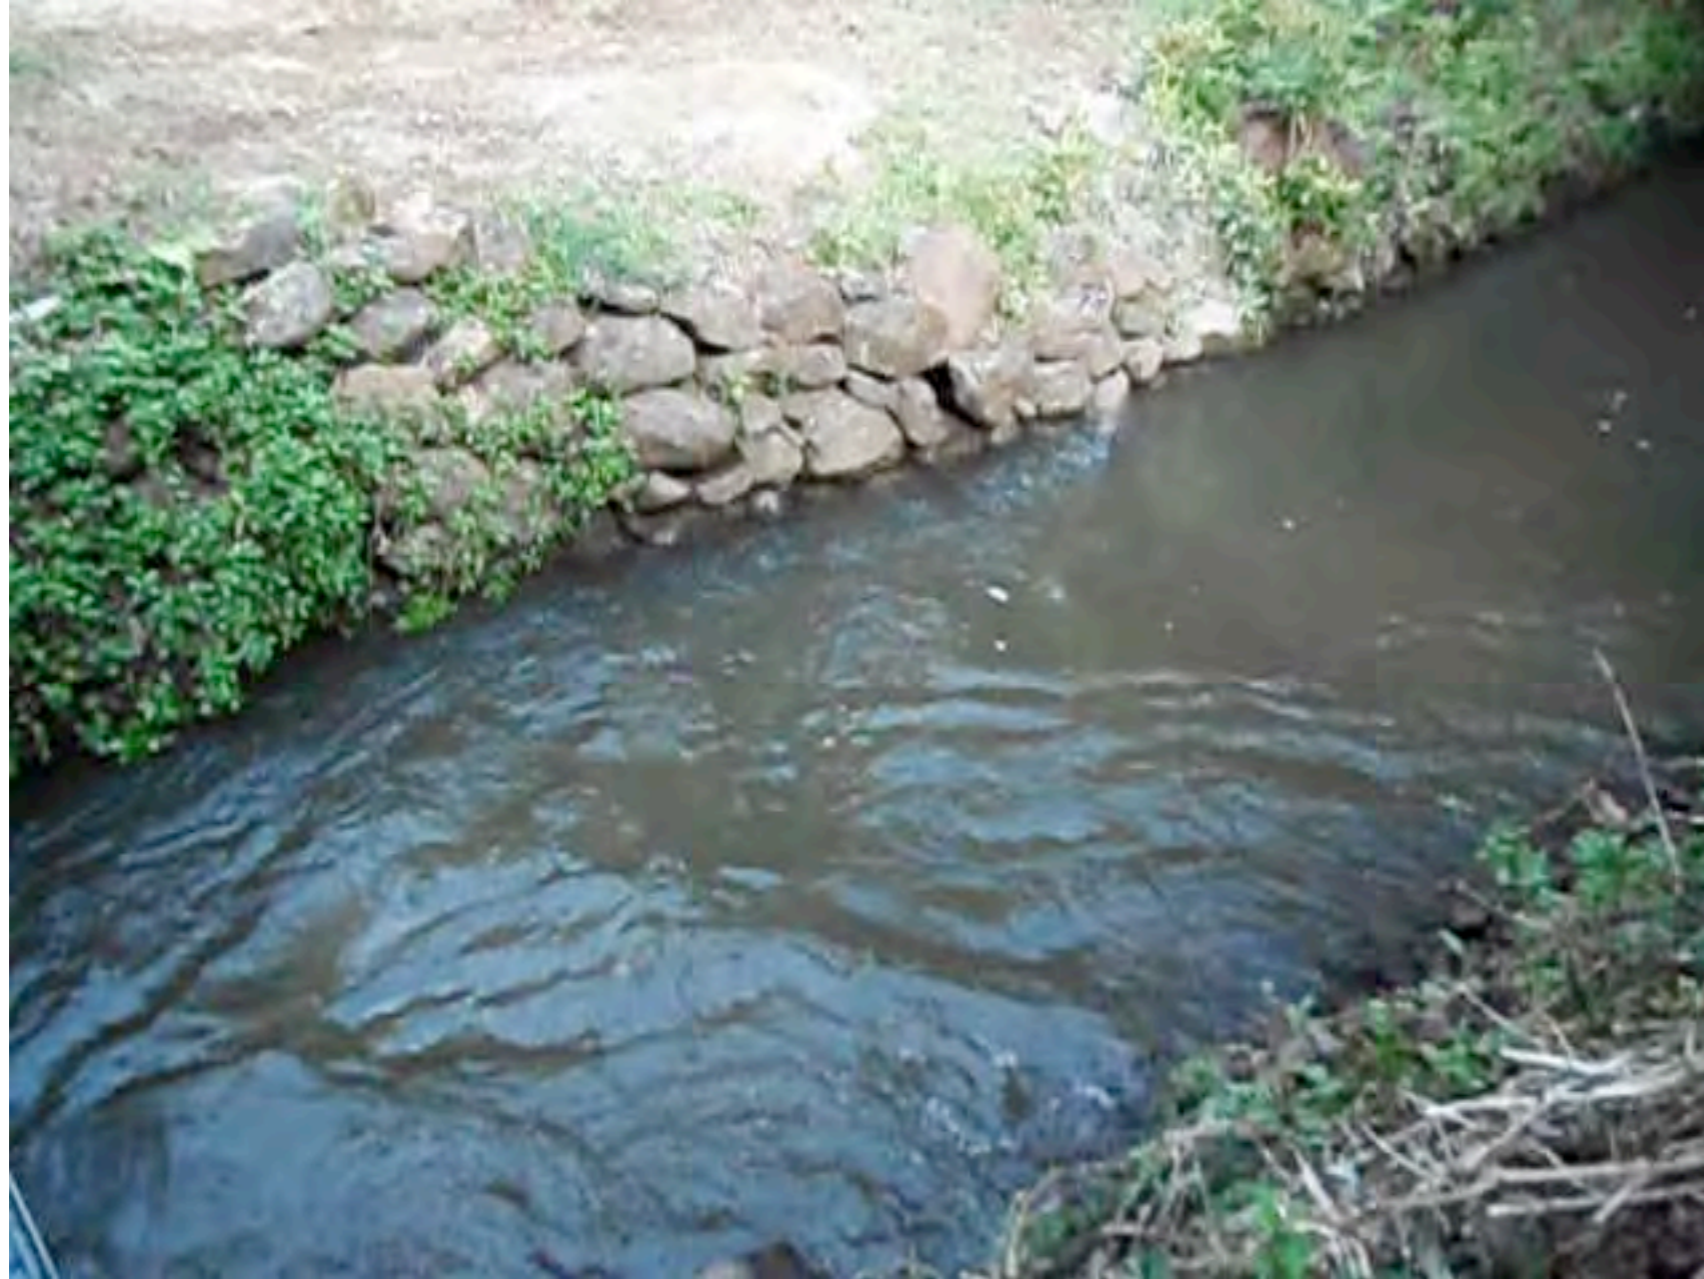
**MT Vid #1  
3/2013**

## **Video of Lowrie Ditch at Puolua stream intake**

Video shows how a portion of Puolua flow is channeled towards new 8 inch wide bypass pipe, while the remaining flow is captured directly into the Lowrie Ditch.  
Video 3/2015
