COMMISSION ON WATER RESOURCE MANAGEMENT  
 STATE OF HAWAII

PETITION TO AMEND INTERIM	)	Case No.: CCH-MA13-01
INSTREAM FLOW STANDARDS FOR	)	
HONOPOU, HUELO (PUOLUA),	)	OBJECTIONS, IN PART, OF
HANEHOI, WAIKAMOI, ALO,	)	MAUI TOMORROW TO
WAHINEPEE, PUOHOKAMOA,	)	HEARINGS OFFICER'S
HAIPIUAENA, PUNALAU/KOLEA,	)	AMENDED RECOMMENDATION
HONOMANU, NUAAILUA, PIINAAU,	)	RE INTERIM RESTORATION OF
PALAUHULU, 'OHI'A (WAIANU),	)	STREAM FLOW; EXHIBIT "A";
WAIOKAMILO, KUALANI,	)	MT EXHIBITS "1" – "40"; MT
WAILUANUI, WEST WAILUAIKI, EAST	)	MAPS "1" – "4"; CERTIFICATE
WAILUAIKI, KOPILIULA, PUAKEA,	)	OF SERVICE
WAIOHUE, PAAKEA, WAIAAKA,	)	
KAPAUULA, HANAWI and MAKAPIPI	)	
STREAMS	)	
	)

**OBJECTIONS, IN PART, OF MAUI TOMORROW TO HEARINGS OFFICER'S  
 AMENDED RECOMMENDATION RE INTERIM RESTORATION OF STREAM  
 FLOW**

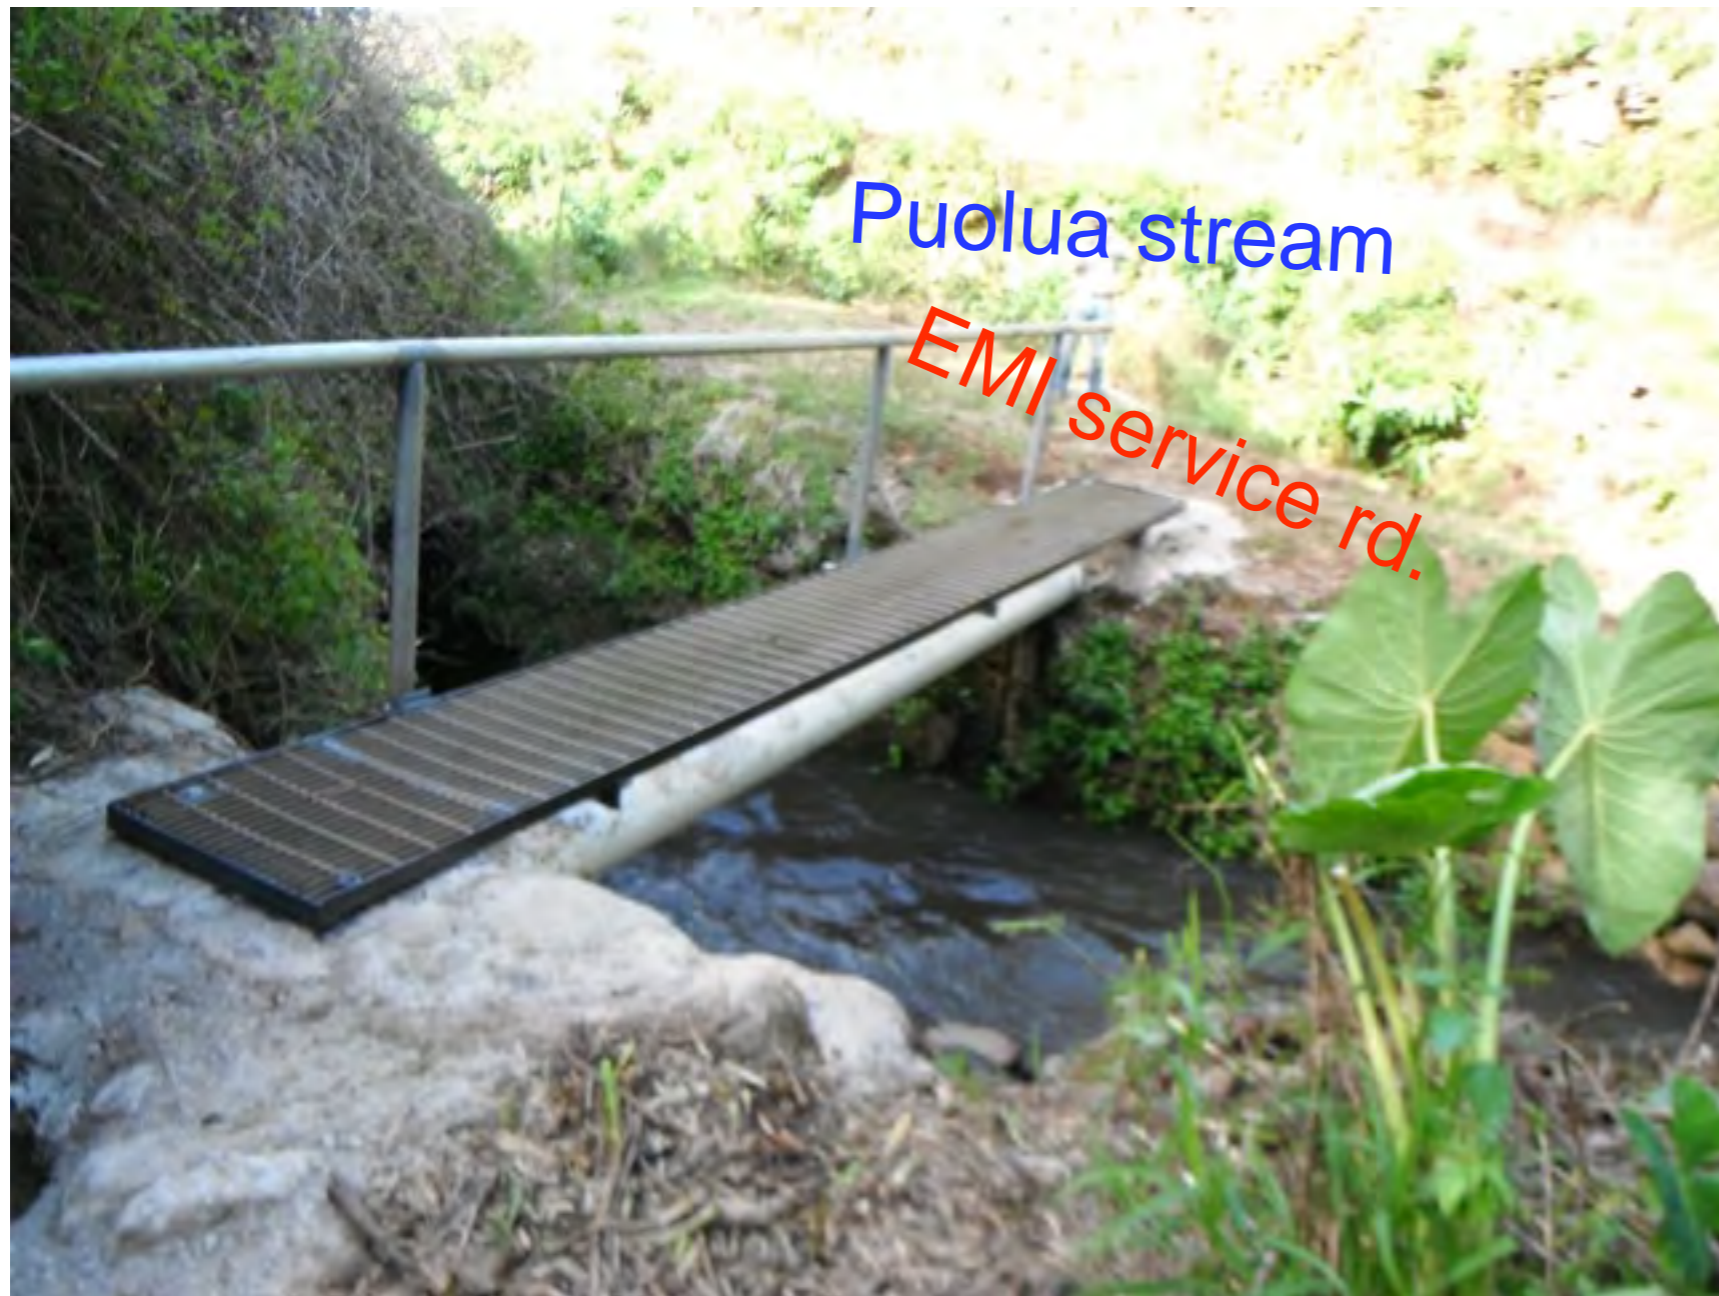
**MT EX #3 I**

### **Lowrie Ditch at Puolua stream**

Lowrie Ditch flows under new 8" bypass pipe and into a tunnel. A dirt EMI service road runs along ditch, and Puolua stream continues makai of the road

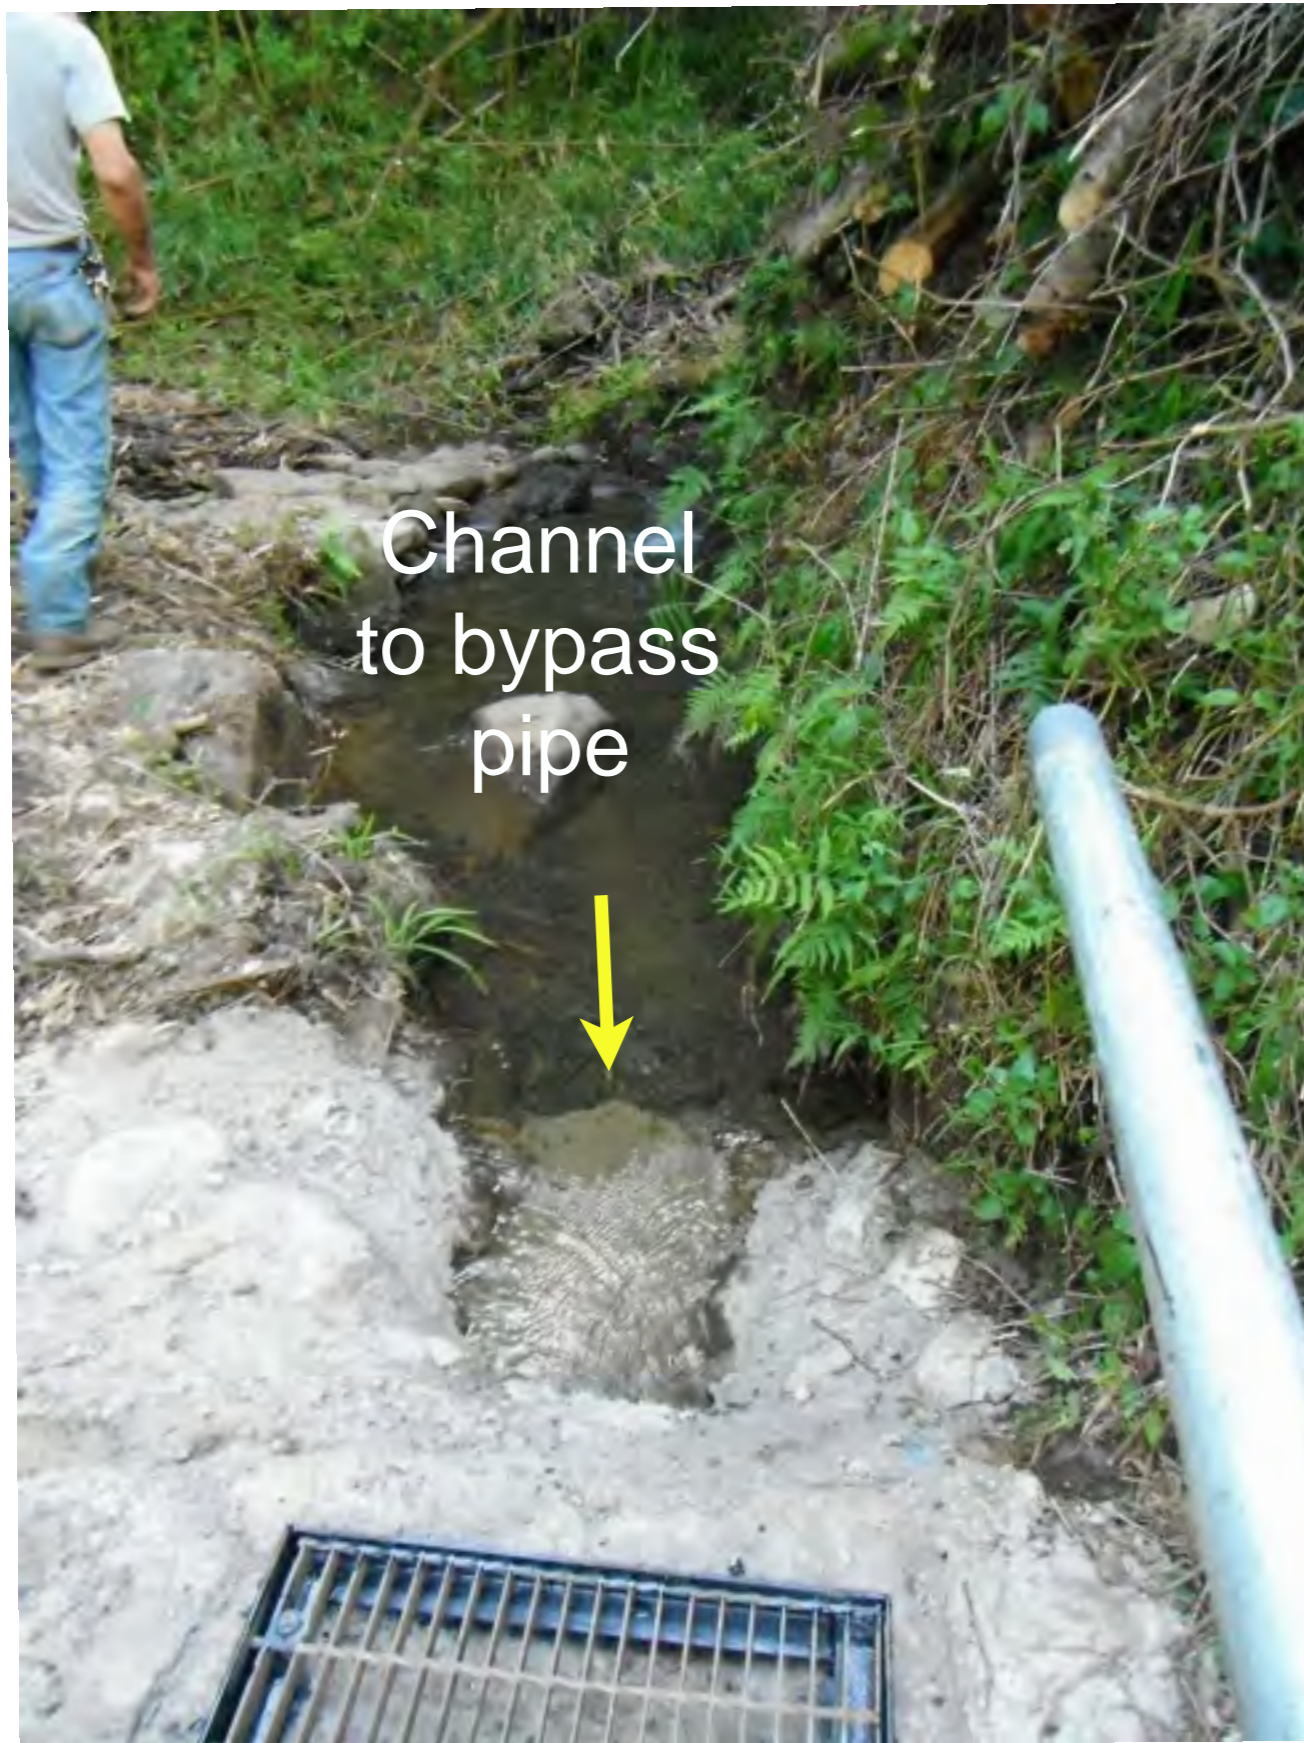
**MT EX #32**  
3/2015

## Lowrie Ditch at Puolua stream

Puolua stream was modified to create a channel for a portion of stream water to flow into new 8" bypass pipe that passes under the EMI service road and empties into Puolua stream makai of the road

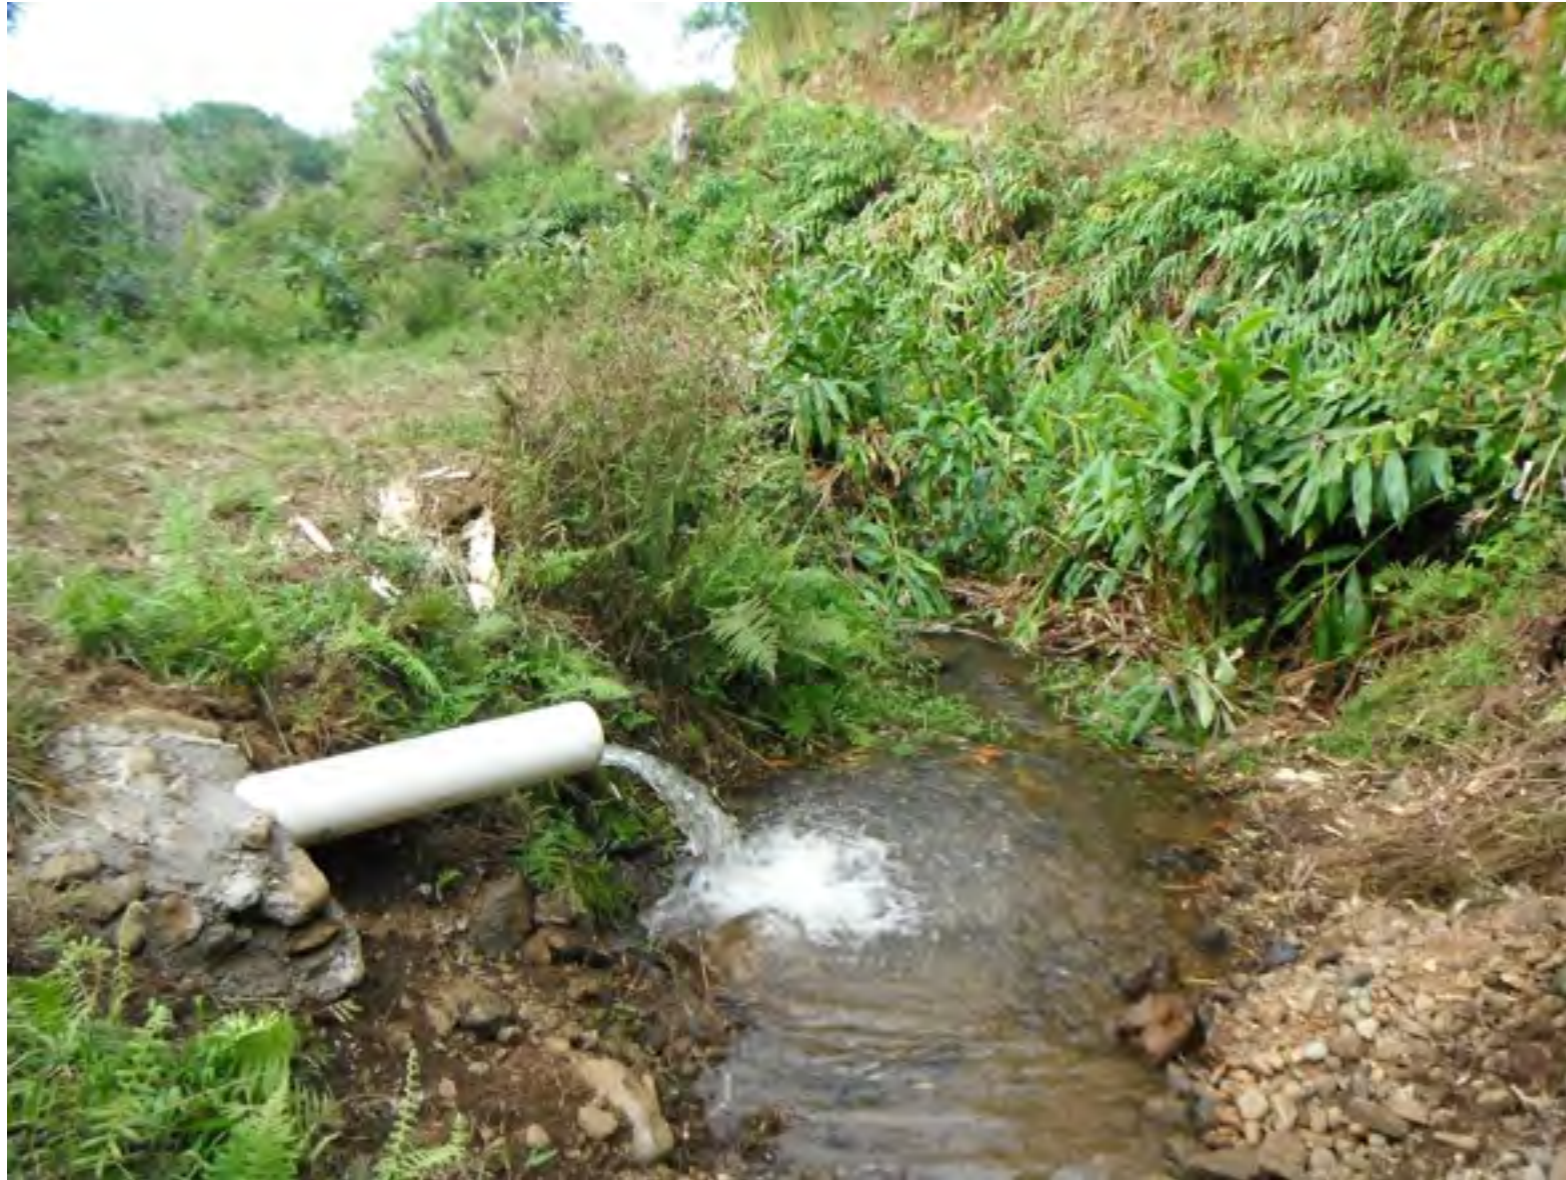
## **Lowrie Ditch Puolua stream bypass pipe**

Makai end of new 8" bypass pipe that currently passes under EMI dirt service road and conveys stream water into Puolua stream.

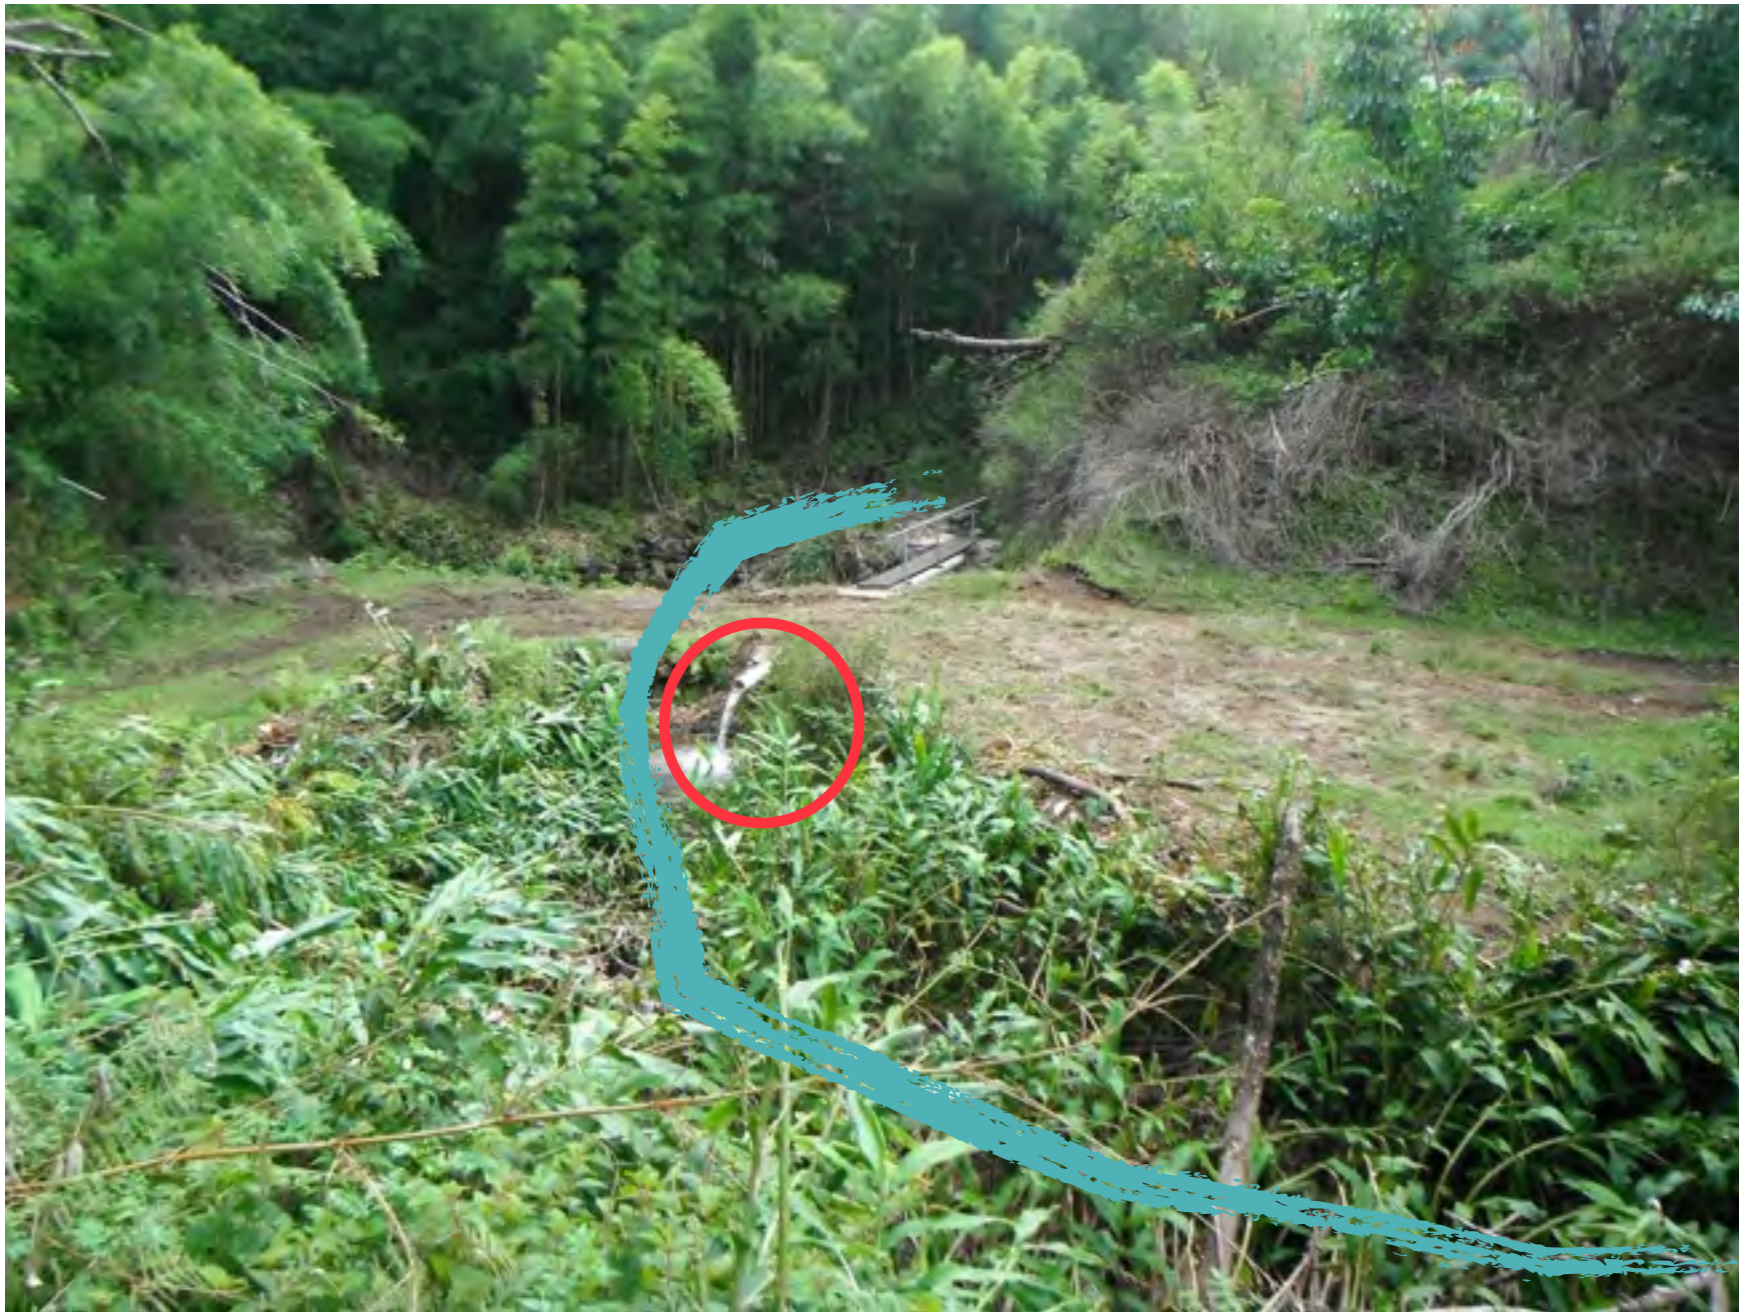
**MT EX #34**  
3/2015

Overgrown Puolua stream bed (owned by EMI) is in foreground. Bypass pipe passes under service road & empties into stream (red circle.)

Road would need to be modified if stream flowed. Blue line shows natural curve in stream channel

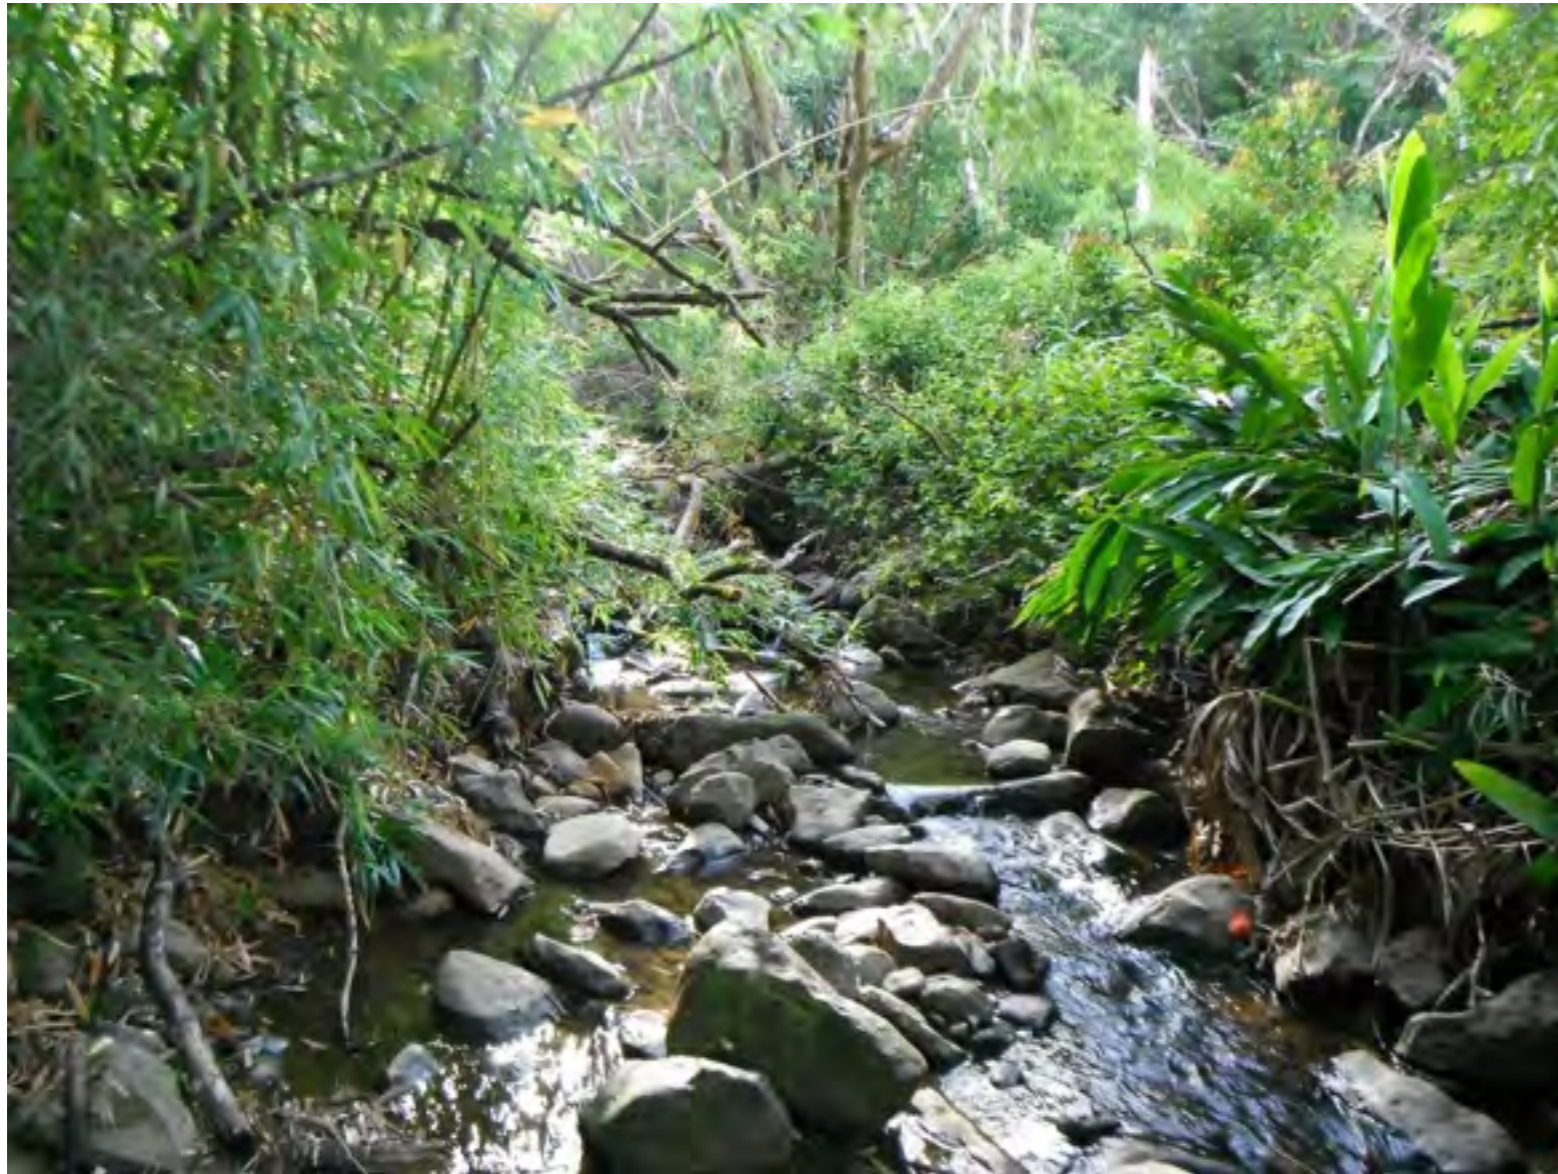
## **Puolua stream just upstream of Lowrie Ditch Diversion L-7a**

Puolua stream bed and surrounding land are all “owned” by EMI/A&B, who do not maintain the stream channel. It is choked with alien species and fallen trees, impeding stream flows.

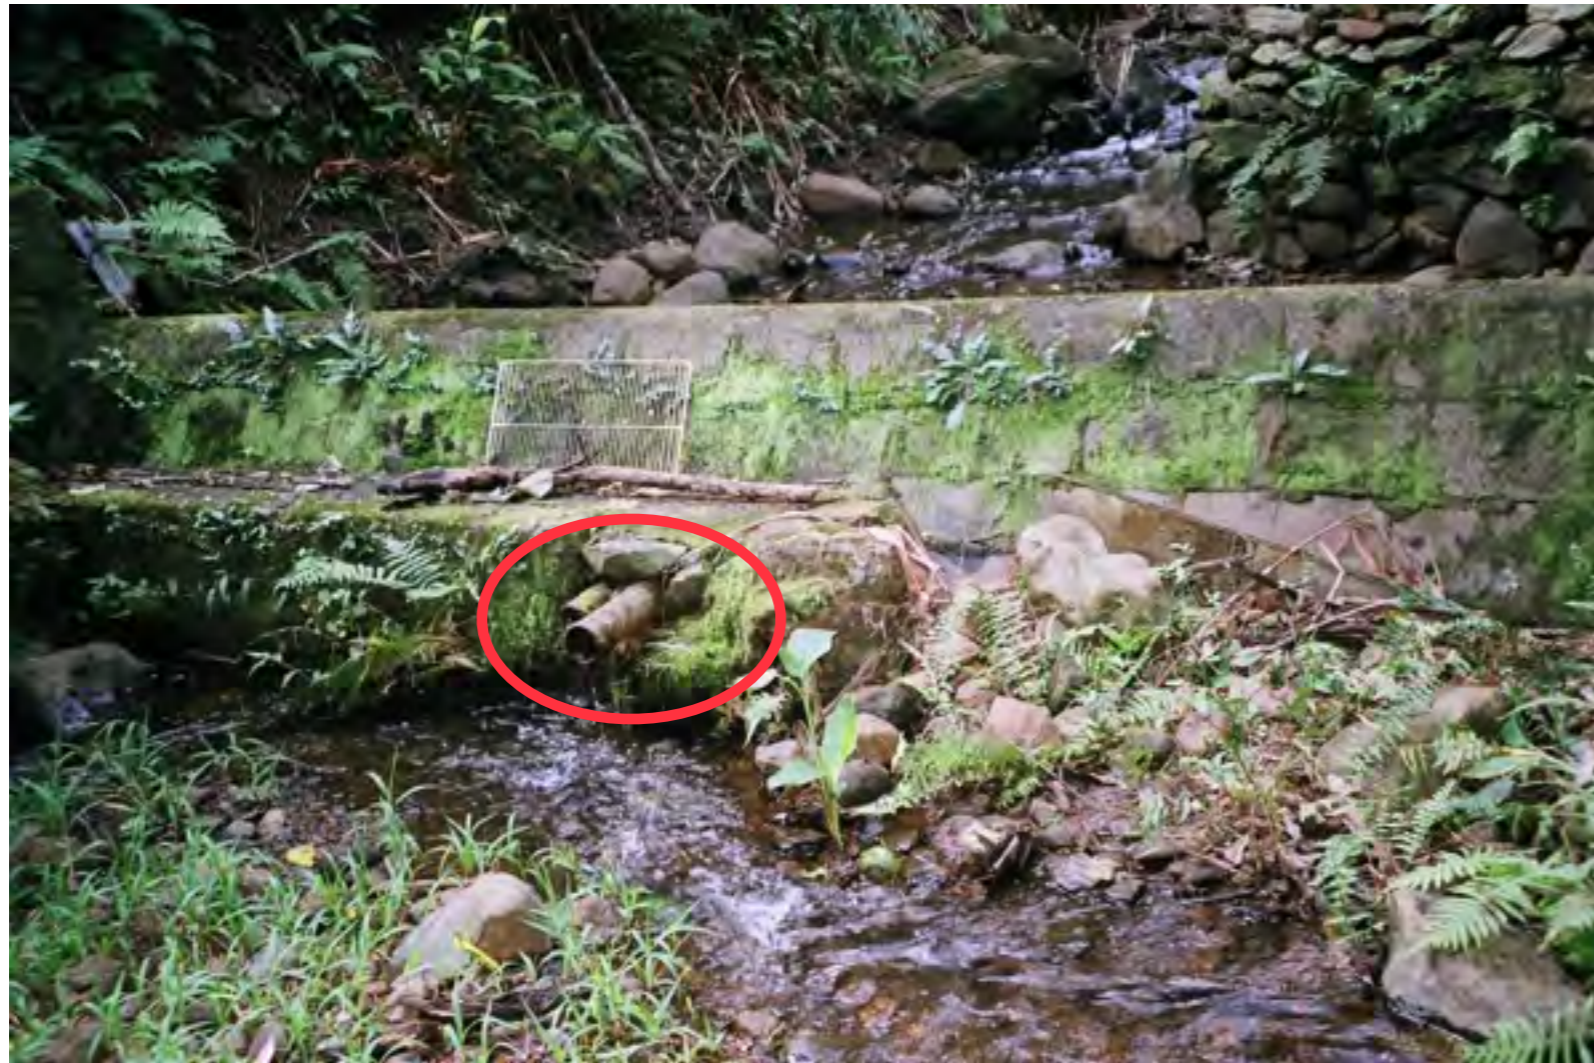
**MT EX #36**

### Haiku Ditch Intake at Puolua stream

Puolua stream channel is dammed and passed through a grate into New Haiku Ditch tunnel.

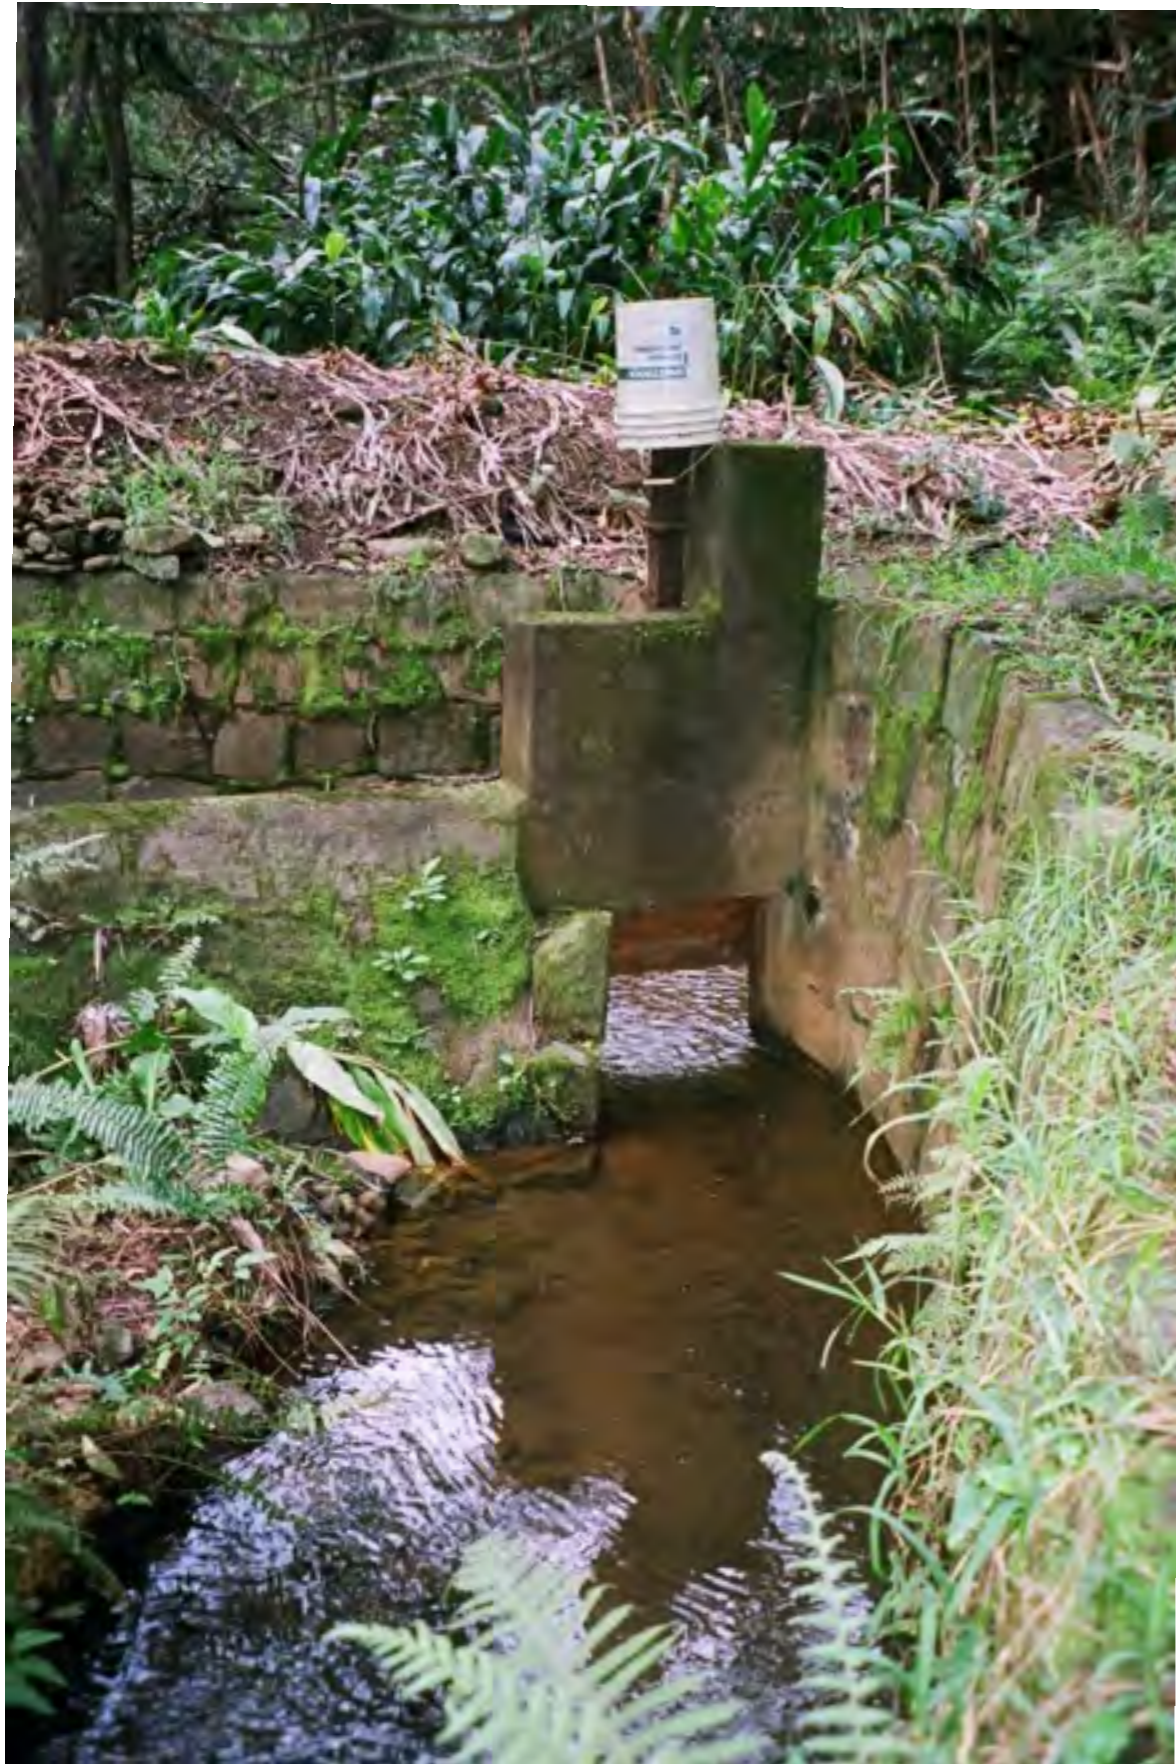
## New Haiku Ditch Diversion- Puolua (H-4) intake

EMI Sluice Gate on Puolua Stream  
Feb 2009

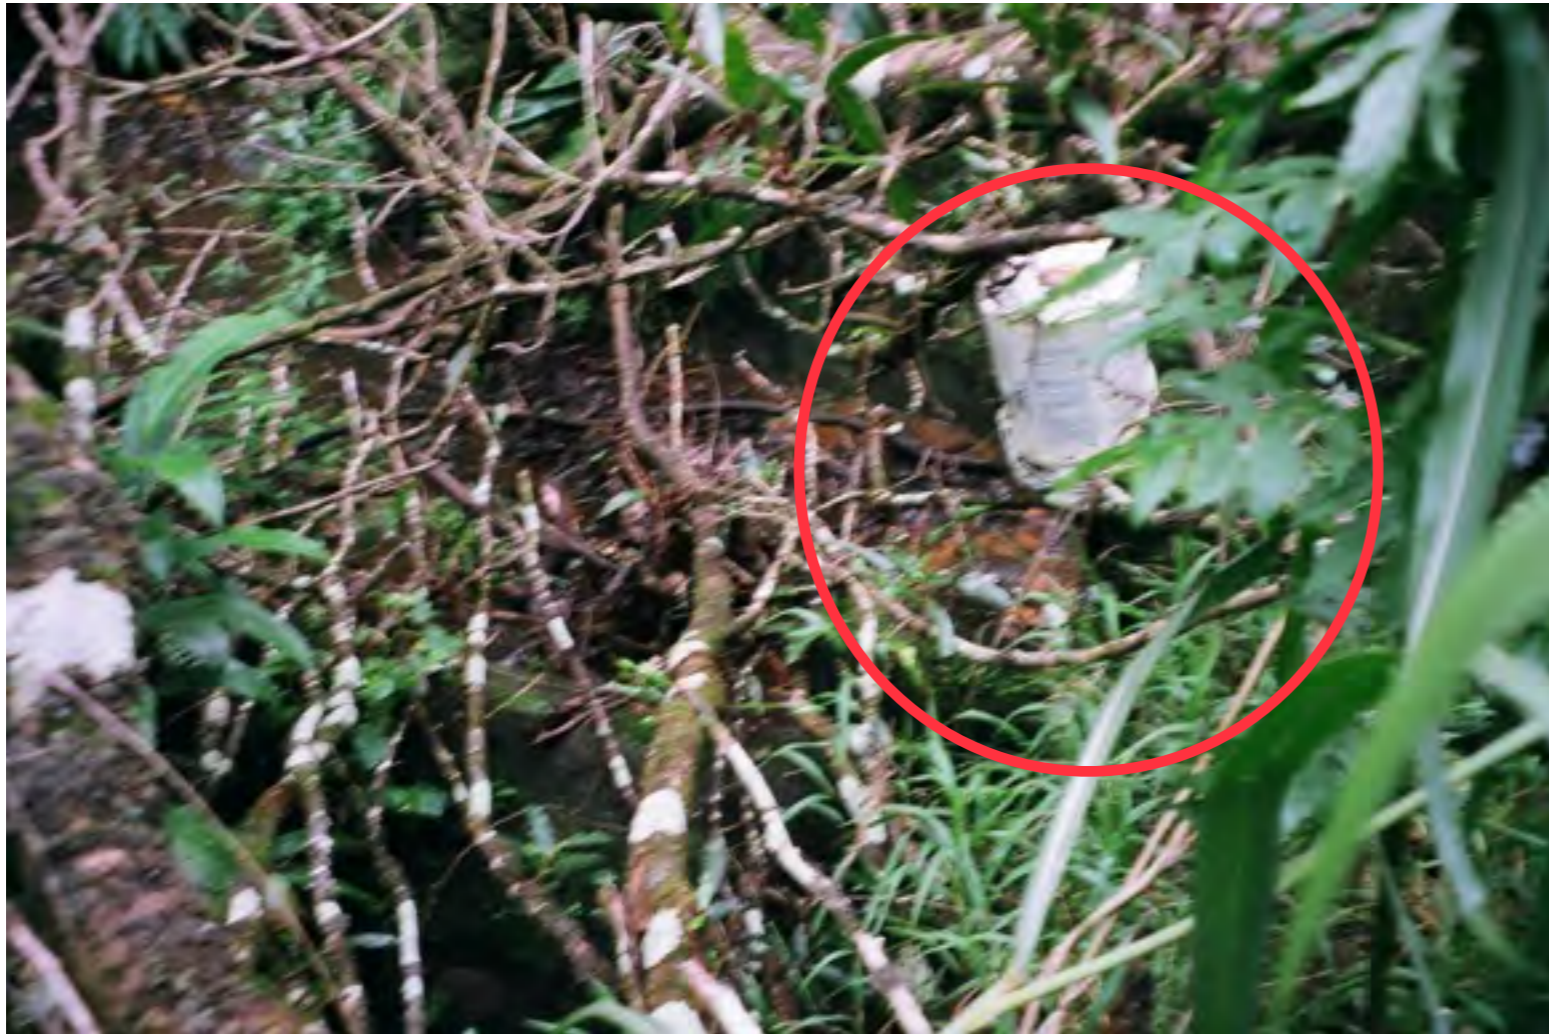
**MT EX #38**  
4/2011

### Haiku Ditch Intake gate at Puolua stream

Same sluice gate as last slide, two years later- April 2011- on Haiku Ditch/Puolua intake.(same white bucket on diversion gate handle)

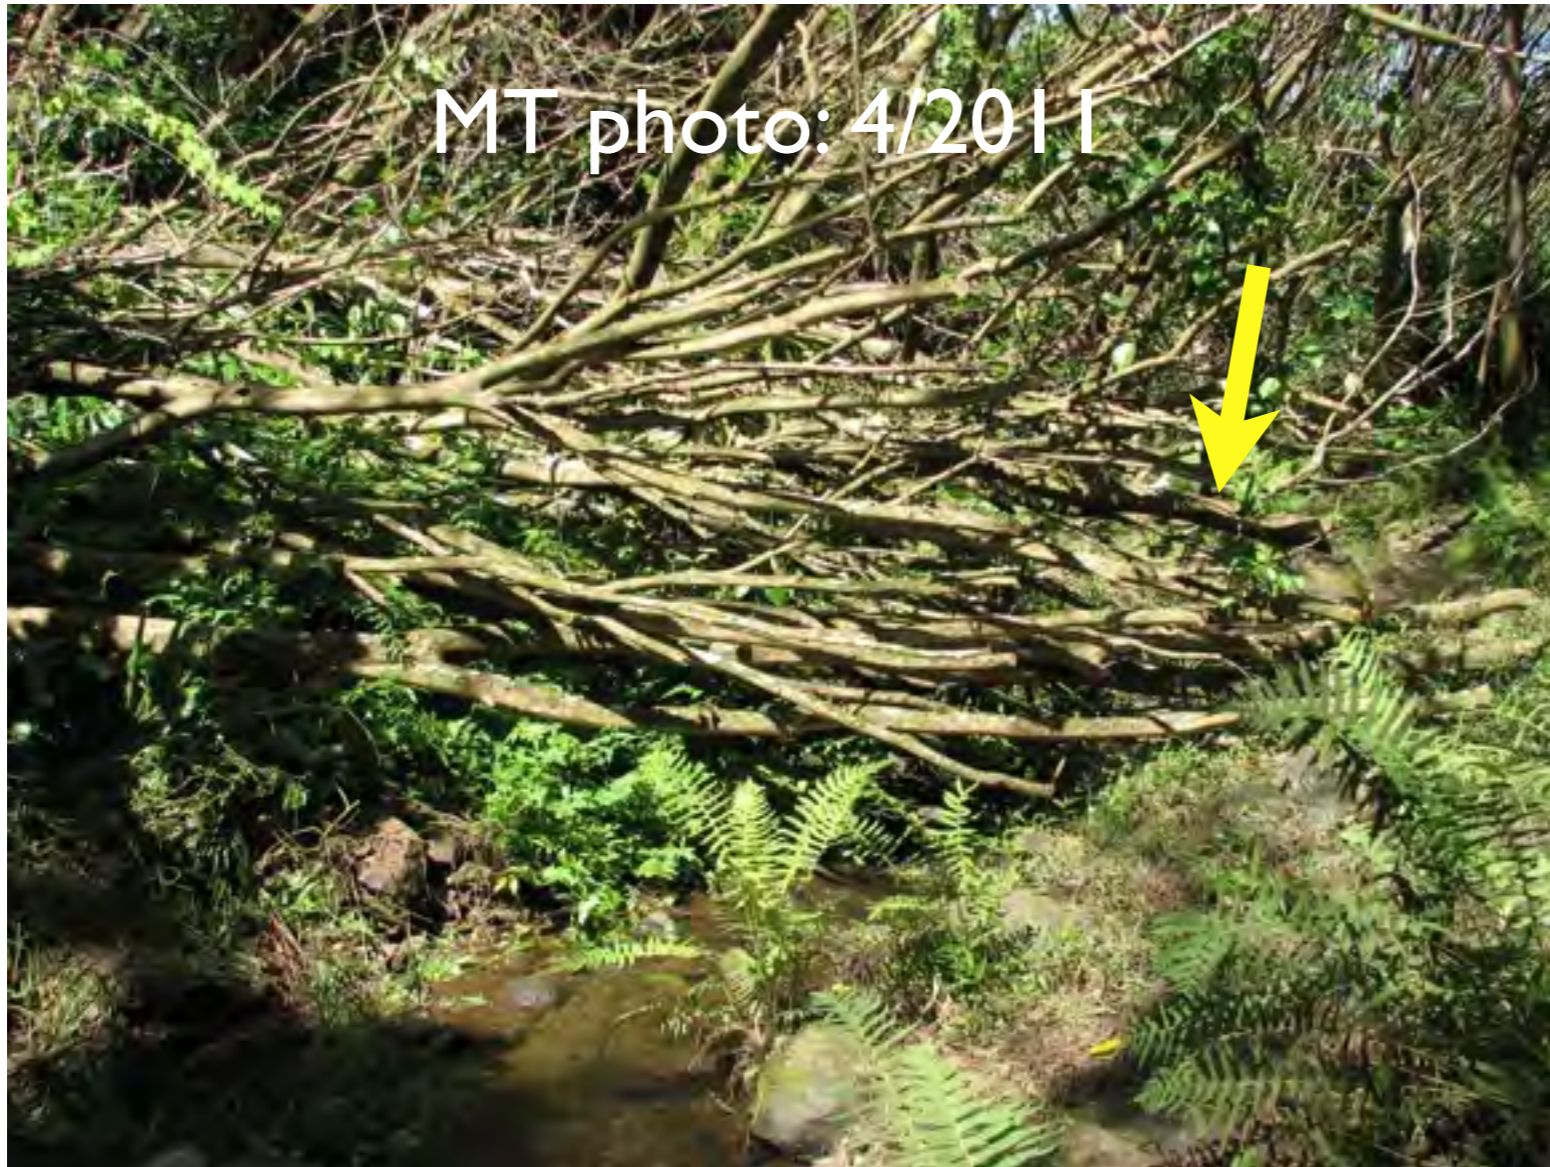
MT EH #39  
4/2011

## Haiku Ditch Intake gate at Puolua stream

View downstream to Haiku  
Ditch/Puolua intake wall  
(arrow) buried under fallen  
Roseapple trees.

Visits by CWRM to Puolua  
stream to monitor IIFS  
compliance ended in 2009.

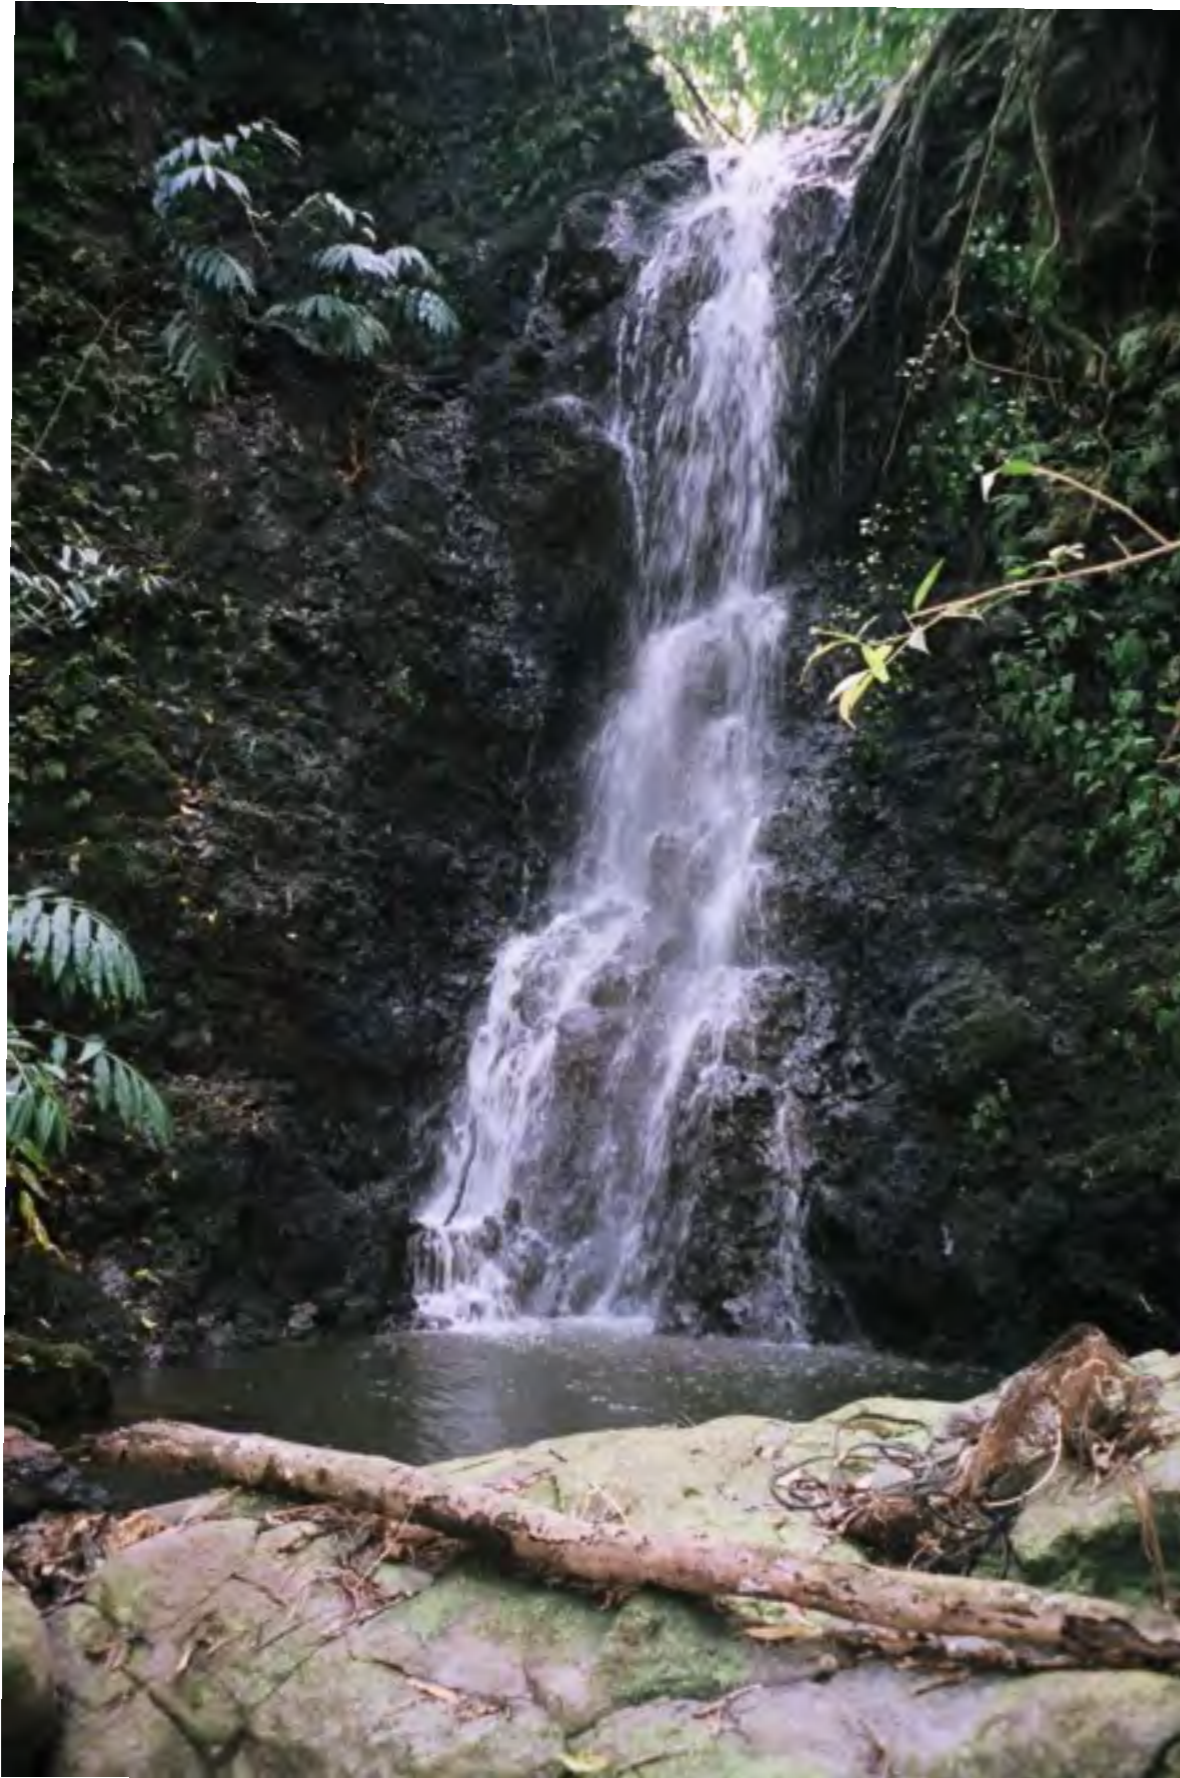
Feb 2009  
Puolua Stream  
Waterfall and pool just  
upstream of Haiku Ditch on  
EMI/A&B land.

This pool once had  
recreational use by local  
families, but the stream bed  
is now overgrown
