Watershed Park Borrow Pit Stewardship Plan

Prepared for the Green Kirkland Partnership

Catharina J. Penberthy

August 2013

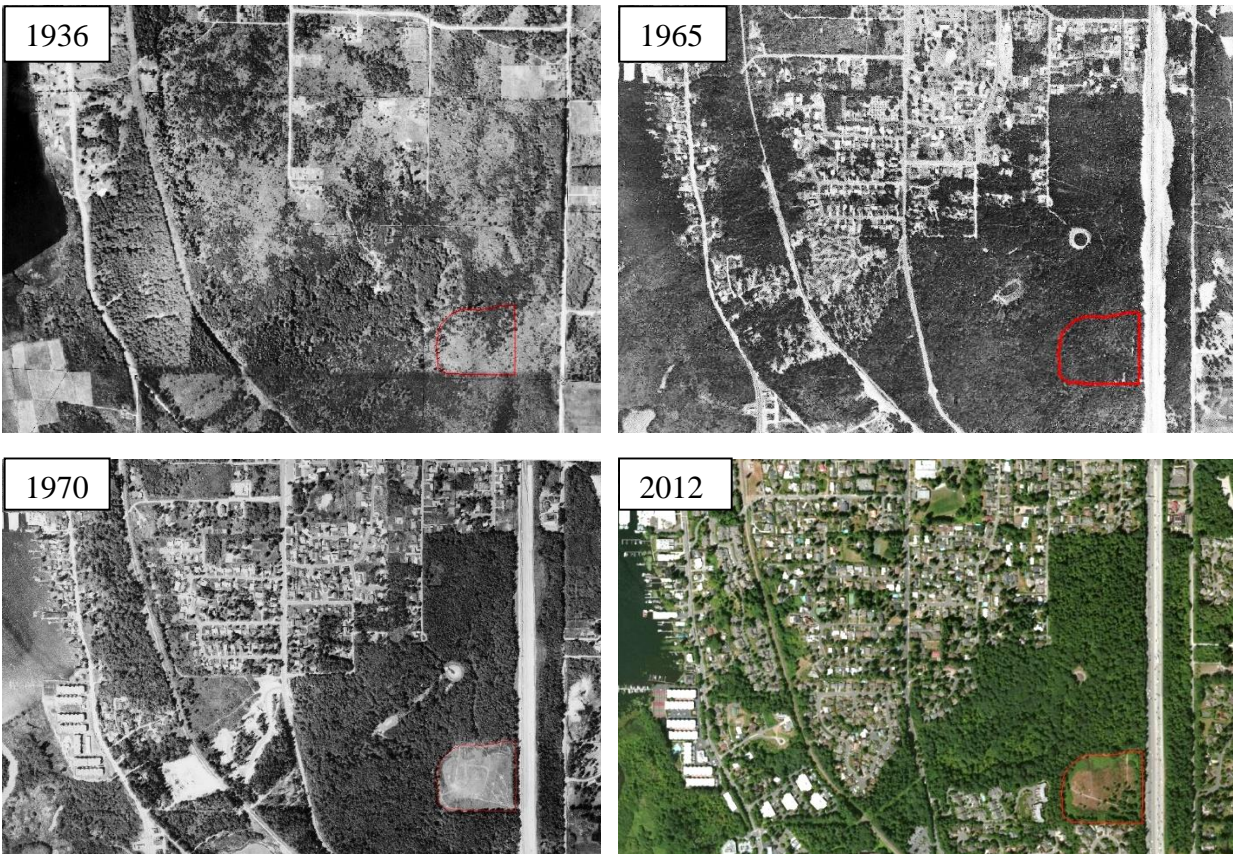
Figure 2. Watershed Park and surrounding landscape over time (King County 2008; Pacific Aerial Surveys 1965; Washington State Department of Natural Resource 1970; ESRI 2013). The project site is outlined in red.

Work on Interstate 405, adjacent to the park, was in full swing at this time. In the late 1960s, the project site was mined for gravel and sand, and used as a staging area during construction of the freeway, before being abandoned in 1968 (Sheldon et al. 2006). The extent of the destruction at the site is clearly visible on a 1970 aerial photograph (Figure 2). The site appears to be mostly bare of vegetation, and crisscrossed by a network of roads.

As can be seen from the 2012 satellite image (Figure 2), recovery has been slow—very little natural reforestation has occurred. Unfavorable site conditions are mostly to blame, but increasing levels of anthropogenic disturbance in the surrounding areas are probably also contributing to the continued degraded state of this site.

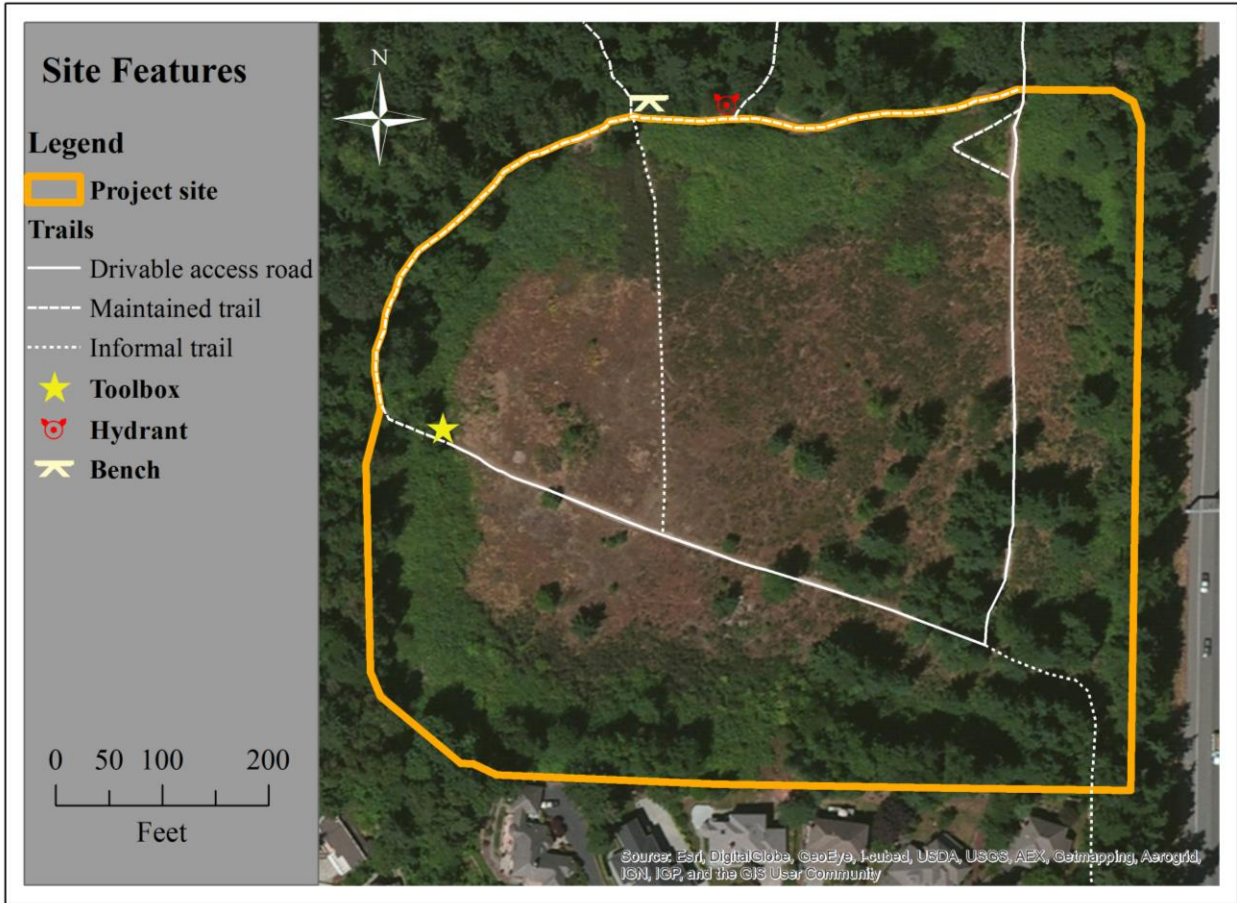
Figure 3. Plan view showing the main features of the project site.

The pit itself can be accessed by vehicle from the northeast corner via one of these old access roads (Figure 3). The road is poorly maintained and the grade fairly steep where it enters the pit, necessitating a 4-wheel drive vehicle. The road traverses the site from north to south, and then turns west, continuing all the way to the western edge of the pit. Mulch and other supplies can be delivered to any point along the road. However, because of the poor road conditions, deliveries are limited to the drier months of the year.

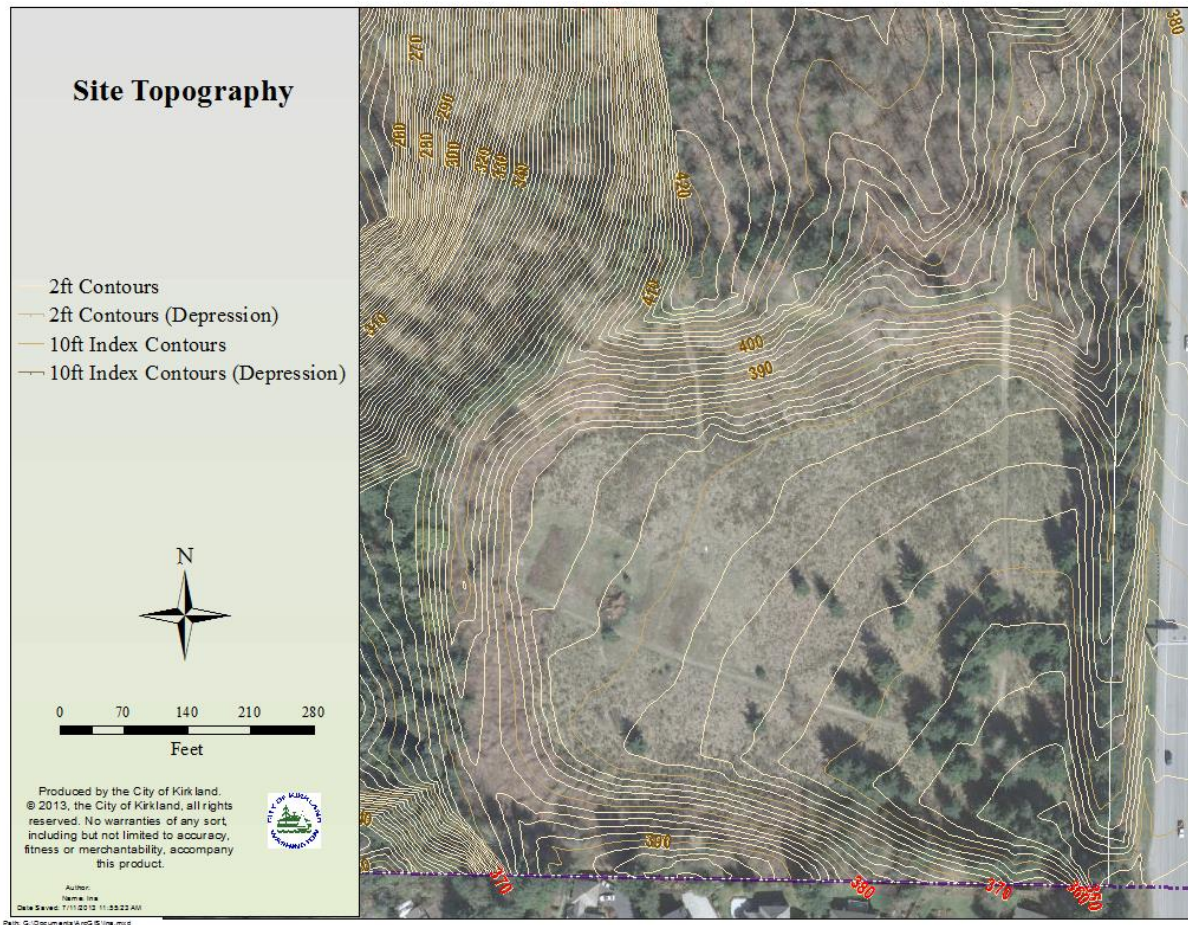
Figure 4. Two foot contour lines at the Watershed Park borrow pit (Obtained from the City of Kirkland).

pit floor are variable and moderately steep, especially to the north and south, with grades varying between 21 and 36%. The pit floor slopes gently towards the southeast corner at a grade of <5%. The topography of the pit floor is often uneven —ridges, swales, mound and pits, relicts of past human activities, are common features of the pit floor (Figure 5), and are often associated with local variations in vegetation cover. The vertical scale of these features is small, rarely exceeding 18 inches.

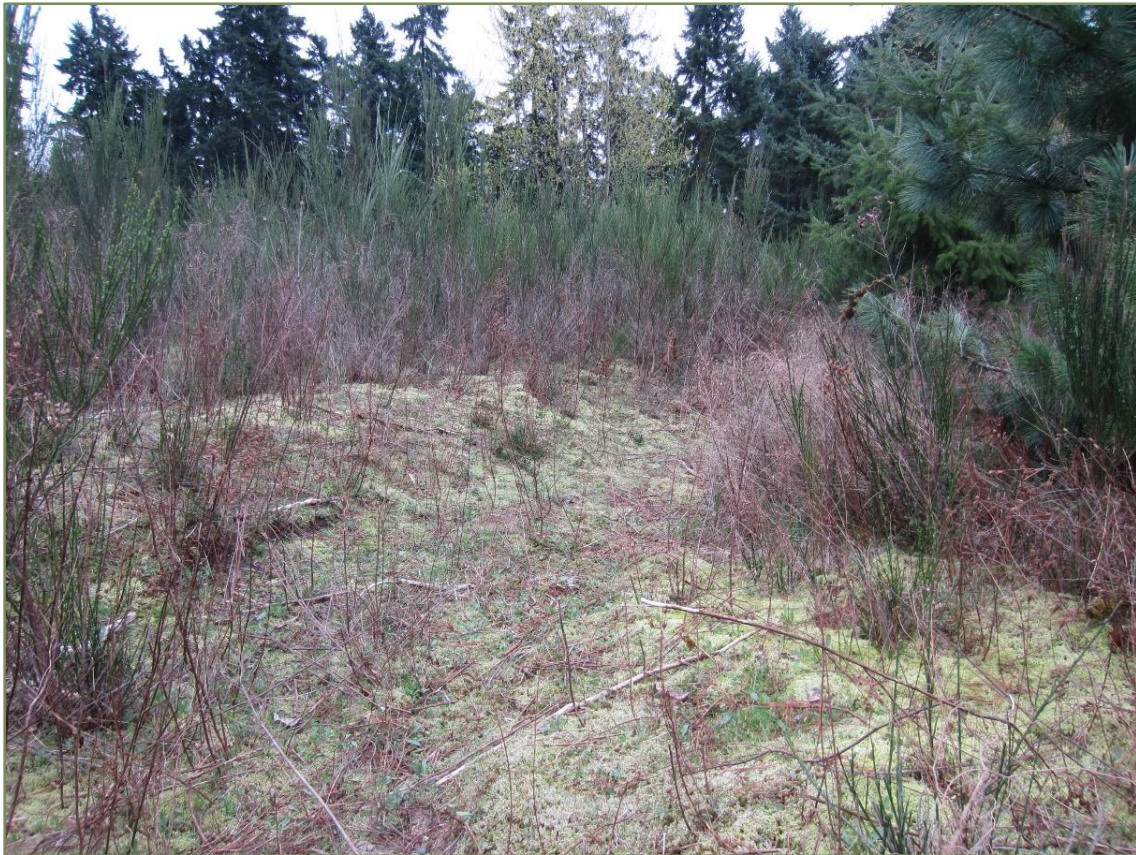
Figure 5. Uneven pit floor topography: Aerial photographs suggest that the shallow ridges and swales in this image are old wheel track ruts. Note the sparse vegetation associated with these features.

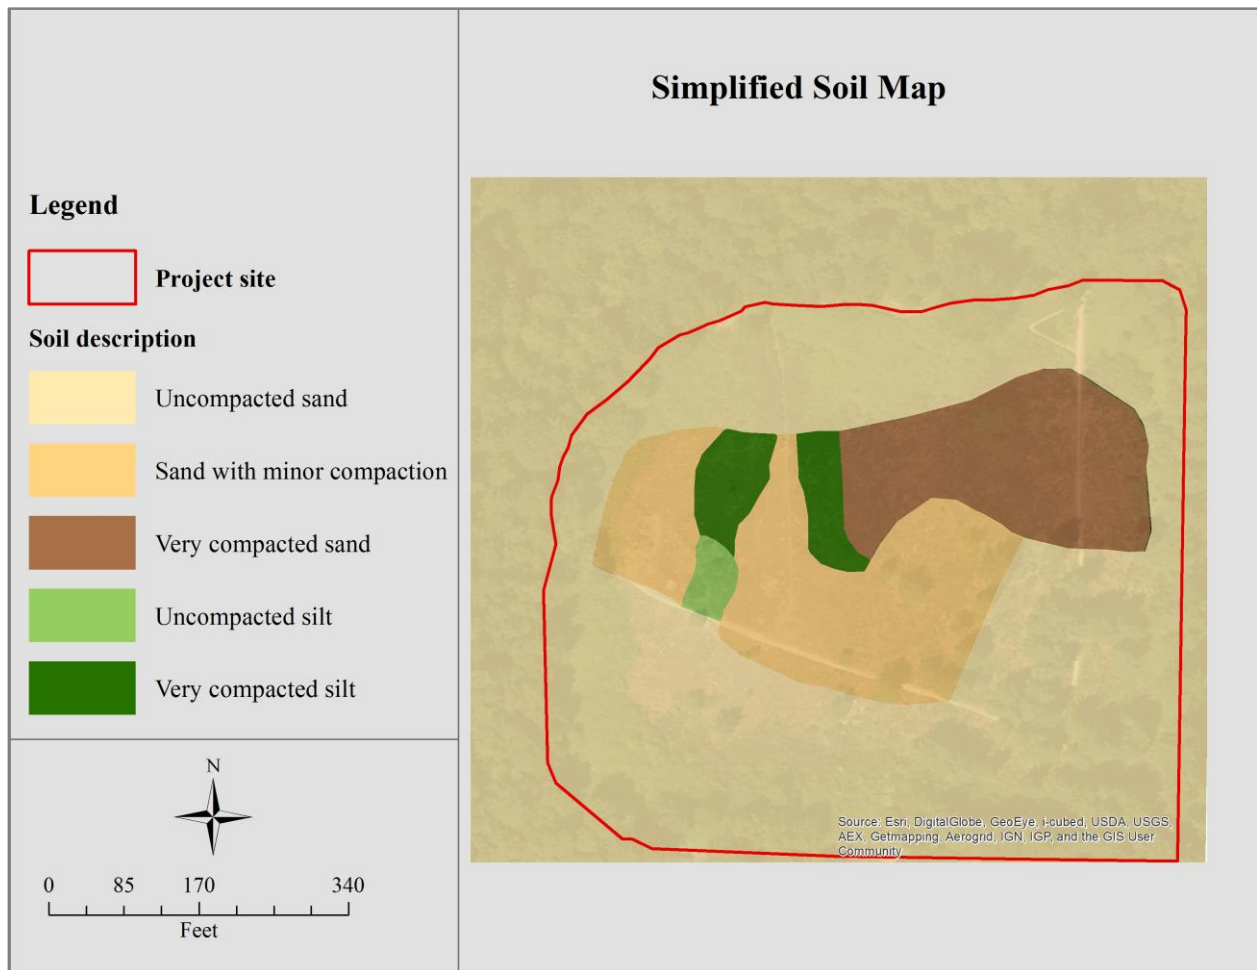
Figure 6. Generalized soil map of the project area.

Across most of the pit floor and the slopes (Figure 6), the subsoil consists of well-sorted, loose, fine-to medium-grained, grayish-to yellowish-brown, well-drained sand, probably representing outwash deposited by glacial meltwater.

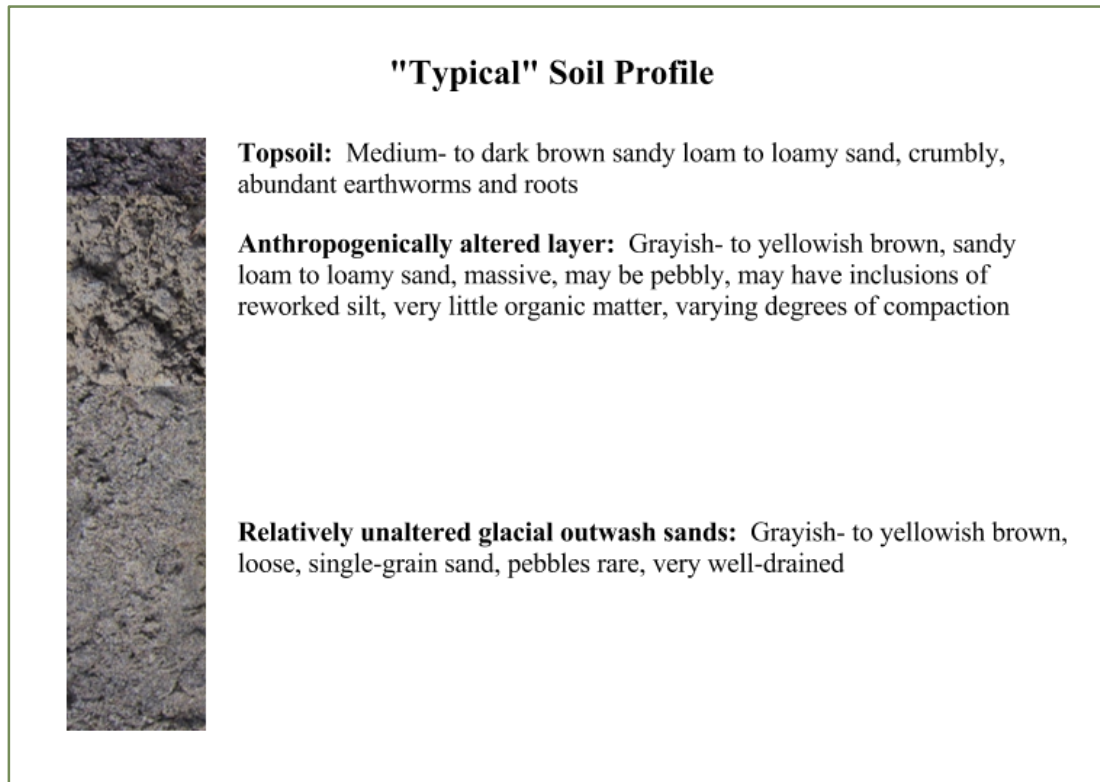
Figure 7. “Typical” soil profile of sandy soils at Watershed Park borrow pit.

Some topsoil development did occur over the past four decades. The surface layer of the soil, generally 1 to 3 inches thick, but as thick as 12 inches in some locations, is typically a medium- to dark-brown, sandy loam with granular structure. The dark color of this material can be attributed to the addition of organic material in the form of decaying vegetation. Abundant earthworms were commonly observed in this layer.

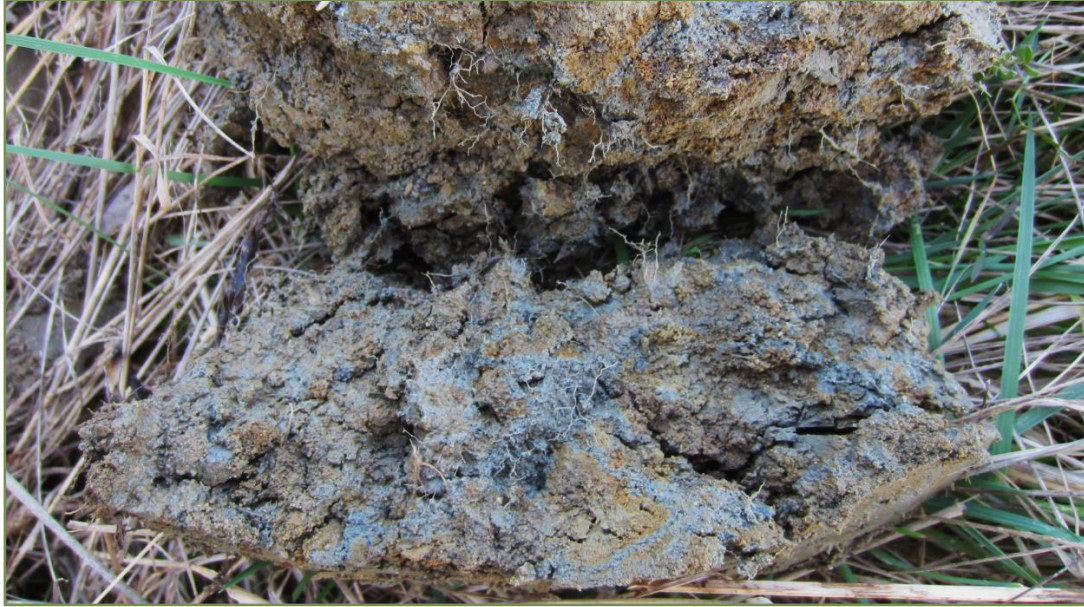
brown sandy clay loam or clay loam. While occasional reddish redox concentrations are common towards the bottom of this layer (Figure 8), poor drainage does not appear to be a significant problem where these soils have not been compacted. Where compaction of these soils did occur, mostly in the northern half of the site, very wet, poorly drained conditions prevail (Figure 9).

Figure 9. Red and gray mottling in layers overlying compacted fine-grained soils. These redoximorphic features are typical of seasonally saturated soils.

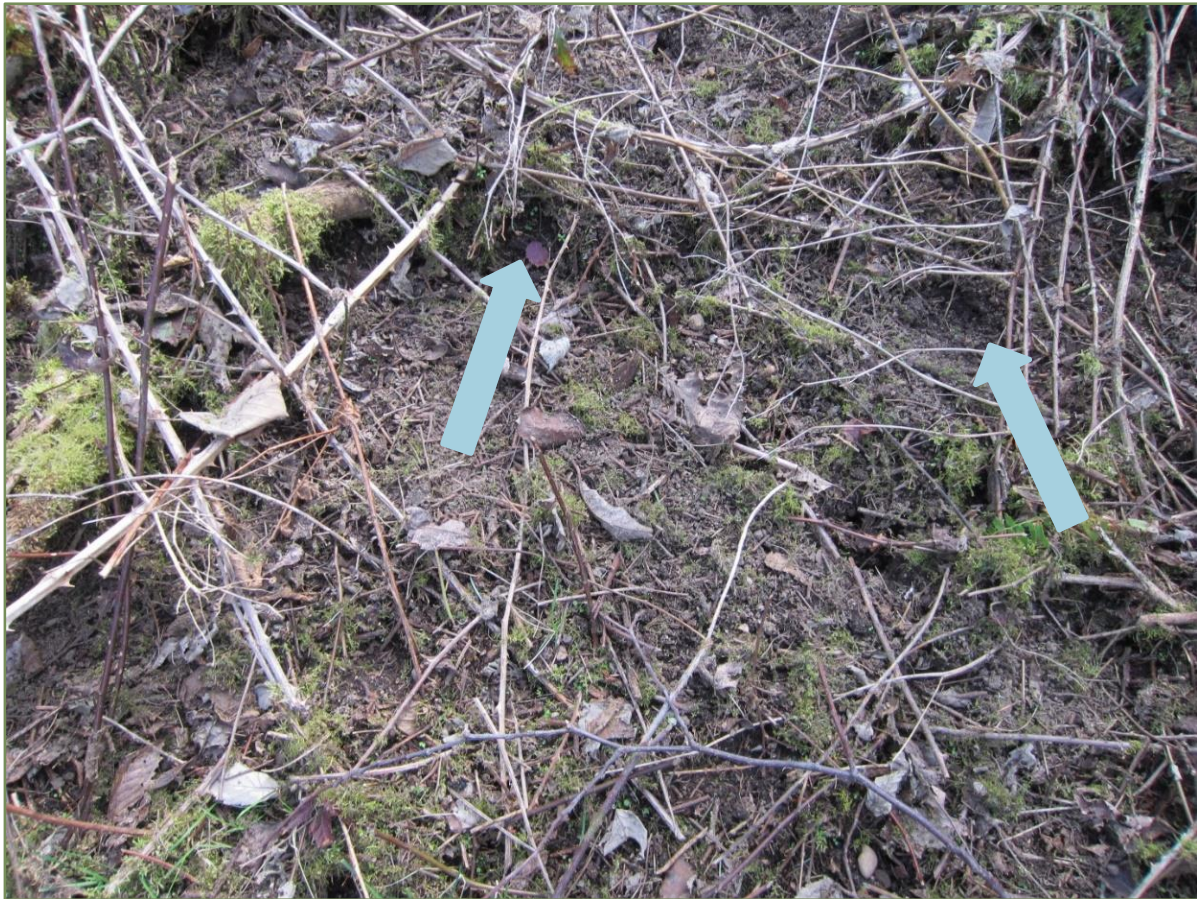
poor, resulting in a seasonally perched water table during the winter months. The irregular topography of the pit floor helps to slow down and retain storm water run-off. During periods of heavy or extended rainfall, stormwater run-off, some of it generated in other areas of the park, can be seen flowing downhill along the compacted trails towards the southeast corner of the pit (see figure 3 for a map of the trails present on site).

Figure 10. Soil erosion occurring along the slope under a canopy of Scot's broom and Himalayan blackberry. Arrows indicate areas where the soil is being washed away.

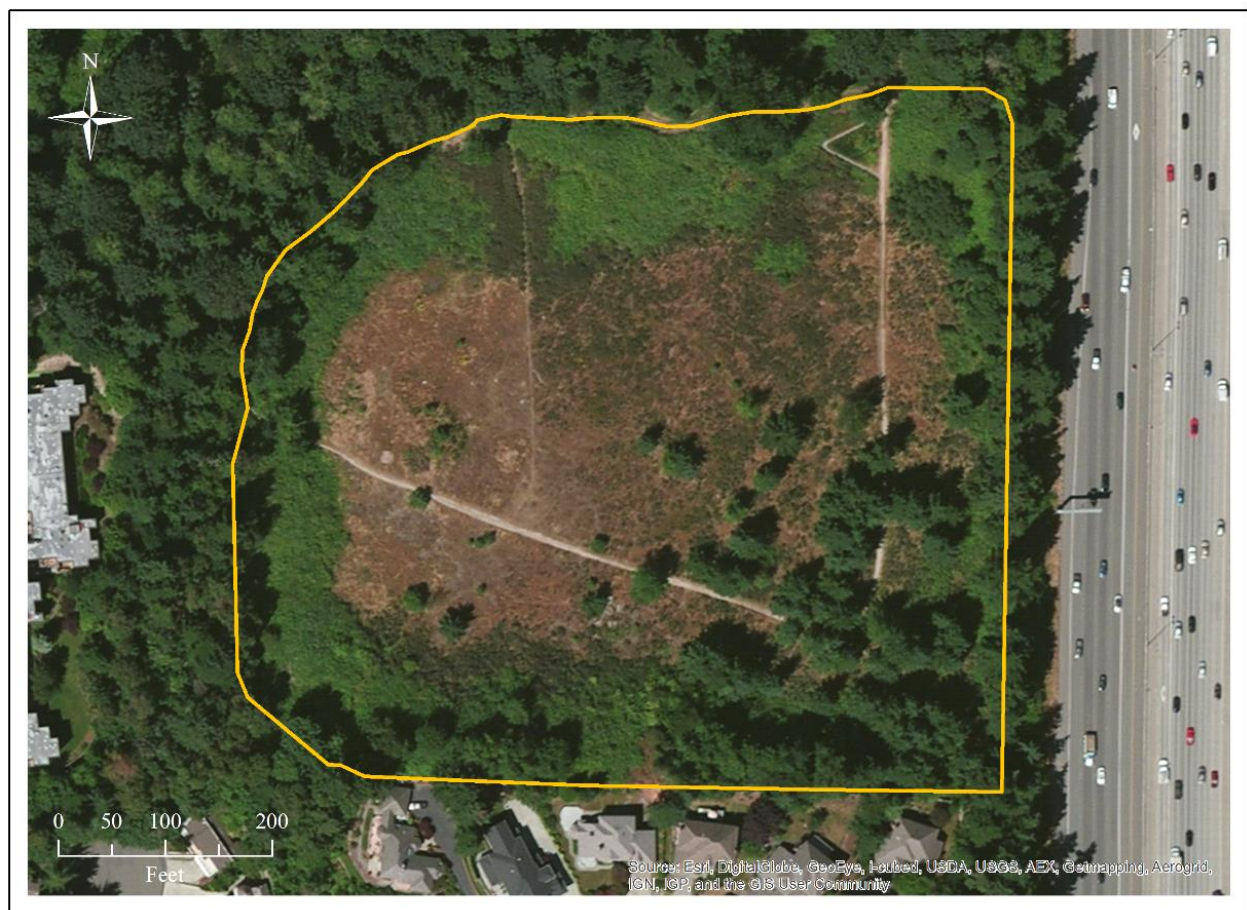
Figure 11. 2012 satellite image of the site (ESRI 2013). Slopes surrounding the pit area have dense cover of Himalayan blackberry (lighter green) and Scot's broom (grayish green). Sparser Scot's broom cover characterizes the central pit area. Note that Scot's

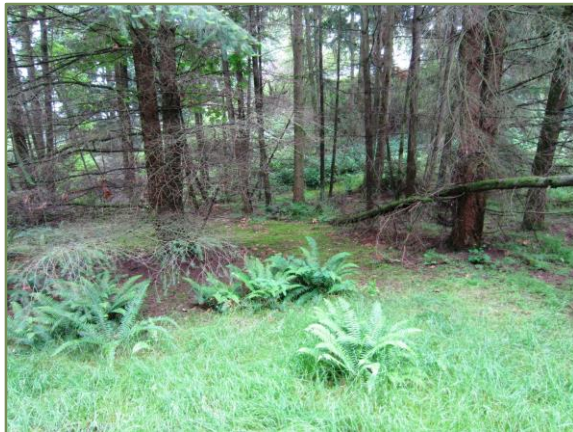
Figure 12. Douglas-fir stand in the southeastern corner of the site. Note the sparse understory beneath the trees. Sword ferns are growing along the drip line of the trees. Introduced grasses and forbs represent the dominant vegetation in canopy gaps.

Where the canopy starts to open up, western sword fern commonly occurs along the drip line of Douglas-fir trees along with tall Oregon grape, cleavers and blackcap raspberry (see Figure 12; Figure 35). Indian plum seedlings are common, but most do not seem to survive past the seedling stage (Figure 36).

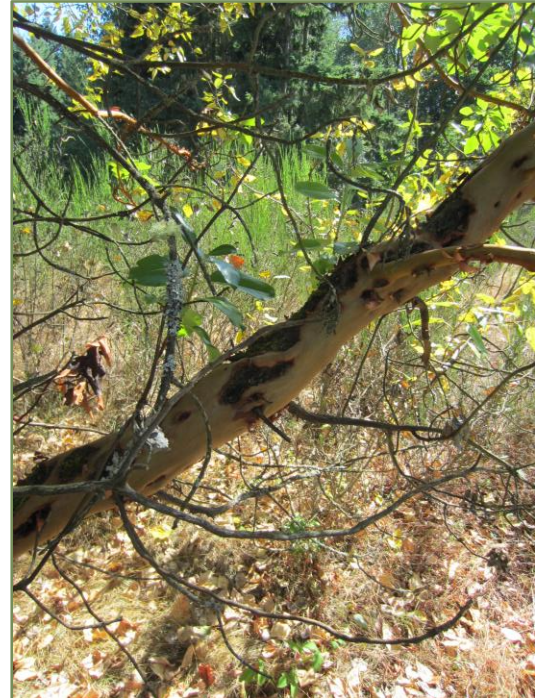
- Along the rest of the pit floor, native vegetation is limited to a few scattered trees and shrubs, often occurring in clumps, mostly Douglas-fir, black cottonwood, Pacific madrone (*Arbutus menziesii*), red elderberry and greasewood/snowbrush (*Ceanothus velutinus*). Hooded ladies tresses (*Spiranthes romanzoffiana*) is the only native forb present (Figure 13). Tree ages vary from seedlings to mature (Figure 14). The few red alder trees are generally small and appear stressed; dead branches are common. Pacific madrone trees are invariably diseased (Figure 15).

Figure 15. Cankers on stem of a Pacific Madrone tree.

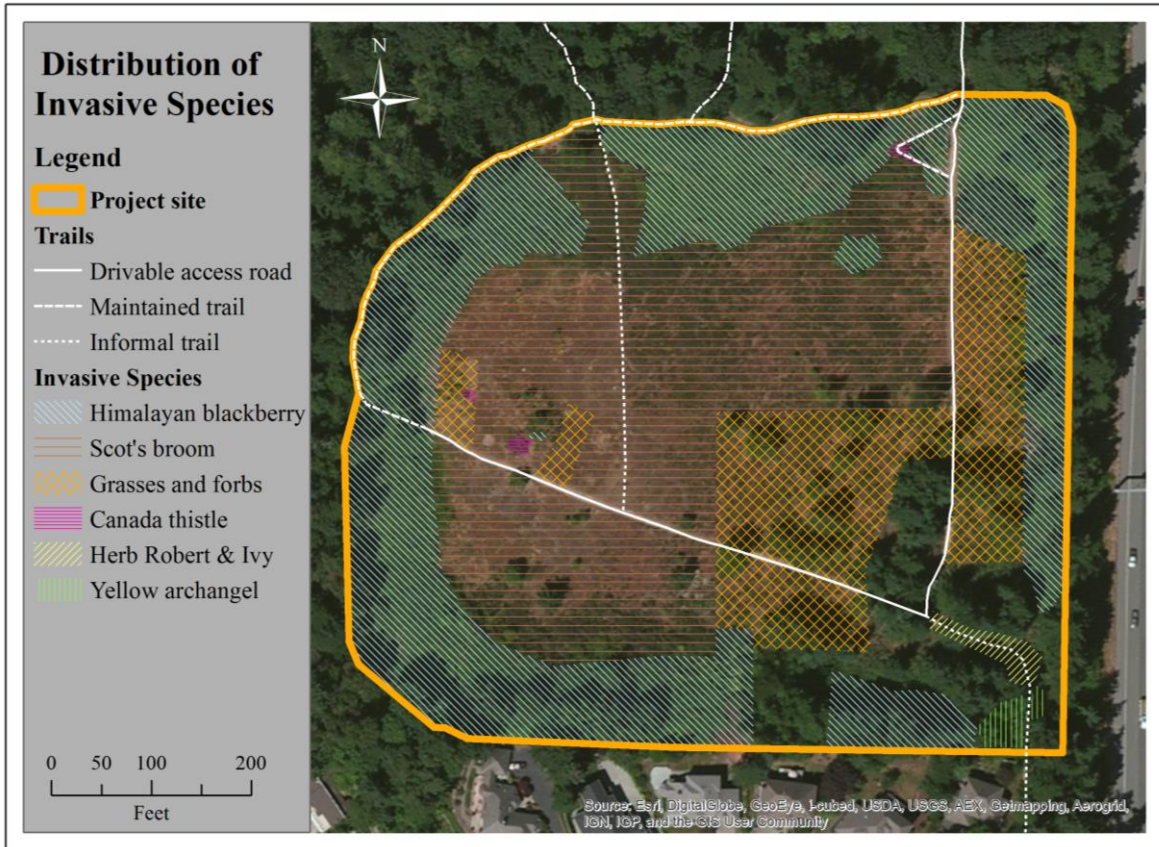
Figure 16. Distribution of non-native, invasive vegetation at the site. Note that introduced grasses and forbs dominate in areas from which Scot's broom has been removed.

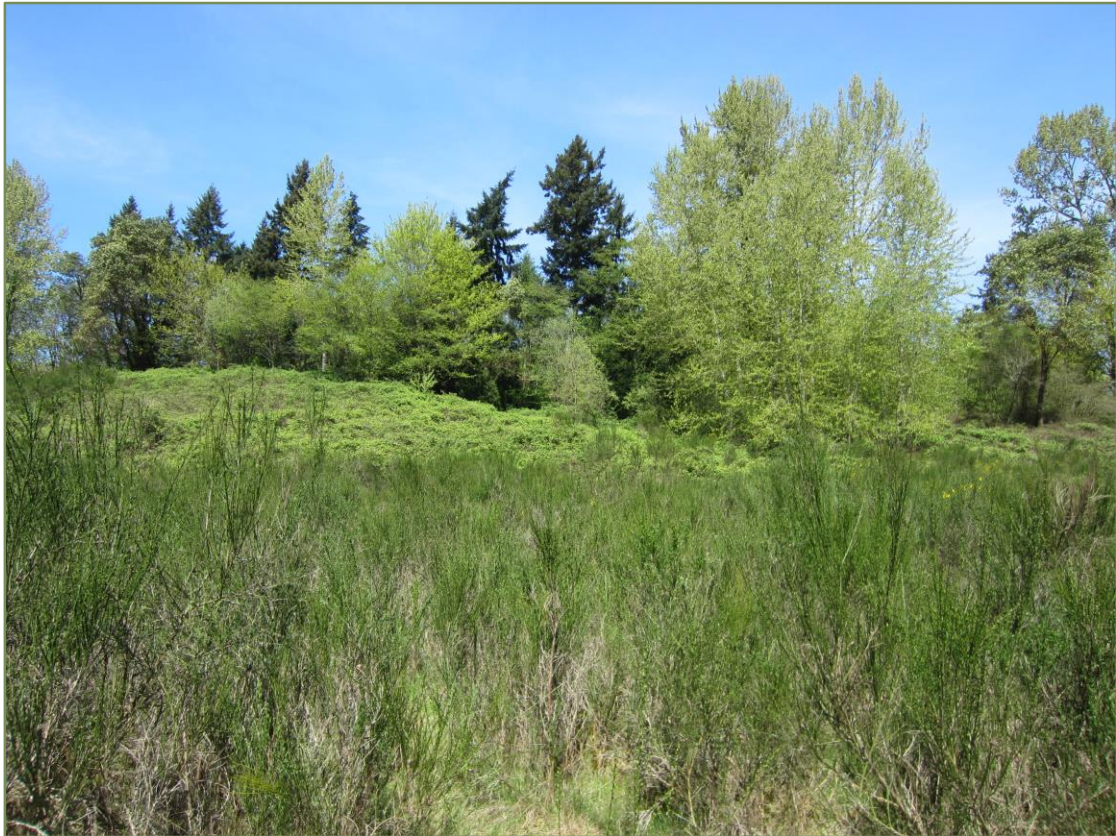
- The slopes are covered mostly by Himalayan blackberry (*Rubus armeniacus*) and less commonly Scot's broom (Figure 17), with cover close to 100%. Evergreen blackberry (*R. laciniatus*), a close relative of Himalayan blackberry is present in minor amounts. For the remainder of this document, references to Himalayan blackberry can be assumed to include evergreen blackberry.

Figure 17. Scot's broom dominating the pit floor (foreground), with Himalayan blackberry along the slopes in the background.

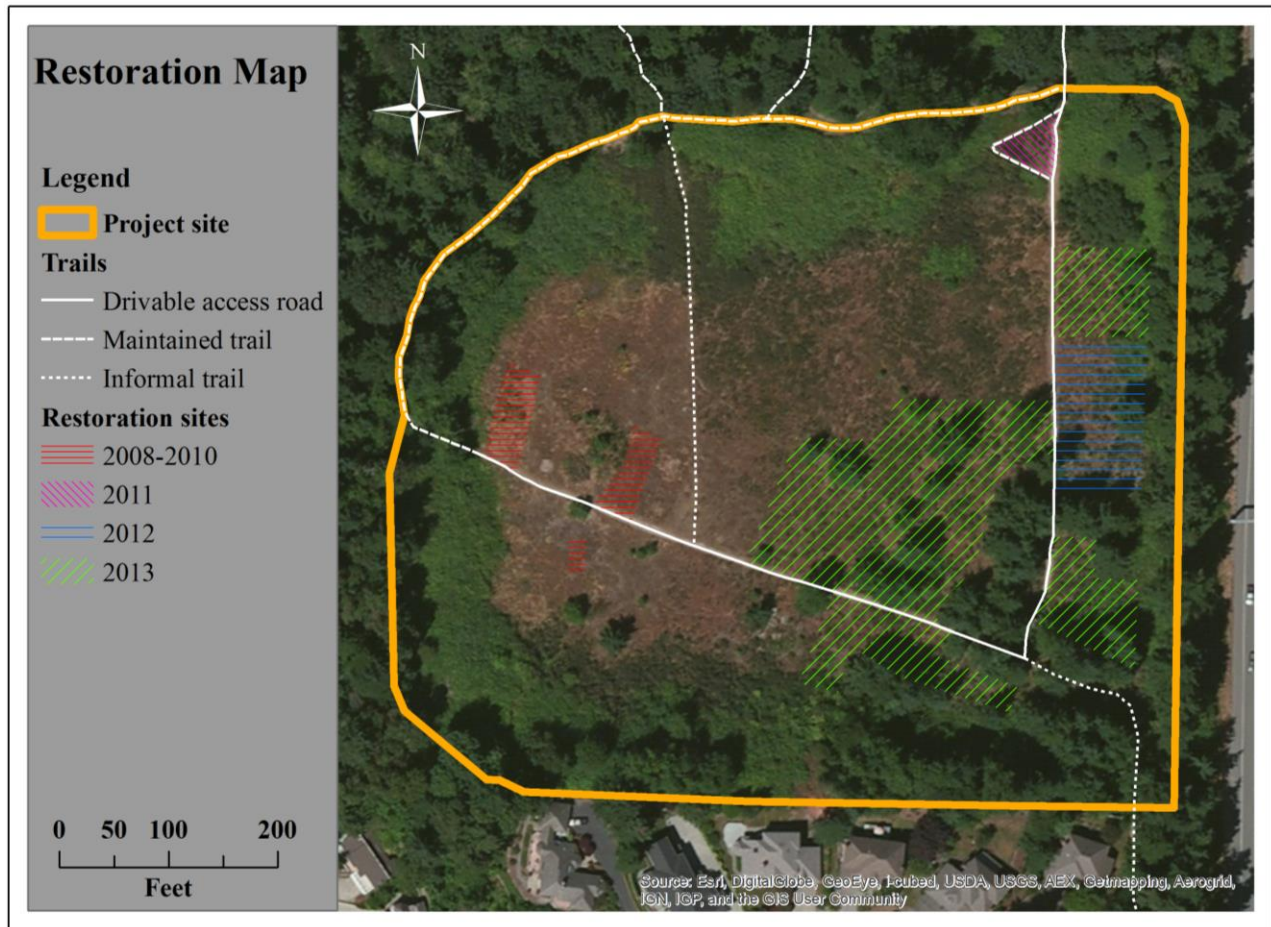
Restoration has been initiated at several locations at the site (Figure 18).

Figure 18. Map showing the locations of current restoration activities at the Watershed Park borrow pit. 2008-2010 sites where no plants survived and which have not been maintained are not shown on this map.

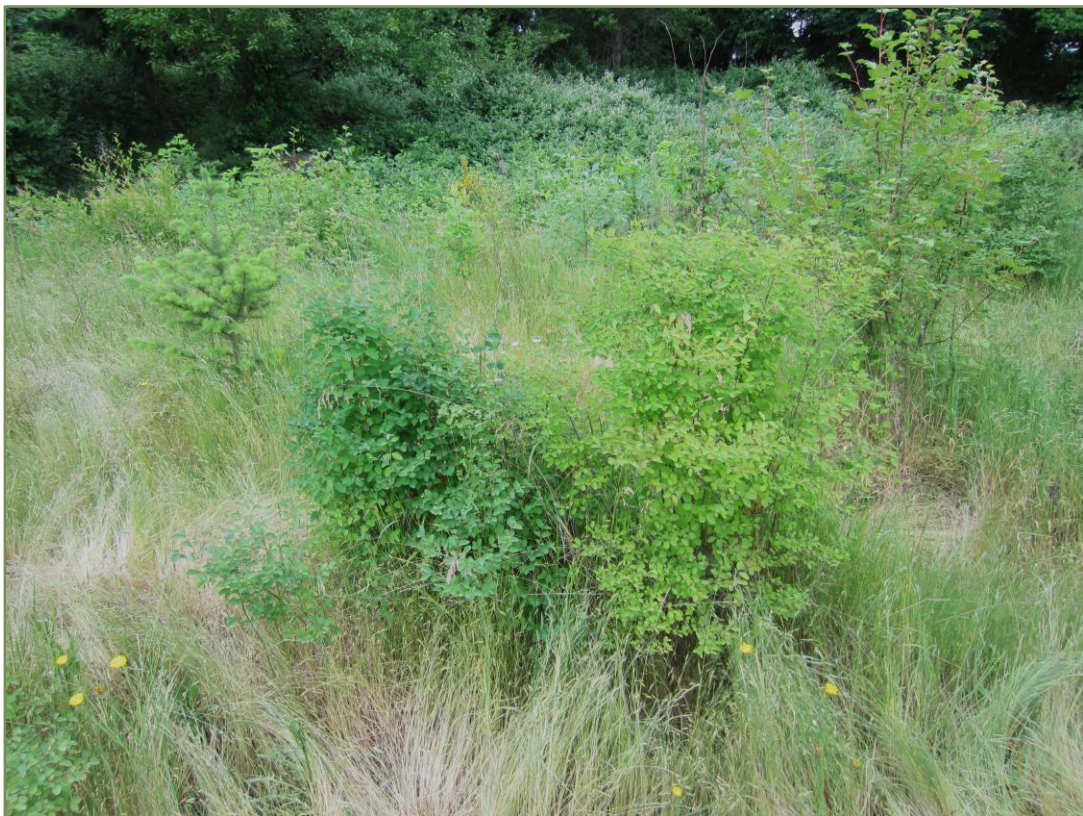
Some of the plots have been tilled and replanted several times since. Survival rates were variable and low, ranging between 0 and 25% for all species combined (13% for all plots and all species combined). Survival rates do not appear to be directly related to the amount of compost applied, although the plot that received the most compost (about 6.5 inches), was also the plot with the lowest mortality. Competition from forbs and grasses remains a problem (Figure 19).

Figure 19. Native trees and shrubs facing fierce competition from introduced grasses and forbs. This area was cleared, amended with 6.5 inches of compost, tilled and planted in 2008. It has been cleared and replanted in 2010 and 2012.

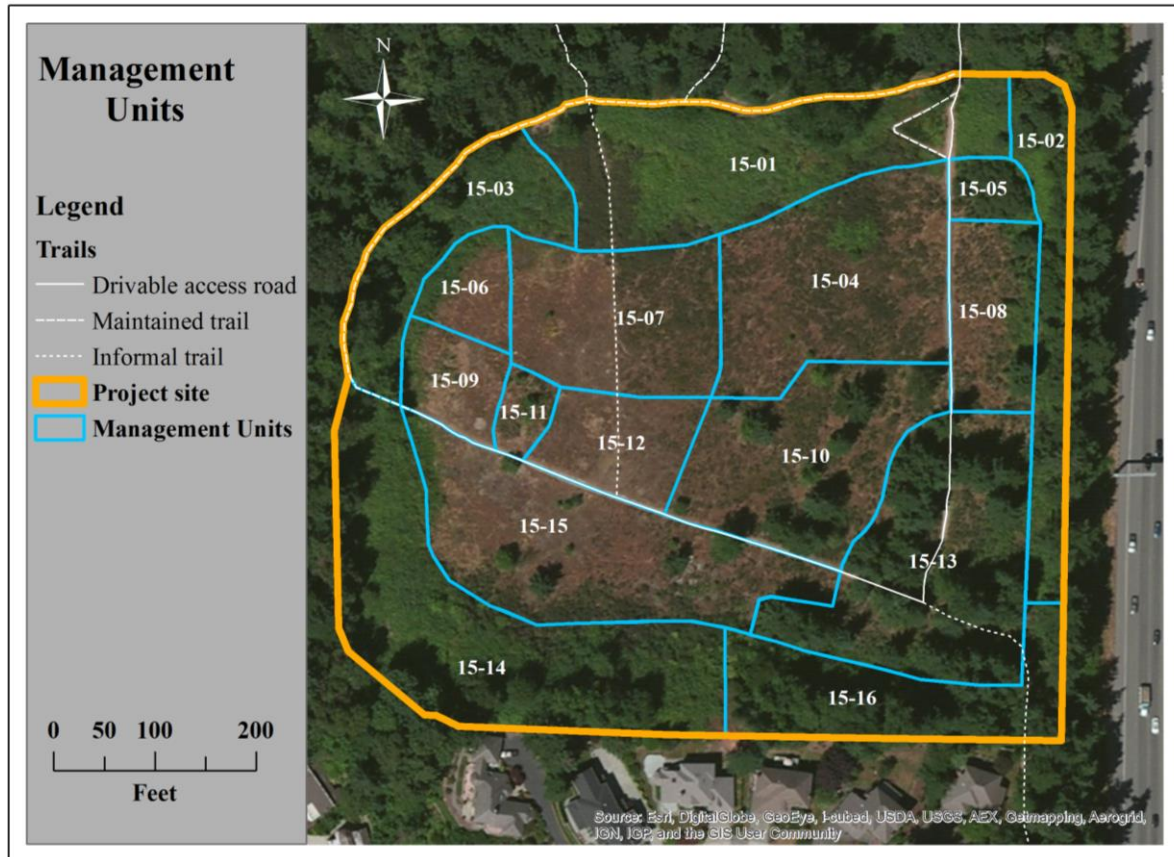
Figure 20. Management units.

Figure 20 shows the location and extent of each of the restoration management units delineated. The narrative below summarizes the main features of each management unit. More detailed information about each management unit can be found in Table I and Table II.

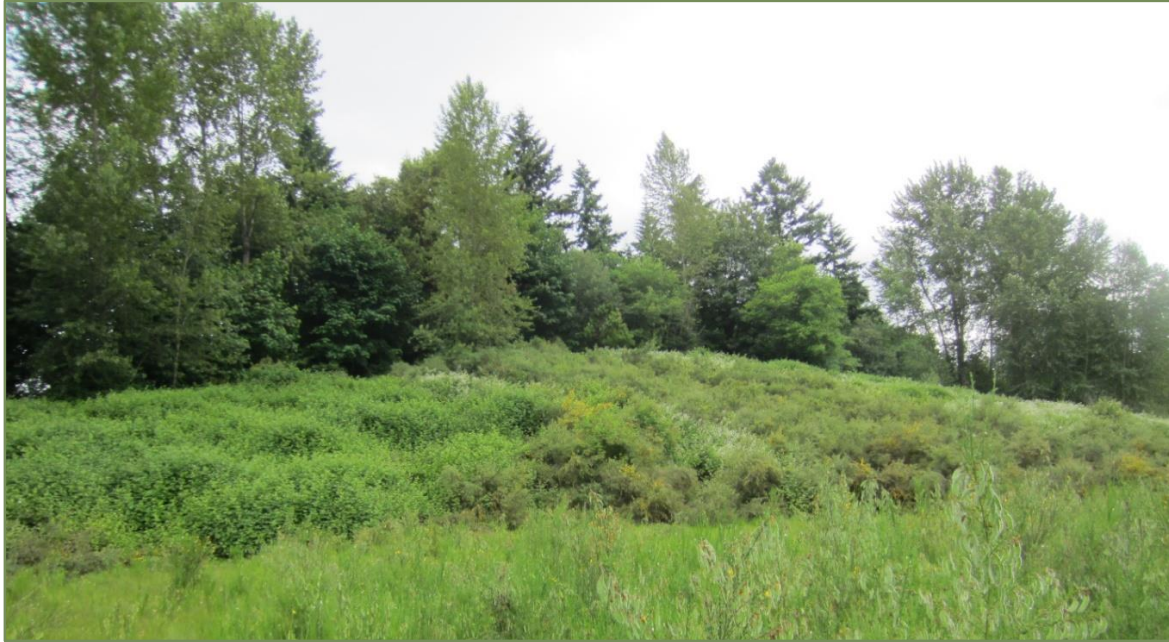
Management unit 15-01 comprises the south-facing slope bounding the site to the north. This is a very exposed, moderately steep area (Figure 21). The only shade is provided by a small clonal stand of black cottonwood trees and a few red alders, all growing at the top of the slope. Himalayan blackberry and Scot's broom form dense thickets; non-native forbs and grasses occur along trail edges. Canada thistle is also present along the trail switchback. Soils are mostly well-drained, loamy sand, and generally not compacted--where compaction was observed it was minor and associated with access roads and trails.

Figure 21. View of the northern slope (15-01) from the south. Most of the trees visible in the photo are part of the forested upland areas adjacent to the project site.

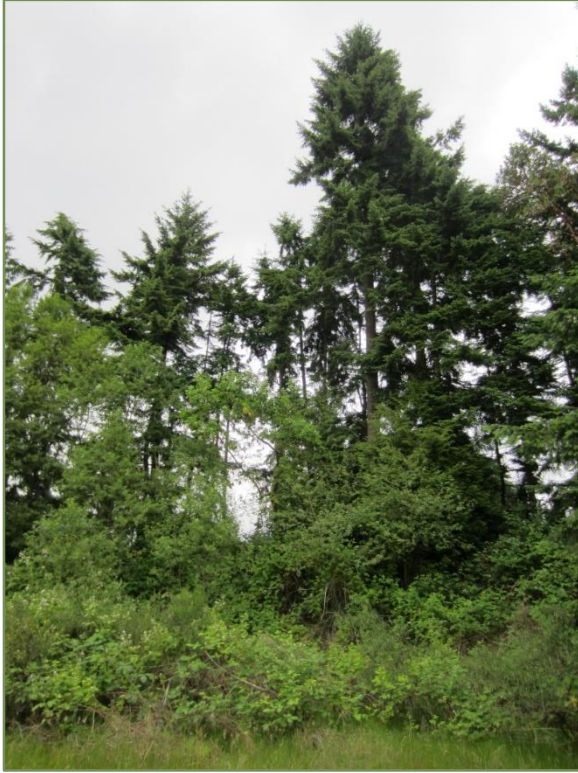
Figure 22. View of the eastern slope (15-02). Coniferous trees occur along the top of the slope, while vegetation along the slope itself consists of smaller deciduous trees and Himalayan blackberry.

This unit includes most of the eastern slope bounding the central pit area. A chain-link fence separating the park from I-405 marks the eastern edge. There are some deciduous trees growing along the slope, mostly black cottonwood, bitter cherry and red alder (Figure 22). Trees at the top of the slope and along the edge of the I-405 right-of-way provide additional shade—total tree canopy cover is 50-75%. Trees at the top of the slope are mostly evergreen Douglas-fir, Pacific madrone and western redcedar. The dominant understory species is Himalayan blackberry. Soils are well-drained, loamy sand.

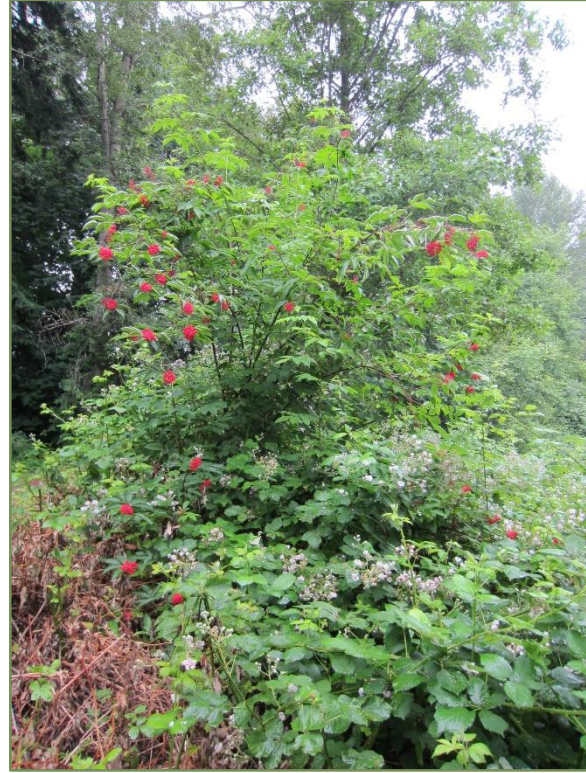
Figure 23. Himalayan blackberry in 15-03 encroaching on red elderberry.

Management unit 15-03 comprises the western slope north of the main E-W trail. The vegetation is dominated by Himalayan blackberry. A few surviving native shrubs, mostly Indian plum and red elderberry, are being swamped by invasive blackberry (Figure 23). Deciduous trees, mostly black cottonwood, red alder, bitter cherry and bigleaf maple provide some shade, especially towards the top of the slope. Native tree canopy cover is less than 25%. Minor amounts of western sword fern and tall Oregon grape are associated with clumps of deciduous trees. The soil is well-drained, sandy loam, with minor compaction, mostly along the edges of the trail.

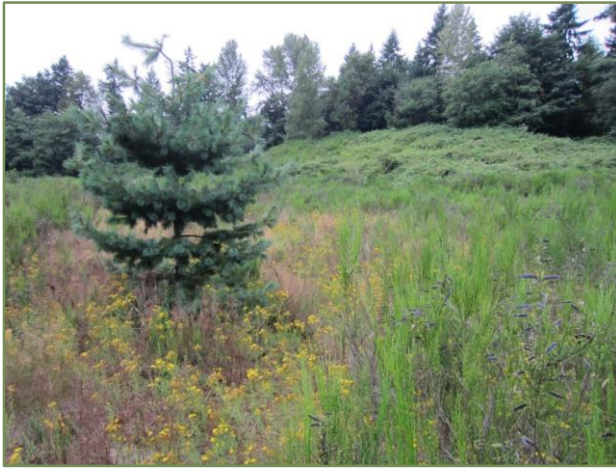
Figure 24. View of management unit 15-04 from the south. Vegetative cover includes Scot's broom, non-native grasses, St. John's wort (yellow flowers in the photo) and other introduced forbs. The small tree on the left is a western white pine.

This area is in the northeast corner of the pit, west of the N-S access road. There is no significant tree canopy cover in this management unit. The soil is sandy loam with a very compacted subsoil at between 8 and 12” deep. Because of the compaction, poor drainage results in a few seasonally wet areas, particularly in the northern half of the unit. The vegetation is predominantly Scot’s broom with an understory of non-native grasses and forbs (Figure 24).

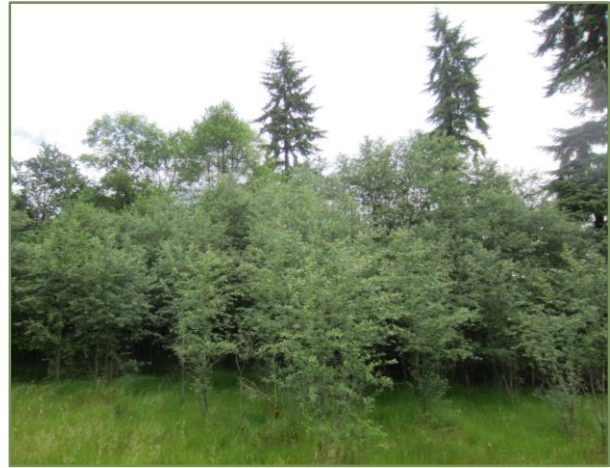
Figure 25. Regenerating bitter cherry grove with an understory of non-native grasses—15-05.

15-05 is a small management unit in the northeast corner of the pit, east of the N-S trail. Tree canopy cover is between 50 and 75% and consists predominantly of a grove of regenerating bitter cherry trees (Figure 25). The understory is comprised predominantly of non-native grasses. The soil is well-drained, loamy sand with minor compaction along the edge of the trail.

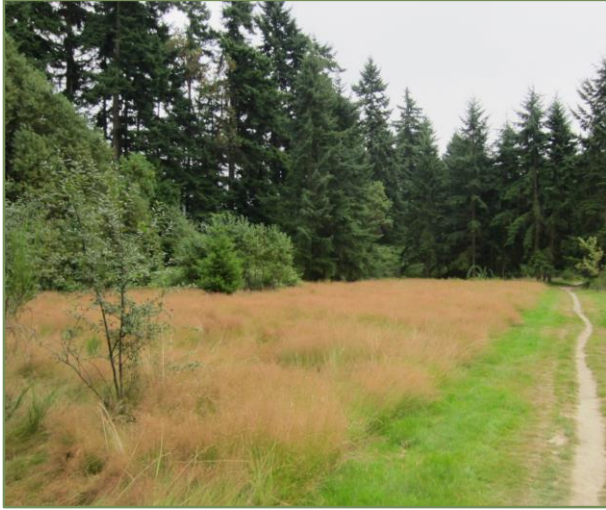
Figure 26. Management unit 15-08 (left of the trail)-view from the north. Tree cover is <25% and consists of Douglas-fir and regenerating bitter cherry at the toe of the slope. This area has been cleared of Scot's broom and planted with native trees and shrubs during 2012.

15-08 is the northeastern corner of the pit, south of the bitter cherry grove, east of the N-S trail (Figure 26). The soil in this management unit is loamy sand, and very compacted in the northern half. There is some native tree canopy (<25%), mostly along the bottom of the slope where several Douglas-fir trees of various ages are present. Regenerating bitter cherry saplings are also common in the northern part. This site was cleared of Scot's broom during the winter of 2012; native trees and shrubs were also installed at that time. Additional trees and shrubs were installed during fall 2012. The dominant vegetation is non-native grasses and forbs.

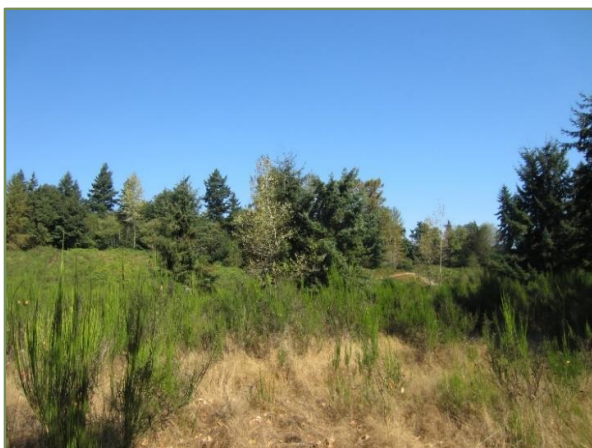
Figure 28. The western half of 15-12 before clearing and planting in October 2012. Vegetation consists of Scot's broom with an understory of mostly grasses and hairy cat's ear.

This area was cleared of Scot's broom in 2012-2013 and planted with native trees and shrubs (Figure 28 and Figure 29). The presence of tansy ragwort is a particular concern in this management unit. Along with common sheep sorrel and St. John's wort, tansy ragwort seems to be spreading rapidly since the removal of the Scot's broom shrub layer.

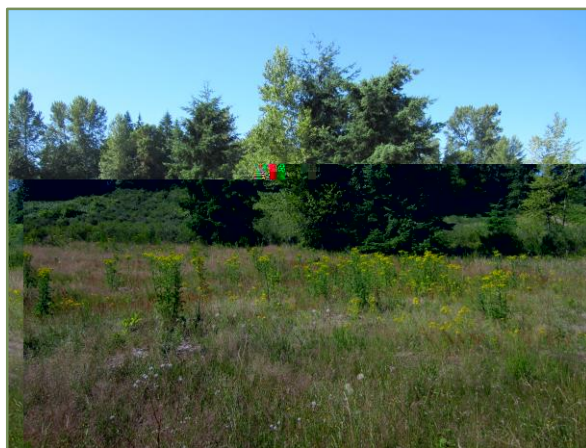
Figure 29. The same area in July 2013. Tansy ragwort (tall yellow flowers) and St. John's wort (shorter yellow flowers) are thriving, along with common sheep sorrel (reddish tint)

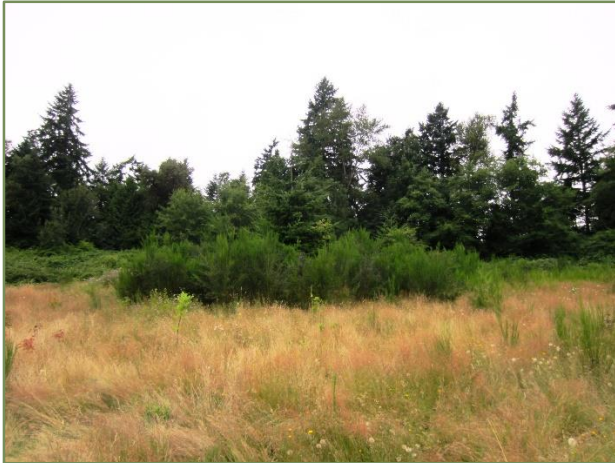
Figure 30. 15-11--island of vigorously growing trees and shrubs on fine-grained soils surrounded by predominantly grass and sparse Scot's broom seedlings.

This is a small, densely vegetated area along the E-W trail, sandwiched between 15-09 and 15-12 (Figure 30). The vegetation consists of a few small Douglas-fir trees, estimated to be between 8 and 15 years old, a red elderberry bush and a one-seed hawthorn tree, surrounded by vigorously growing Scot's broom seedlings with an understory of introduced grasses. Scot's broom seedlings in this area are as much as 10 feet tall, compared to about 3 feet in the adjacent area that was cleared at the same time. The soil is silt, with generally very little compaction, except for the southern end of this area, next to the trail, which is highly compacted.

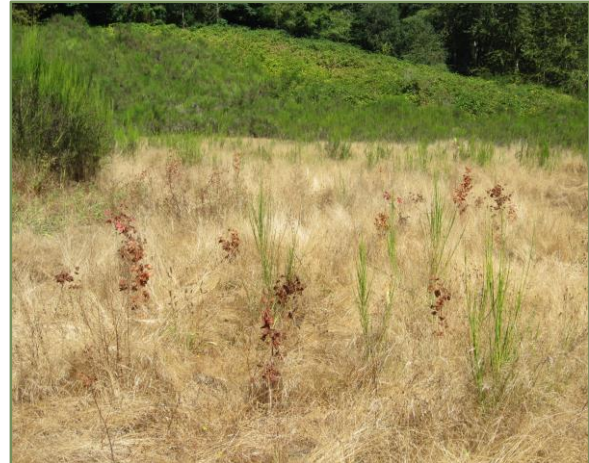
Figure 31. Southwestern corner of 15-12 towards the end of summer 2012. Vegetation consists of introduced grasses and forbs, Scot's broom saplings and some very stressed vine maples.

The southwestern half of this management unit (west of the informal trail) was treated with biosolids compost, tilled and planted with native trees and shrubs in 2008, and replanted in 2010 and 2012. Survival was poor. As of April 2013 there were some surviving vine maple, Oregon ash, snowberry, red-flowering currant and red elderberry, but these plants do not seem to be thriving (Figure 31). In addition, this plot has been invaded by Canada thistle and oxeye daisy along the western edge.

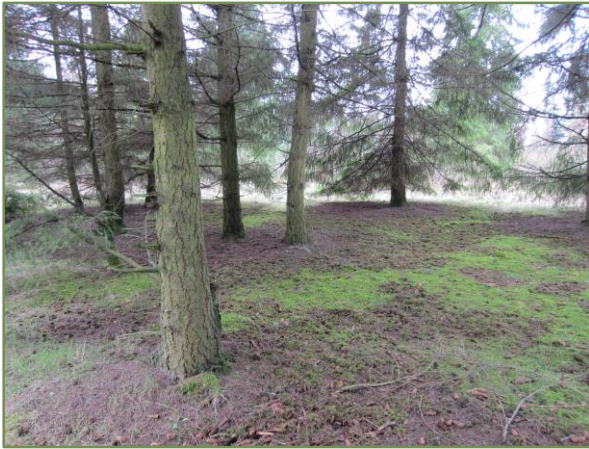
Figure 32. Douglas-fir tree stand in 15-13. Understory cover is absent to sparse, the only ground cover being moss.

This is the area of the pit with the most tree canopy cover--average cover in this unit is about 75%, ranging from 0 to 100%. The dominant tree species is Douglas-fir, with subordinate black cottonwood and red alder. Where tree cover is dense, understory vegetation is absent to sparse, the only ground cover being moss (Figure 32). No regenerating trees were observed. Several trees have fallen down, especially towards the back of the site where the ground starts sloping, contributing to downed woody debris recruitment (Figure 33).
