Watershed Park Borrow Pit Stewardship Plan

Prepared for the Green Kirkland Partnership

Catharina J. Penberthy

August 2013

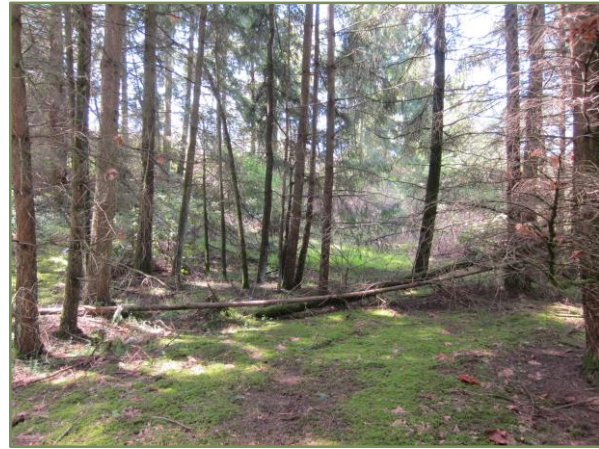
This is the area of the pit with the most tree canopy cover--average cover in this unit is about 75%, ranging from 0 to 100%. The dominant tree species is Douglas-fir, with subordinate black cottonwood and red alder. Where tree cover is dense, understory vegetation is absent to sparse, the only ground cover being moss (Figure 32). No regenerating trees were observed. Several trees have fallen down, especially towards the back of the site where the ground starts sloping, contributing to downed woody debris recruitment (Figure 33).

Figure 33. Fallen trees contributing to downed woody debris recruitment.

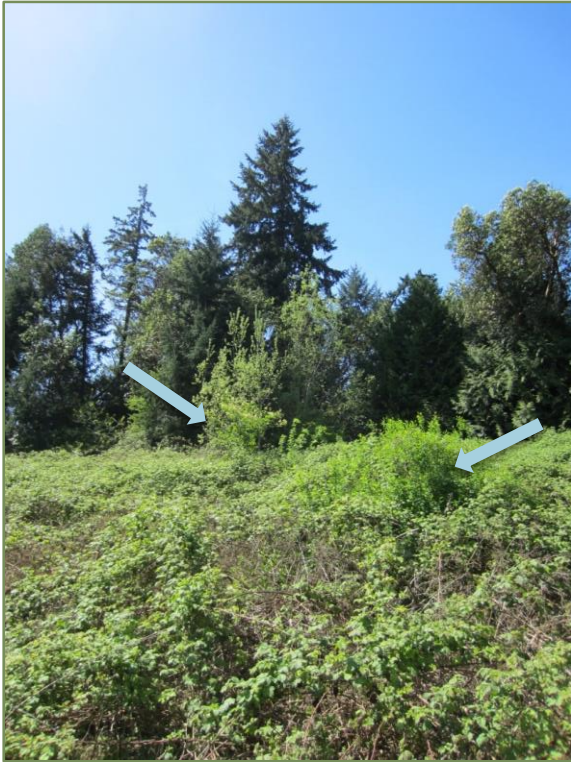
Figure 37. Indian plum and red elderberry in a sea of Himalayan blackberry along the slope in the southwestern corner of the site (15-14).

15-14 comprises the slope in the southwestern corner of the site. The slope is very exposed; minor canopy cover is provided by trees growing at the top of the slope, and a few scattered black cottonwoods and bitter cherry trees growing on the slope. The vegetation is dominated by Himalayan blackberry, and, along the lower slopes, Scot's broom. Apart from the few trees, the only native vegetation is scattered Indian plum and red elderberry bushes being overgrown by Himalayan blackberry (Figure 37).

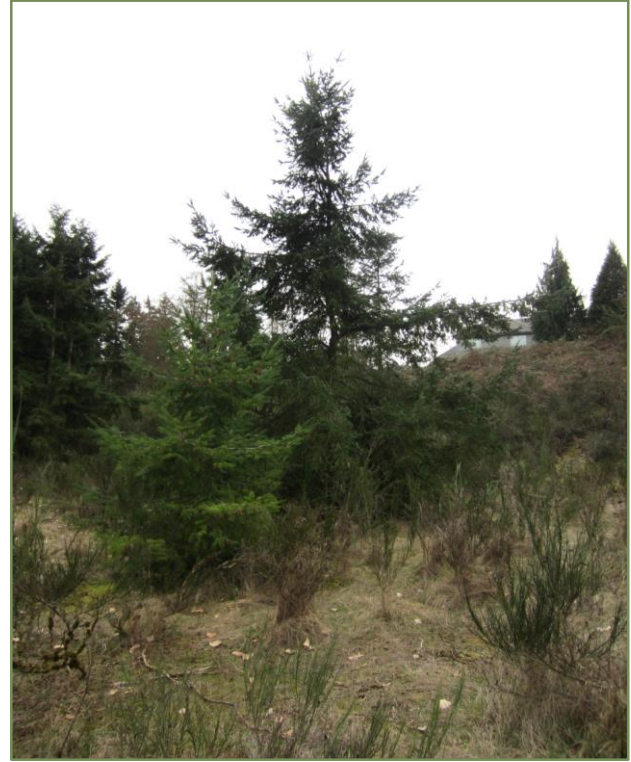
Figure 38. Scattered Douglas-fir trees surrounded by sparse Scot's broom cover in the southwestern corner of the borrow pit (15-15).

15-15 covers the southwestern corner of the pit. This area is characterized by very loose, sandy soils. Compaction is rare, and there does not appear to be much fine-grained material mixed into the soil. Vegetation is sparse, likely because of the droughty soils. Scot's broom cover is about 30%, with an understory of introduced grasses and forbs. Scattered Douglas-fir, Pacific madrone, red alder and black cottonwood trees of various ages and sizes provide sparse canopy cover (Figure 38).

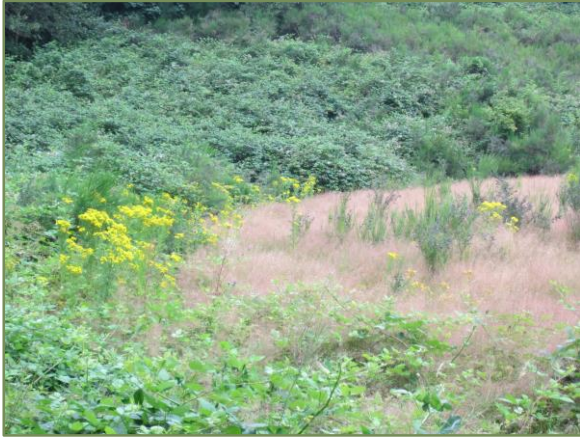
Figure 42. In the image above, note how tansy ragwort (yellow flowers) is preferentially colonizing the toe of the slope where resources are higher.

- Some parts of the planting area will be more amenable to the establishment of native plants than other parts—these are microsites where resources such as moisture, organic matter and nutrients collect and are retained, or where soil temperatures are less extreme. Such microsites may be created by features such as woody debris—the area directly to the northeast of a downed log will be relatively protected from the heat of the sun (Haskell et al 2012), in local depressions, at the toe of the slope, or where existing vegetation creates shade. Once trees and shrubs are established, they can then act as nurse plants for other vegetation. Exploiting such microsites can lead to higher survival. Figure 42 to Figure 46 show examples of such microsites at the project site, and how plant establishment and performance are affected.

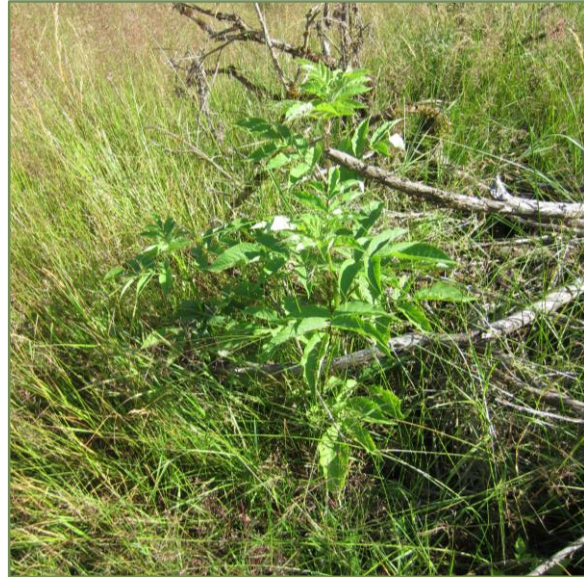
Figure 43. Red elderberry shrub growing among the remains of a pile of removed Scot's broom that offers some protection and increased resources.

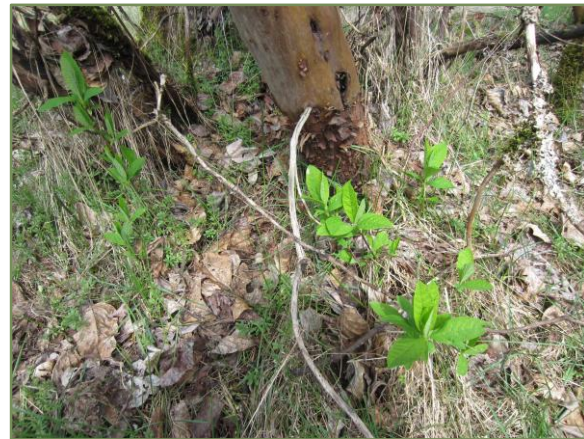
Figure 44. This photo was taken towards the end of summer 2012. Sword ferns growing along the drip line of the trees where there is more shade, and where moisture and nutrient levels are likely higher, are thriving, while those growing out in the open (in the foreground) are desiccated.

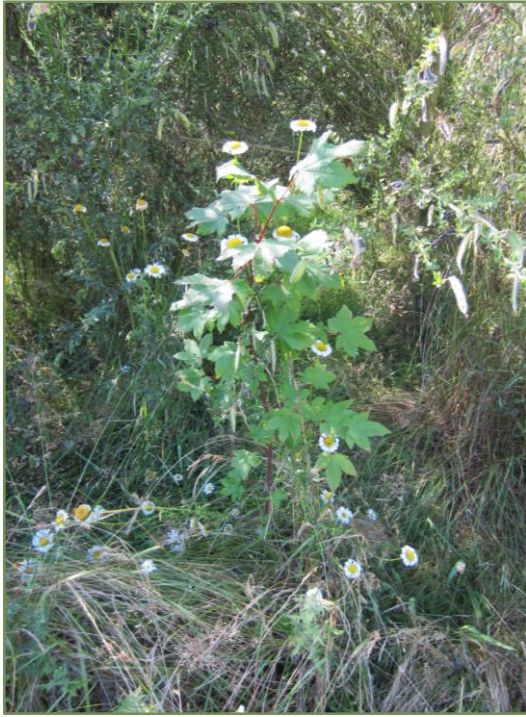
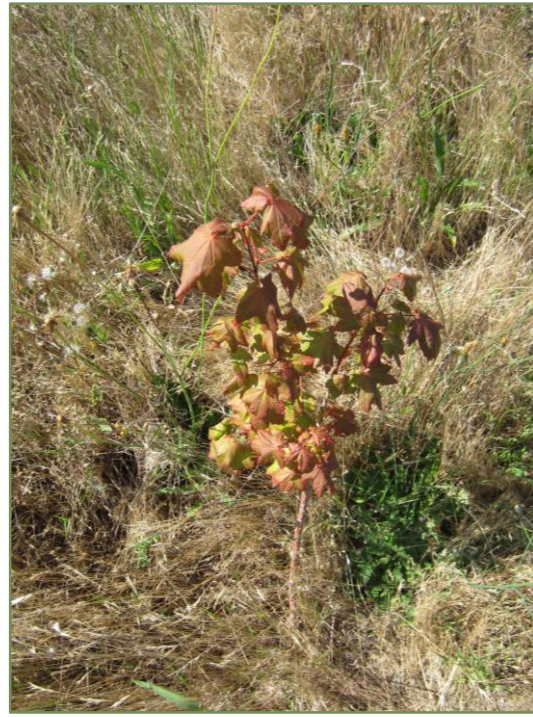
Figure 46. The two photos above were taken at the project site on the same day in July 2013. The two vine maples in the images were installed a few feet apart. The vine maple on the left is growing in a relatively shady spot. The leaves are green and the plant seems healthy. The one on the right is growing in full sun and appears stressed—the leaves are curling down and have turned color prematurely.

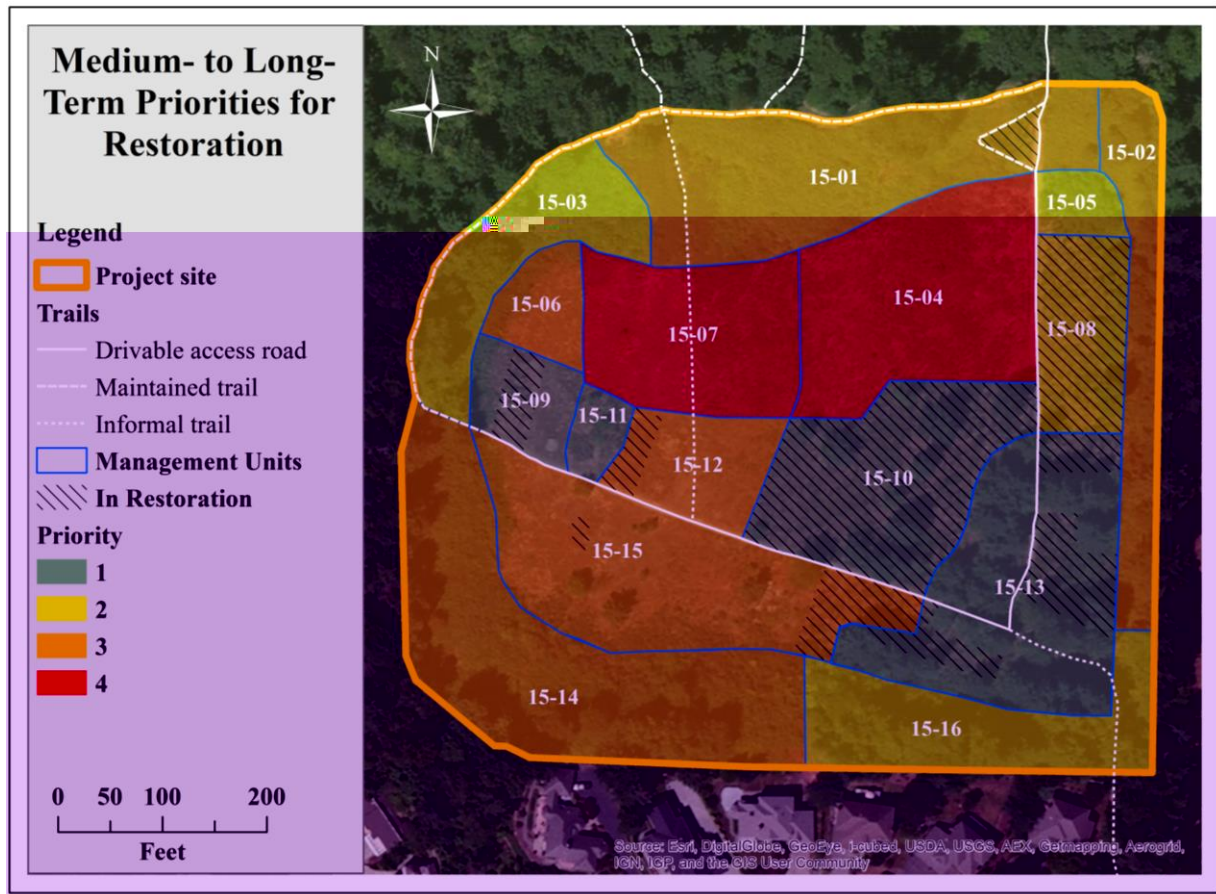
Figure 48. Medium- to long-term priorities for restoration, with one being the highest priority and 4 the lowest.

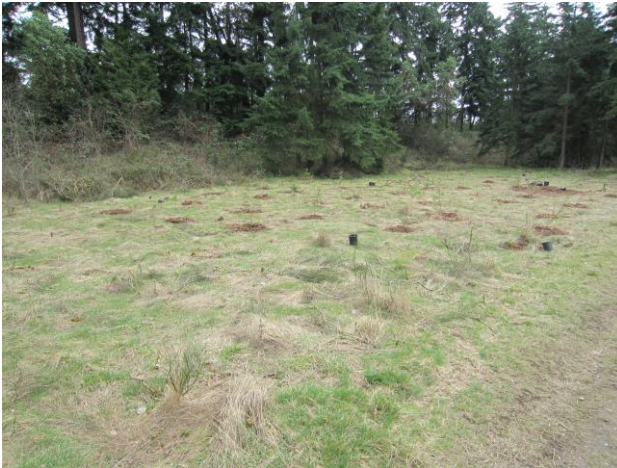
Photo points: Taken from N-S trail facing southeast corner of management unit. No before picture available.

March 2012 After planting

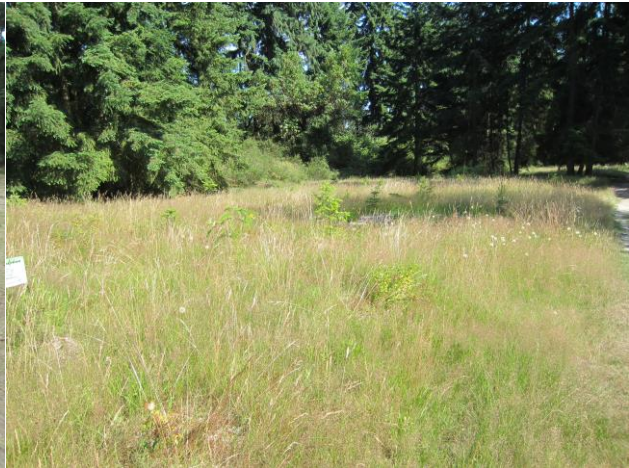
July 2013

Invasive cover: 09/2013: About 5% regrowth of Scot’s broom from cut stumps; isolated seedlings

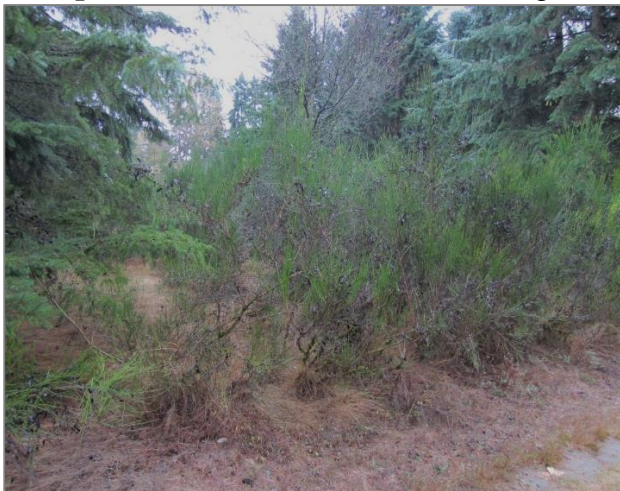
Photo points: Taken from E-W trail facing north

October 2012 Before clearing

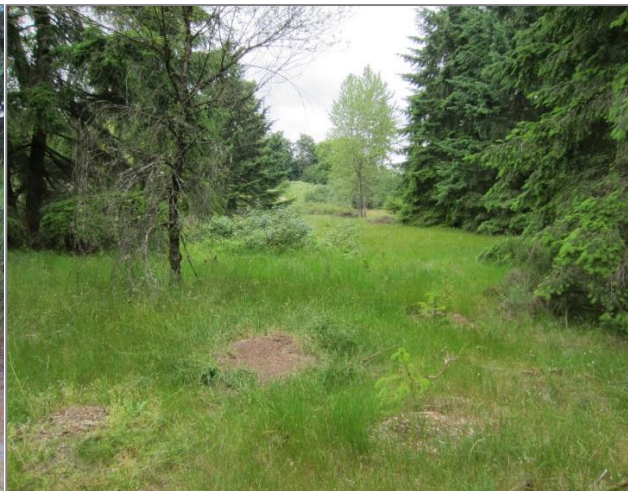
June 2013 After planting

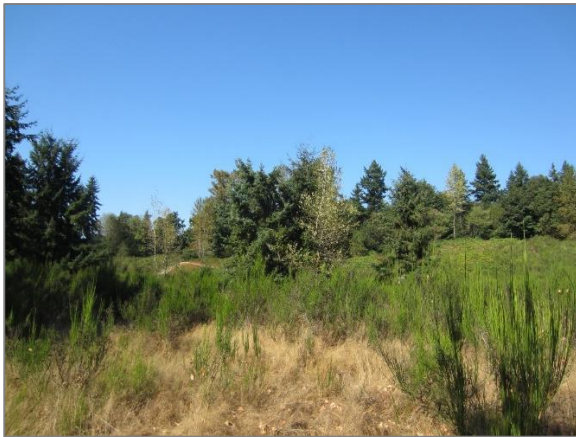
Photo points: Taken from E-W trail facing north, not landmark trees in background

October 2012 Before clearing

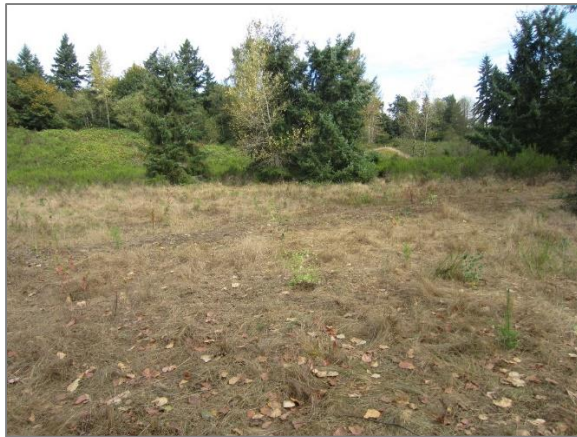
October 2012 After planting

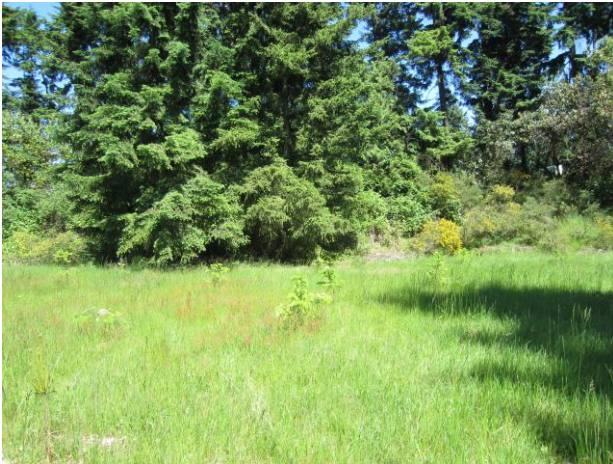
Photo points: No before picture available. Taken from N-S trail facing east.

June 2013 After planting

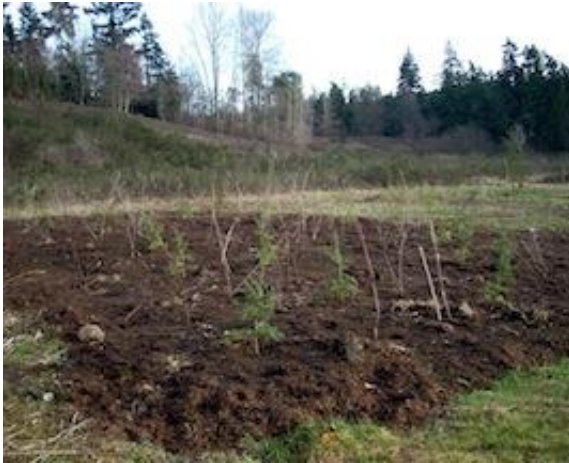
Photopoints: No before picture available. Taken from E-W trail facing northwest corner of the site

After planting 12/2008 (Photo credit: C. Henry)

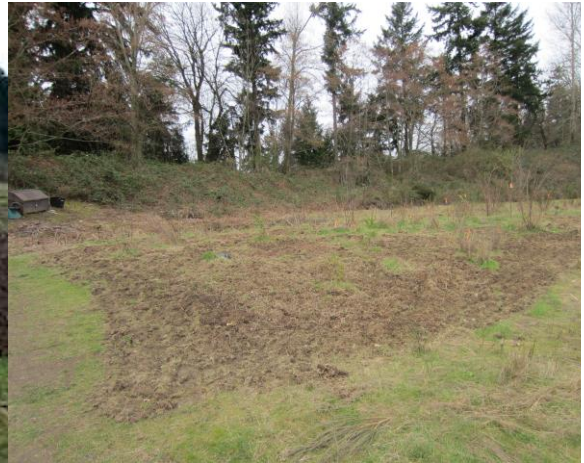
After maintenance clearing 03/2012
