Kincaid Ravine Restoration Project: A Two Year Progress Report with a Focus on Hydrology Improvements and Place Making

Restoration of a Degraded Urban Forest in a Campus Setting: A Two Year Review of work at Kincaid Ravine

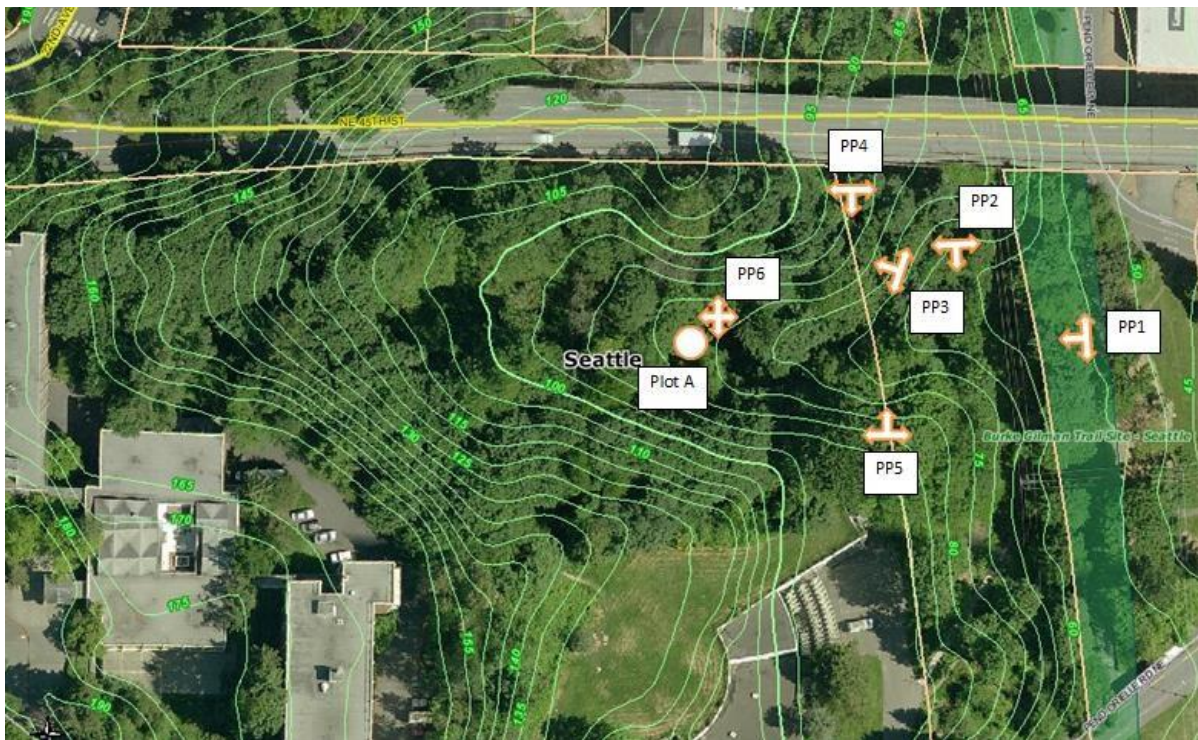
Figure 3-A. Location of VMP A and Photo Points

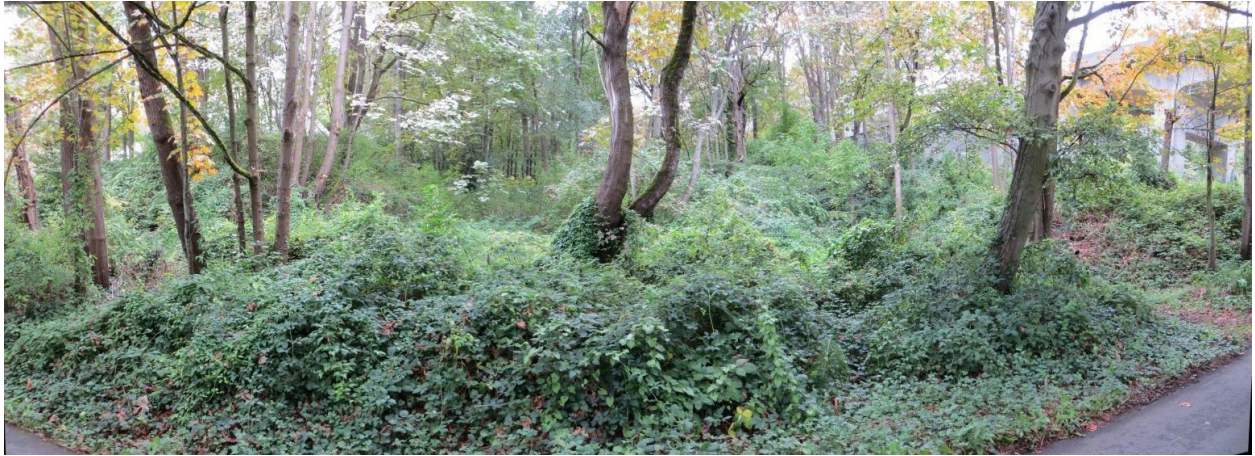
Figure 3-B. PP 1, October 3, 2013

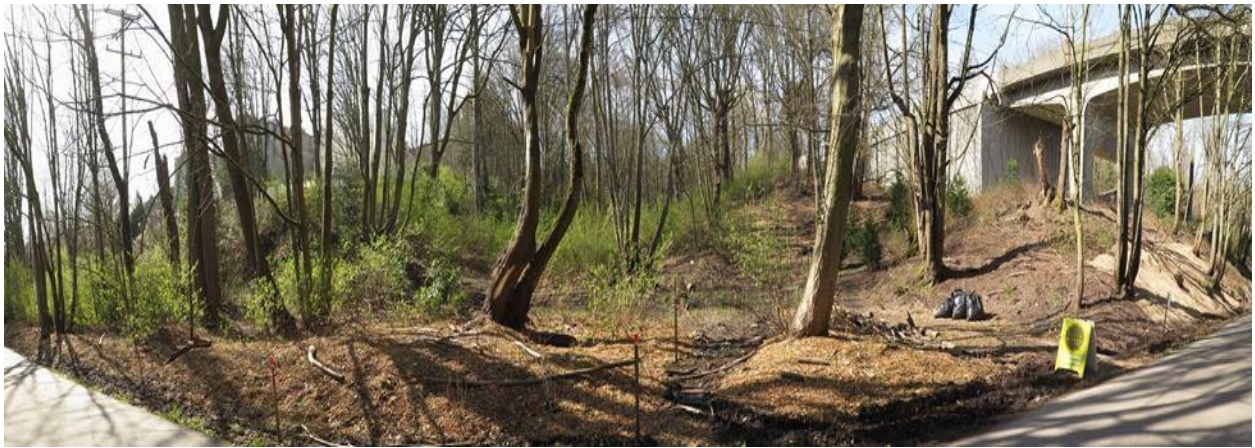
Figure 3-C. PP 1, March 13, 2014

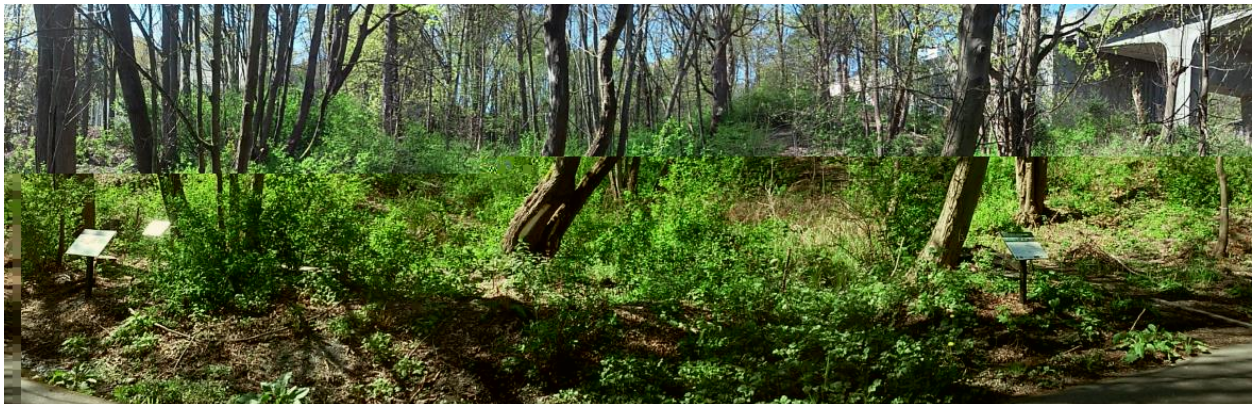
Figure 3-D. PP 1, March 25, 2016

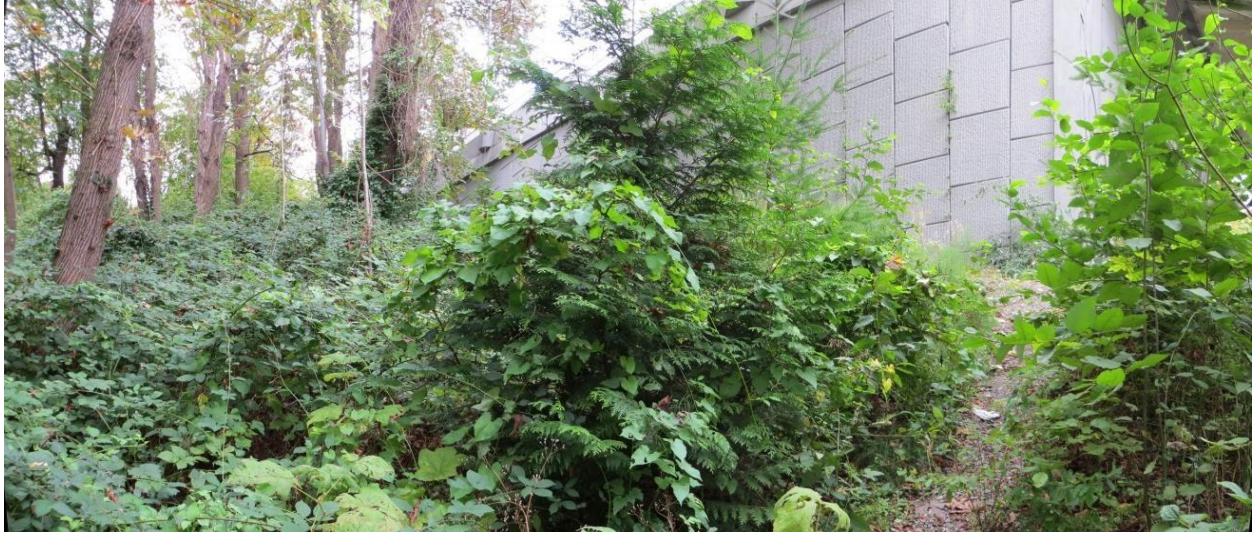
Figure 3-E. PP 3, October 3, 2013

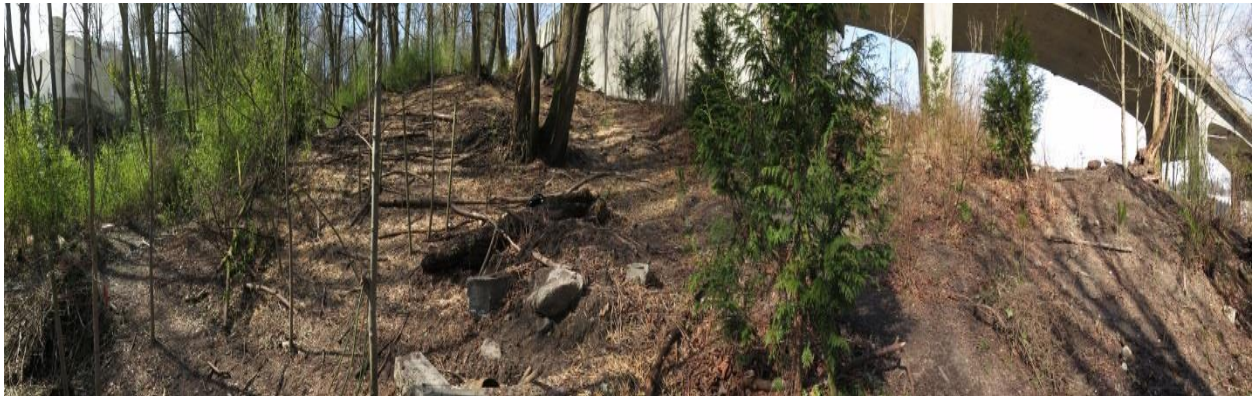
Figure 3-F. PP 3, March 13, 2014

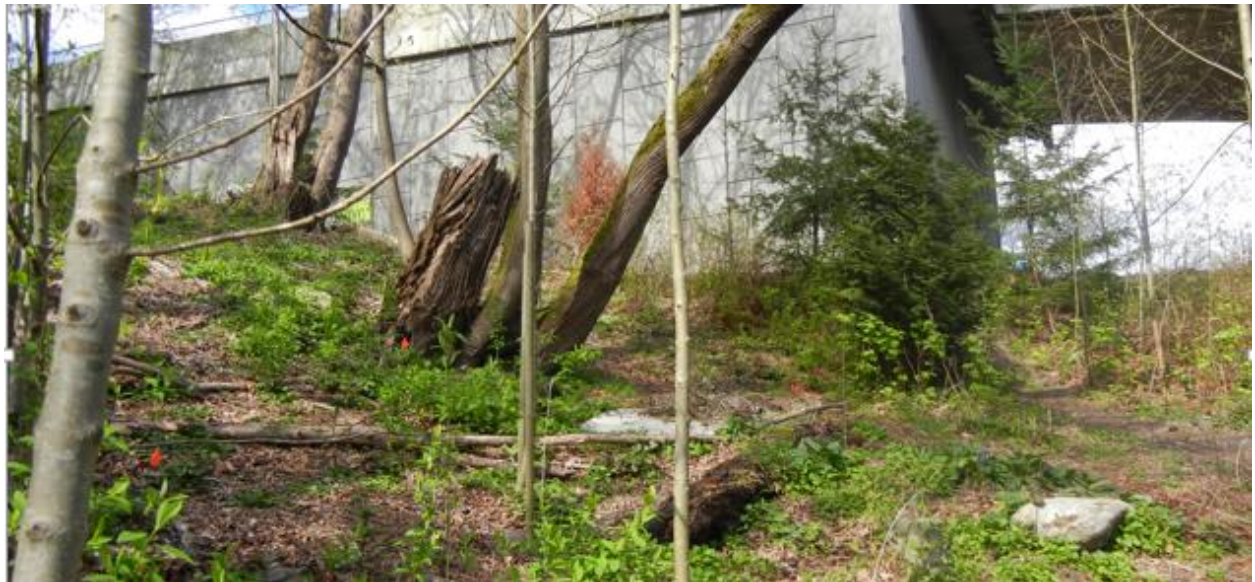
Figure 3-G. PP 3, March 25, 2016

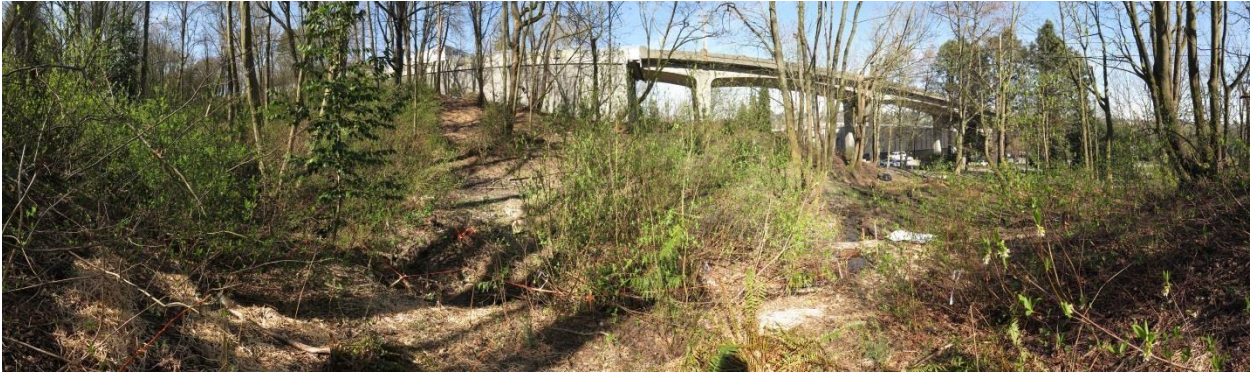
Figure 3-H. PP 5, March 13, 2014

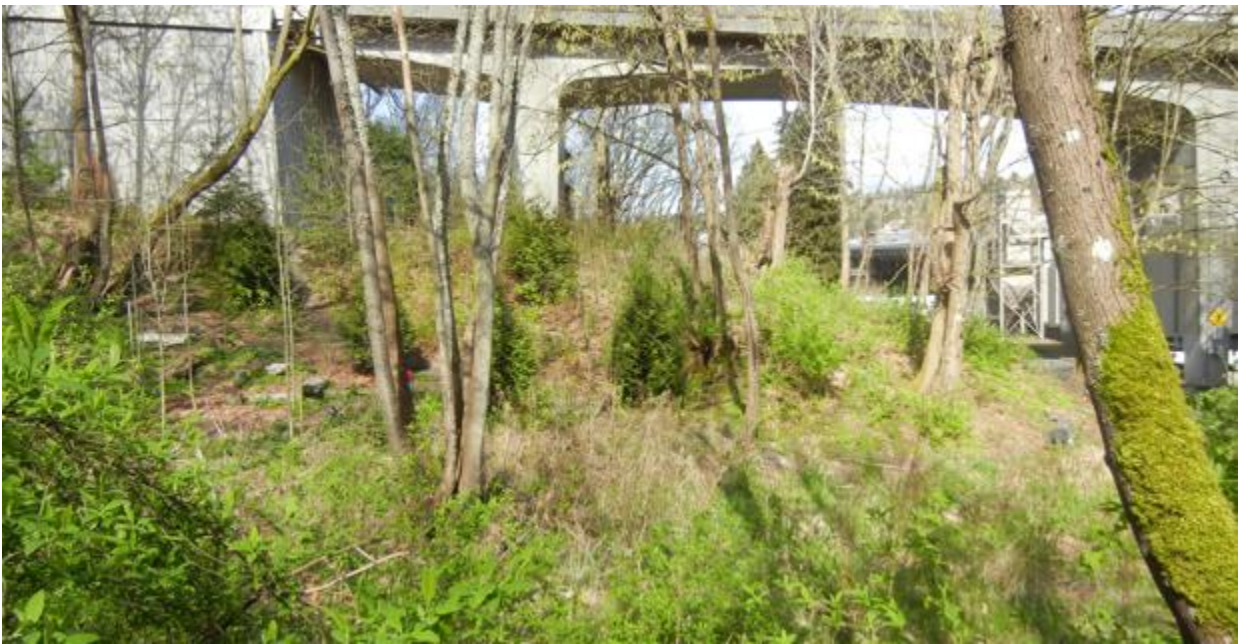
Figure 3-I. PP 5, March 25, 2016

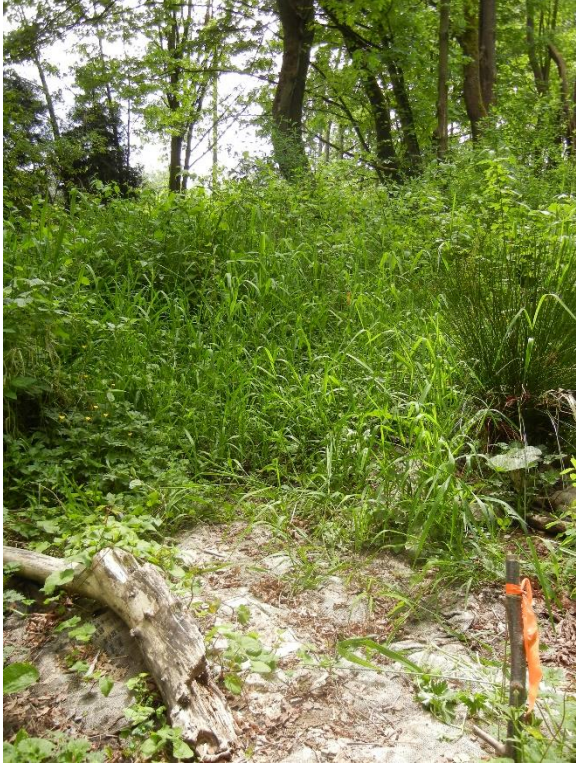
Figure 3-J. Treatment 1 in April 2016

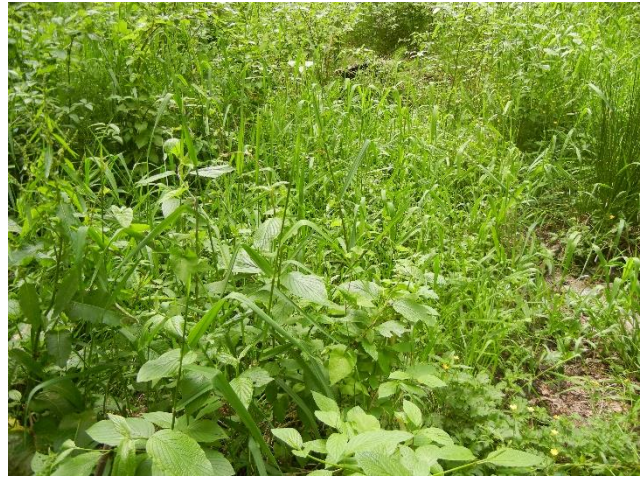
Figure 3-K. Treatment 2 in April of 2016

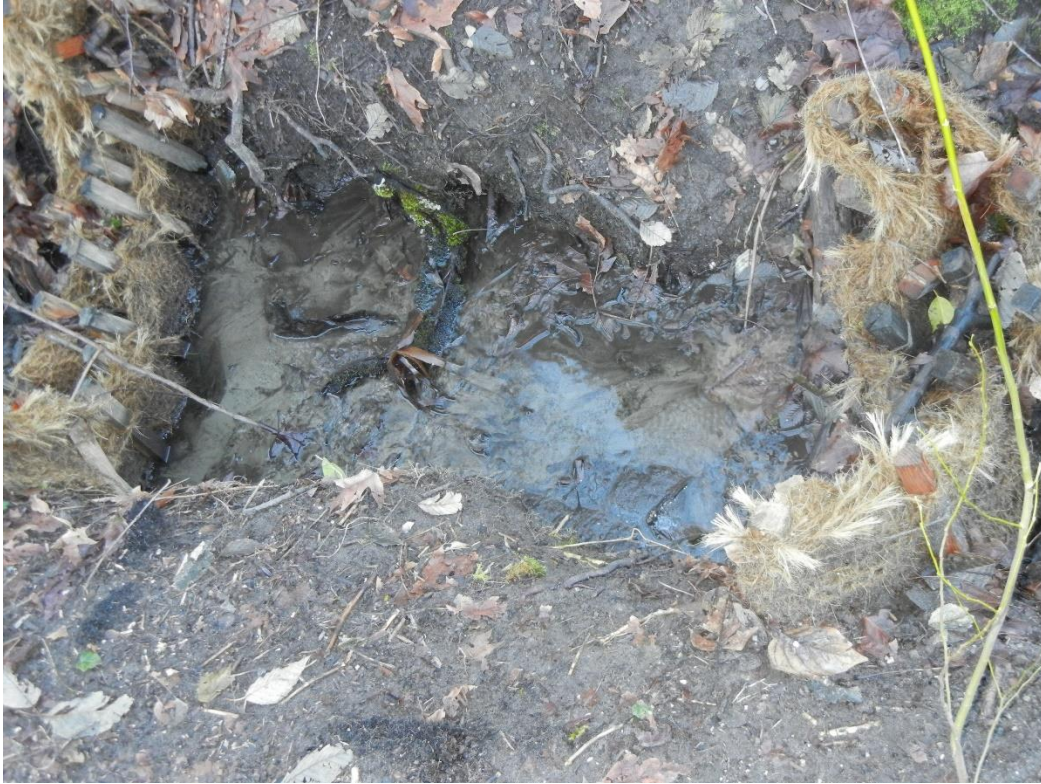
Figure 4-D. Picket Fences 2 months after installation shown increasing sediment deposition

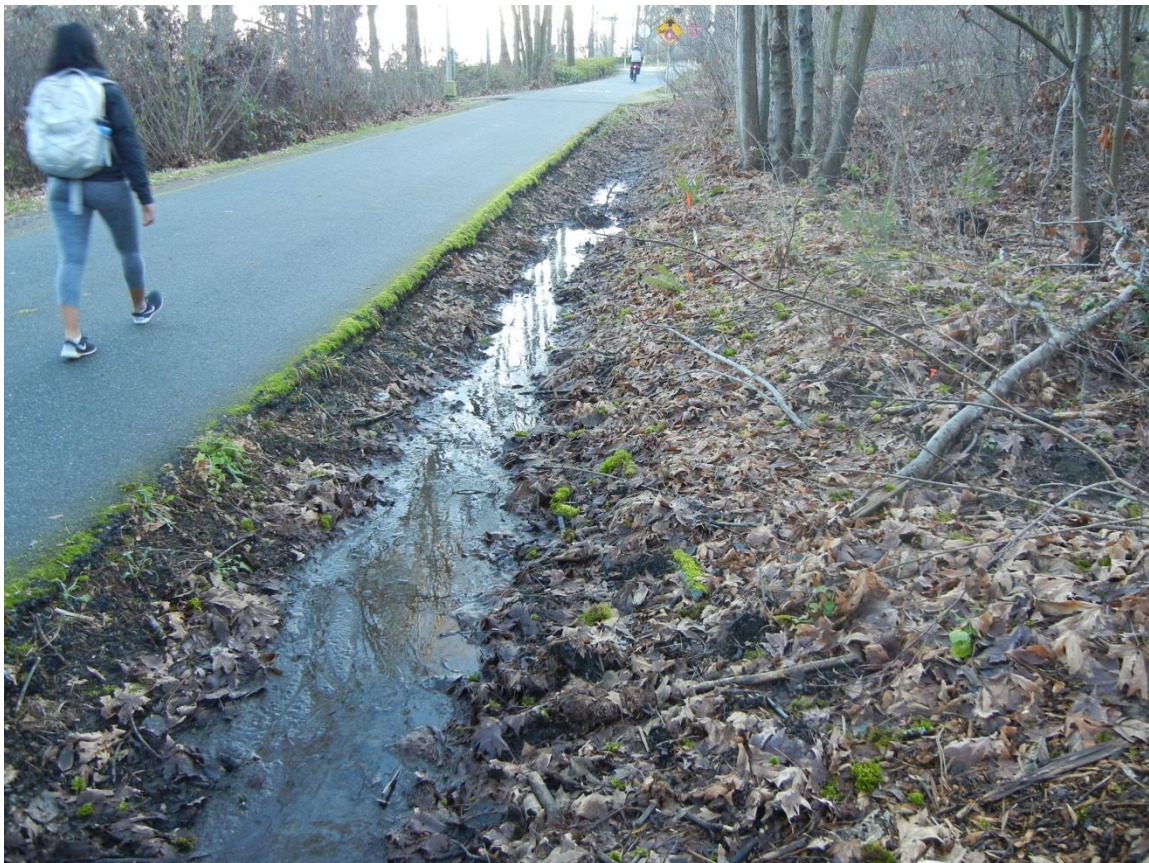
Figure 4-E. Trail Side Ditch flowing south used for infiltration. Photo taken 1/8/2016

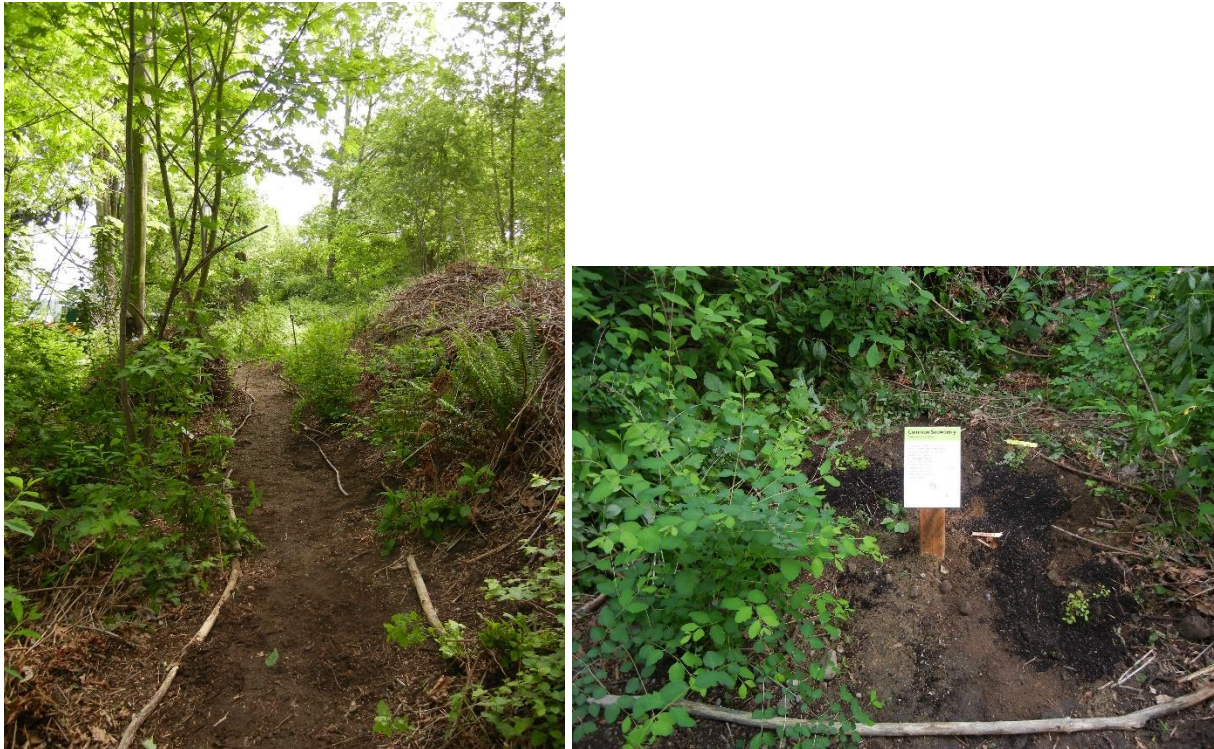
Figure 5-A. Interpretive Trail (left) and one of 6, mini native species ID signs installed along the trail (right).

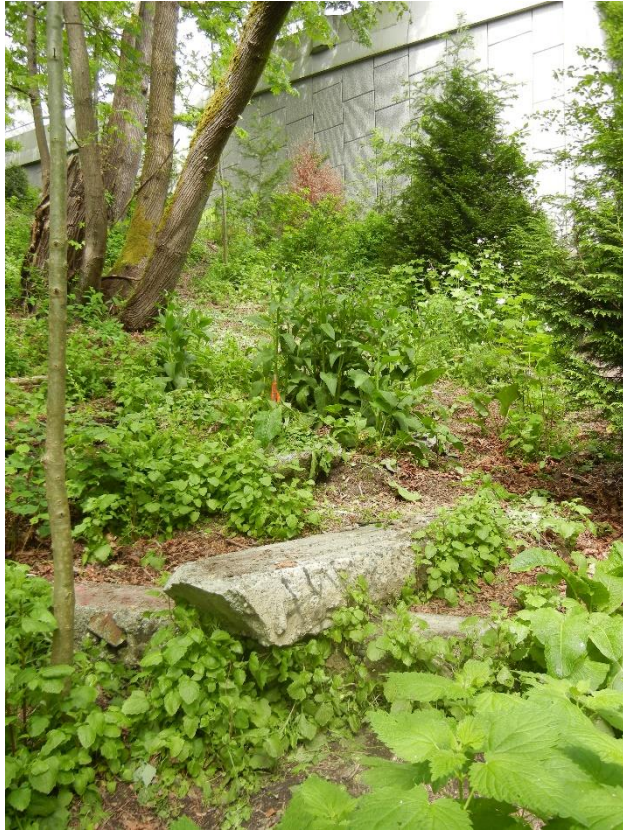
Figure 5-B. Proposed site for seating and educational signage on value of wetland habitats
