**Establishment of American Dunegrass (*Leymus mollis*) Communities  
at Upland Dredge Material Disposal Sites for Sand Stabilization and  
Invasive Plant Species Control**

**Seattle District  
US Army Corps of Engineers**

**January 2005**

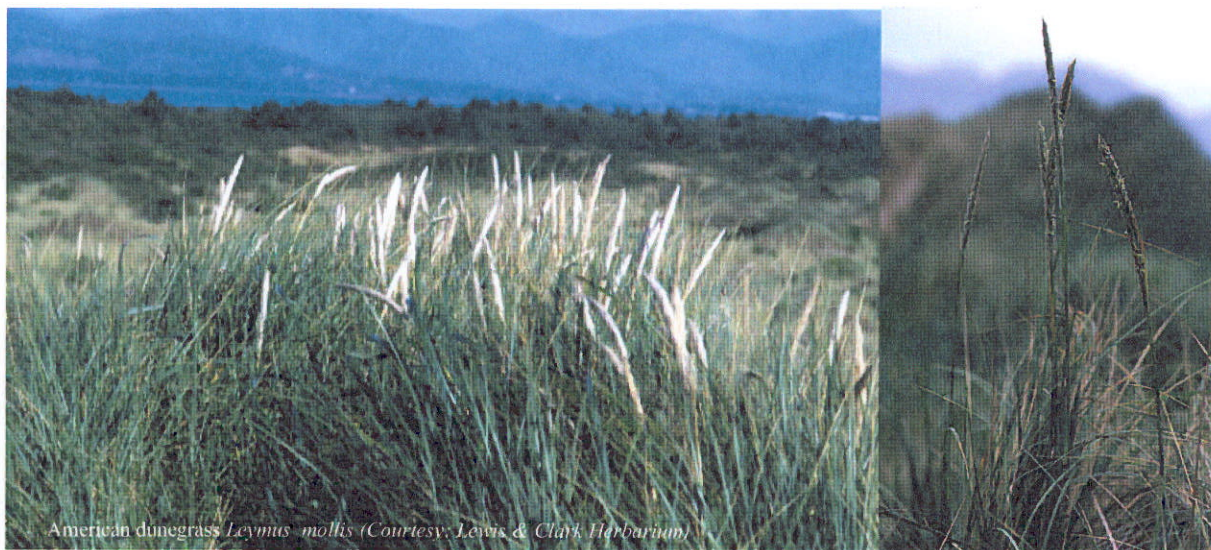
American dunegrass, *Leymus* (formerly, *Elymus*) *mollis* was the dominant grass on dunes immediately adjacent to the ocean until the introduction of European beachgrass, which is now the more abundant species (Pojar, 1994). American dunegrass traps airborne sands that accumulate around the plant base. The sand accumulation triggers both horizontal and vertical rhizomatous growth.

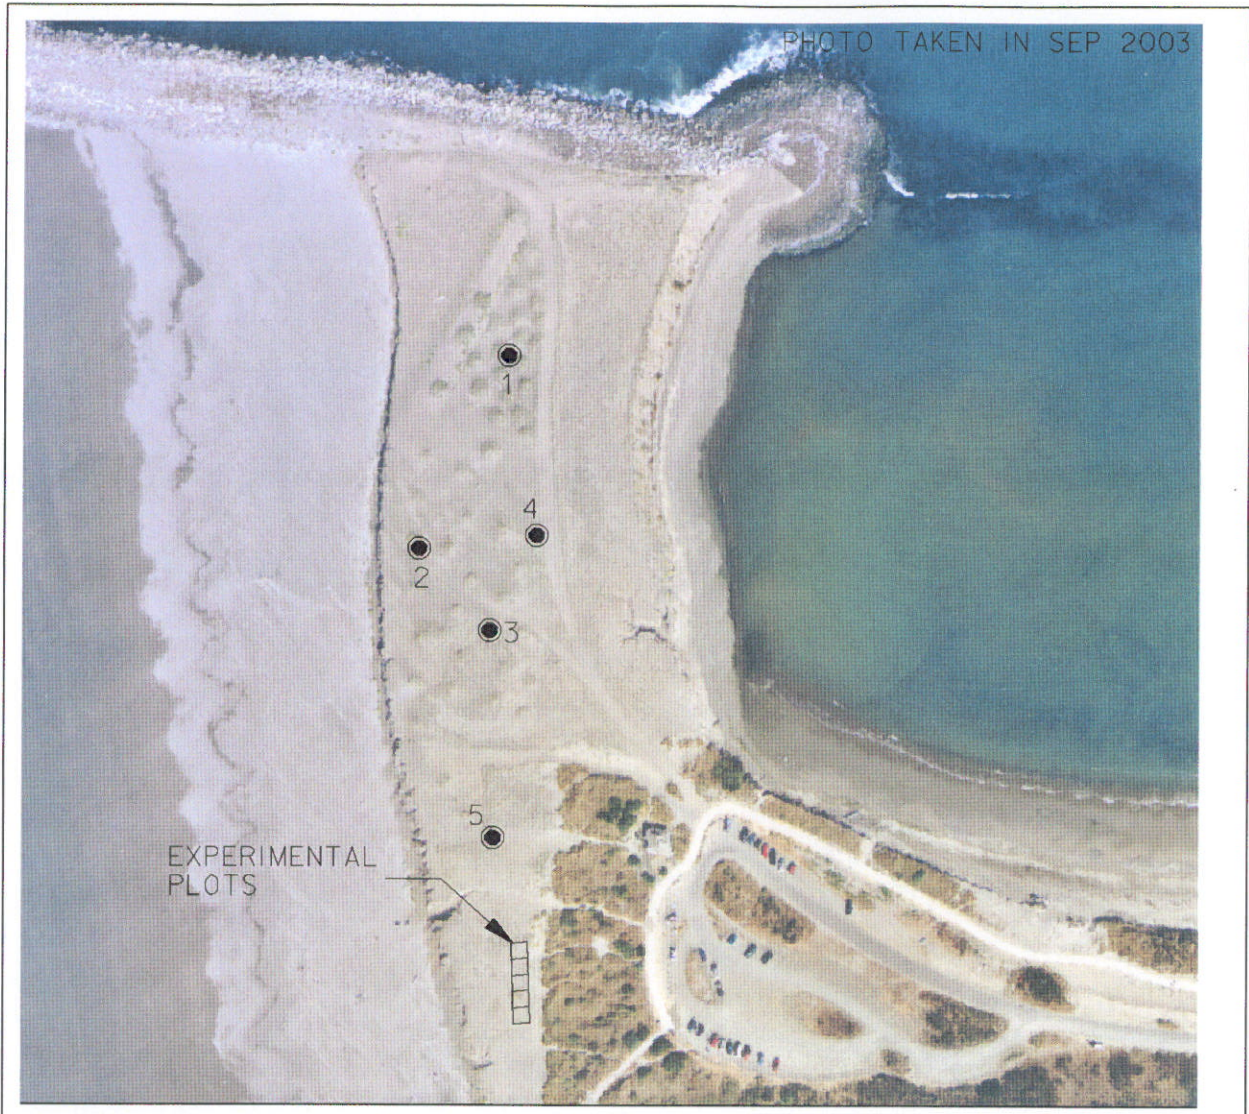
**FIGURE 3-3 Study Site**

The study site for monitoring American dunegrass establishment methods is located at the South Jetty Breach Fill at Grays Harbor, Washington (3-3). The South Jetty Breach Fill is located along the shoreline of Half Moon Bay in southwestern Grays Harbor, adjacent to Westhaven State Park in Westport, Grays Harbor County, Washington (T16N, R12W, Section 1). Driving directions to the site from Aberdeen, Washington are as follows. Turn left on H Street proceeding west on Highway 105 for 18 miles. Turn right off Highway 105 on West Spokane Avenue. Proceed towards Westport on Spokane Avenue to the sign for Westhaven State Park (immediately before the city wastewater treatment plant). Follow the drive to the parking area. The study site is located immediately west of the parking lot.

- PHOTO MONITORING STATION
- EXPERIMENTAL PLOT LOCATION

Five permanent photo stations were established throughout the volunteer planting zone (See Figure 3-3). Each station was staked and surveyed following earthwork activities. At each station, a single landscape photograph was taken aiming north, south, west and east. The photographic record is to document survival and establishment of the American dunegrass community over time.

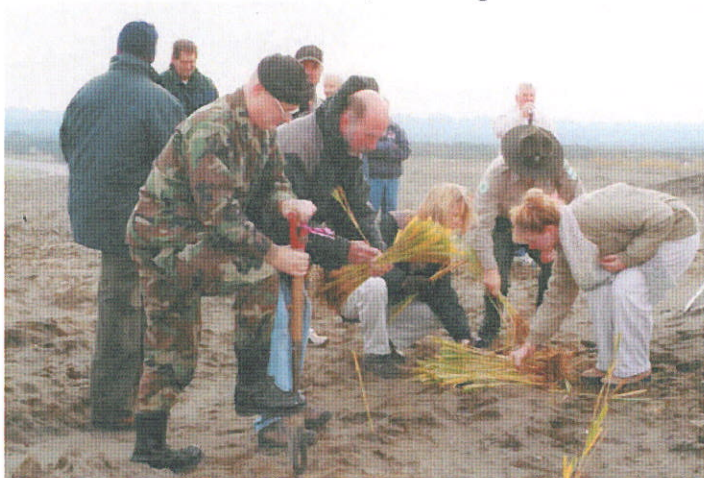
Prior to arrival of volunteers, the Corps crew leaders transported the material from storage and stockpiled the plant bundles throughout the planting area.

When volunteers arrived, crew leaders oriented them to the site and provided a brief demonstration on proper planting techniques. Volunteers worked in groups of two. One person used a clam shovel or spade to make approximately 100 divits in the sand. Divits were 18 to 24-inches on center. The other laborer followed by placing the plant culm (or culms) approximately 6 to 8-inches deep in each divit. The plants do not need to be placed vertically. Culms can be placed in any position and will resume growth, thereby eliminating the

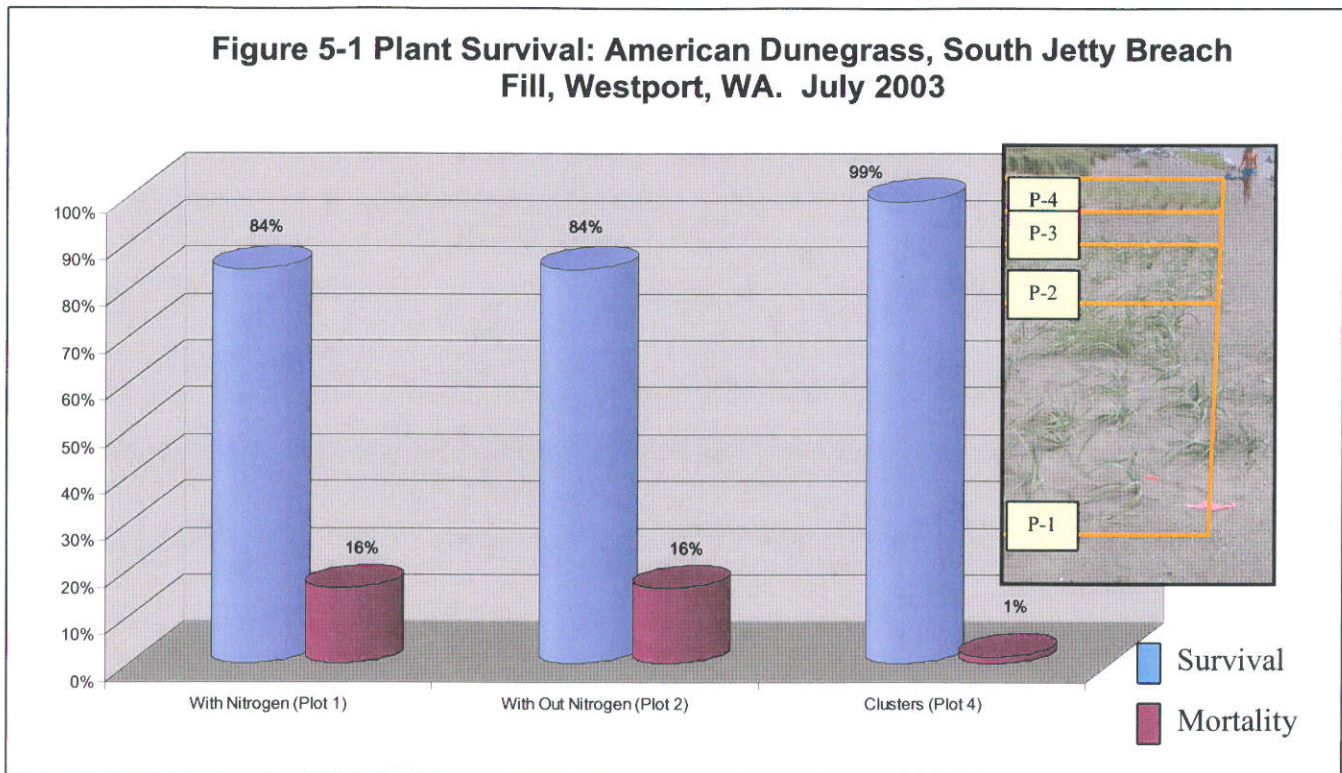
**Figure 5-1 Plant Survival: American Dunegrass, South Jetty Breach Fill, Westport, WA. July 2003**

Plots 1 and 2 evaluate if the application of Nitrogen (N) effects plant survival. Plot 4 compares survival of clustered plantings verse individual culms. All three plots experienced an above average, high survival rate. Although many restoration practitioners consider an 80 percent survival rate ambitious, the standard expectancy for plant survival in a restoration or remediation setting is 80 percent (King Co. DDES, 2004). All plots exceeded this expectancy (Figure 5-1). The photo inset depicts plot locations.

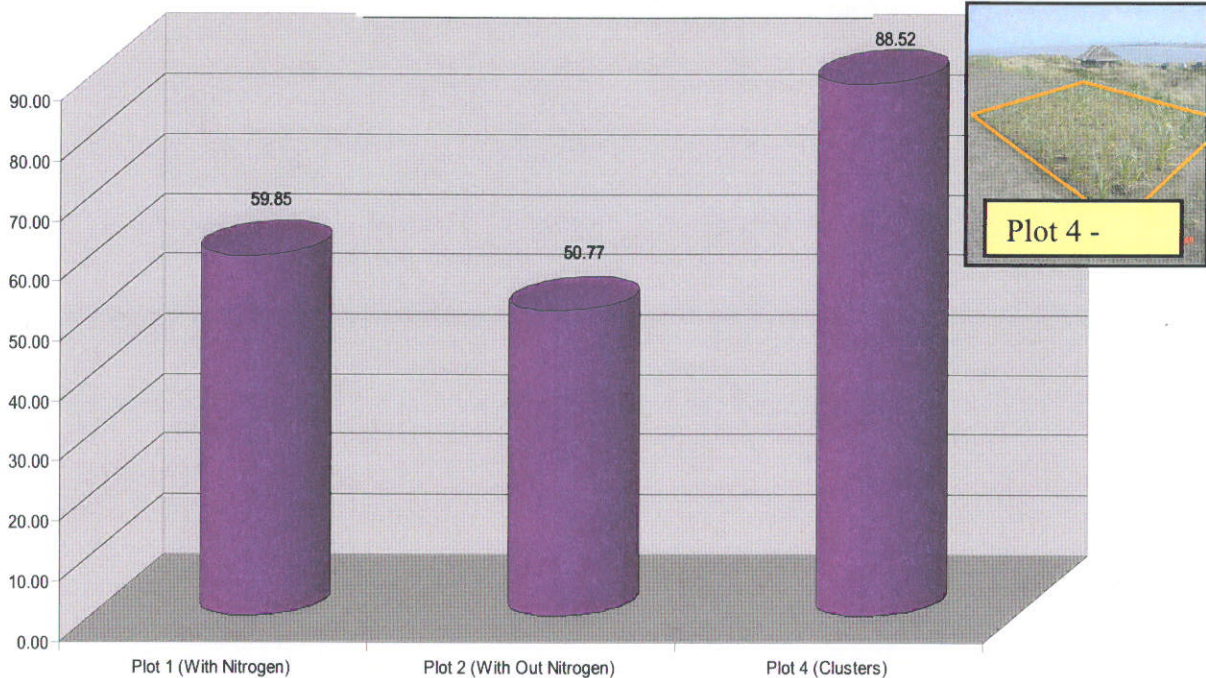
**Figure 5-2. Above Ground Biomass: American Dunegrass, South Jetty Breach Fill, Westport, WA**

Average Area (length of blade x width of blade) in sq. cm of the American Dunegrass at Westport, WA July 2003

Above ground biomass (plant growth) was monitored to determine if application of N, or clustering individual plant culms, effects growth. Figure 5-2 presents the average area (length x width of each blade) of American dunegrass for plots 1,2, and 4. Ten percent of each plot was harvested for analysis. The plot 4 photo inset depicts abundant above ground growth.

Growth of American dunegrass is also stimulated by fresh sand accumulation (Williams, 1980, ADNR, 1994). As depicted in Figure 5-2, clustered plantings have a larger surface area of above ground biomass than a single culm. The greater area of above ground biomass serves to trap airborne sands more effectively than a single culm. Thus, greater sand deposition occurs and results in more aggressive plant growth. Although clustered planting accelerates growth, it should be noted that individual culms also serve to effectively trap smaller quantities of airborne sands. As individual plants mature, their ability to accumulate sand and stimulate growth increases.

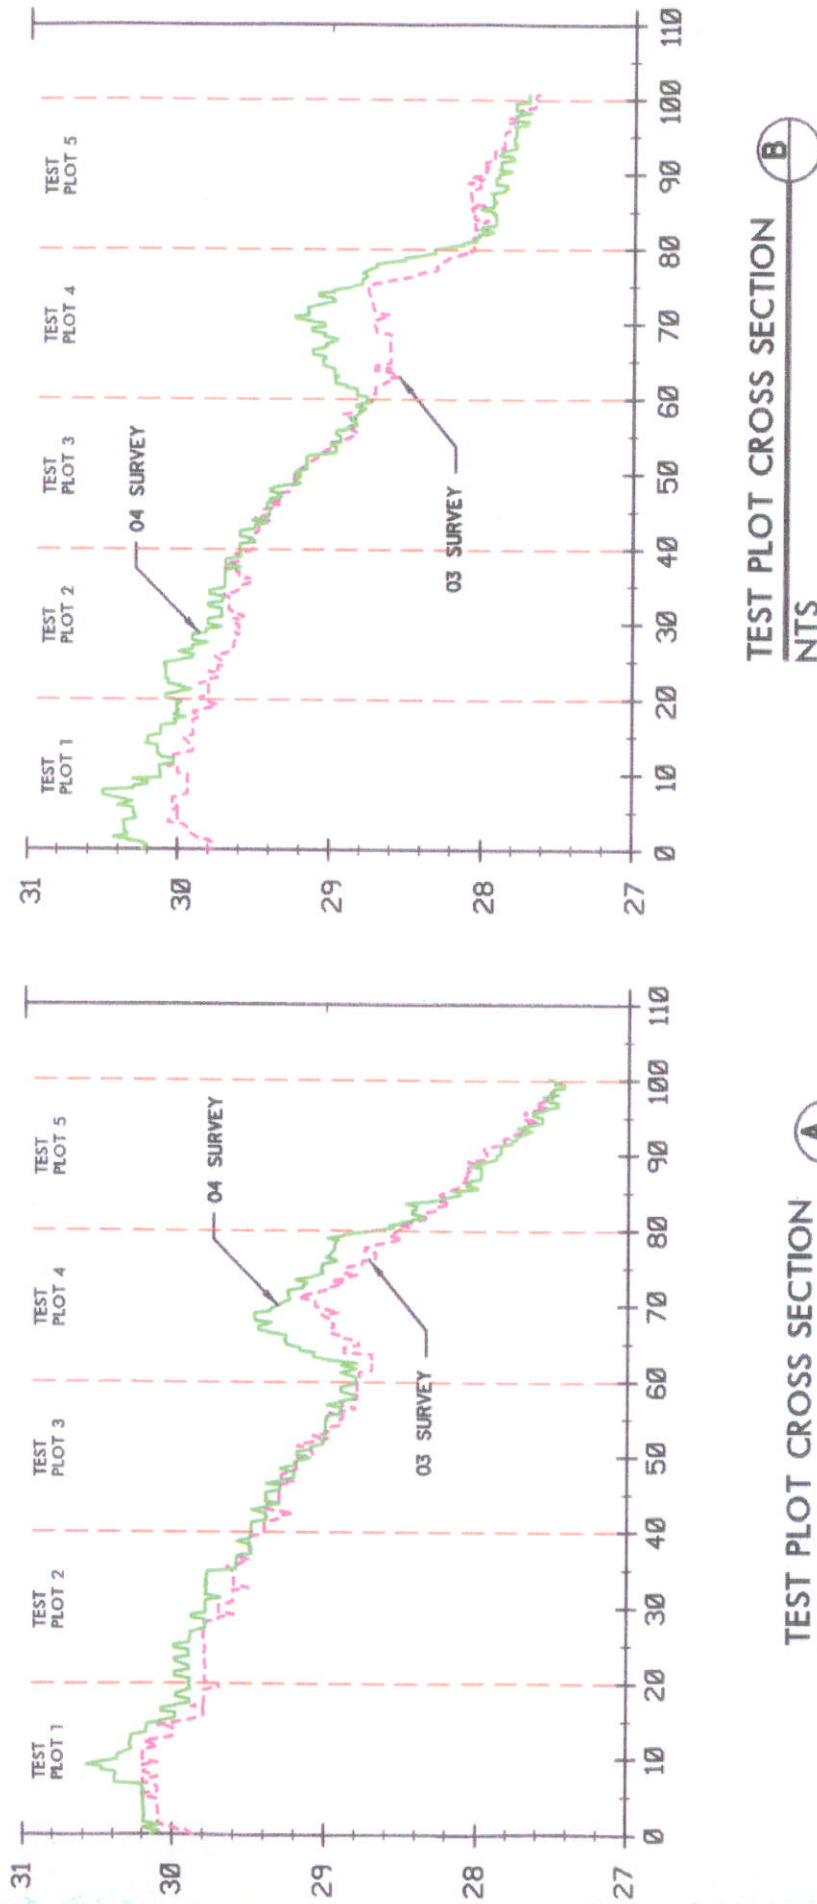
**Figure 5-5: Topography Cross-Sections. American Dunegrass, South Jetty Breach Fill, Westport WA, 2003 & 2004 Comparison**

NOTE:  
 1. VERTICAL EXAGGERATION ON CROSS SECTIONS IS 20:1  
 2. VERTICAL CONTROL IS BASED ON NOS MLLW IN FT

One of the goals of planting upland dredge material is to aid in sand retention. If one of the treatments retains sand more effectively, it should be noted for future consideration of planting. Microtopography within the experimental plots was monitored to determine the quantity of sand accumulation under the various treatments. It's speculated that a greater quantity of above ground biomass will capture and retain airborne sands more effectively than individual culms.
