Mapping & Managing Urban Ecosystems

A summary of the 2018-2019 Urban Ecosystems graduate internship & methodology case study from Seattle Public Utilities Urban Ecosystems group

MEH Project Report Final Draft
In partial fulfillment of the Master of Environmental Horticulture degree program

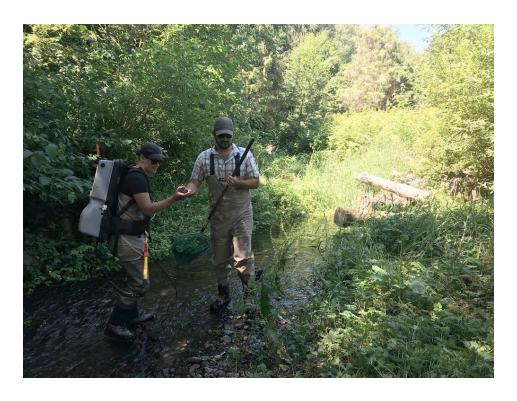
Figure i: Two members of the SPU Urban Ecosystems team electrofish the Kingfisher reach of Thorton Creek for biological data collection associated with post-restoration stream habitat surveys

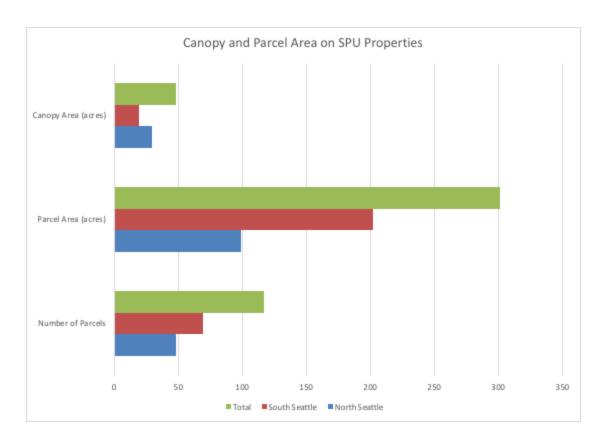
Figure 1: Canopy and parcel area on SPU properties, including totals within the Seattle municipal boundary, and subtotals within the northern and southern segments of Seattle (as divided north and south of Denny Way).

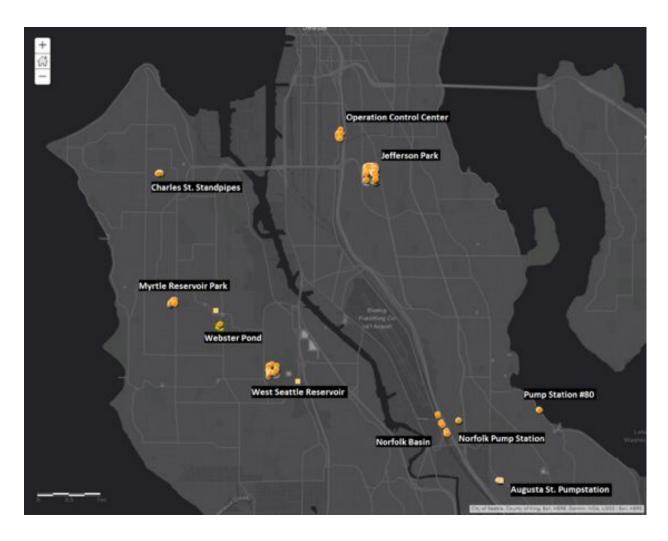
Figure 2 - Map of southern portion of Seattle and individuals site locations. Orange dots represent trees mapped at those locations.

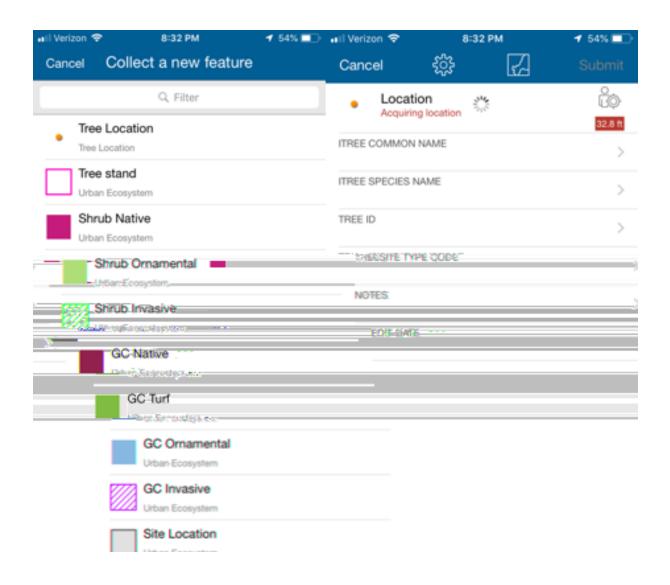
Figure 3: Mobile interface for ArcGIS Collector on a phone. First, a feature type is selected from the list provided. That feature is then located on the map file utilizing either GPS location or selecting a location on the map. Information is then entered into attribute tables associated with that feature through the fields in the subsequent prompts.

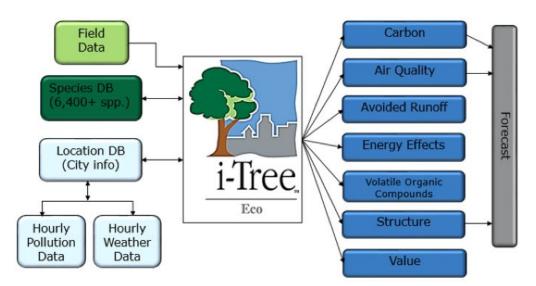
Figure 4: Schematic of iTree Eco model design. Field data measurements of trees in combined with a species database internal to iTree, along with pollution and weather data based on the case study location. Blue boxes list the ecosystem values modeled by iTree Eco.

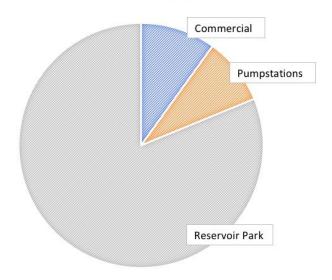
Figure 5: Total number of trees at individual study sites, summed by the land-use category their were assigned. Reservoir parks consisted of most of the land area of sites that were mapped, and contributed over 75% of the total trees included in the data set.

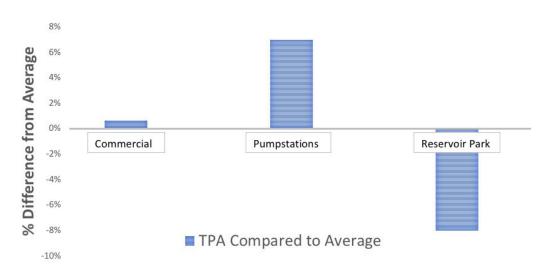
Figure 6: Tree Density by land-use category, compared to the average density across all sites (x-axis). This figure demonstrates that trees at pump-stations are typically planted at above-average densities, and trees at reservoir parks are typically planted at below-average densities.

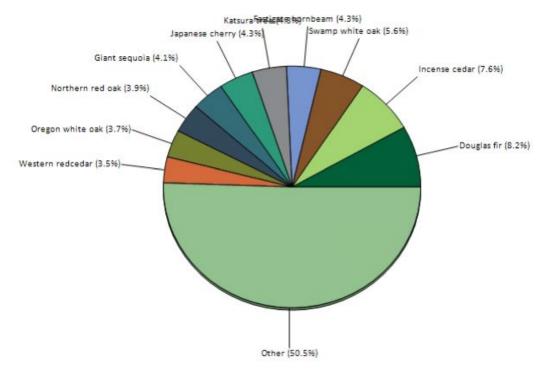
Figure 7: Tree species composition within the study area. This demonstrates that 10 species combined make up roughly 50% of all trees surveyed, and that the three most frequent species combined make up 20% of all trees surveyed. Douglas-fir (*Pseudotsuga menziesii*) and incense cedar (*Calocedrus decurrens*) are the two species that make up the greatest percentage of the overall tree population.

The forest structure analysis results show that the tree population includes a diversity of coniferous and broadleaf tree species, yet only 10 species represent 50% of the population. The significance of this observation is that threats to any of these 10 species, such as an insect pest or change in a climatic condition, could cause significant damage to the overall urban forest.

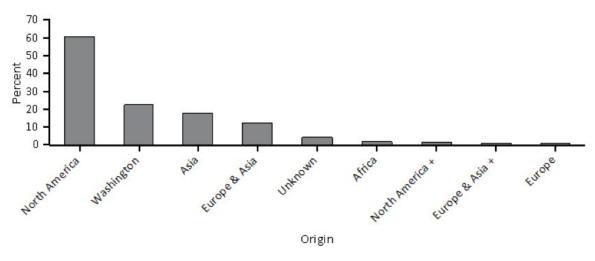
Figure 8: Percent of surveyed live tree population by area of native origin. This chart represents overlapping categories, therefore is not expected to sum to 100%. Furthermore, plant native ranges are not typically constrained by political boundaries, like those native to Europe & Asia. 20% of trees surveyed are considered native to Washington state, and 60% of trees surveyed are considered to be from North American origin (this includes all washington state species). An additional 20% of species are of Asian origin, while the remaining 20% are from other origins.

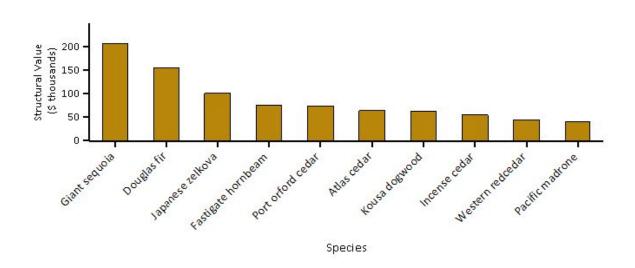
Figure 9 - Tree species with the greatest structural value, which is the value to replace the tree in its current condition if it were to die or be removed.

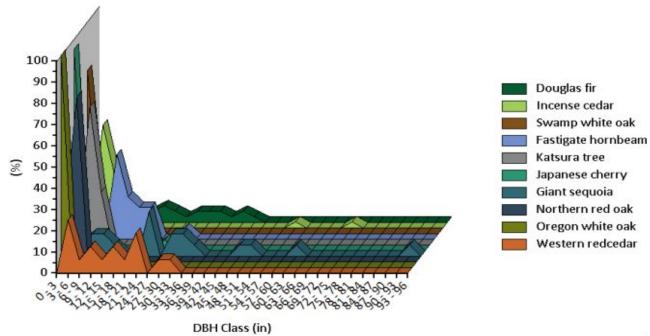
Figure 10: DBH class distribution for the ten most frequently occurring species within the dataset. Each segment of the x-axis represents a 3" range in stem diameters from 0" up to 96". Most trees are under 2' in diameter, and the largest tree diameters are represented by the west-coast coniferous species.

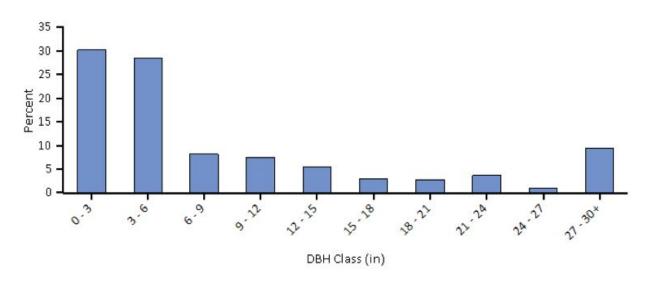
Figure 11: Tree DBH (stem diameters at 4.5') class distribution for all 463 surveyed trees combined. 60% of all trees were small: below 6" in diameter. All trees with diameters 27" or above are grouped in this figure, showing a weak bimodal distribution between small trees (<6") and large trees (>27", with a low frequency of medium-sized trees through the size distribution.

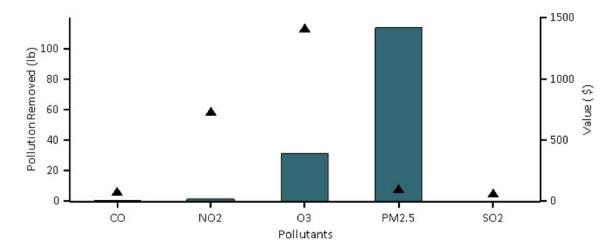
Figure 12: Annual pollution removal (triangles) and dollar values (bars) by surveyed trees. In this chart, we see that removal of pollutants such as Nitrous dioxide and Ozone, have relatively low dollar values compared to the total weight removed. In contrast, removal of small weights of particulate matter is relatively valuable.

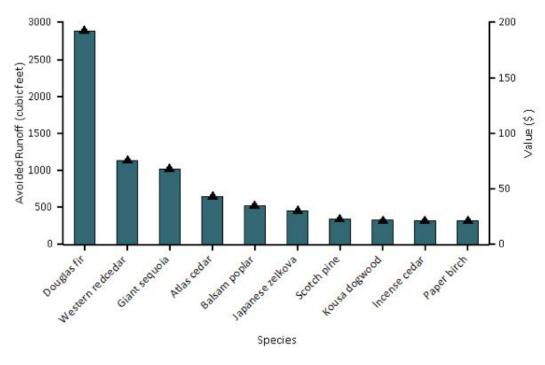
Figure 13: Total cubic feet of surface water runoff managed, and relative values of that service, compared across the ten species that manage the greatest quantity of runoff. This ecosystem service is of particular importance to SPU, as the manager of storm water in Seattle.

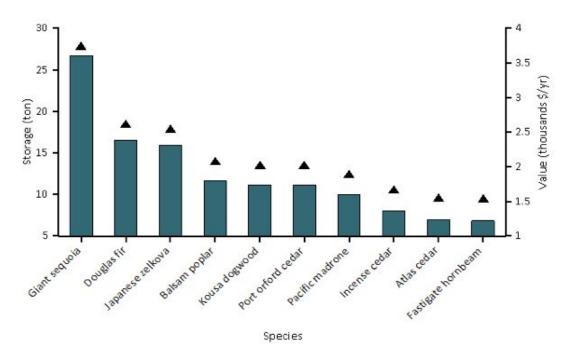
Figure 14: Estimated carbon storage (triangles) and values (bars) for ten tree species surveyed with the greatest carbon storage. Giant sequoias typically create large stems and buttresses which serve as large carbon stores, and those individuals within the study area were mature.

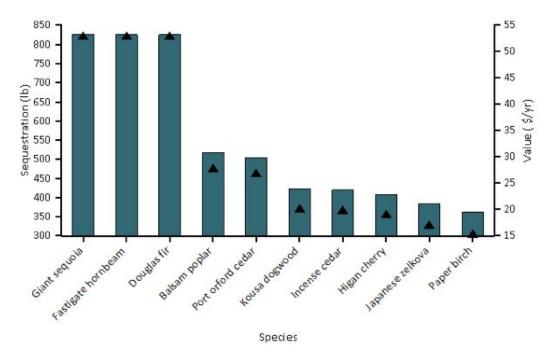
Figure 15: Estimated annual gross carbon sequestration (triangles) and values (bars) for those ten tree species with the greatest rates of carbon sequestration.

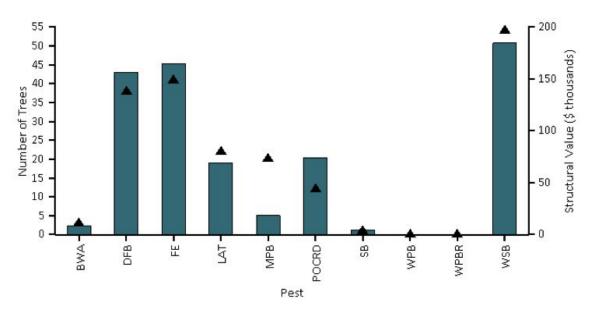
Figure 16: The total number of trees at risk (triangles) and the associated structural values (bars) for those trees at risk, organized by those species of pests known to be located in King County.

affected dramatically by large outbreaks of Douglas-fir beetle, or in the case of increased Douglas-fir mortality due to increasing summer drought conditions.

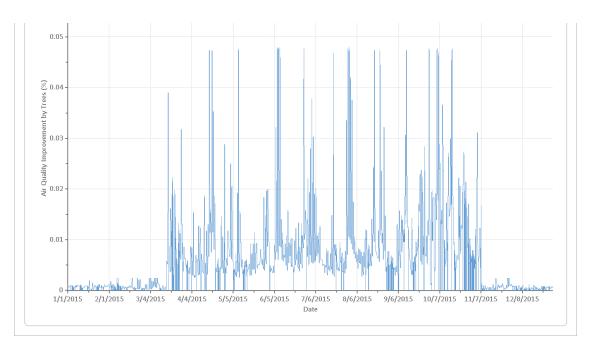
Figure 17: Potential annual air quality improvements by trees within the case study. Air quality improvements are greatly reduced during the winter months when trees are not photosynthesizing ,and deciduous trees have shed their canopies.

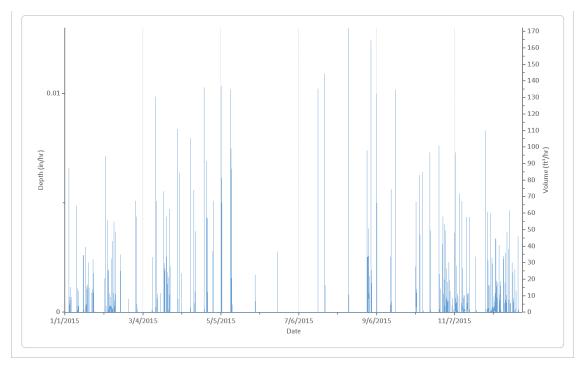
Figure 18: Potential annual avoided runoff, displayed in monthly intervals. Runoff is only produced in a system when there is precipitation beyond what can be absorbed or stored by the vegetation and substrate.

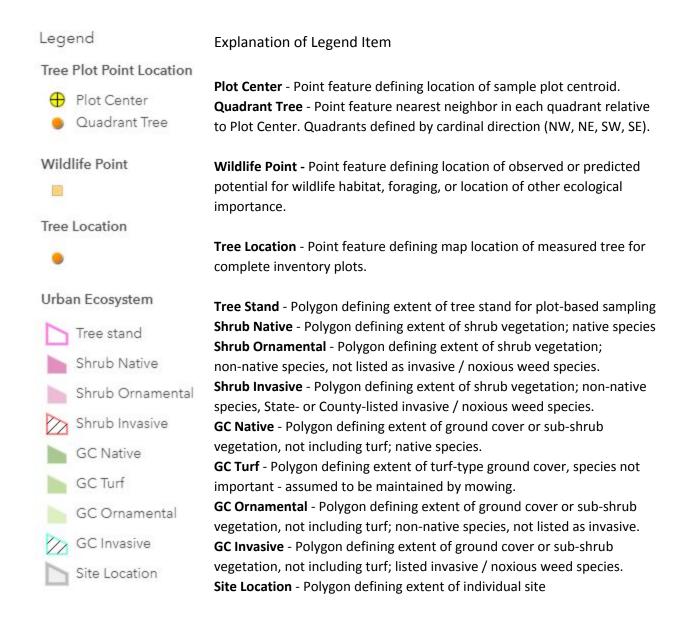
Figure 20: A legend for all individual site vegetation maps on the following pages. This legend represents all of the map features that were created and utilized for this case study. The order of this legend also represents the map drawing order from top-to-bottom, with Plot Center being drawn on the very top, and Site Locations being drawn as the bottom-most layer.

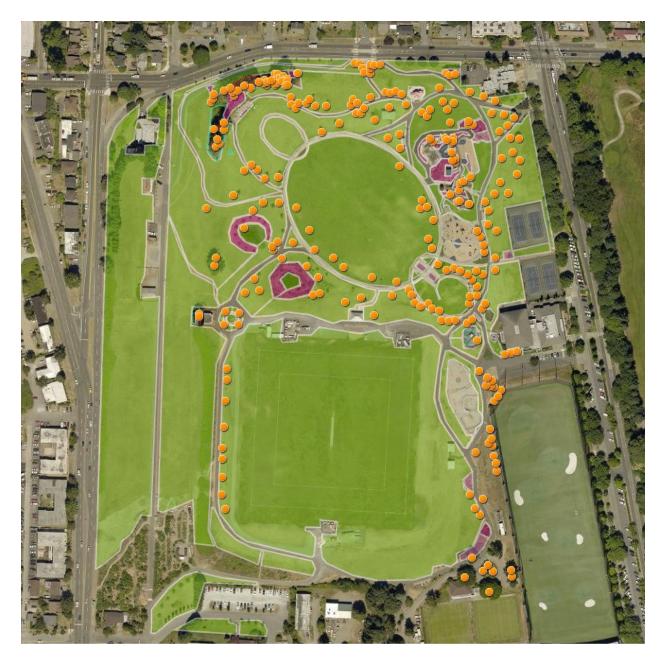
Figure 31: Map section of the Urban Ecosystems Map including the Beacon Hill Reservoir site. This was the largest site surveyed with the greatest quantity of trees.

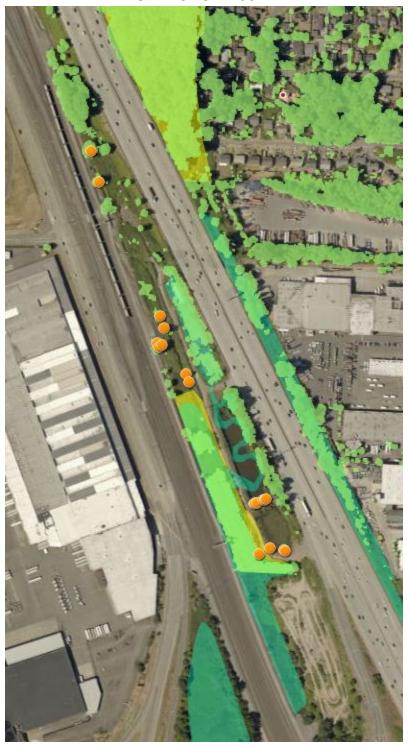
Figure 39: Map section of the Urban Ecosystems Map including the Norfolk basin site including the canopy cover layer (light green) produced by a 2017 LiDAR study across Seattle. This site was initially surveyed within the complete inventory method, but also requires the sample inventory method for full coverage, as can be seen from the canopy cover layer. For this reason, the trees measured at this site were excluded from analysis within this case study.

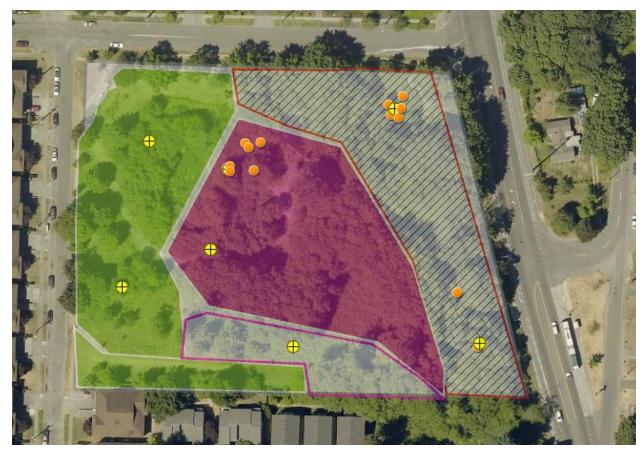
Figure 42: Sample Plots within multiple tree stands at the Webster Stormwater Detention Pond. Plot centers are depicted by cross-hairs, orange dots represent locations of representative trees that were sampled.

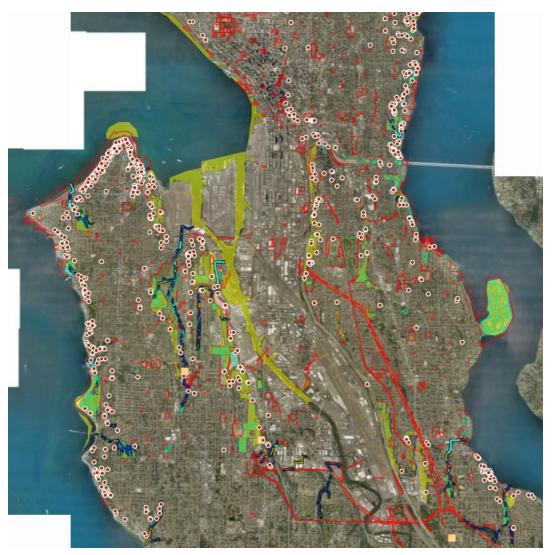
Figure 44: An example of several supplemental data layers that can be utilized to access relevant legal, topographical, or environmental information across an entire study area, or at an individual study site. This analysis informs field data collection and enhances the power of data collected within an individual case study. This example shows city-owned parcel boundaries, environmentally critical areas (including wetlands and wildlife habitats) as well as known landslide locations. The legend is depicted to the right.

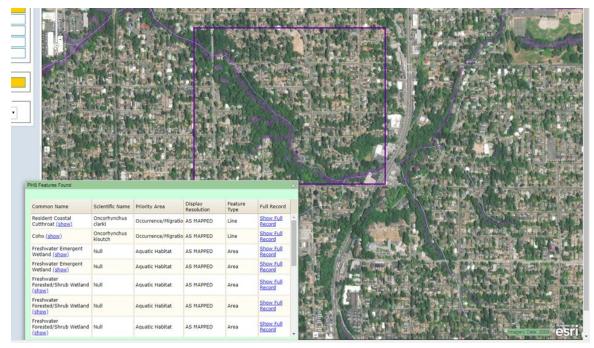
Figure 45: Example of Critical Habitat Area & Endangered Species data layers being utilized for the Thornton Creek watershed, an urban creek system managed by Seattle Public Utilities. The data layer, provided by the US Fish and Wildlife Service and available to the public for a small fee, indicates that two endangered salmonid species, and two critical habitat types, are located within the area-of-interest depicted by the purple rectangle.

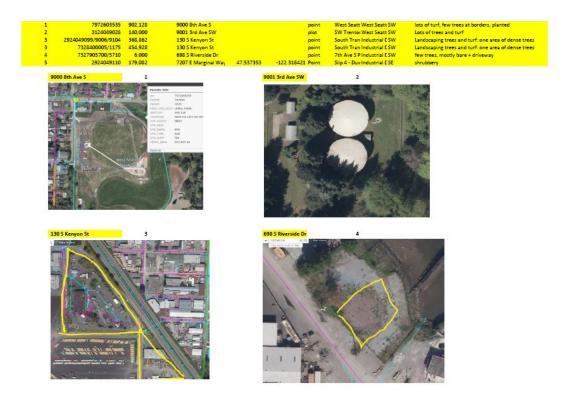
Figure 46: Example of preliminary site analysis: data table with important notes regarding site. Map screenshots of site locations including markups noting important features or boundaries.

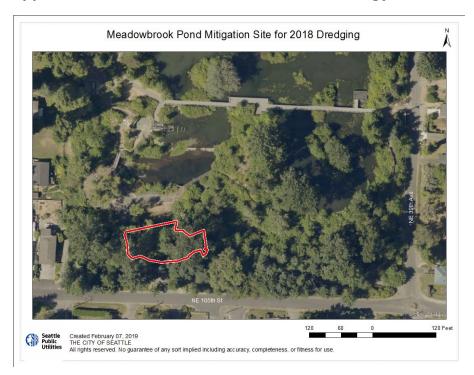
Figure 47: Example of mitigation site mapping utilizing collector and location streaming

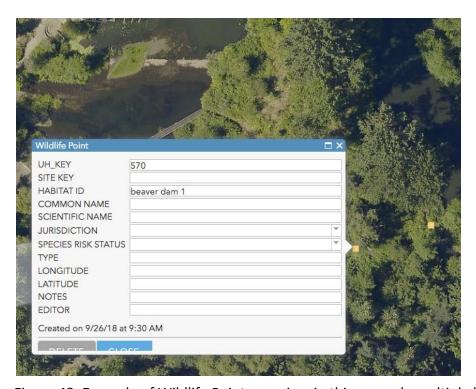
Figure 48: Example of Wildlife Point mapping, in this example multiple beaver dams at a project site are located within the Urban Ecosystems map

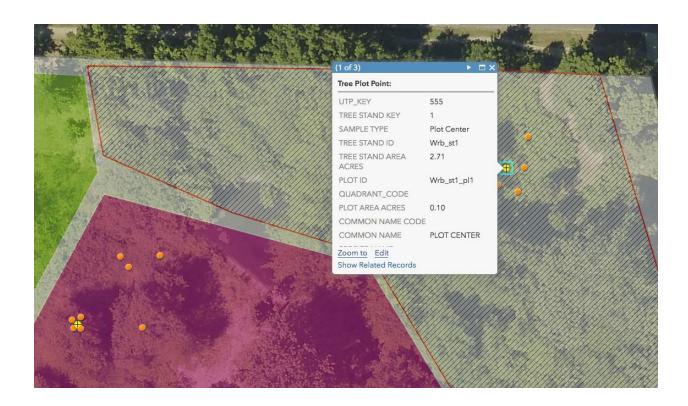
Figure 49: Example of Plot Status method design:
