Monitoring Plant Performance at Two Restored Beaches:  
Bowman and Cornet Bay  
Deception Pass State Park, WA

A thesis

submitted in partial fulfillment  
of the requirements for the degree of  
Master of Environmental Horticulture

University of Washington 2018

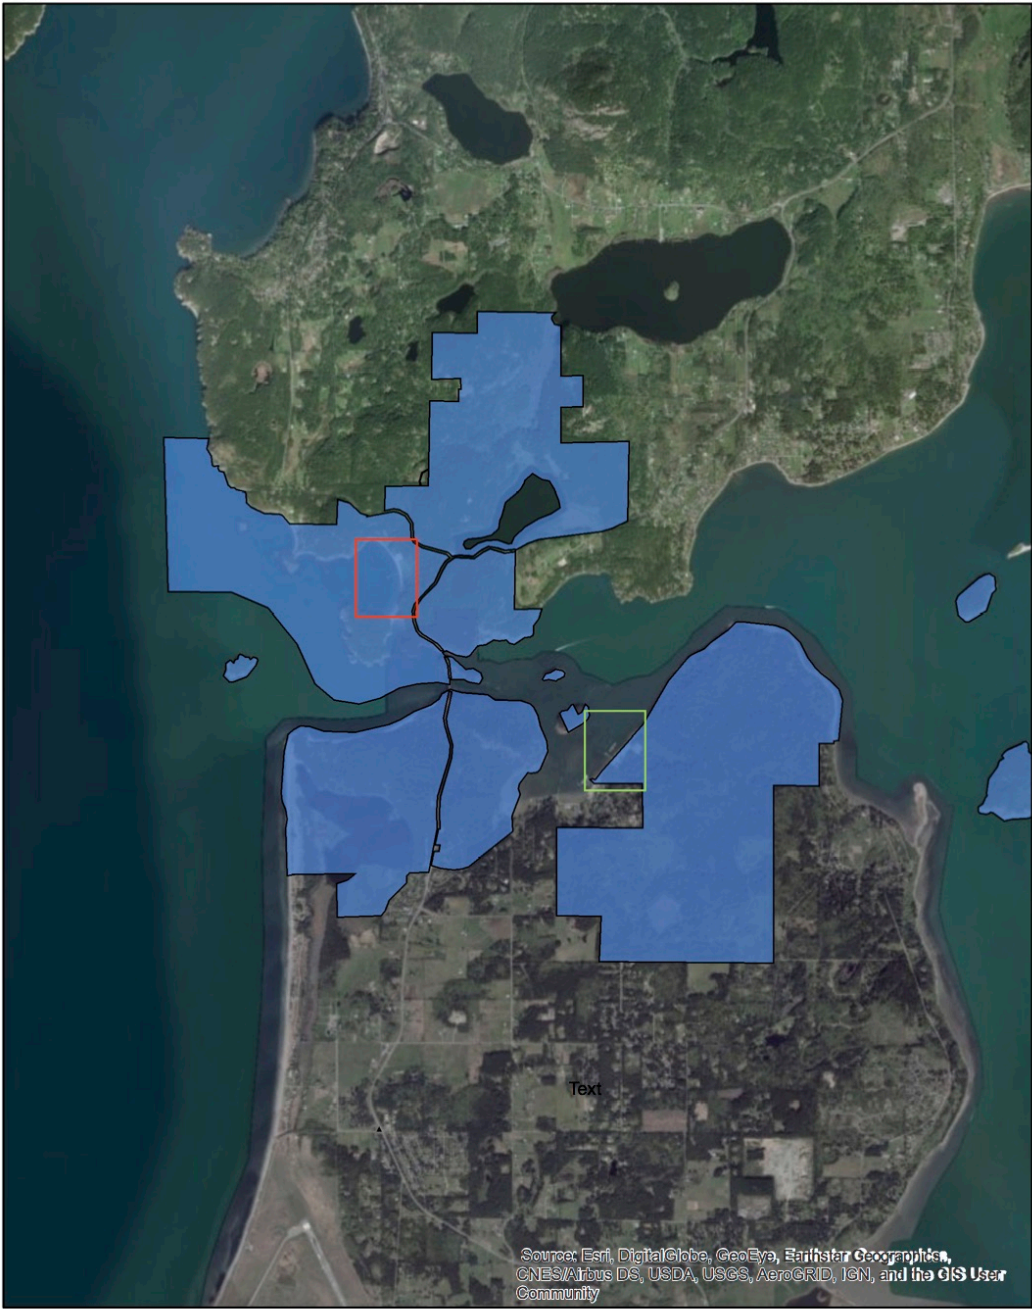
**Figure 1: Deception Pass State Park, WA Park Boundary and Study Sites**

# Deception Pass State Park Boundary and Study Sites

sediment deposition processes and threaten habitat for salmonids (Lynn 1998). Thus, the survival of near and backshore coastal ecotones and many of their associated species depend on preservation, restoration and proper management. The purpose of this study is to gather data on plant performance and progress of two nearshore restoration sites, Bowman Bay and Cornet Bay at Deception Pass State Park, WA in order to prepare recommendations for future management (Figure 1).

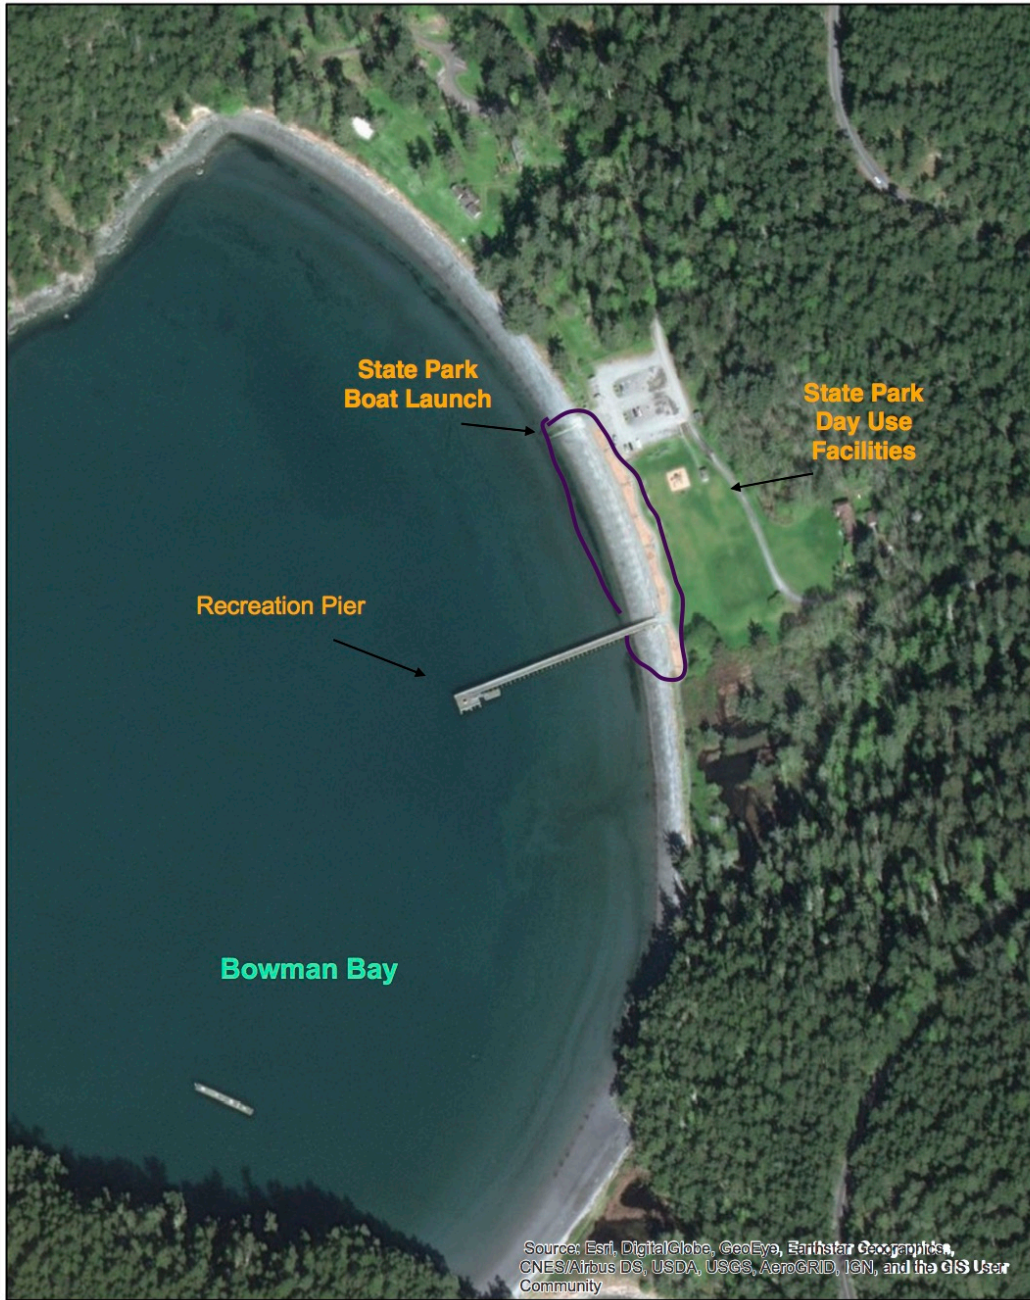
Figure 3: Bowman Bay Project Site Map and Area

### Bowman Bay Project Site and Area Map

processes. The beach has a moderately steep slope (5:1 to 6:1; H:V) for a beach in the Puget Sound region (Blue, Johannessen & MacLennan 2014). A storm berm, an accretionary feature comprised of coarse gravel, is present 100 feet from mean higher high water (MHHW). The beach face is composed of sand and gravel. A wooden pier extends into the water for 450 feet to provide recreational access and a concrete boat ramp is also present (Figure 3). In contrast, the upland area is composed of a gravel parking lot, playground, expansive lawn and a network of trails.

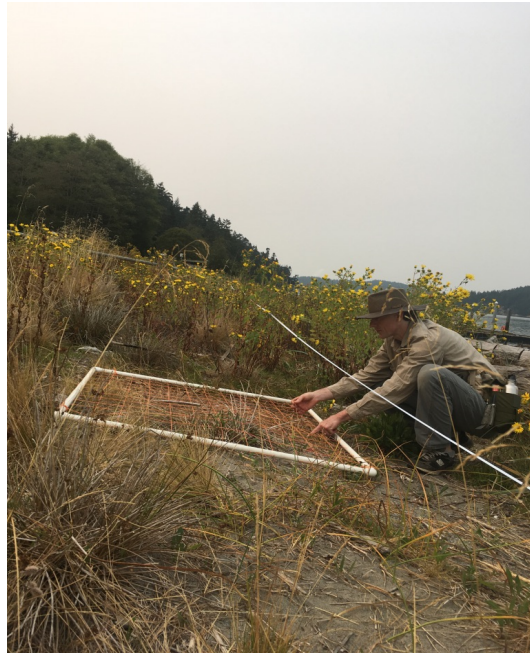
**Figure 5: Example of 4 ft. spacing of transects**

For a complete protocol on how to measure plant cover and survivorship in the field including a materials list and data sheets see Appendix 10-14.

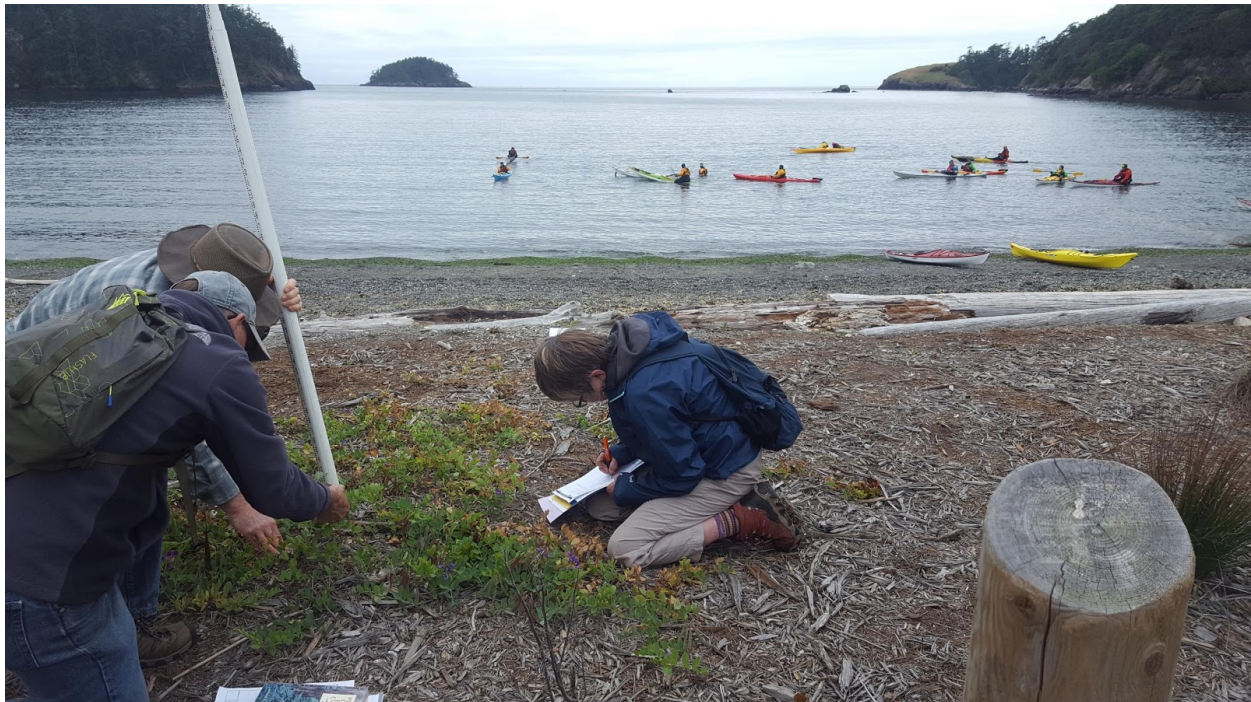
Figure 7: Volunteer's assessing height and Survivorship of *Lathyrus japonicus* at Bowman Bay

Survivorship Rating	Description
1	Dead or nearly dead
2	Live plant with dead portions and/or signs of stress
3	Signs of new vegetative growth without reproduction
4	Poor reproduction (few and poorly developed flowers/fruit)
5	Healthy reproduction (many well-developed flowers/fruit)

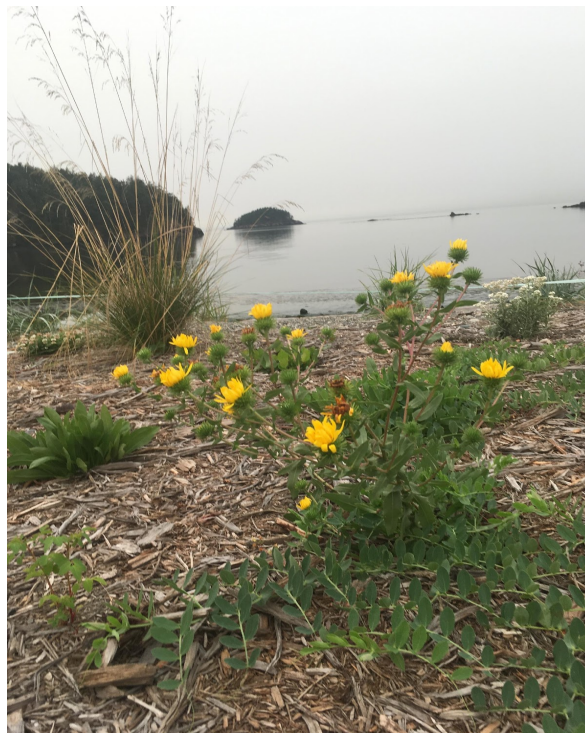
**Figure 15: Recruited *Grindelia integrifolia***

A total of 81 plants were measured as naturally recruited in Zone 2 (Figure 14). This included many conifer and *Alnus rubra* seedlings in addition to *Grindelia integrifolia* (Figure 15).

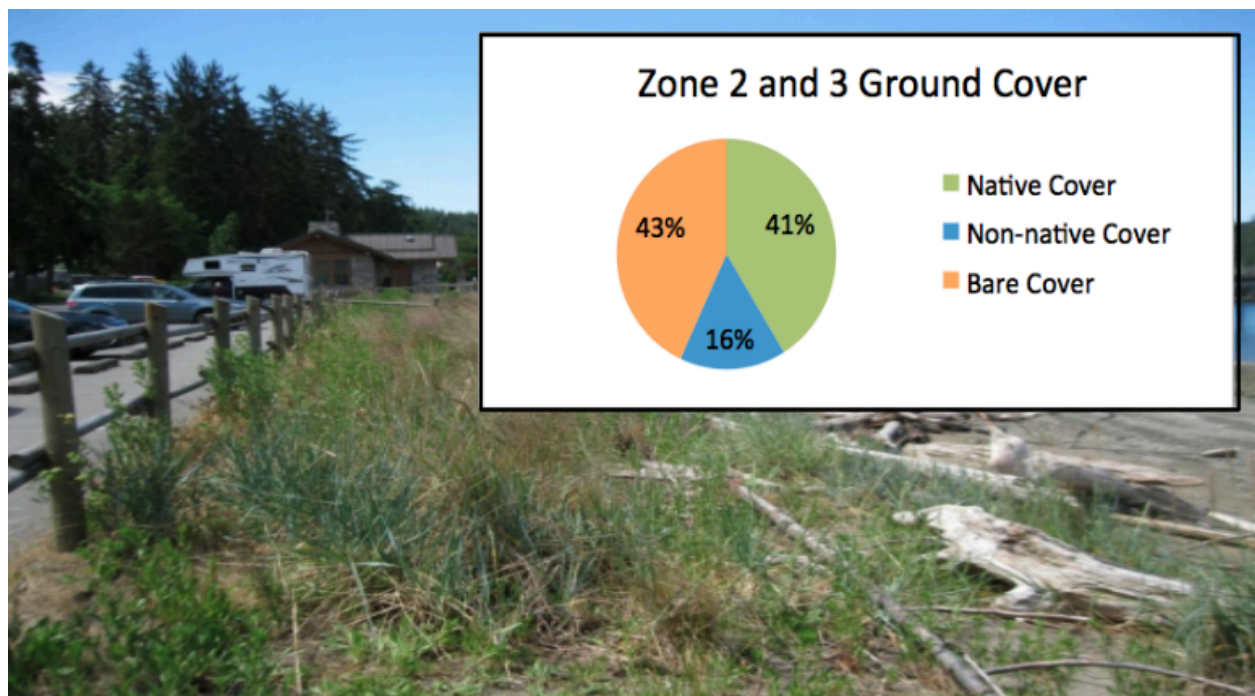
**Figure 16: Plant cover in Zones 2 and 3 at Cornet Bay Phase 1**

268 quadrats were sampled for coverage and stocking in Zones 2 and 3 of Phase 1. A total of 4,850 plants were originally installed in the 0.63 acre area, at a spacing of approximately 2 foot centers. There is still a significant percentage of bare ground cover at 43% (Figure 16). Native vegetation covers 41% of the area and non-native ground cover is at 16%. Native cover slightly decreased from the previous year (from 51% to 41%).

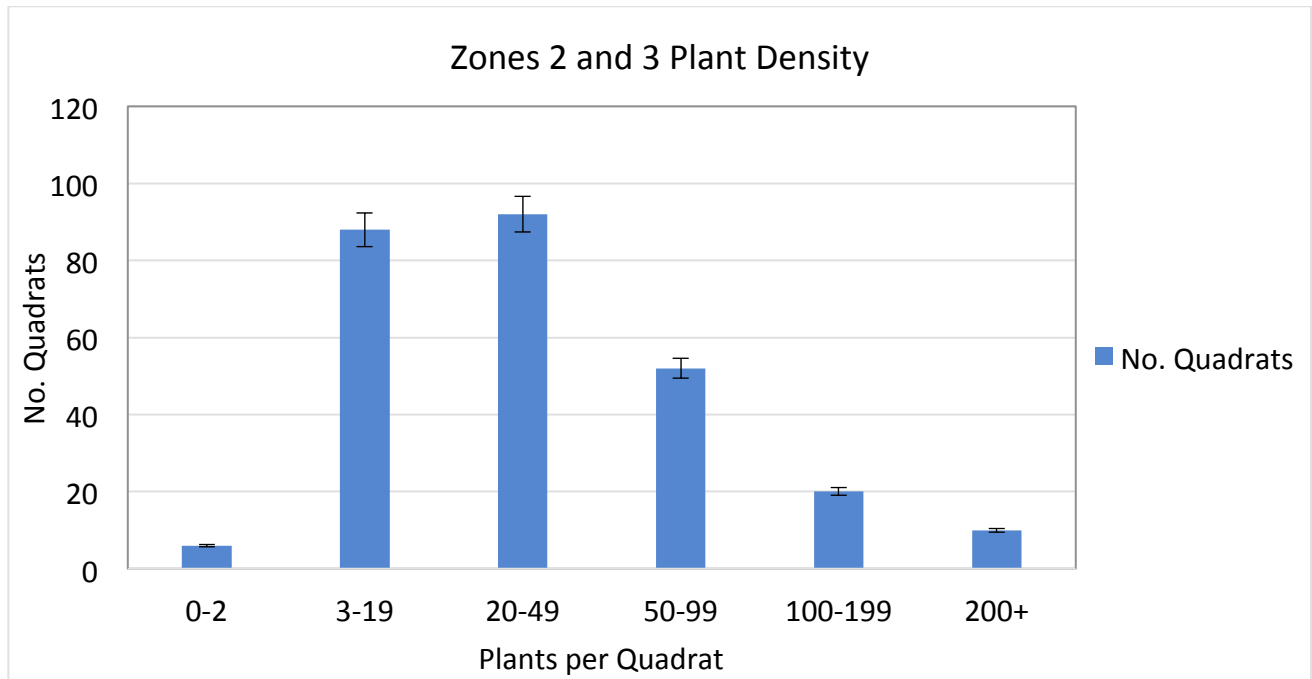
**Figure 18: Native Plant Density in Zones 2 and 3 of Phase 1 at Cornet Bay**

Zones 2 and 3 are well stocked. 98% of quadrats sampled had 3 or more native plants per quadrat. 6 quadrats were poorly stocked with 0-2 native plants per quadrat however; the majority of sampled quadrats had 20-49 native plants or more per quadrat (Figure 18).

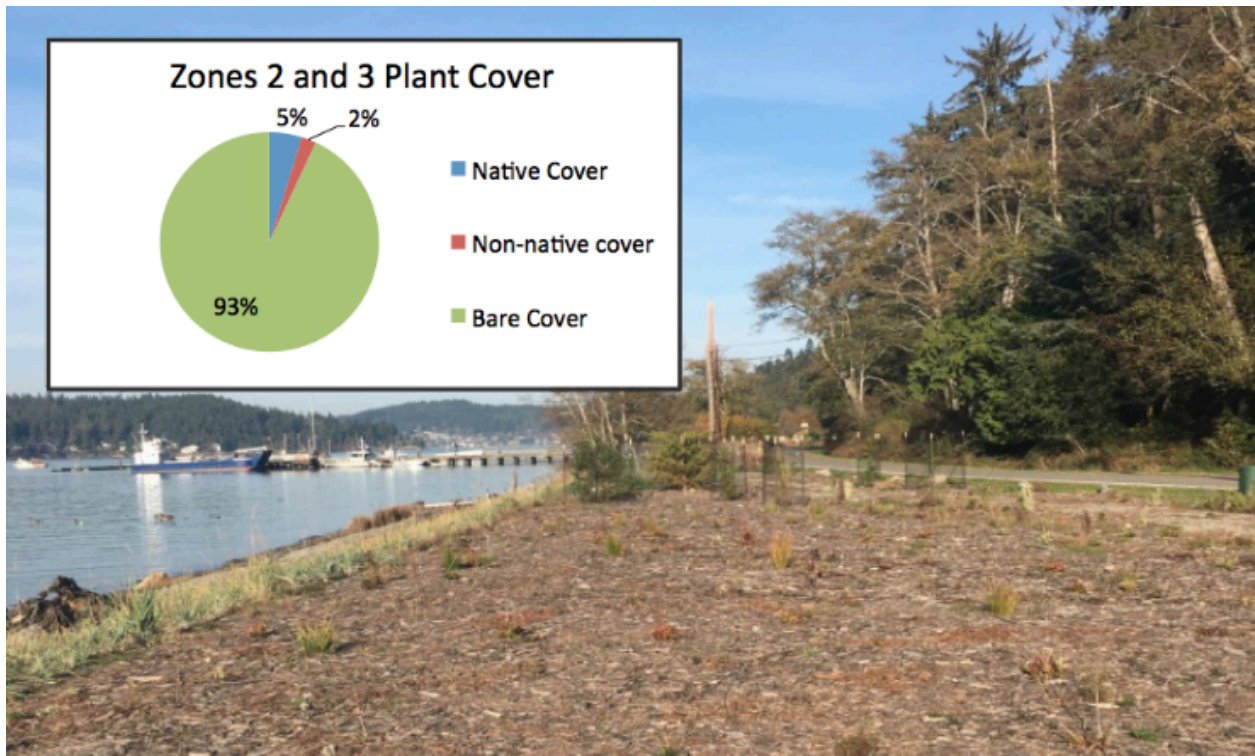
**Figure 21: Plant Cover in Zone 2 and 3 at Cornet Bay Phase 2**

abundant species sampled in this cover class at 23% and 26%, respectively (Figure 22). However, the probability of all recruited seedlings surviving the harsh conditions of the site is unlikely. Non-native European pasture grasses were the most abundant species within Zones 2 and 3, representing 11% of the plants counted.

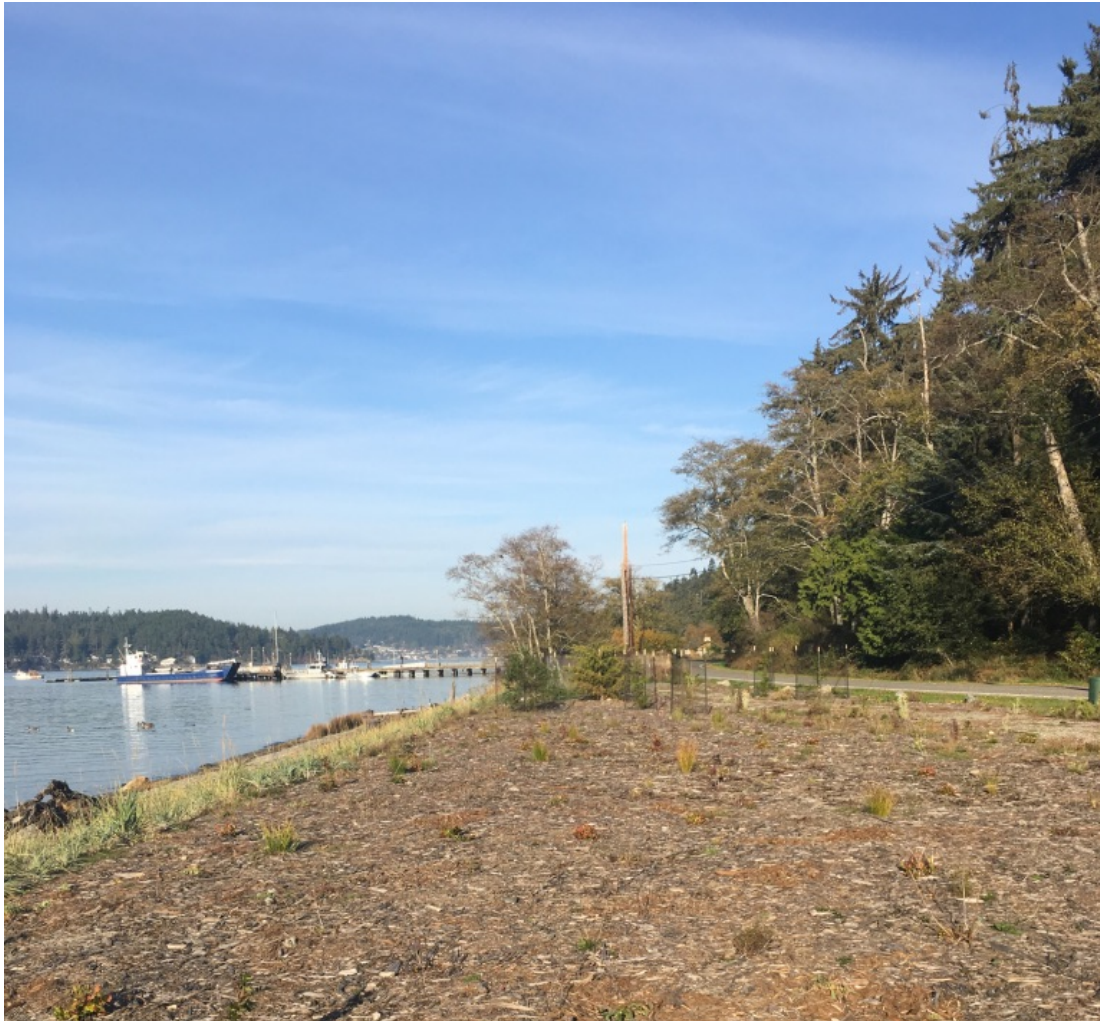
**Figure 25: Photo of Zone 2, 3 and 4 Phase 2 at Cornet Bay**

Plant survival in Zone 4 of Phase 2 was over 100% (Figure 24 and 25). This is an increase from 74% the previous year. However, note that 196 plants were given a mortality rating of 2 (live plant with dead portions and/or signs of stress). This signifies that though overall plant survival is high many plants are struggling. Willow species had the poorest survival rate at 14%, however this is an increase from 0% the previous year. In contrast, *Gaultheria shallon* is the most abundant plant species with a survival rate of over 100%. This signifies this species' ability to actively colonize the site with rhizomes, producing plant recruitments. A total of 35 plants were recorded as naturally recruited (Figure 26) including *Ribes lacustre* and *Rubus ursinus*. Additionally, all *Alnus rubra* plant recruitments were seedlings.
