Puerto Rico and Caribbean Beach Network  
Planning School  
University of Puerto Rico  
Rio Piedras Campus

Final Report

**Assessment of beach morphology at Puerto Rico Island**  
Contrato Núm. 2015-000101

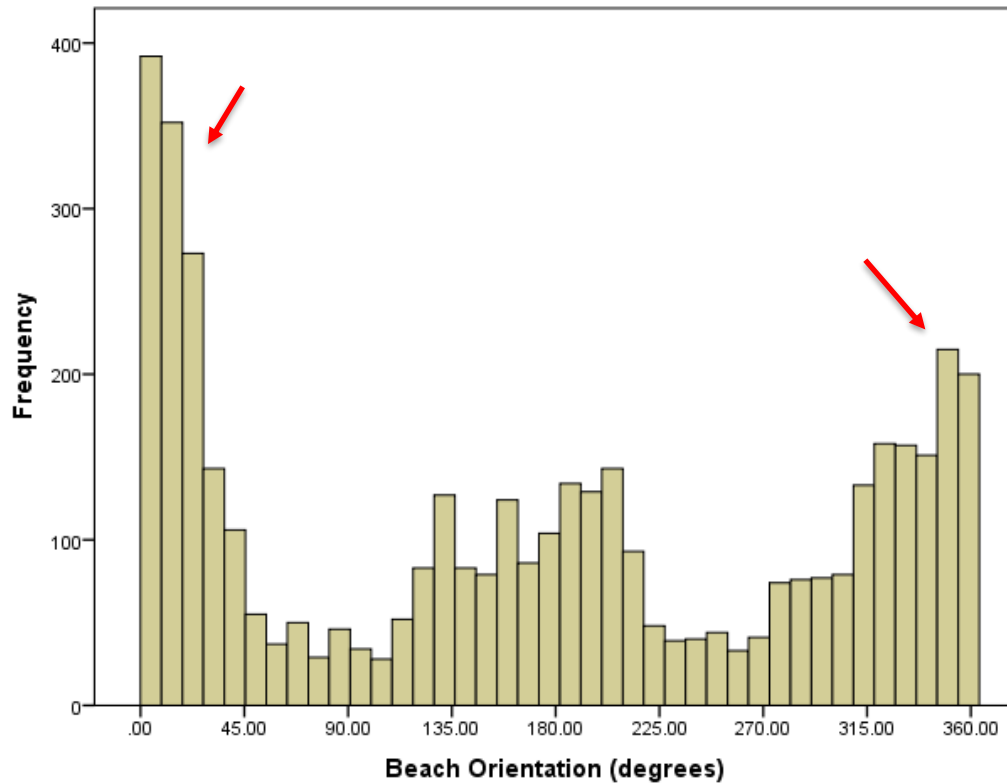
Figure 14. Beach orientation frequency distribution at Puerto Rico, 2010.

Beaches showed different shapes and orientation at the Island. Major beaches includes in this study showed north and northwest orientation (Figure 14). These beaches are located in the north, northwest, west and northeast of the Island presenting irregular shapes as lunate, concave form. This finding is very important to understand the possible impact of swells approaching from the north and northwest associated with cold front systems. Flamenco beach is an example of a beach unit with different beach orientations (Figure 15).

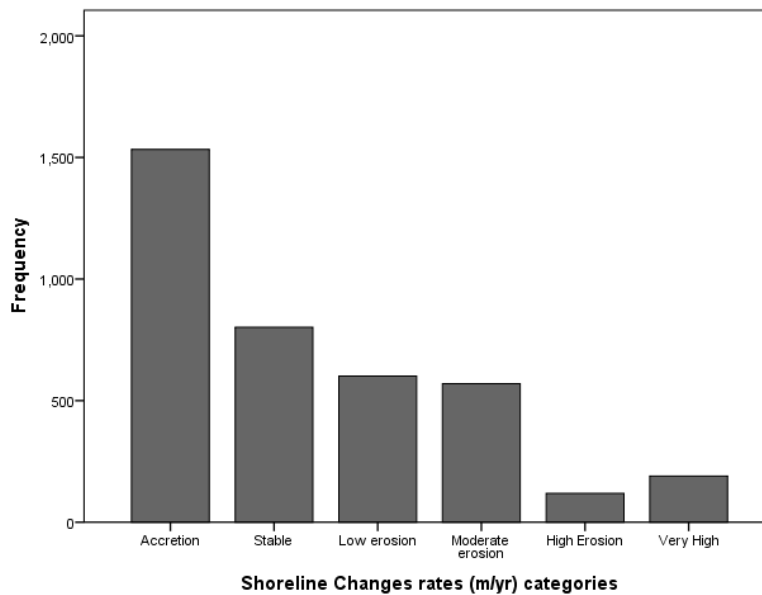
Figure 17. Frequency distribution of shoreline changes rate categories.

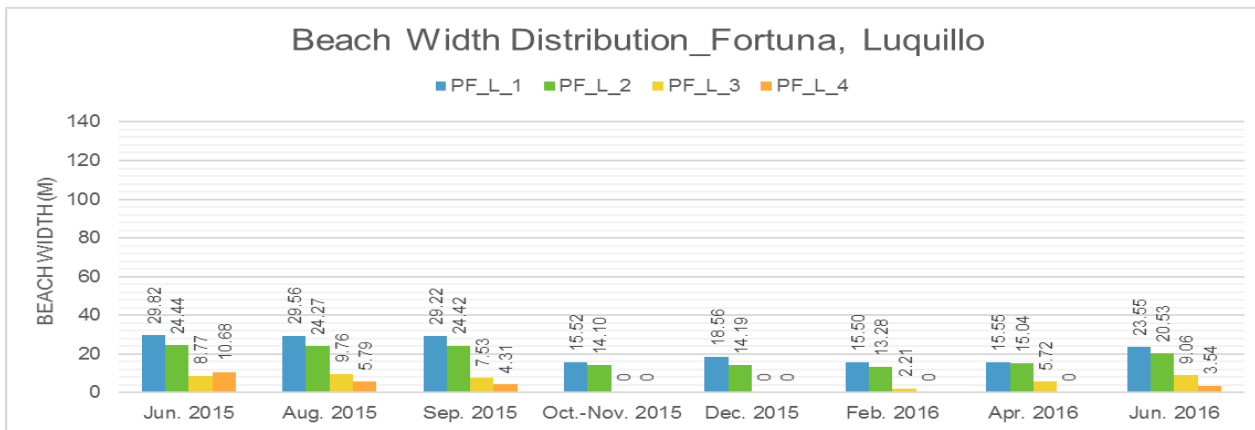
Figure 22. Beach width distribution at Punta Santiago, Fortuna and Parcelas Suárez.

One hundred four (104) beach widths measurement were collected from June 2015 to August 2016 in all selected beaches. Beach width ranges from 0.1 to 128.7 meters. Major beach widths were identified at Playa Grande at Arecibo where beach widths ranges from 20 to 128.71 meters. The wider beach plain is located in station 1 at Playa Grande. Smaller beach widths were measured at Fortuna Beach, Luquillo. Severe loss of beach extension was identified in the western site where is located the residential and touristic areas. Differences in beach widths can identified by stations per beach. This can be related with with beach orientation of each segment.

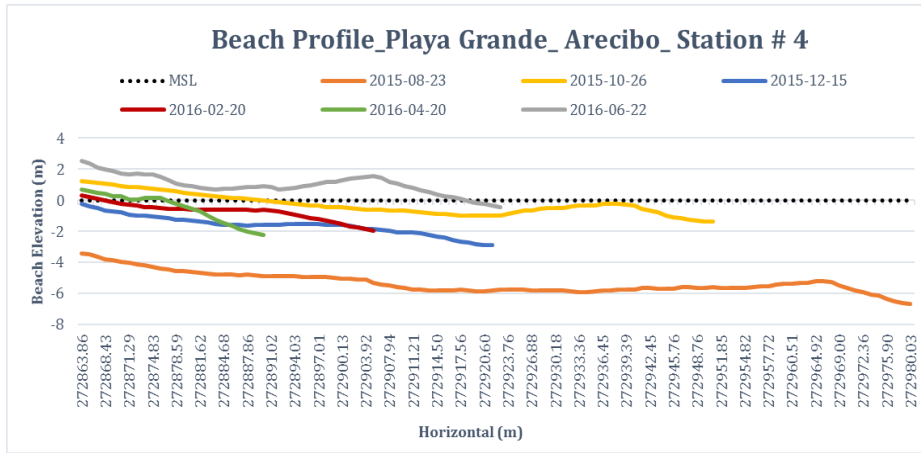
Figure 25. Beach profiles stations at Playa Grande, Arecibo

Twenty eight (28) beach profiles were measured at Playa Grande, Arecibo from August 2015 to June 2016. Beach profiles showed variability in shapes, elevation and width between stations for the study period. Beach elevation and width differences may related with the coastal orientation between stations. The seasonal summer-winter cycle is not well defined in this beach base on the profiling data. As an example, an important sand accumulation was identified in station 1 during winter season related with the occurrence of swells associated with cold system events in the North Atlantic area. In addition, beach accretion was observed in the majority of the stations for June 2016, except station 3 where loss of sand was identified for the same period. This beach has the ability to reconstruct the profile in a short period.

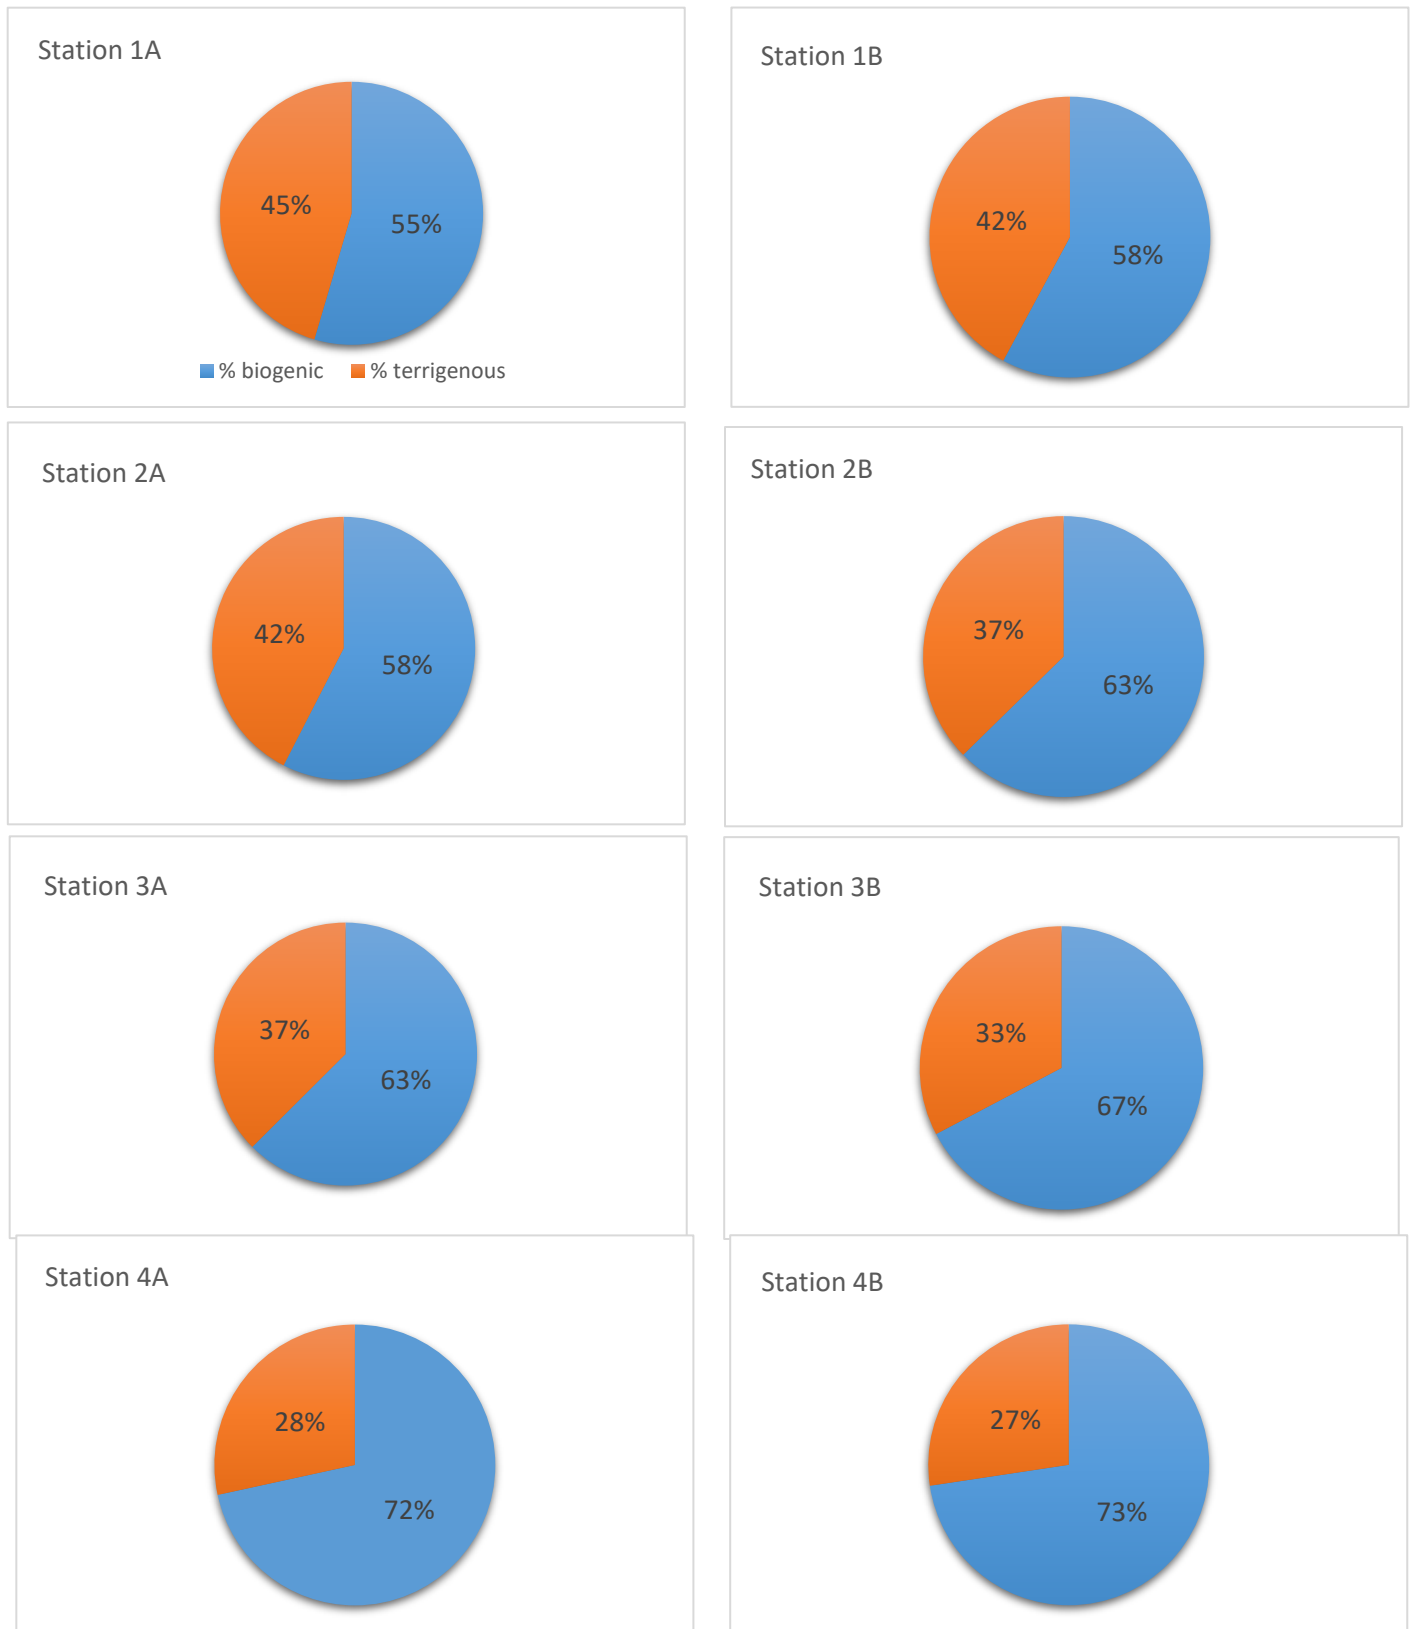
Figure 47. Beach Sediment Composition by station at Playa Puerto Nuevo, Vega Baja, Puerto Rico (2015-16)

Five hundred seventeen (517) beach sediment samples were collected and analyzed to identify beach sediment composition. Three sediment components were identified in beach sites included in this study. These are biogenic ( $\geq 75\%$  calcium carbonate component), terrigenous ( $\geq$  terrigenous component as minerals/rock fragments) and mixed biogenic and terrigenous sediments (between 26 to 74 % both components). Carbonate biogenic sands came from biogenic production, including spicules, forams, coral fragment, carbonate seaweeds and molluscan shell debris. Biogenic sands were found at Playa Santa (Guánica) and Fortuna Beach (Luquillo). Terrigenous sands came from the erosion of terrestrial rock that can be transported from different source distances through river sediment transportation. Terrigenous beaches were identified at El Maní, Mayaguez and Punta Santiago (Humacao). Mixed carbonate and terrigenous sand beaches are found at Playa Grande (Arecibo) and Playa Puerto Nuevo (Vega Baja). Parcelas Suárez showed two separate beach sections based on sediment composition. These are: a mixed carbonate and terrigenous beach (station 1, 3 and 4) and terrigenous beach (stations 2, 5, 6 and 8). Differences in sediment composition were identified between backbeach and swash zone in some of the study sites.
