5 3 1	The Morehead 7.5-minute quadrangle is located in Rowan county in Eastern Kentucky near the Appalachian Basin. The economic geology includes two natural gas fields(North Triplett Field and Bluestone Field), refractory clay of the Olive Hill Clay Bed of Crider (1913) and the Newman Limestone. The Quarries are shown on the map as af2 materials. The distribution of surficial materials is related to specific bedrock lithology, weathering rates, and the influence of mining and other types of development. The units described on this map reflect natural processes collectively operating as a dynamic geomorphic system (Newell, 1978). They are the result of the relationship between processes and landforms. Chemical and mechanical weathering, mass wasting, and streamflow are the main agents creating and transporting the surficial materials that become the residual, alluvial, and colluvial units.

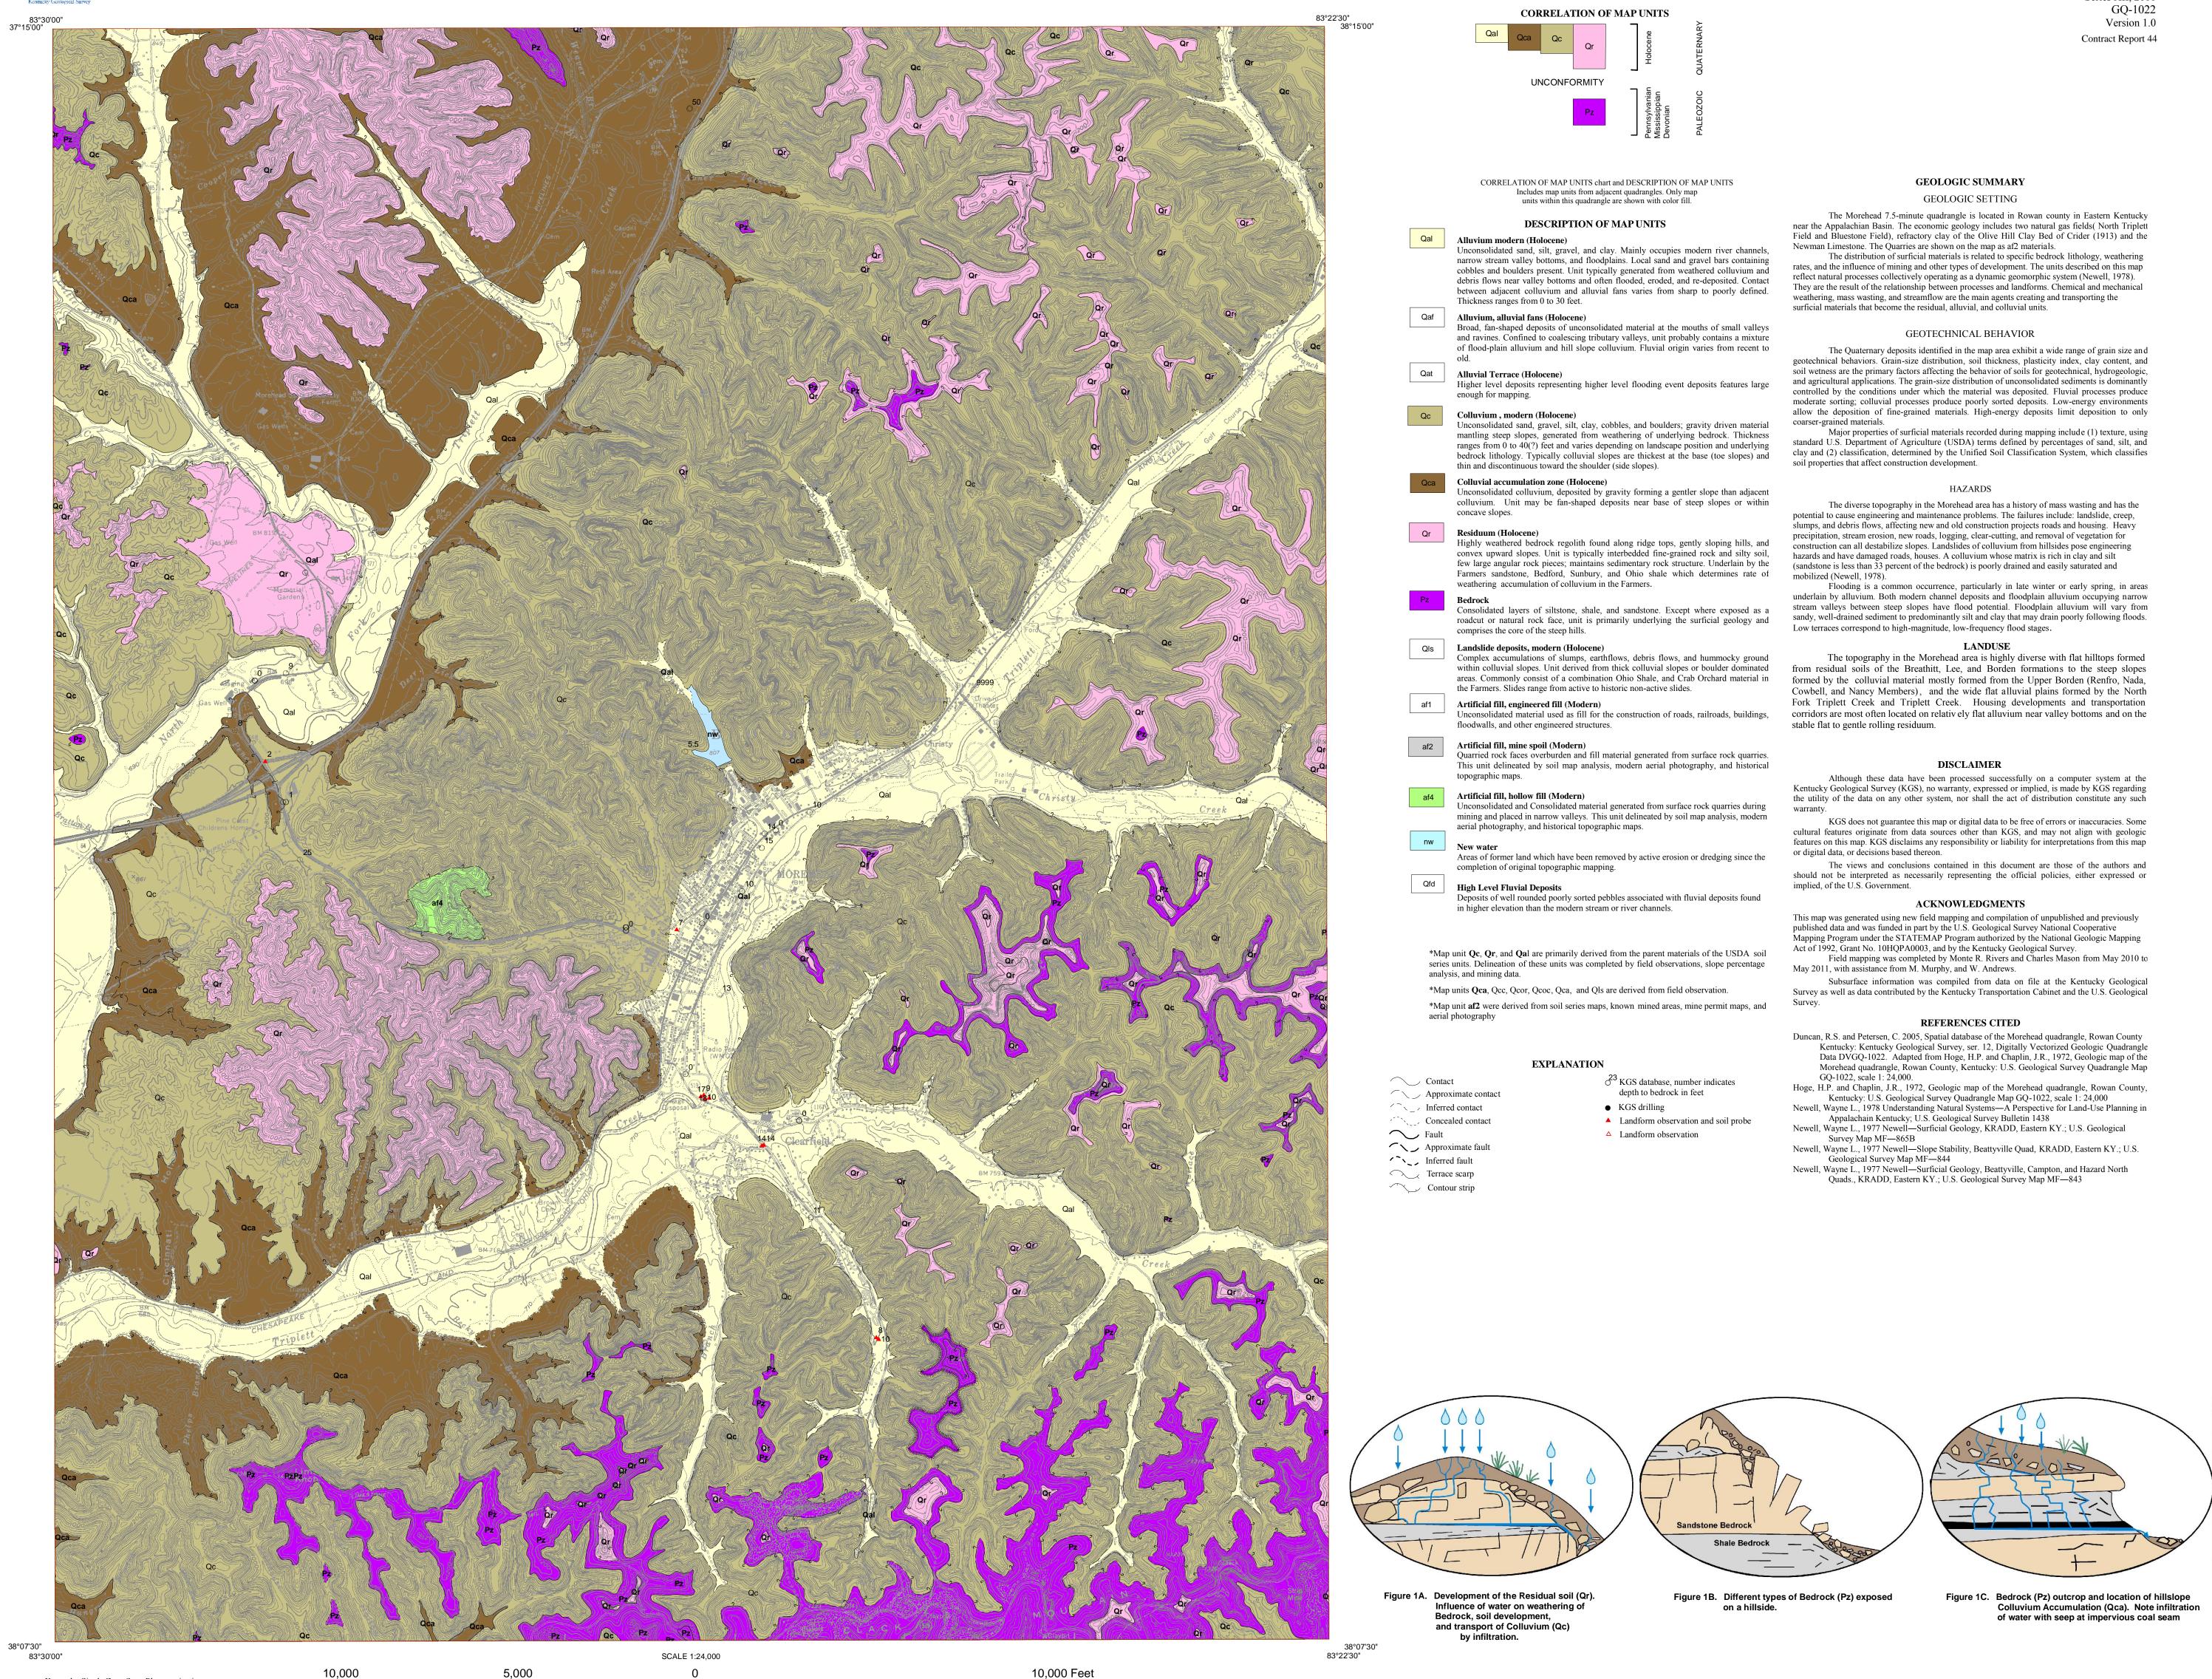
Kentucky Single Zone State Plane projection Topographic base and cultural features are from Kentucky Raster Graphics from Kymartian.ky.gov/krgmaps/KRG of MOREHEAD 10,000 5,000 0 0.5 1 Kilometers CONTOUR INTERVAL 20 FEET
