**Alaska - Pacific
River Forecast Center
6930 Sand Lake Road
Anchorage, Alaska 99502-1845
<http://aprfc.arh.noaa.gov>
800-847-1739**

August Flooding in Southcentral Alaska

High Water Level Reference Levels by Larry Rundquist

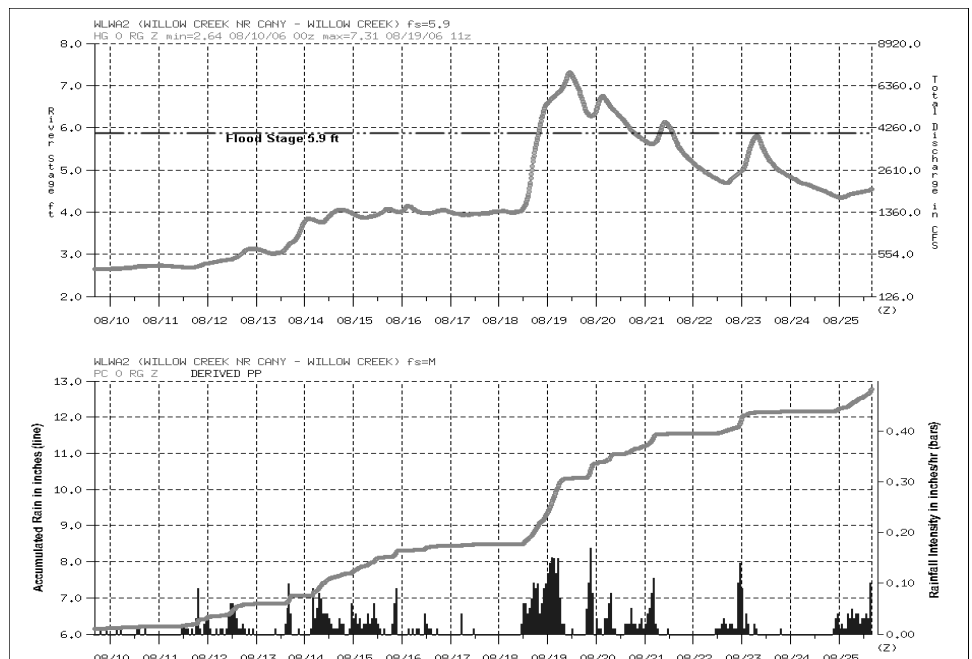
Water level and rainfall graphs at the USGS gage on Willow Creek in the canyon

Wet was the word for August of 2006 in southcentral Alaska! After a relatively dry start, rain began falling during the second week of the month. By August 16 water levels were already elevated on Susitna basin and Anchorage bowl streams (see graphs at right), and meteorological models were indicating the possibility of significant rain in southcentral Alaska beginning on the 18th.

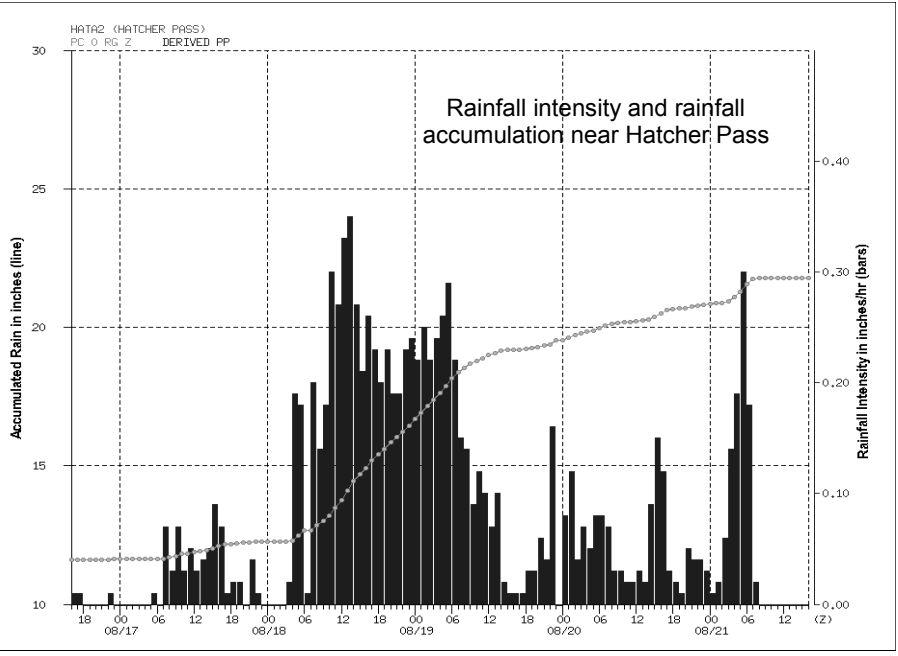
southern Alaska. Westerly to southwesterly winds with this system led to downsloping and relatively little rain in the western Susitna basin and enhancement of the rain in the eastern and northern Susitna Basin. Up to 6 inches of rain were reported in the eastern and northern Susitna basin on the 18th and nearly 9 inches accumulated over the two day period. Hourly rainfall intensities were as large as 0.40"/hr during the event. The graph at right shows rainfall totals at Hatcher Pass.

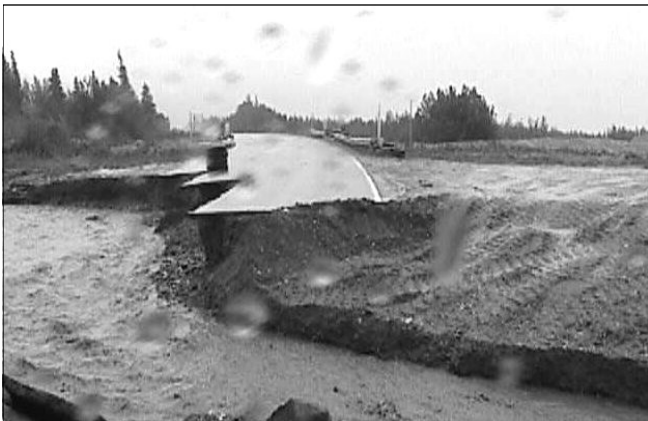
Richardson Hwy washed out south of Delta Junction

Several heavy rain events in the Alaska Range over the summer resulted in some significant flooding along the Richardson Highway. Over a three day period in mid-June, between 4 to 7 inches of rain fell from Delta Junction to Paxson. Flash flooding of small streams spread debris over the road and completely washed it out in several locations. More rain a few days later brought streams to bankfull again and pushed more water across the highway. More heavy rain in August resulted in another round of flooding and mudslides along the highway.

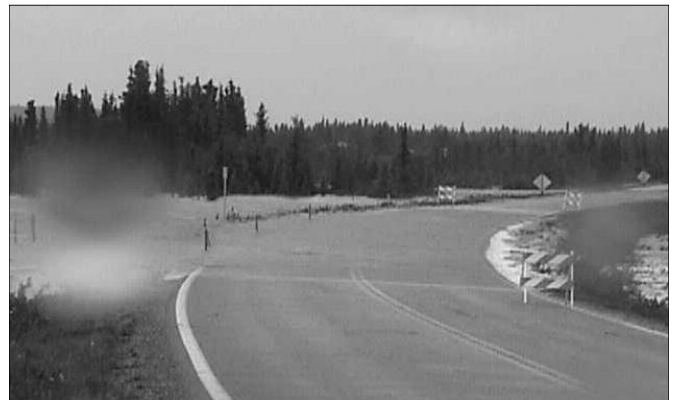
Water flows over the Richardson Hwy at Donnelly Creek State Recreation Site

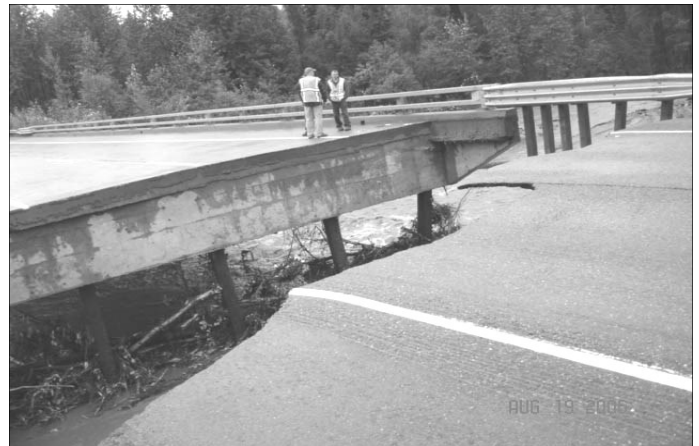
Washed out approach to bridge over
Troublesome Creek
on the Parks Hwy
August 2006

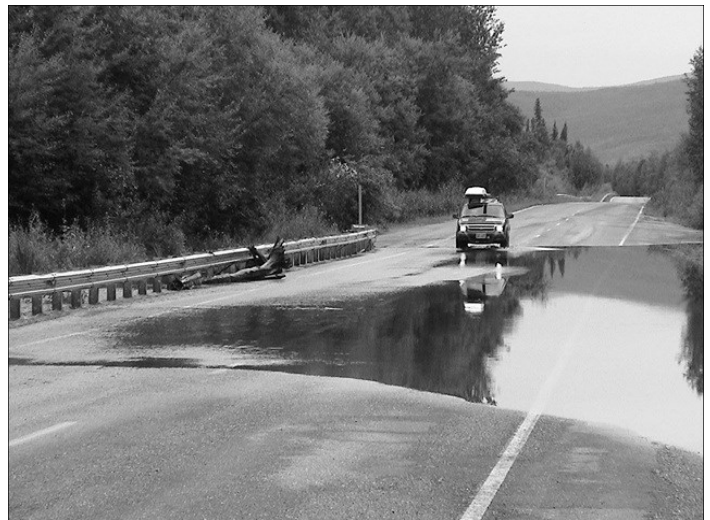
Minor flooding at Mile 31 of Chena Hot Springs Road in Fairbanks August 2003

Minor Flooding is defined to have minimal or no property damage, but possibly some public threat. In remote areas with few specific impacts, floods with 5-10 year recurrence interval would be assumed to be causing minor flooding on streams in the area. Examples of conditions that would be considered minor flooding include:

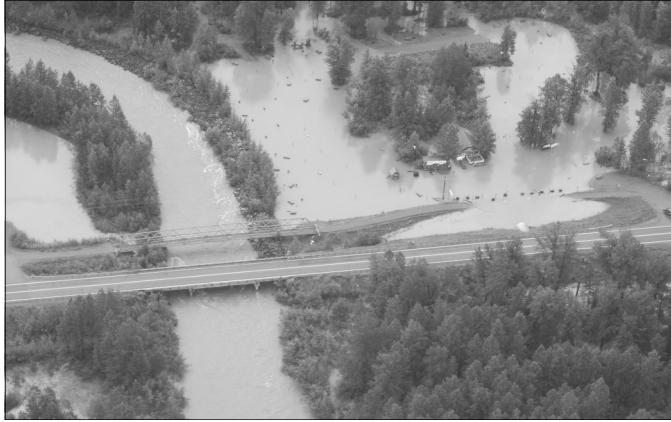
Water inundates the Montana Creek Campground located off the Parks Highway - an example of moderate flooding August 2006

Moderate Flooding is defined to have some inundation of structures and roads near the stream. Some evacuations of people and/or transfer of property to higher elevations may be necessary. In remote areas with few specific impacts, floods with 15-40 year recurrence interval would be assumed to be causing moderate flooding on streams in the area. Examples of conditions that would be considered moderate flooding include:

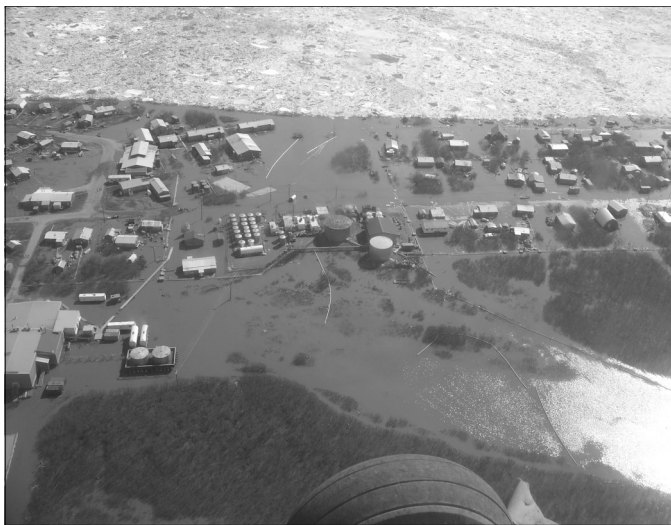
Moderate flooding in the village of Emmonak on the Yukon River May 2006

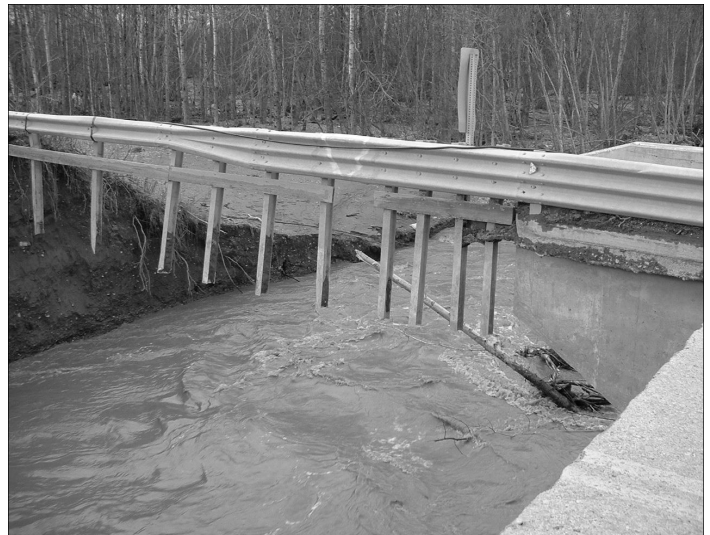
Bridge washed out over Deep Creek due to heavy rains October 2002

Major Flooding is defined to have extensive inundation of structures and roads. Significant evacuations of people and/or transfer of property to higher elevations are necessary. In remote areas with few specific impacts, floods with 50-100 year recurrence interval would be assumed to be causing major flooding on streams in the area. Examples of conditions that would be considered major flooding include:

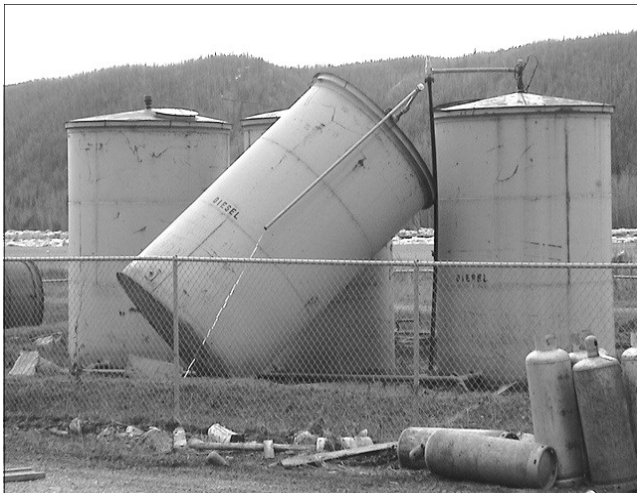
Fuel tank topples due to breakup related flooding in the village of Hughes on the Koyukuk River
May 2003

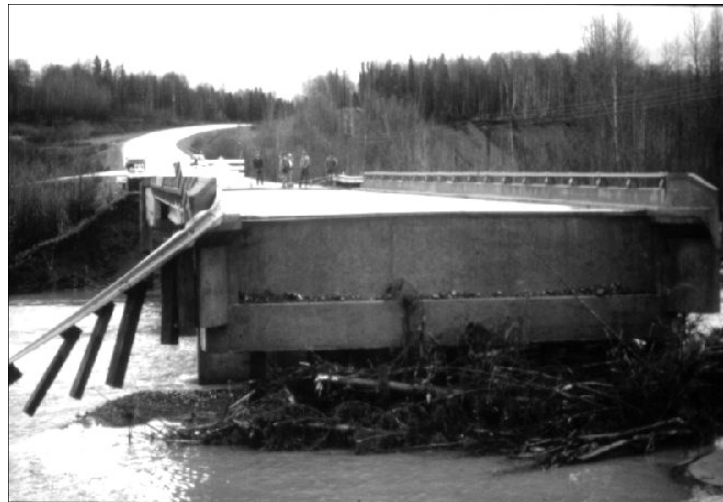
The approach to the bridge over Montana Creek on the Parks Highway washed out
October 1986
