**Mendenhall Valley Jökulhlaup
Flood Event**

**Alaska - Pacific
River Forecast Center
6930 Sand Lake Road
Anchorage, Alaska 99502-1845
<http://aprfc.arh.noaa.gov>
800-847-1739**

**Mendenhall Valley Jökulhlaup Flood Event
by Aaron Jacobs**

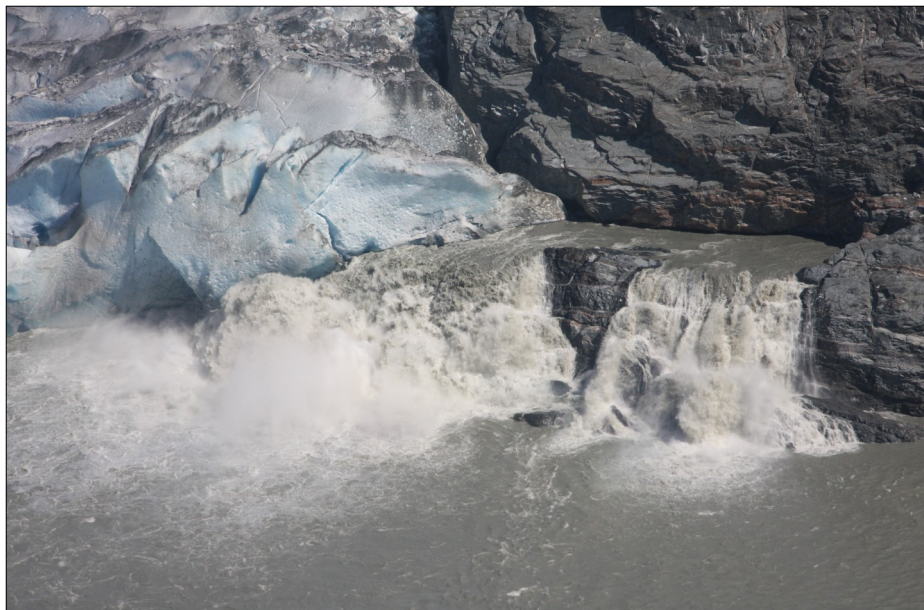
Flood waters flow underneath the Mendenhall Glacier. The flat rock the water is flowing over is approximately 75 feet wide.

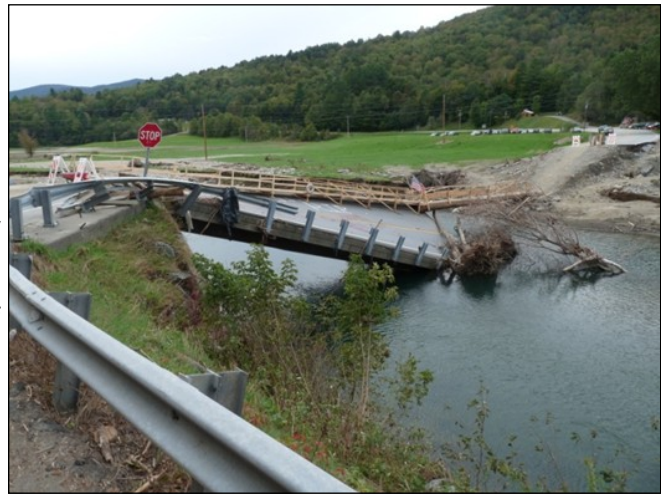
Bridge destroyed on Hwy 100
near Rochester, Vermont

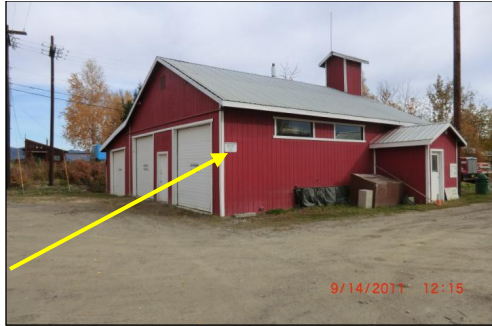
High Water Mark sign on the fire hall in Eagle to commemorate the devastating Yukon River ice jam flood in May 2009

The National Weather Service has teamed up with the US Army Corps of Engineers (COE) to install high water mark signs in several Alaska communities. These small placards identify the water depth and date of the record flood for the community. The signs are being placed in highly visible locations in order to bring awareness of flooding to the local residents and visitors. The first sign was installed at Crooked Creek on the Kuskokwim River to observe the record breakup flood last spring on May 8, 2011. Signs were also hung on the fire hall and Laundromat in Eagle to commemorate the devastating Yukon River ice jam flood in May 2009. Additional signs will be placed in other communities in years to come.
