Kuigmek: from the river

January 2024

Alaska-Pacific
River Forecast Center

Focus on: 2023 Breakup Summary - Crooked Creek

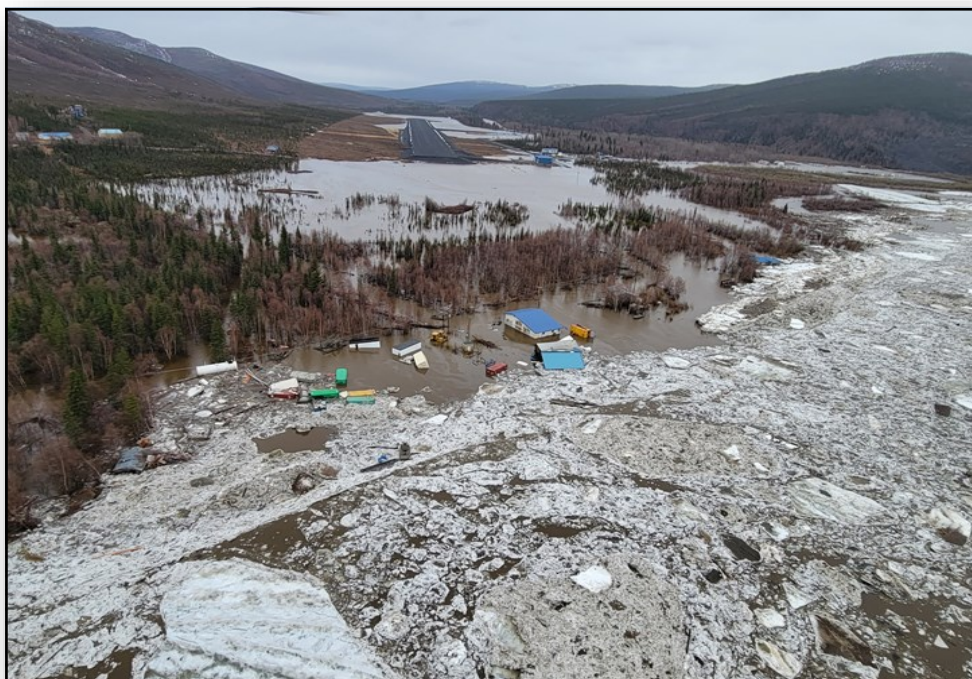
Figure 2: Aerial view of Crooked Creek flooding on the morning of the 14th, captured just after the river crested.

The River Watch team landed in Crooked Creek to relay the upriver ice jam information and local river conditions, briefing the community on the possibility of ice jamming and rising water. The ice jam formed downstream from Crooked Creek late on May 13 near Rabbit Island.

Water levels quickly rose tens of feet, flooding up to the second story of numerous buildings and forcing residents to evacuate uphill to the school. Aerial flights in the morning of the 14th confirmed widespread flooding in the community, with overbank ice and portions of the town cut off due to flooded local roads. Fortunately, the runway remained above the floodwaters and allowed for coordination and access for flood response.

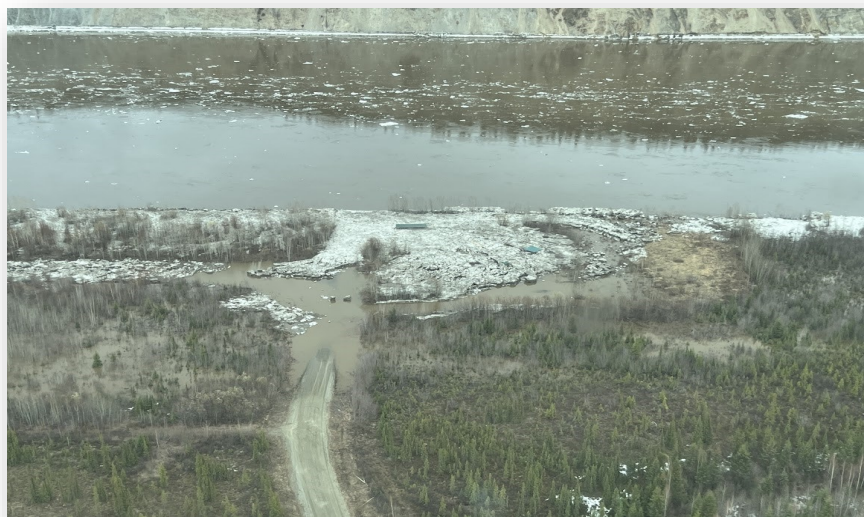
Figure 5: Moderate flooding in Eagle pushed ice overbank covering the access road between Eagle and Eagle Village. This took several days to clear.

The Fortymile ice arrived at Eagle late in the day on the 12th, flooded several buildings, and deposited ice on the road between Eagle and Eagle Village that limited access and took several days to remove. After Eagle, the breakup front kept moving - an observer 28 miles upriver of Circle reported the highest water they had ever seen at their cabin. On May 13, the Riverwatch team observed widespread flooding (trees inundated, islands covered in ice, river well out of bank) upriver from Circle. When the ice started running at Circle on May 13, the breakup front had a 90-mile-long ice run behind it.

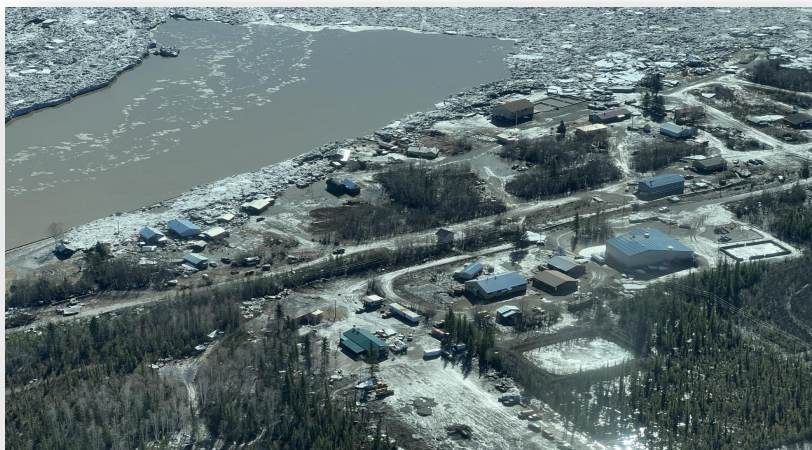
Figure 6: Stranded ice and floodwaters on May 14th in Circle. In addition to the flooding, the water had lifted and shifted some buildings off their foundations.

Flooding in Circle occurred quickly; the water rose extremely fast, and major flooding was first reported around 8 pm. Overnight, there was extensive damage, with flood waters likely higher than the previous flood of record, 1945. Most structures in the town flooded; the store had water up to the first floor's ceiling, and the airport apron and taxiway were flooded. Ice was stranded along the waterfront throughout the community. By the following day, floodwaters had receded and dropped below the airport access road by 3 pm May 14.

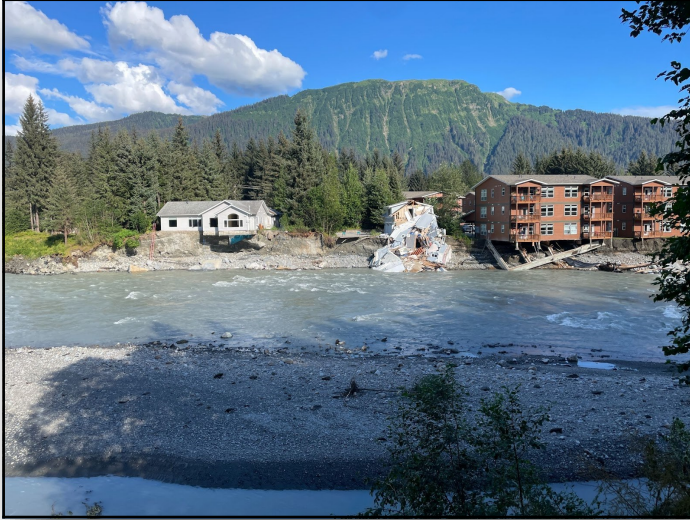
Figure 10: Mendenhall River looking at Riverside Condos, a house that fell into the river, and a major damaged house.

On August 5th, 2023, the Mendenhall River in Juneau flooded, cresting three feet above any previous record. This flood caused significant flooding and erosion along Mendenhall Lake and River. From the flooding alone, several homes had six feet of water in them. The erosion took 20-150 feet of land in some locations, compromising multiple homes and an apartment complex.
