NOAA Technical Memorandum NWS WR- 147

OCCURRENCE AND DISTRIBUTION OF FLASH FLOODS IN THE
WESTERN REGION

Thomas L. Dietrich
Western Region Headquarters
Hydrology Division
Salt Lake City, Utah
December 1979

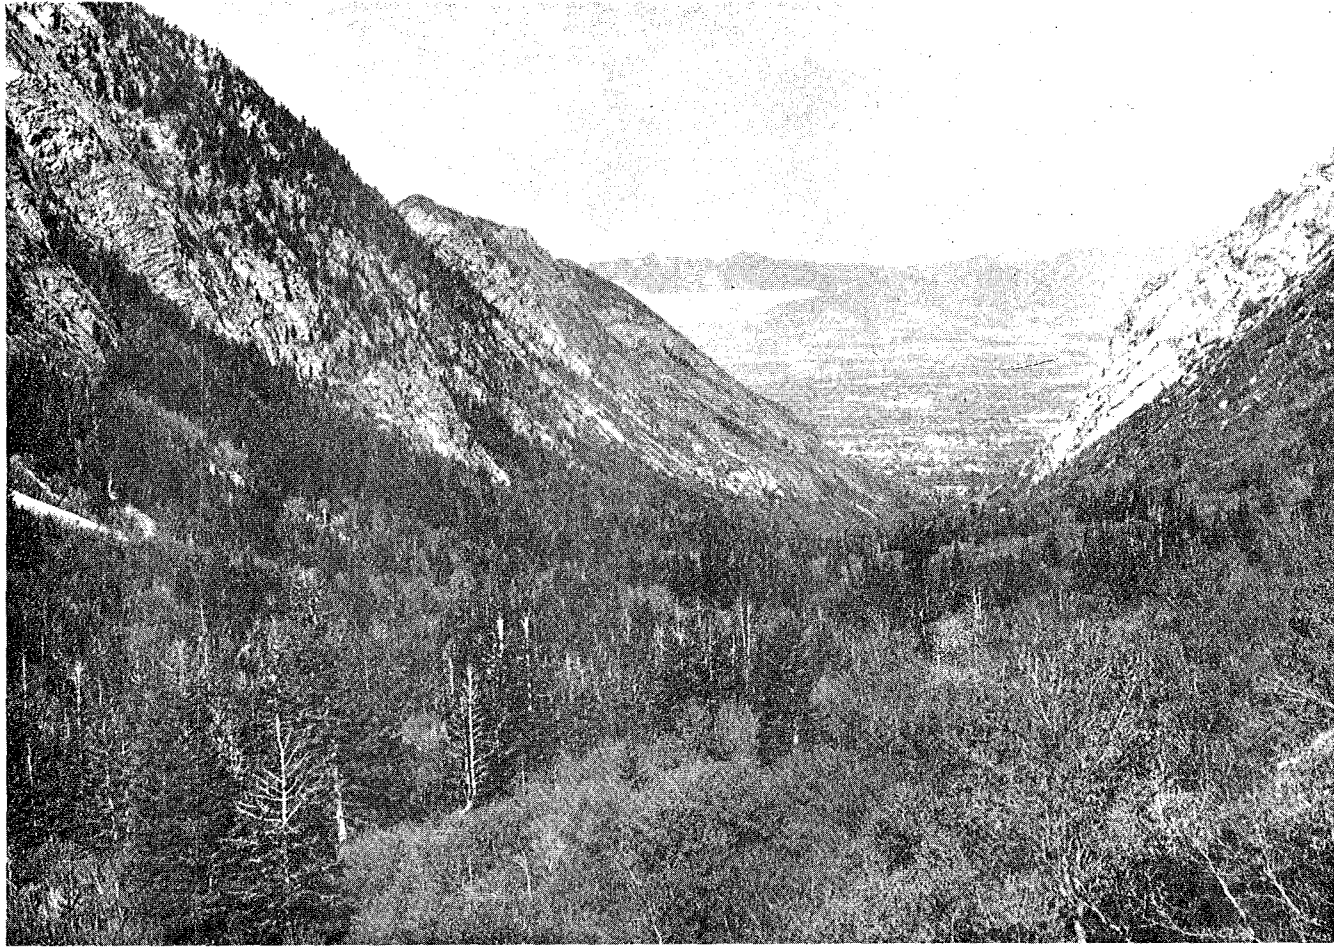
Figure 8. Little Cottonwood Canyon, near Salt Lake City, Utah

In the Western Region topography plays a very important role in the generation of flash floods. The steep slopes and cliffs (Figure 8) provide a strong orographic lifting mechanism intensifying the precipitation. The intense, short duration precipitation in turn produces rapid runoff and very high peaks for small amounts of rainfall.

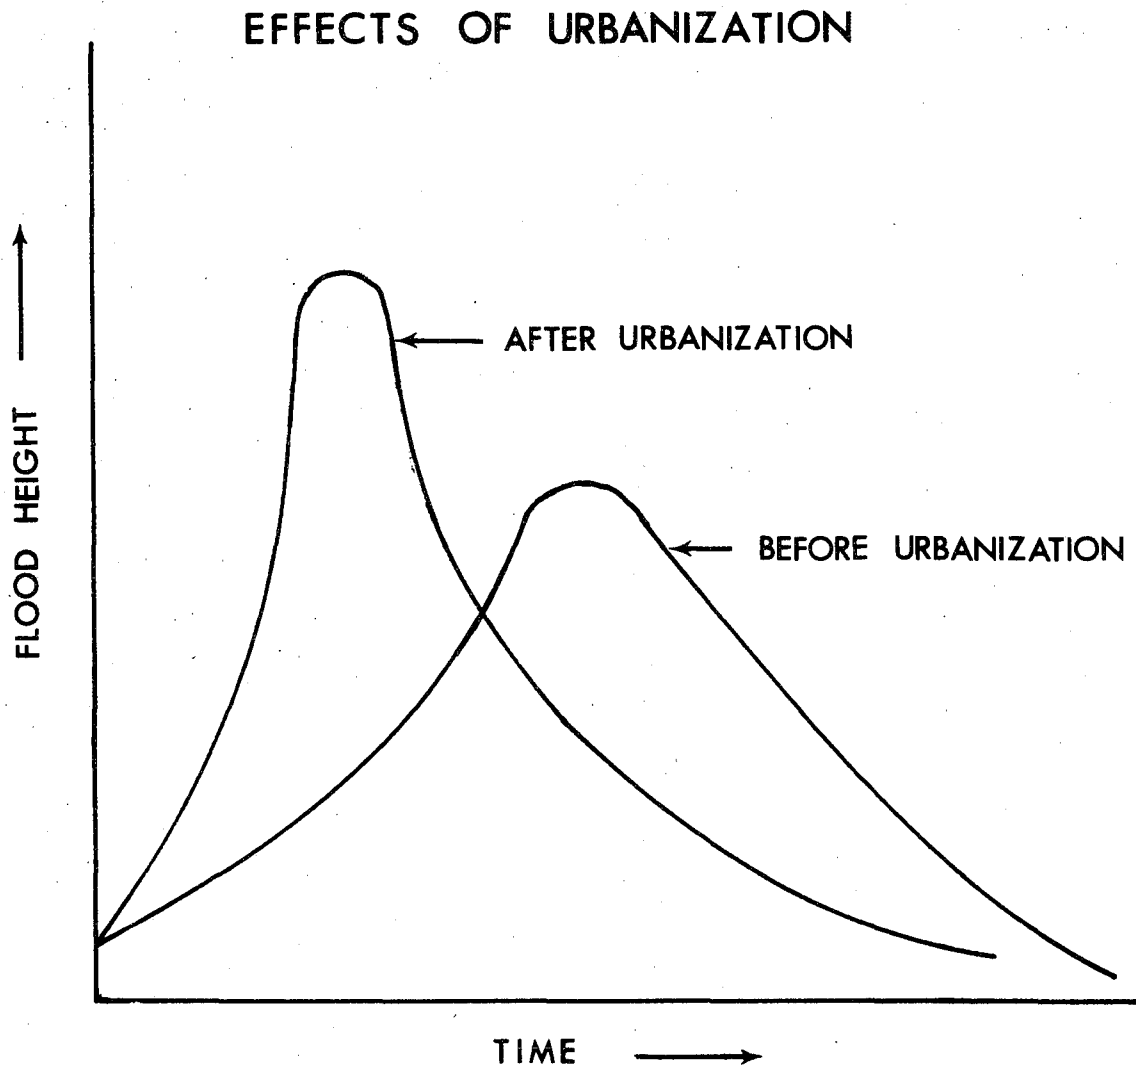
Figure 10. Effects of Urbanization on Flood Heights

Urbanization (Figure 9), with more roads, parking lots and buildings, produces increased runoff amounts and quicker response times (Figure 10) over what would occur in the natural landscape.

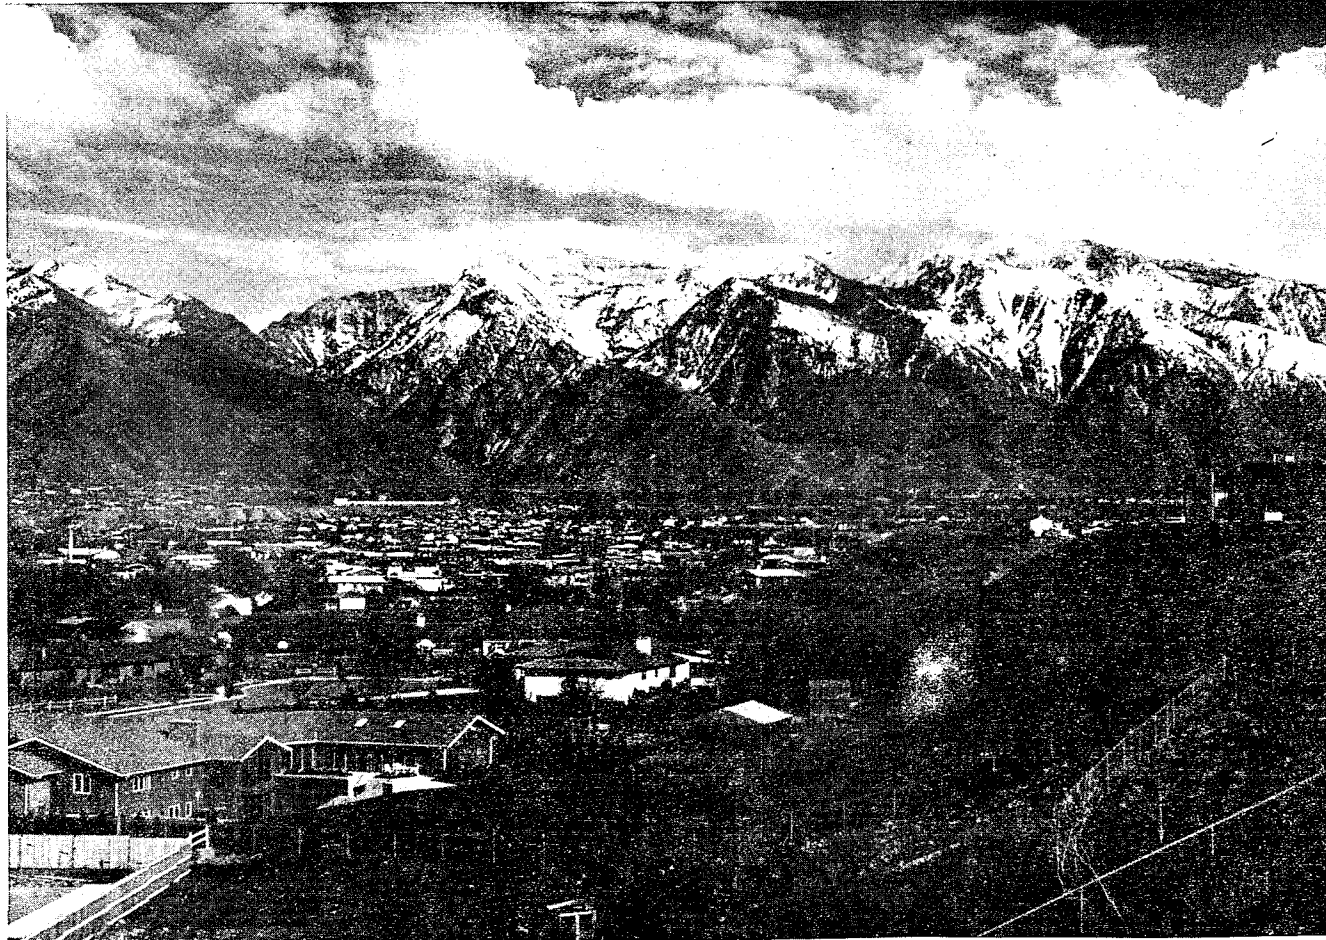
Figure 14. Wasatch Front, Salt Lake City, Utah

The short, steep canyons and large ravines that drain the west-facing slope of the Wasatch Range (Figure 14) are especially vulnerable to flash floods. According to Butler and Marsell (1972), 31% of the flash floods reported in Utah from 1939 to 1969 were in the six counties along the Wasatch Front.
