Coastal Erosion and Adaptation on the Rhode Island Coastline

Summary Report, May 2013

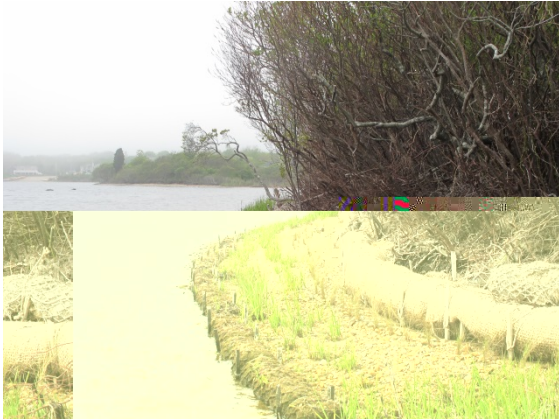
Bioengineering or soft engineering techniques include the use of biodegradable materials such as jute and coir fibers to protect shorelines from erosion. Coir logs are made from woven coconut fiber and can be used at the base of an eroding bank or salt marsh. This is an example of a project in Charlestown, RI where a combination of coir logs and marsh grass was used.

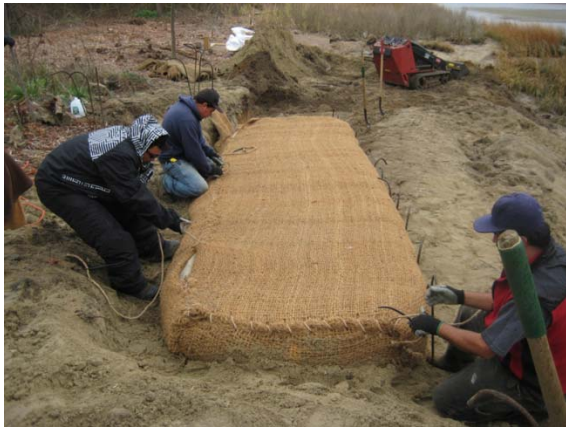
Coir envelopes are coir fabric filled in place with locally compatible sand and then stitched together, holding the sand in place. These envelopes can then be used to create a terraced bank where natural material and sand absorb wave energy and reduce erosive wave reflection. Coir envelopes should be planted or seeded with native grasses or coastal shrubs to prevent breakdown of the material by UV exposure. This is an example from Byway Road in Barrington, RI.

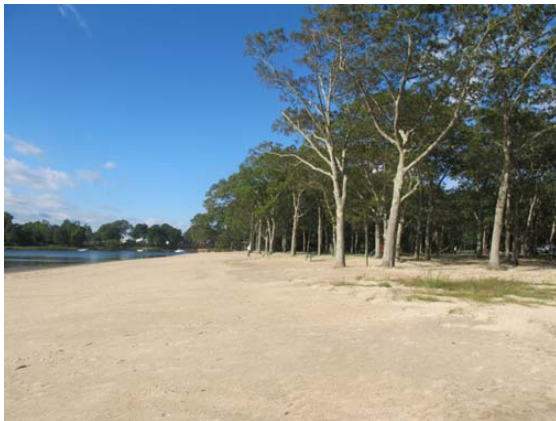
In this case at City Park Beach in Warwick, there was an area where there was room to grade and carve back the shoreline to create a more gradual, dissipative slope. In some of these areas, it may be possible to combine a living shoreline approach. Shoreline grading is regulated under Section 300.2 of the CRMC regulation. The standards for shoreline grading state that “cutting into rather than filling out over a coastal bank is the preferred method of changing upland slopes”.

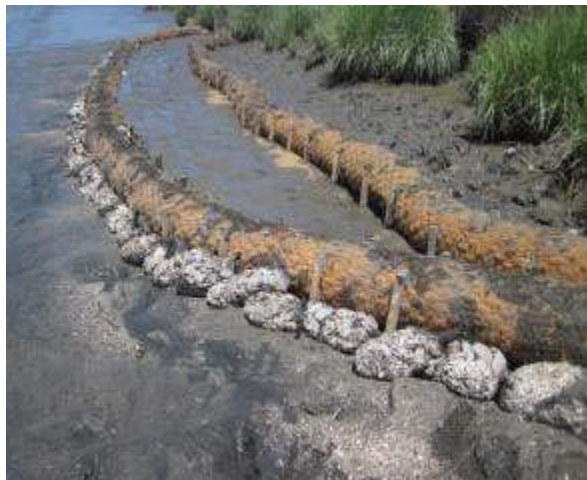
This technique involves using natural materials to recruit bivalves such as ribbed mussels or oysters to stabilize low marsh edges. The approach combines the use of coir fabric and logs with shell bags or other substrate. The shellfish bind tightly together and allow sediment to accumulate while adding habitat complexity and preventing erosion of the marsh edge. Mussel beds can also protect the marsh edge from goose predation and can benefit other species of fish and crabs. This example from Delaware Bay shows the use of shell bags in front of coir logs that were seeded with mussels (Whalen, et al. 2011).

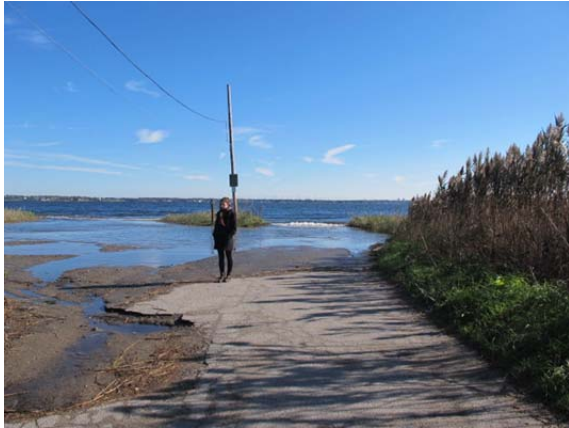
There are areas where shoreline retreat may be the best adaptive technique when dealing with erosion and sea level rise. This could include closing roads that are located in a tidal marsh or removing infrastructure. In areas where roads are at or just above high tide, alternative access will need to be provided during storm events and spring tides. Long term planning for moving recreational facilities and homes or outbuildings may also be appropriate where erosion rates are significant or where there is space to move the structure inland. This public access area at the end

of Samuel Gorton Ave in Warwick may need to be removed in the future.

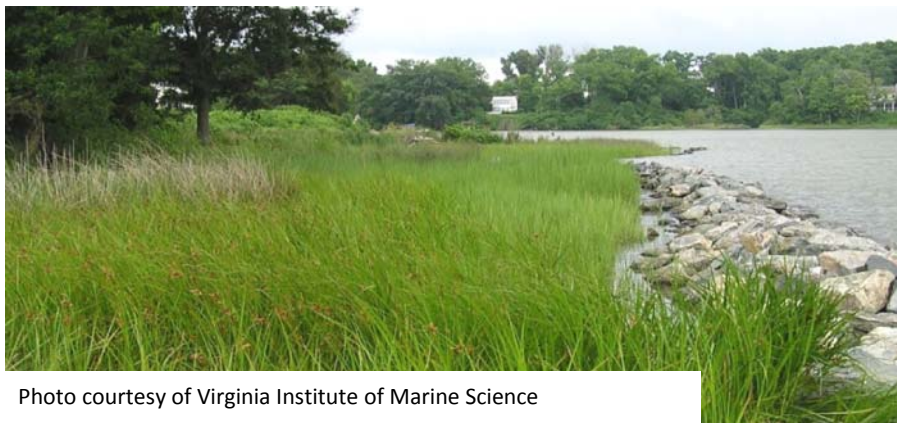
Photo courtesy of Virginia Institute of Marine Science

The marsh sill technique utilizes stone as erosion protection at the edge of the marsh. The design is often segmented or offset so that habitat continuity is not interrupted and fish and other animals can move in and out of the marsh. The example

above is from the Chesapeake Bay where the tidal range is lower and the intertidal area is wide and flat.

While a slope of 10% is shown in much of the design guidance for marsh sills, a more gradual slope closer to 20:1 has been used as design guidance for marsh sill projects in Narragansett Bay. Maryland's Living Shoreline regulations recommend no greater than 3.5 feet of water depth 30 feet from the edge of the existing shoreline in order to create the 10:1 slope.

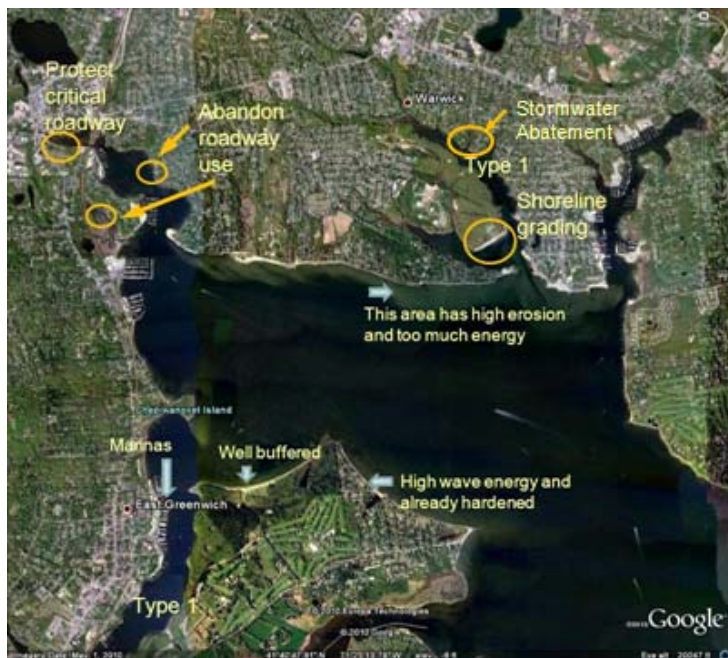
There are few areas where Living Shorelines would be a viable option in Greenwich Bay because much of the shoreline is already hardened or it is well buffered and there is room for retreat. The use of the Living Shoreline marsh sill technique may not be suitable in the Type 1 waters of Buttonwoods, Brushneck and Greenwich Coves since there is already a fringing salt marsh adjacent to the shore. Apponaug Cove is Type 3 waters, and would be suitable due to the water type classification, but has several areas with very steep banks. There is already quite a bit of fringe marsh in this cove, often in

front of shoreline structures. Warwick Cove could also be a suitable location, but there is already a significant amount of fringing marsh habitat present.

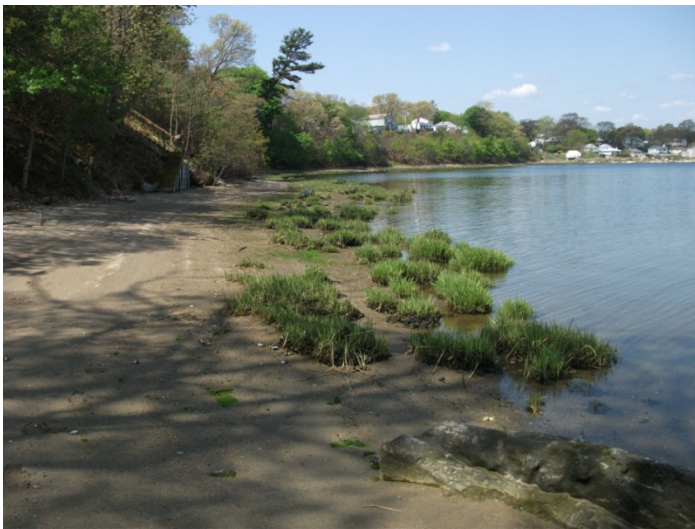
Apponaug Cove: *This shoreline in Apponaug has areas of patchy fringe marsh. It has most likely been impacted by goose predation and shading. The high tide reaches the base of the bluff which is very steep. The intertidal area is shallow, but it still may not be an ideal site for a Living Shoreline marsh sill since the existing marsh area is impacted by geese predation and it would be difficult to establish a new marsh area.*

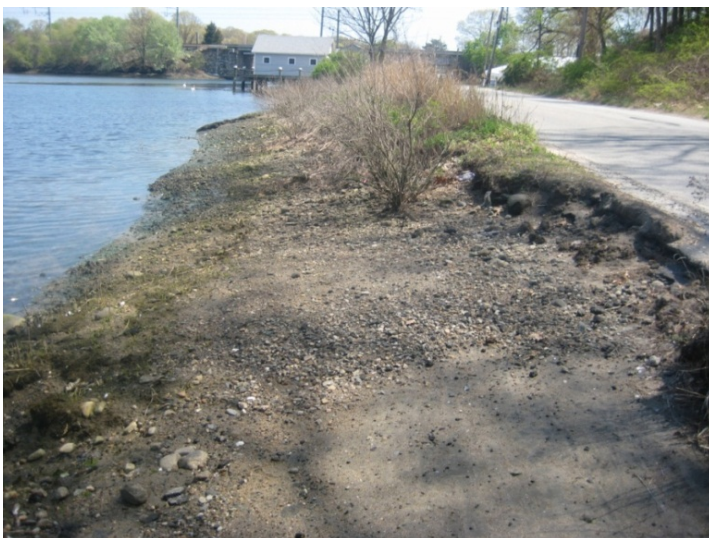
Arnold's Neck Road on Apponaug Cove, *is a possible Living Shoreline site due to low fetch and wide intertidal areas. Challenges include managing stormwater to reduce erosion in an area with limited space and infiltration opportunities. The existing salt marsh is eroding and damaged by a large swan and goose population. A Living Shoreline marsh sill technique would require intertidal fill and a stone sill to create the necessary slope for salt marsh vegetation. The Living Shoreline technique would not solve the flooding from the cove during moon tides due to the road's low elevation.*

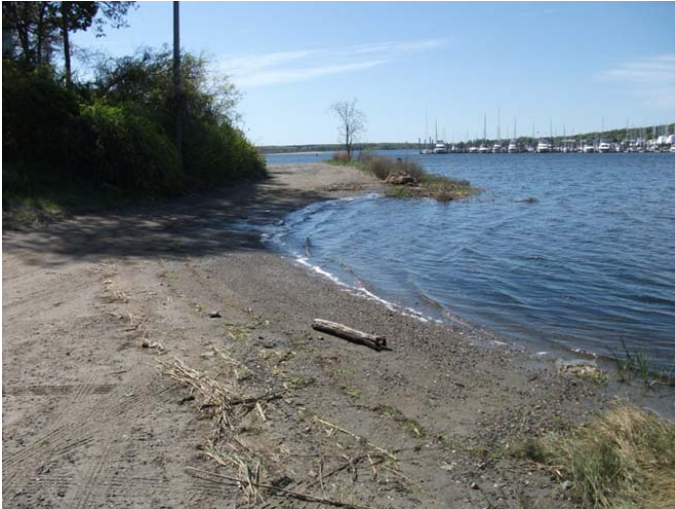
Edgewater Drive on Apponaug Cove is a potential site for abandonment by restricting vehicular access while maintaining public access. This is an unimproved road that still gets use at low tide. It is almost impassable at high tide and could become a safety hazard if not blocked to traffic. Vehicular use in the intertidal area and subsequent soil compaction has impeded fringe marsh from developing.

discontinuing the use of roadways that are either in a salt marsh, or are partially inundated during high tide including Midgely Avenue and Edgewater Drive. The Warwick City Park beach was identified as an area where the shoreline could be carved back and graded in response to continued erosion. This project was completed by the City of Warwick in 2012 as a pilot project identified through this assessment. Arnold's Neck Road, which is the primary access to Apponaug Cove Marina and the Arnold's Neck neighborhood, was identified as a critical piece of infrastructure that should be protected. The road is currently situated just above the high tide line, and will face continued inundation with sea level rise. This road could be protected with a Living Shoreline marsh sill if it was also raised and if the design included infiltration of storm water. It would be difficult to raise this road because of clearance issues with the overhead rail line.

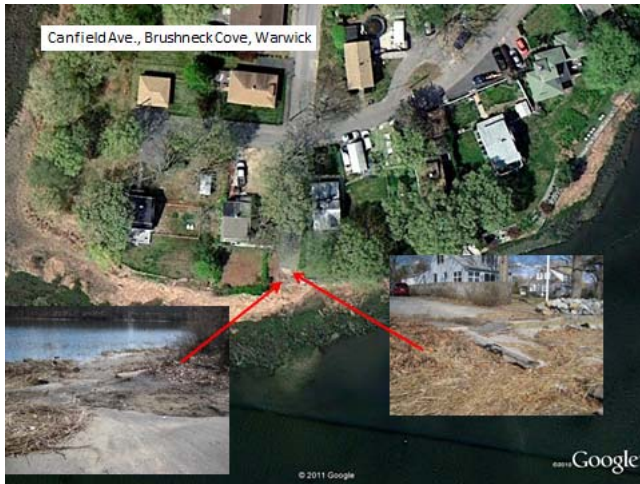
Brushneck Cove, end of road stormwater abatement - Canfield Avenue has opportunities for removal of pavement and a concrete swale that directs stormwater directly to the shore causing erosion of the fringe marsh. Approximately 60 feet of pavement could be removed to allow for stormwater infiltration and the marsh could be replanted.

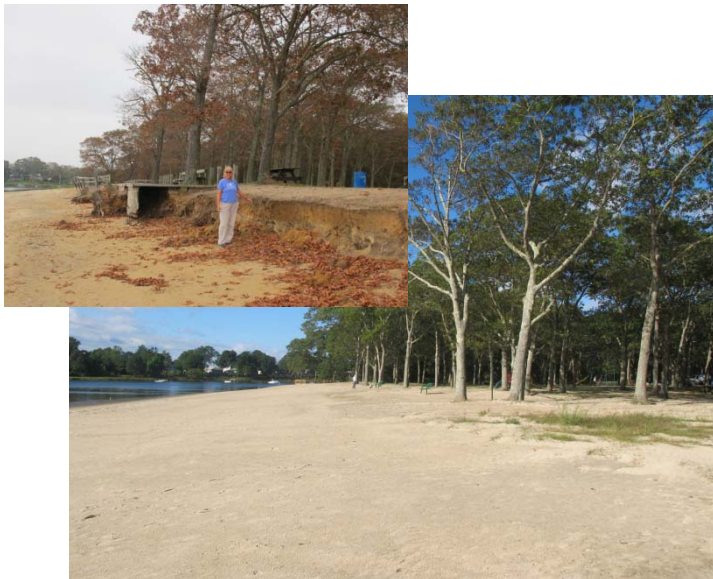
Warwick City Park - In 2004, the City of Warwick received a permit from CRMC to grade an area of the beach shoreline and to remove part of a boardwalk structure at the top of the bank. Erosion of the site continued and the structure continued to be undermined. In 2012, The City received a permit to grade the bank further to reduce the slope and to provide the beach an area to migrate inland as erosion continues.
