# GOES-17 Loop Heat Pipe Fact Sheet

## Role of the Advanced Baseline Imager (ABI) Loop Heat Pipe

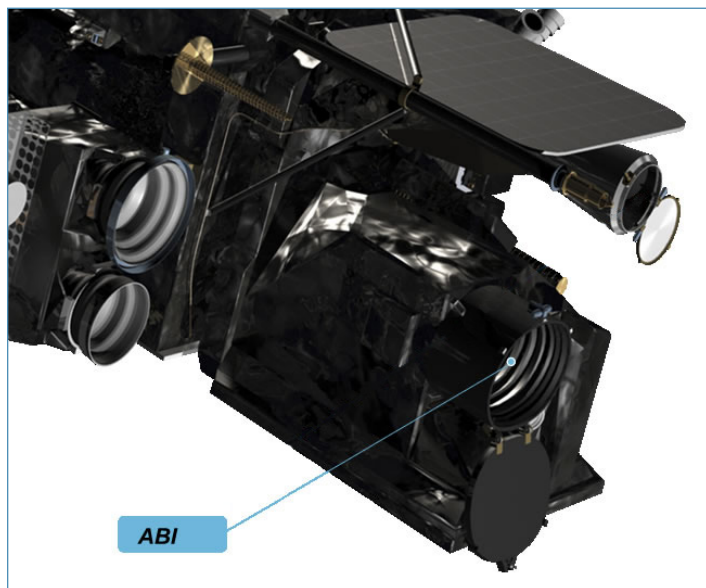
The ABI infrared detectors need to be cold to accurately measure thermal energy from Earth's atmosphere.
