# May 22, 2011 Joplin, MO Tornado Study

## Draft Study Plan and Research Overview

*Briefing for NCST Advisory Committee  
November 7, 2011*

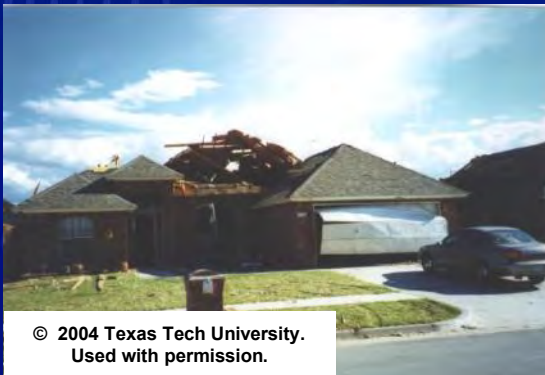
**EF1**

- Typical damage state with EF-scale rating:

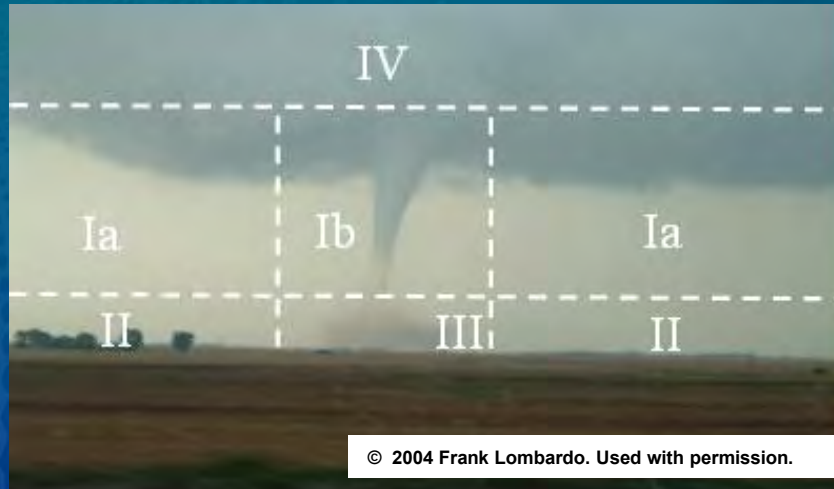
- Tornado Flow Regions

- Ia. Outer Flow
- Ib. Core Flow
- II. Boundary Layer
- III. Corner Flow
- IV. Mesocyclone

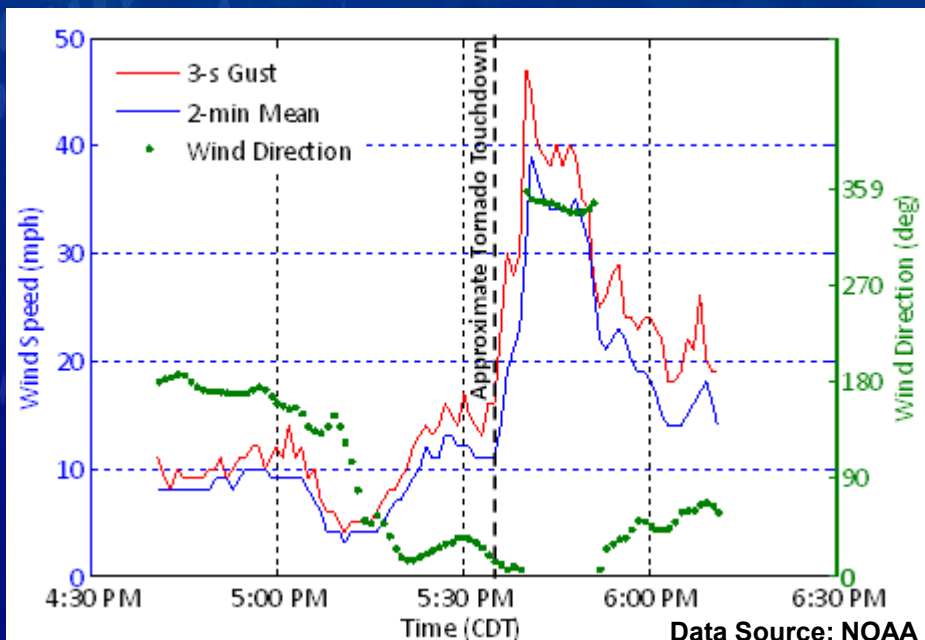
Joplin airport 10m anemometry data showing effects of tornado even though ~ 5-6 miles away! (Region II)

- Gusts ~50 mph
- Sustained ~40 mph
- Wind direction corroborates tornado position (south of airport)

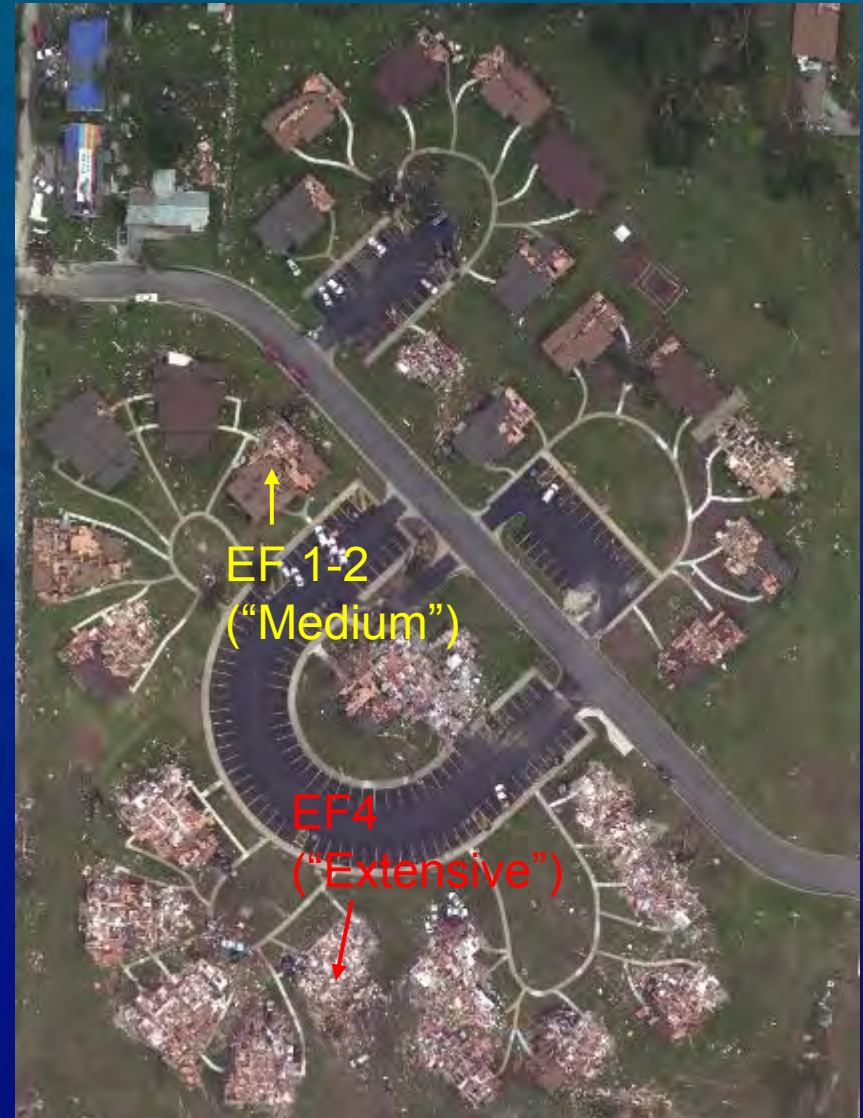
- Observed Damage (Using EF-scale)
- Three data sources
  1. NIST rated from aerial photos and ground photos/videos
  2. Jasper County Geographic Information Services (GIS)
  3. US Army Corps of Engineers (USACE)

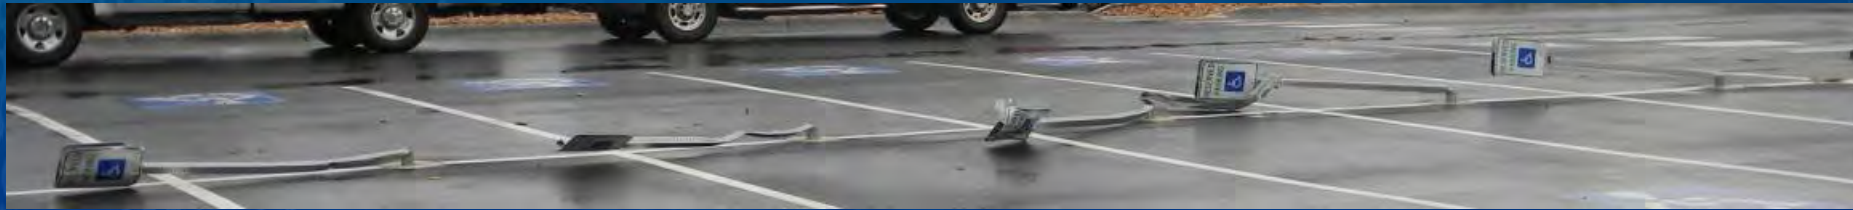
- Back calculations of wind speed from discrete structural failures
  - Lower and upper bounds on wind speed
  - Sign/Lightpost Failure
    - Used in other studies → obtained samples from Joplin Public Works

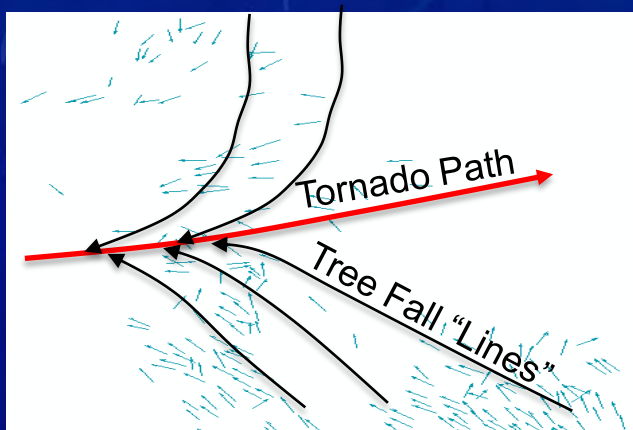
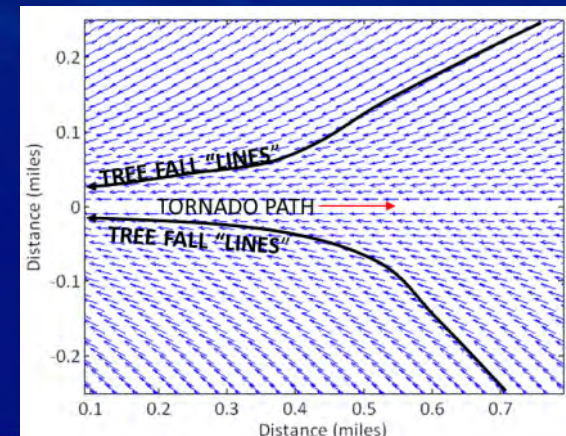
- Tree fall analysis
  - Recent work (Beck and Dotzek, 2010) incorporates both:
    - Wind Field and Tree Damage Model → estimate wind speed

← Actual and Modeled →  
tree fall patterns near  
St. Johns Hospital

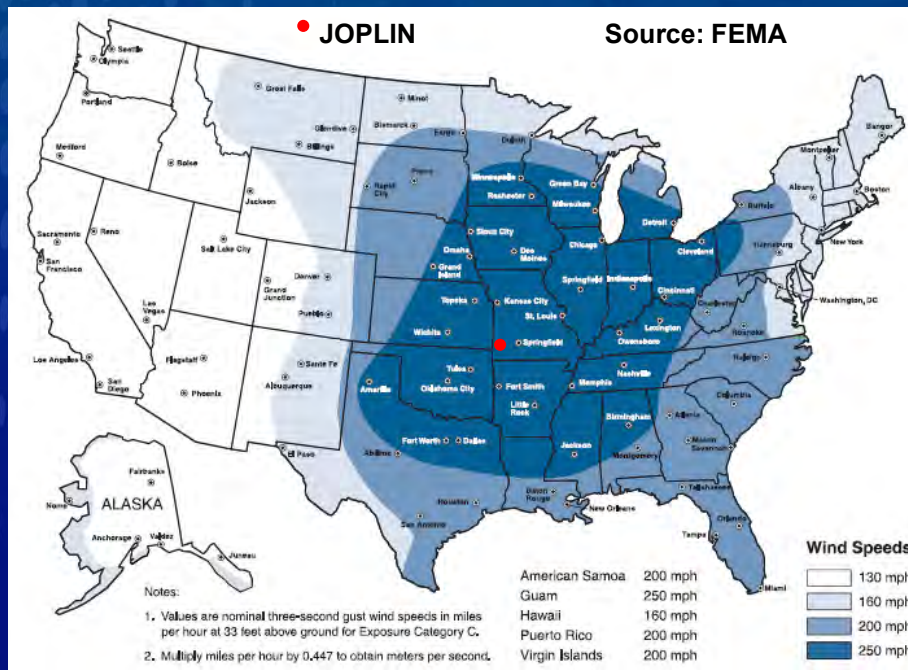
Tornado Safe Room  
Design Wind Speed  
Map (FEMA 361)

- Tornado Hazards Specified in Standards and Guidelines
  - ANSI/ANS-2.3-2011 (for Nuclear Facilities)
  - ASCE/SEI 7-10 (Commentary) →  $10^{-5}$  annual probability (ANSI map)
  - ICC 500, FEMA 361 (for Storm Shelters, Safe Rooms)
  - Typically based on a “point” approach → design of a single structure

Consistent with Tornado  
Hazard Map in the  
ICC 500 Storm Shelter  
Standard

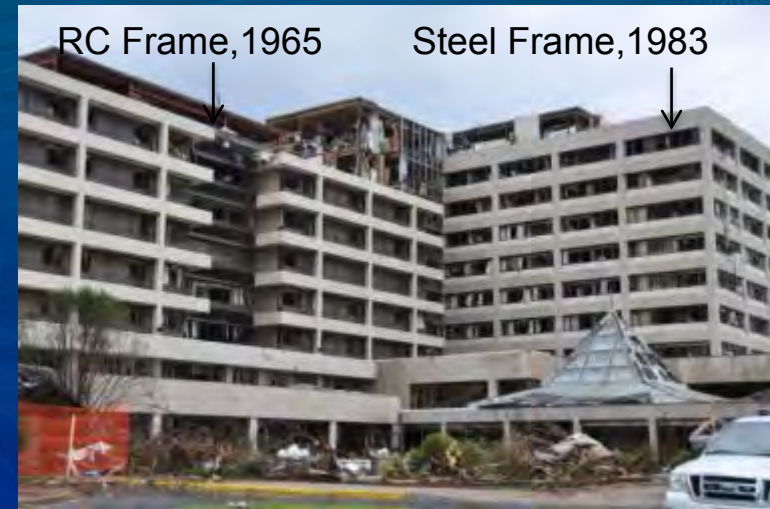
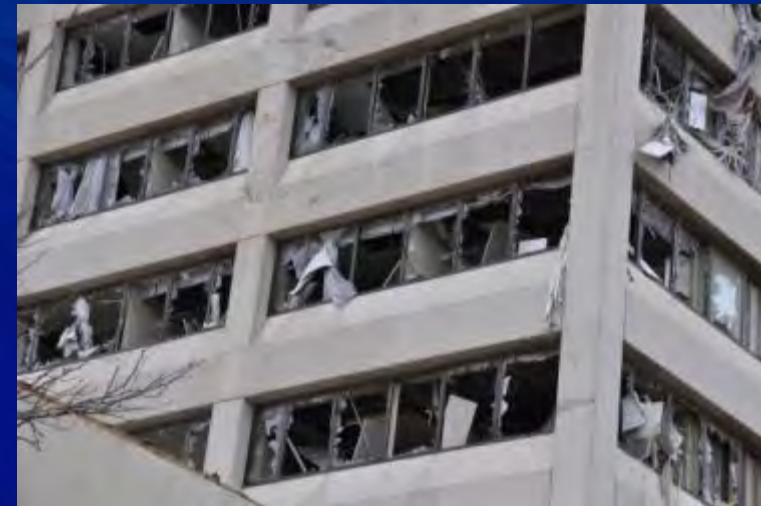
- **Main Buildings** (RC, Steel Frame): Extensive damage to envelope (glazing; roof blow-off) and interior; No observed damage to Main Wind Force Resisting System (MWFRS); Loss of function
- **Ancillary Buildings** (CMU): Collapsed or substantially damaged
- **Performance Issues:**
  - Building envelope/Loss of function
  - Collapse/damage of ancillary buildings
  - Life safety, continuity of vital service not achieved

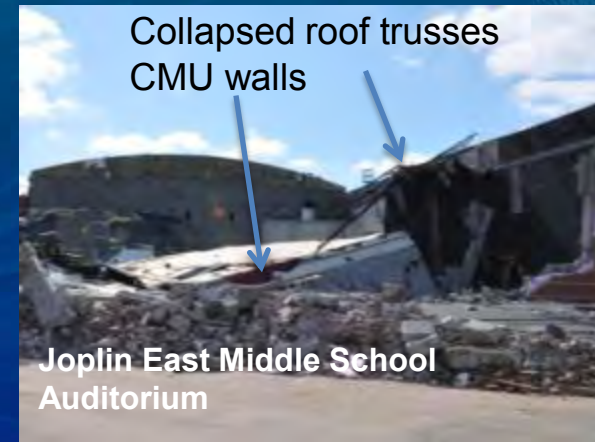
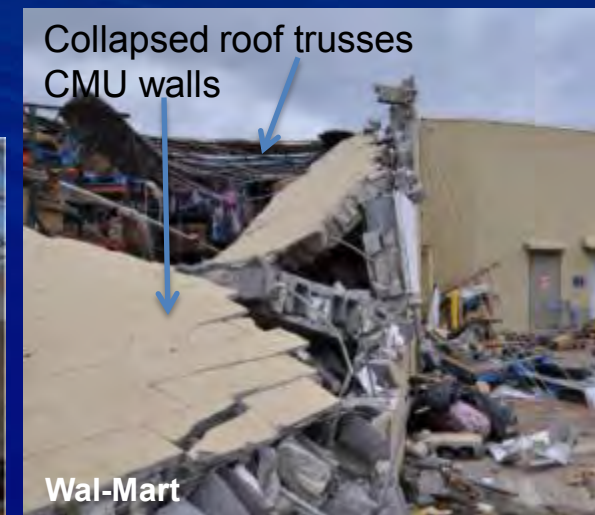
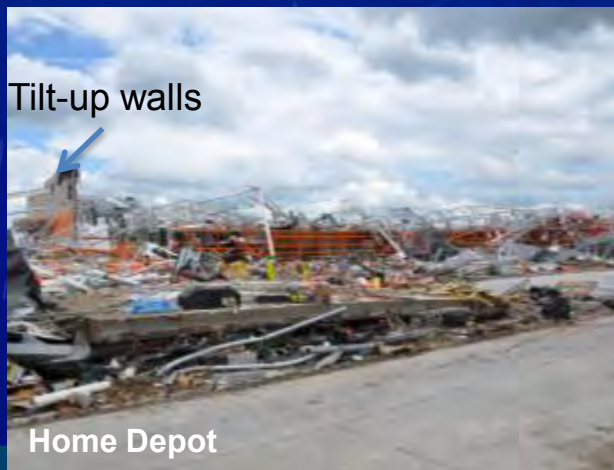
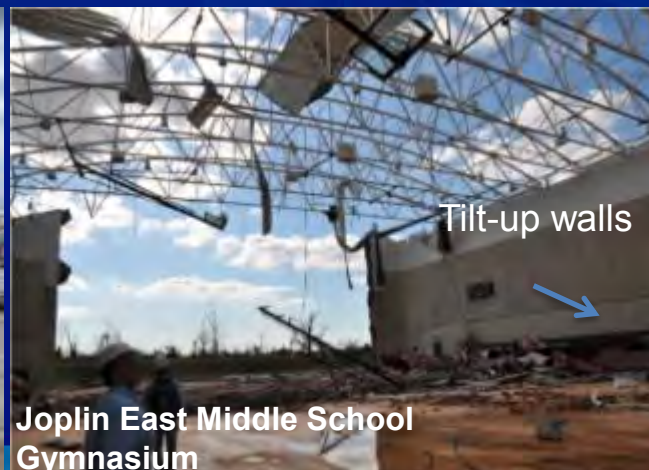
- Tilt-up Wall, CMU Wall with Long-Span Joist Roof: Partial or complete loss of roofing system; Failure of roof-to-wall connections; Collapse of walls
- Performance Issues:
  - Load Path Continuity
  - Robustness

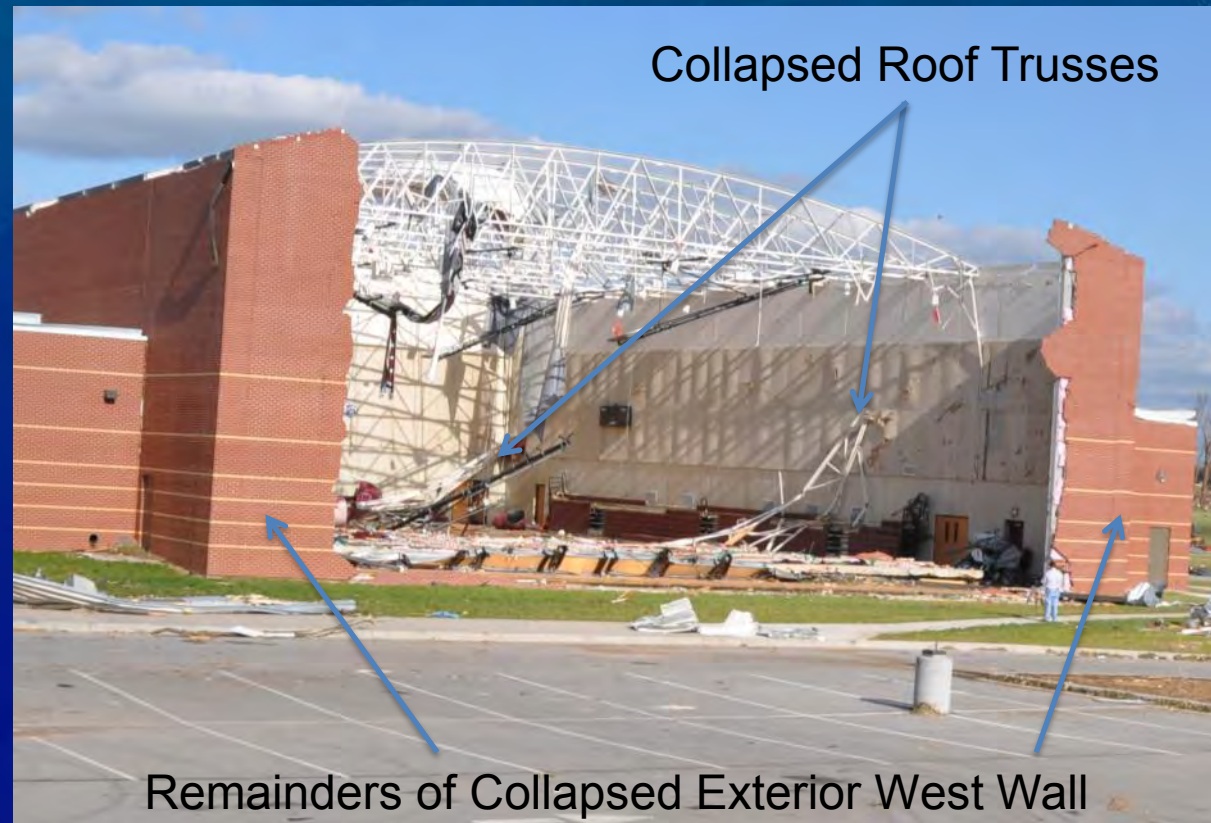
Analysis of Video from Joplin School District Shows Damage Sequence at Joplin East Middle School's Gymnasium

- Loss of steel roof deck
- Collapse of roof trusses (loss of roof-to-wall connection)

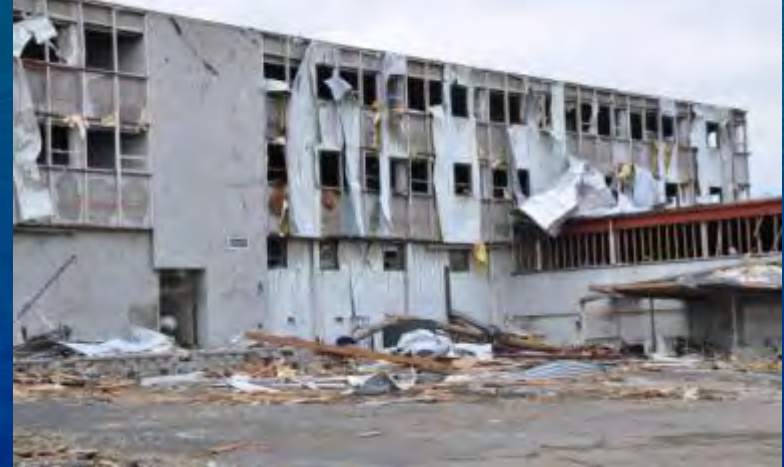
4-Story RC Frame Professional Building

- **RC Frame:** Extensive damage to envelope; No observed damage to MWFRS; Loss of function
- **Light Steel Frame:** Loss of roofing system and building envelope; Damage to structural frame varied from none to moderate, but no collapse
- **Performance Issues:**
  - Building envelope/Loss of function

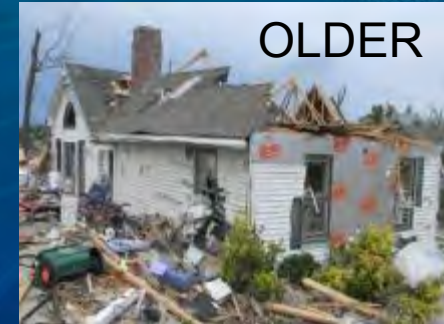
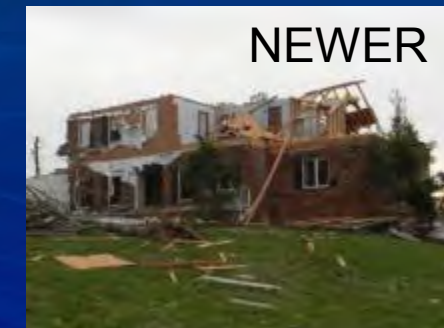
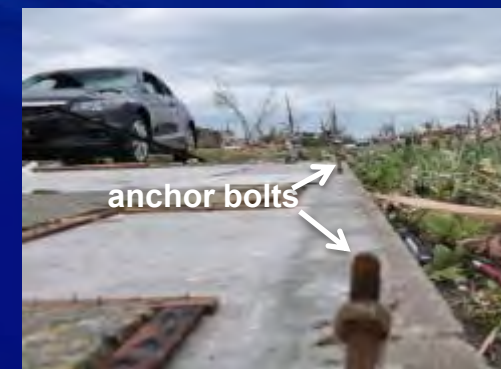
- Wood Frame Single and Multi-Family:
  - Both older (late 1980's) and newer (early 2000's) construction sustained similar damage
  - Damage typically ranged from damage to roof and exterior walls to complete collapse.
- Performance Issues:
  - Building envelope
  - Collapse

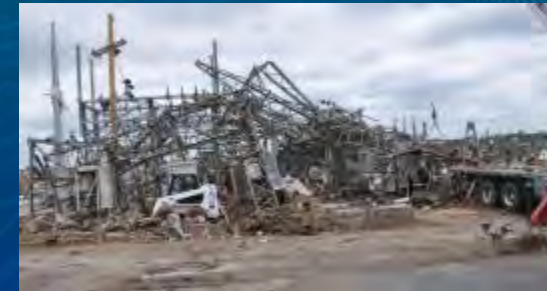
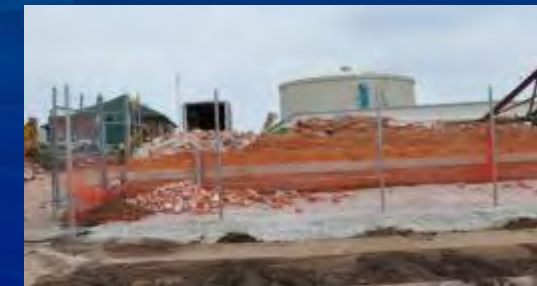
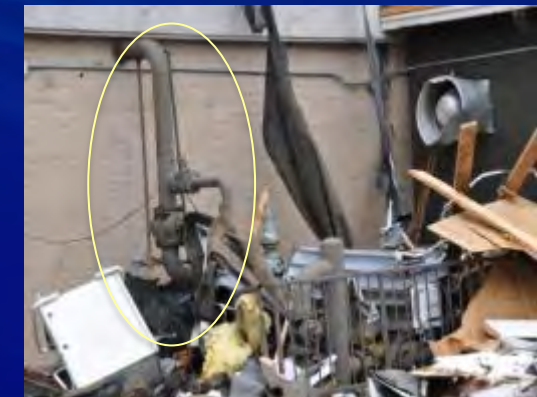
- **Power:** (Source: Empire District Electric)
  - 1 power substation destroyed (supporting steel frame collapsed), 2 damaged. 20,000 without power.
  - Approx. 3,900 poles damaged; 100 miles of line downed; 31 circuits off
  - 10 transmission lines out of service; 135 transmission structures affected; 30 fiber lines cut
- **Water Treatment Plant:** (Source: Missouri American Water Engineering)
  - Unreinforced brick storage building (1898) collapsed
  - Plant remained operational on back-up power
- **High Pressure Gas Valve** (Source: St. John's Hospital)
  - Major leak adjacent to area used to triage tornado victims
  - Not shut off for some time
- **Water:** (Source: Joplin Fire Department)
  - Numerous small leaks due to broken pipes in damaged buildings
  - Unable to use fire hydrants in some areas due to low pressure

- Performance of Lifelines
  - Utility-related fires did not play a prominent role in fatalities, injuries, or property damage
  - Loss of power affected functionality of hospital

- Residential water leaks presented potential negative effect on fire fighting effectiveness
  - High pressure gas leak at hospital presented potential hazardous condition
